Appendix A

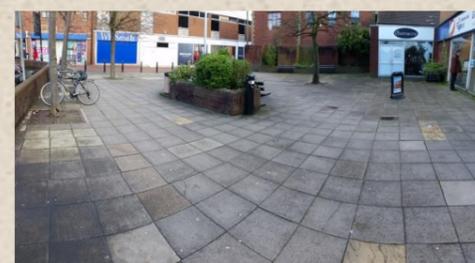
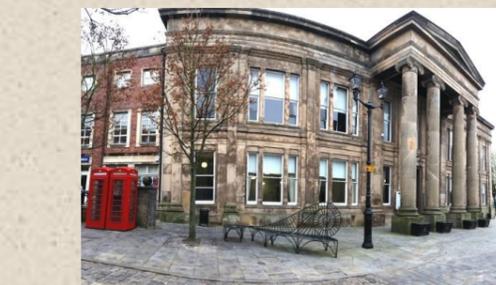
Exchange Street

- Very poor quality public realm
- Deprived impression
- General feeling of neglect
- Mix of street furniture
- Old, dated bins
- Poor bollards mixed with good bollards – that need restoring/painting
- Poor landscaping
- Poor quality paving
- Poor 'modern' street furniture
- To completely renovate this busy area with new paving, landscaping, street furniture and lighting

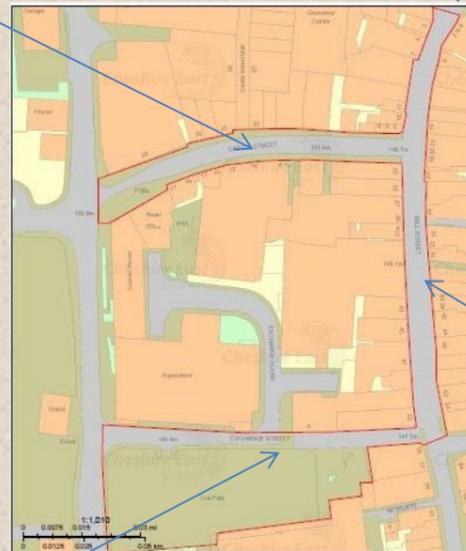
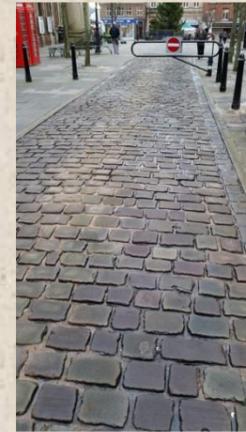
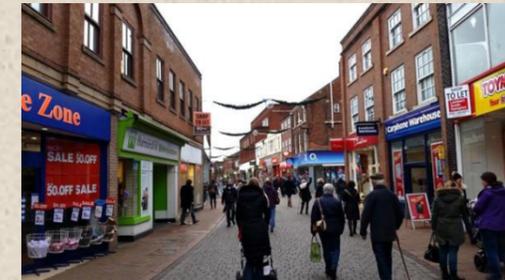
- Central Historic Quarter
- High quality materials
- Bespoke street furniture
- Recently refurbished street furniture, although seats adjacent to NatWest need painting due to skateboarding
- Possibility of cherry lights in trees
- Possibility of LED uplights onto Town Hall pillars
- BT Phone boxes recently restored
- High quality cobbles/setts
- 'No Entry' sign on barrier ugly
- Possible 'gateway to Mill Street' on entry
- Noticeable difference of quality between Market Place and Mill Street cobbles/setts

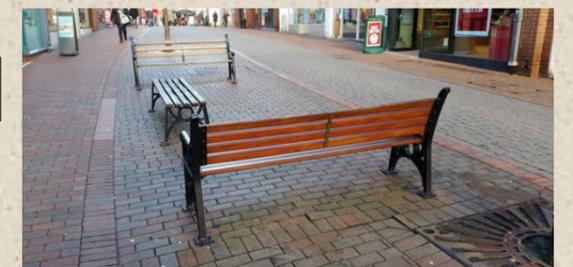
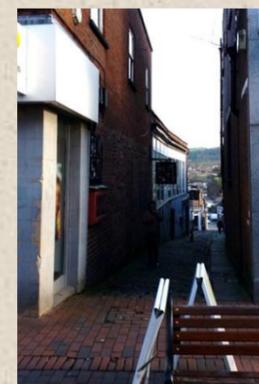
- To continue Market Place quality down Mill Street would be too expensive
- Maintenance issues – drainage/damaged grids
- Possible 'feature' could be made of Back Wall Gate entrance/area
- Street furniture recently painted
- More bespoke furniture could improve area
- Layout of street furniture poor – to review
- Maintenance issues
- Significant lighting improvements would greatly enhance all of Mill Street
- Maintenance issues – giving poor image of the town
- Dead trees in pits to be replaced
- Temporary tarmac in tree pits to be replaced with new trees
