# **THE SILK ROAD, BOLLINGTON**

## **PROPOSED PEDESTRIAN CROSSING**

### **Road Safety Audit Stage 1**

**January 2017**

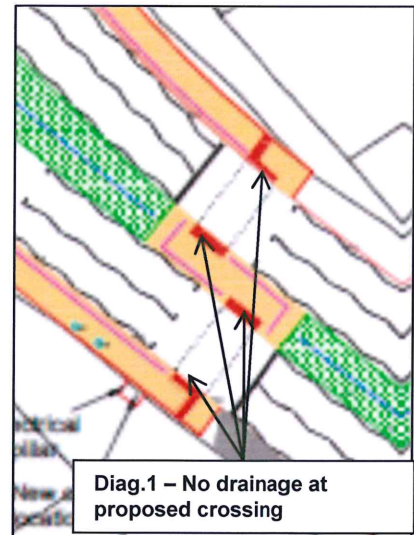
**Description:** The proposed crossing points will lie inbetween existing gully locations. The Audit team feel that this may not remove all standing water from immediately in front of the proposed dropped crossing. Any standing water could lead to a slipping hazard for Non Motorised users (NMU's), particularly during cold weather where ice may form and significantly increase the risk of falling.

Diag.1 – No drainage at proposed crossing

**Recommendation:** It is recommended that drainage is provided to prevent any standing water from gathering in front of the proposed crossing facility.

Problem number	Problem Accepted Yes/No	Recommendation Accepted Yes/No	Design Engineer's comments	Scheme promoter's decision and proposed action
A1.1	Y	Y	Channel gradients to be checked. Positive drainage installed where required	
A1.2	Y	Y	Vegetation to be cut back when crossing installed. To be fed in to the Asset Management system

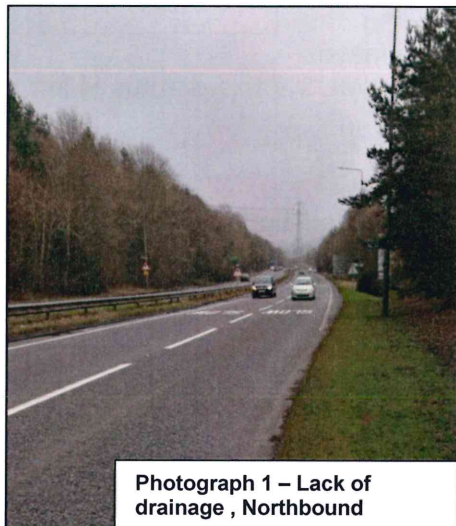
**Summary:** Lack of drainage at crossing points.

Photograph 1 – Lack of drainage , Northbound

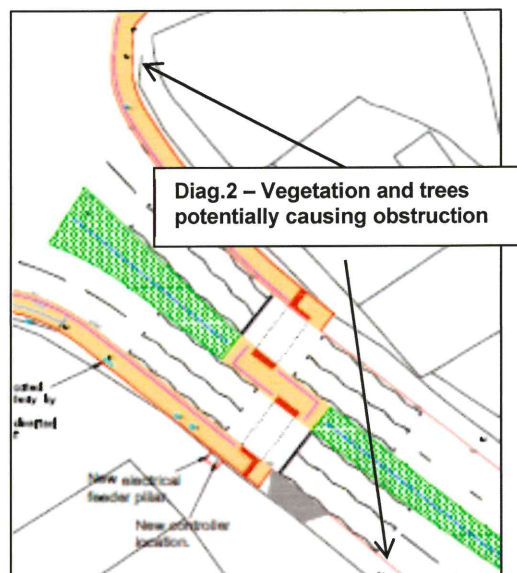
**Summary:** Existing tree line and vegetation may obstruct visibility and fallen leaves may create a slipping hazard..

**Description:** The existing tree line South of the roundabout on the Northbound approach to the roundabout, and the trees and vegetation at the Old Bollington Road approach to the roundabout could obstruct visibility for NMU's, particularly during the summer months when in full leaf. During the autumn and winter months, fallen leaves may present a slipping hazard for NMU's if this detritus is left, particularly during wet weather conditions.

**Recommendation:** It is recommended that maximum visibility is provided for NMU's through regular maintenance of the vegetation and road sweeping.

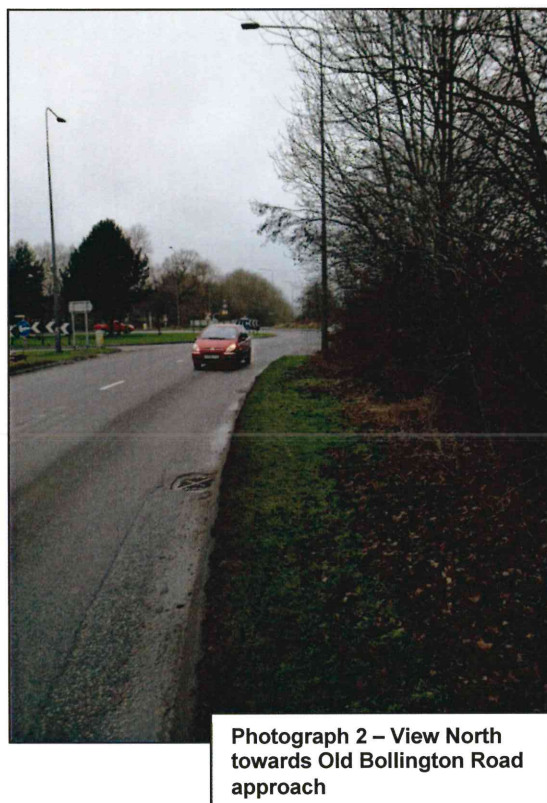
Photograph 2 – View North towards Old Bollington Road approach

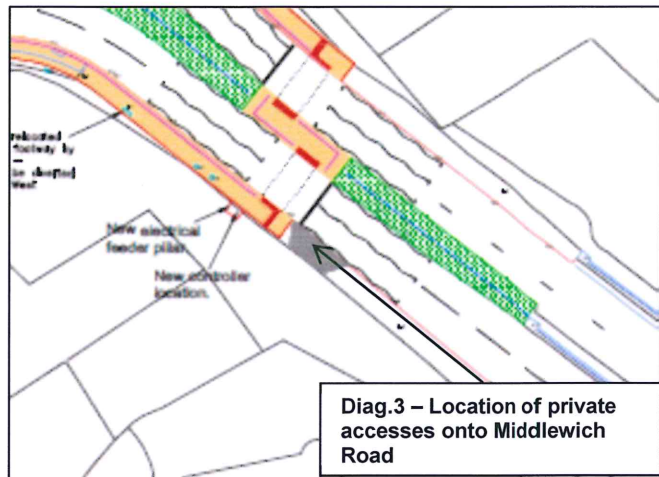
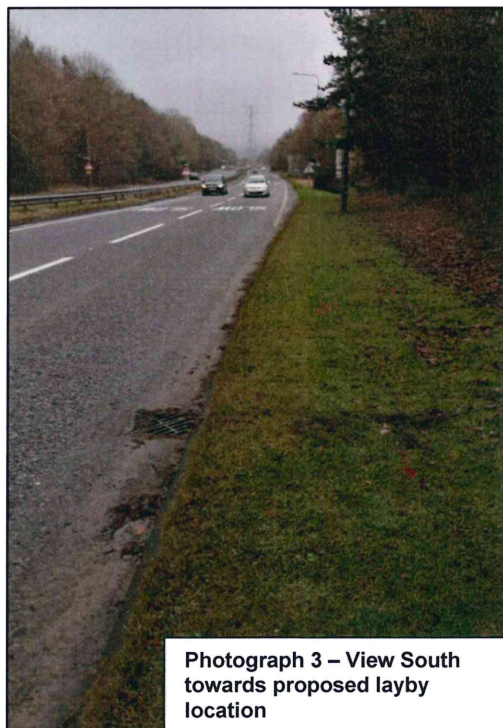
**Summary:** Location of Service vehicle layby.

**Description:** The proposed location of the service vehicle layby could obstruct visibility for NMU's (viewing oncoming vehicles) and drivers travelling Northbound approaching the crossing (viewing pedestrians at the proposed crossing). This could lead to conflict between NMU's and vehicles leading to serious/fatal injuries.

**Recommendation:** It is recommended that the service vehicle layby is relocated to prevent obstructing the view of NMU's and pedestrians.

A1.3	N	N	The reason for the bay location is so that a parked maintenance vehicle does not obstruct the footway. It needs to be on the same side of the road as the controller as this is what the engineer most frequently needs access to. The bay is wide enough so that a parked vehicle should not obstruct the signal head or a waiting ped. Expected usage is very low, it is only likely to be used twice a year for the inspection (one hour each time) and when there is a fault.	<i>Additional</i>
A1.4	Y	Y	Installation of Speed Assessment loops on high speed approaches. Installation of VAS warning signs on approaches. Increase inter green timings of the crossing over the exit from the roundabout	Additional lane markings to be provided on circulatory carriageway.
A2.1	Y	Y	Vegetation to be cut back on installation. Warning signs to be installed on side road approaches/	
A4.1	Y	Y	Lighting columns to be relocated to provide maximum pedestrian / cycle space

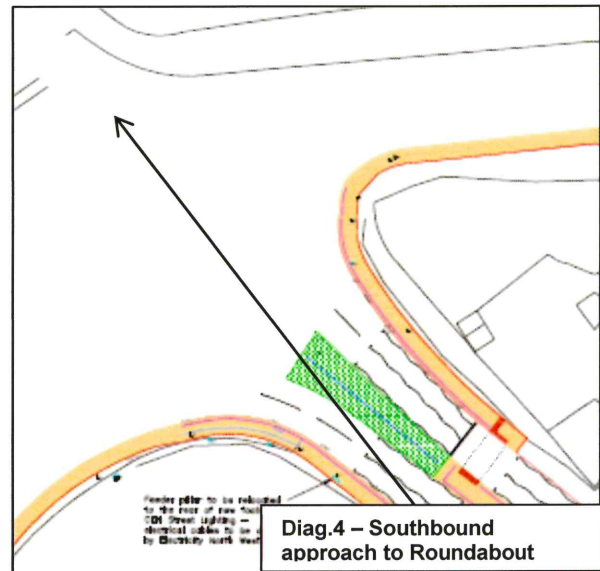
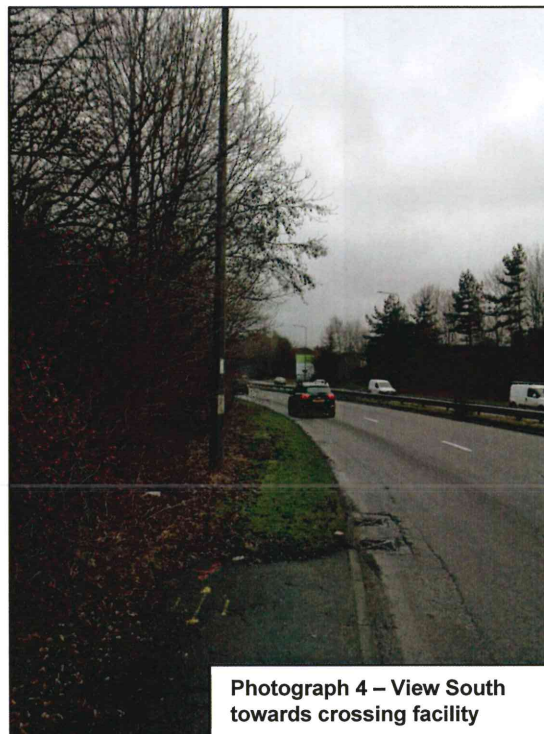
**Summary:** Vehicle speeds exiting the roundabout.

**Description:** During the site visit, the Audit Team observed numerous incidents where drivers exiting the roundabout, travelling Southbound on The Silk Road, were accelerating aggressively and very quickly reaching high speeds. Given the single carriageway approach from the North to the roundabout, and the dual carriageway exit, along with the long straight carriageway upon leaving the junction, this behaviour could potentially lead to serious incidents with vehicles and NMU's, vehicle loss of control and rear end shunts.

**Recommendation:** It is recommended that methods are implemented to reduce the speed of vehicles exiting the roundabout travelling southbound.

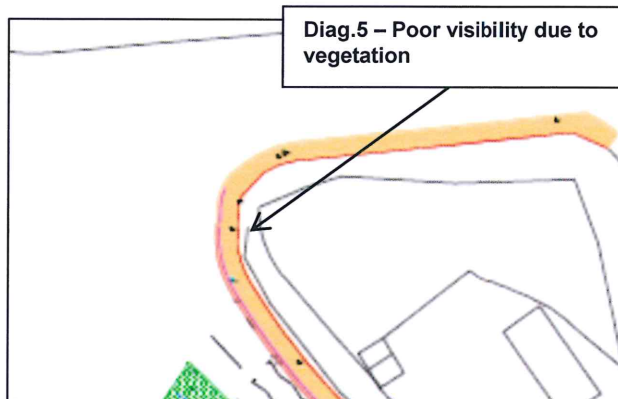
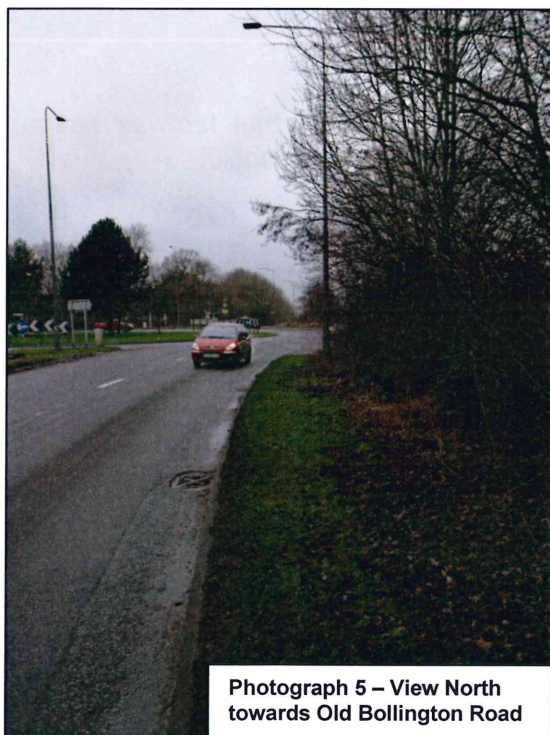
**Summary:** Existing tree line and vegetation may obstruct visibility.

**Description:** The existing tree line and vegetation on the approach to the roundabout from Old Bollington Road will obstruct visibility of the proposed crossing point for drivers wishing to continue onto The Silk Road. This could lead to potential sharp braking manoeuvres, stop line overrunning, loss of control, rear end shunts and conflict with NMU's at the proposed crossing point.

Photograph 5 – View North  
towards Old Bollington Road

**Recommendation:** It is recommended that maximum visibility is provided for drivers on Old Bollington Road approaching the proposed signalised crossing point on The Silk Road. Advanced warning is also recommended.

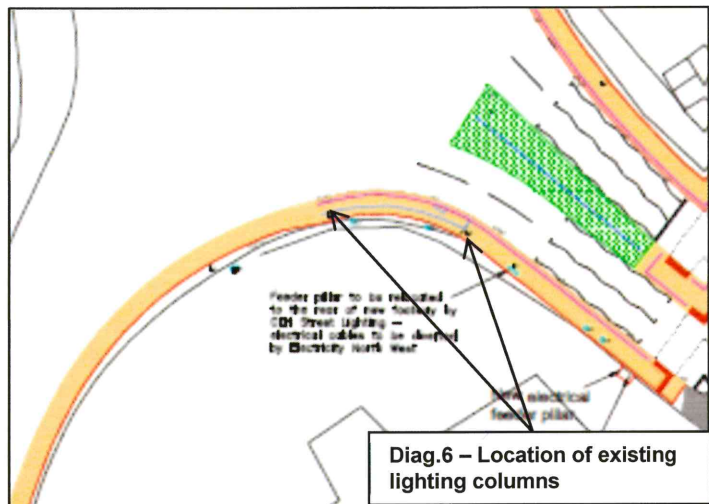
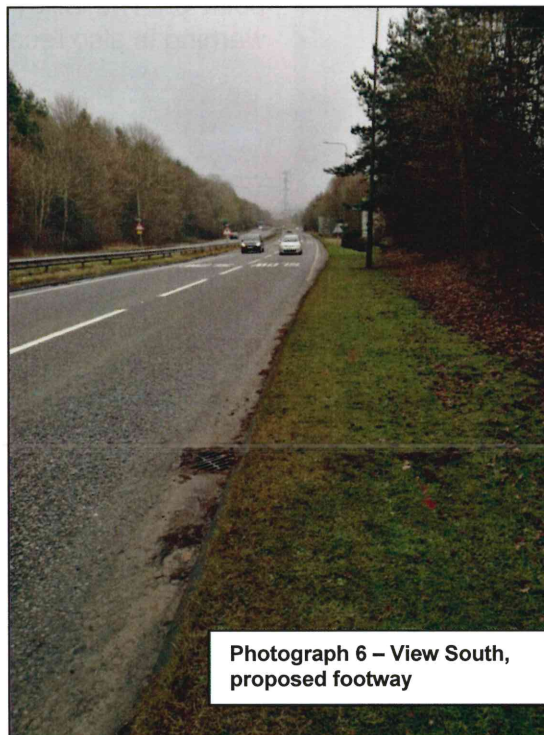
**Summary:** Lighting  
columns in proposed  
footway.

**Description:** The design proposal shows that two existing lighting columns will retain their existing position within the middle of the proposed footway. This could lead to potential conflict for NMU's, particularly if opposing flows of NMU traffic meet at these locations, leading to tripping and falling hazards.

**Recommendation:** It is recommended that footway space is maximised for NMU's to prevent narrowing and potential conflict.
