Appendix 1 – Network Management and Enforcement

Appendix 1 – Examples of improvement projects delivered

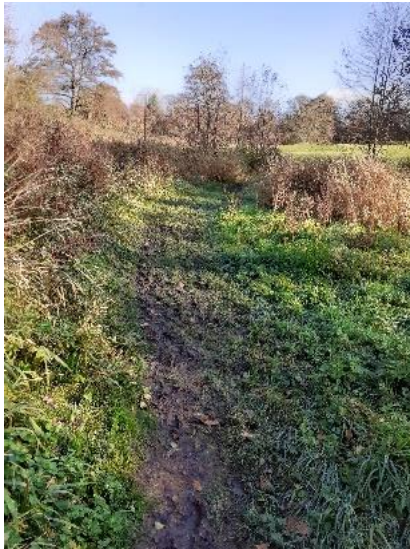
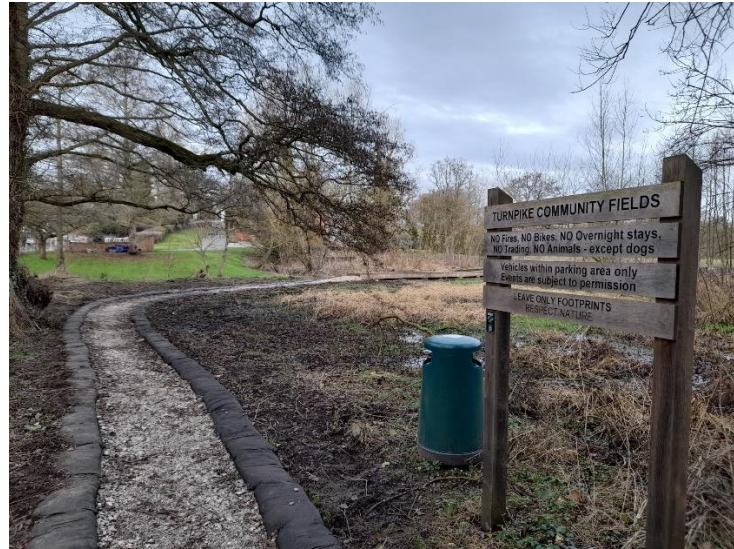
Audlem Footpath No. 26: Audlem Ramblers, working in partnership with the Parish Council and the Peak and Northern Footpath Society, have created a 65m long raised walkway over a section of footpath that is boggy the majority of the year and yet forms a popular circular route for residents, linking in with the Shropshire Union Canal towpath. The project involved innovative use of a product called Flex MSE to create a causeway and the construction of a boardwalk.

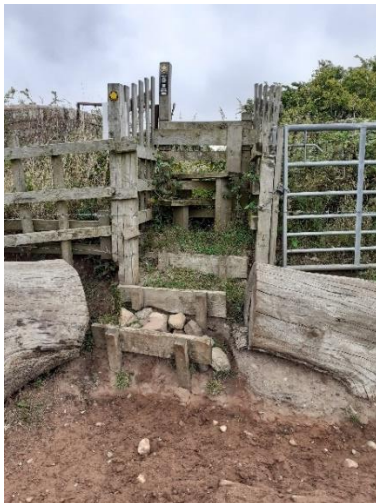
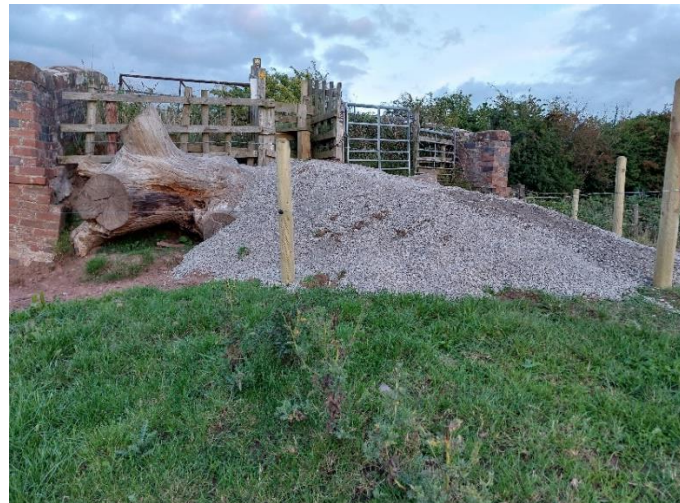
Baddiley Footpath No. 8: On a difficult site and working with the landowner, steps leading up to a stile were removed and a ramp of compacted hardcore put in its place.

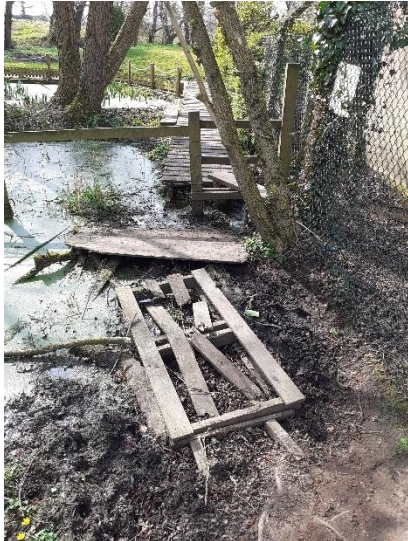
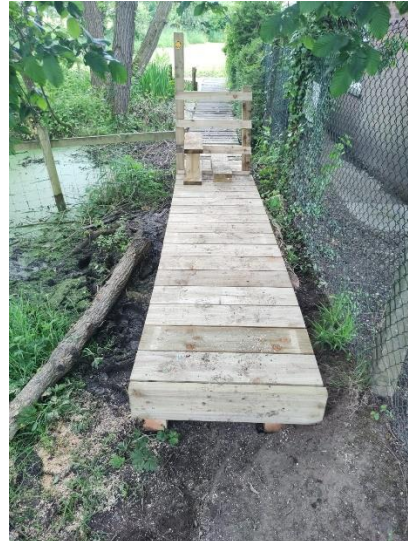
Bunbury Footpath No. 23: Working with volunteers at Bunbury Mill, a path that was difficult to navigate was refurbished. A leaning tree was removed, a wobbly stile replaced and a boardwalk extended to overcome waterlogging. This is a popular path used by local residents and visitors to the Mill.

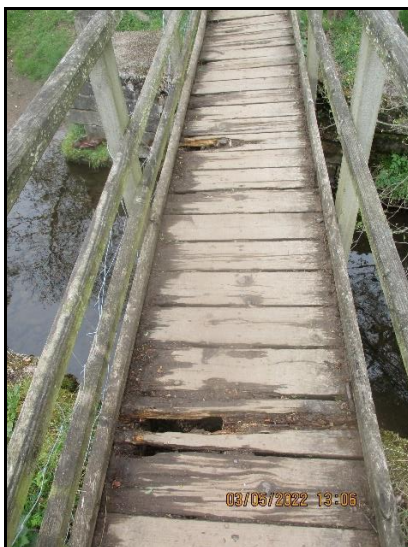
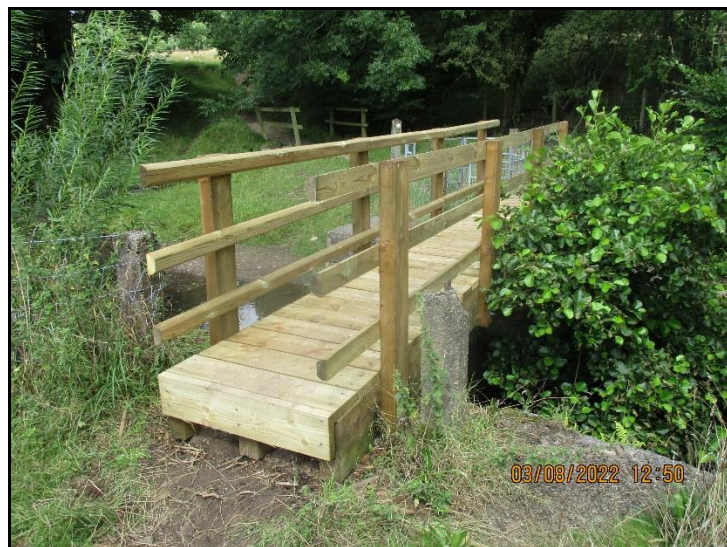
Sutton Footpath No. 5: Replacement 8m bridge on a popular walk from nearby Macclesfield and Langley.

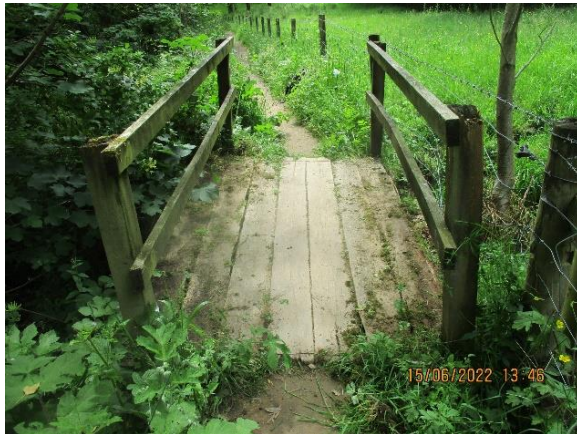
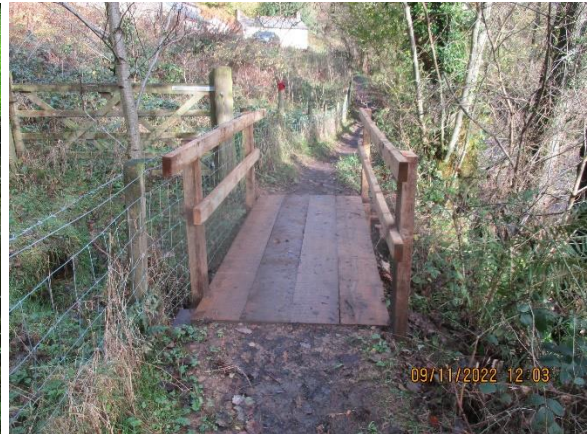
Wincle Footpath No. 38: Replacement 3m bridge on very popular route alongside the River Dane in picturesque Wincle.

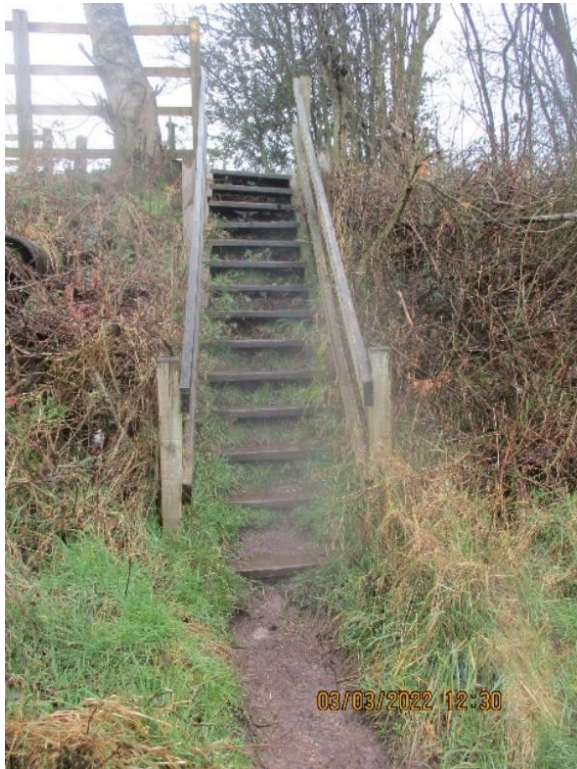
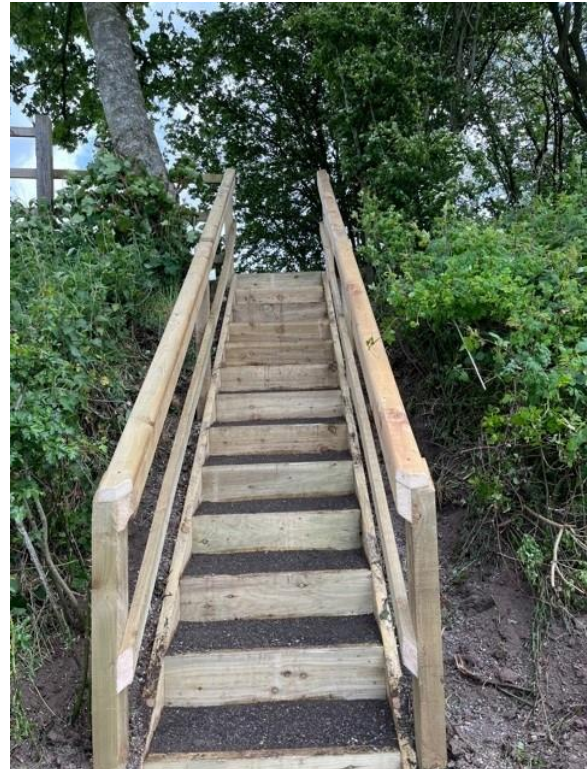
Plumley Footpath No. 16: replacement of a flight of steps.

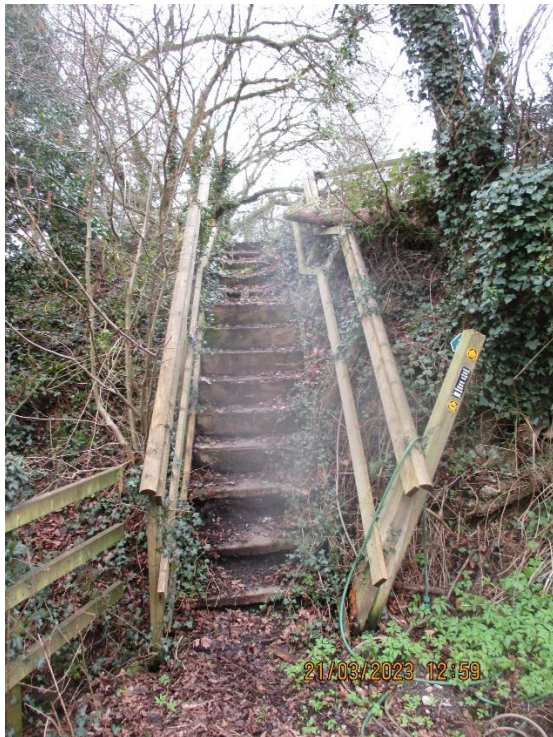
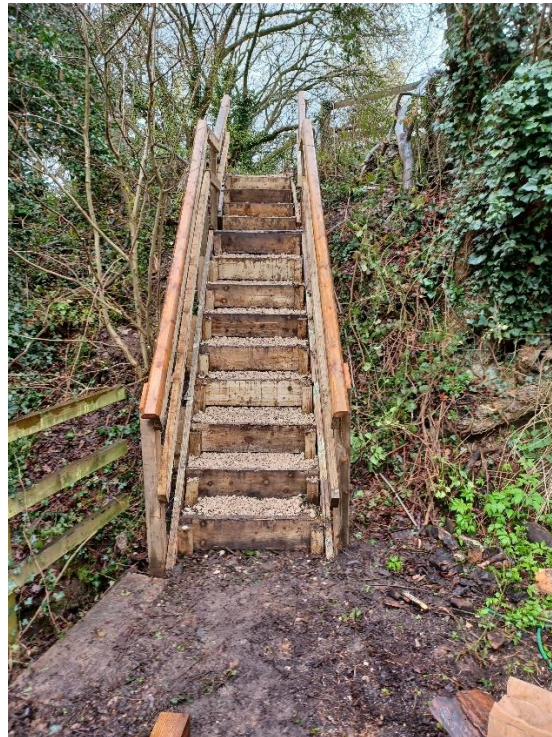
Mobberley Footpath No. 11: replacement of a flight of steps.

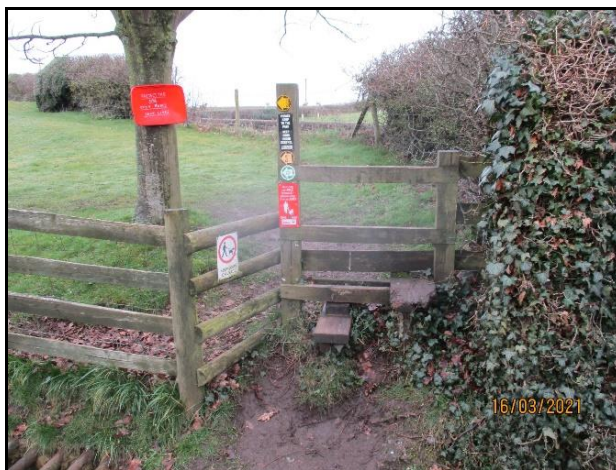
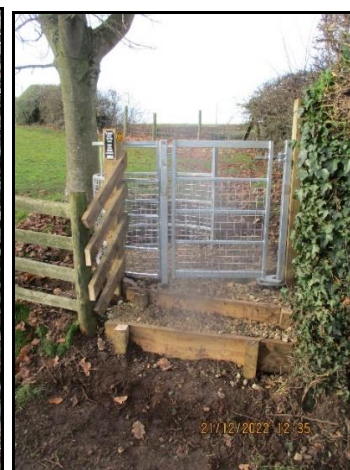
Somerford Footpath No.6: on a popular walk on the urban fringes of Congleton.

Accessibility improvements: investment in durable metal path furniture, such as the following examples of a gate replacements of stiles on a Public Footpaths, results in reduced maintenance, reduced liabilities and more accessible routes:

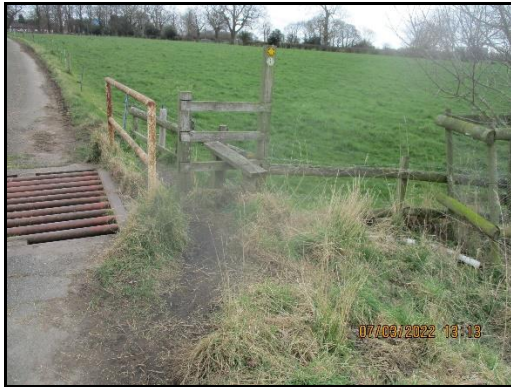
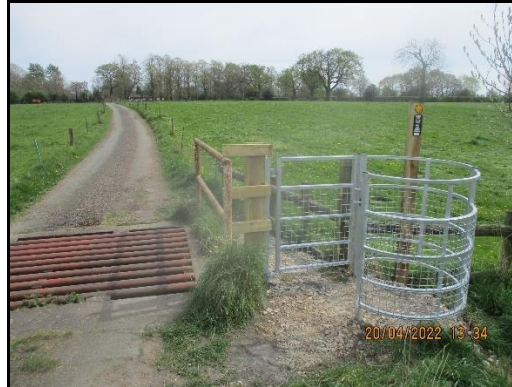
Haslington Footpath No. 9: A very popular walk on the edge of Haslington and part of the village circular walk.

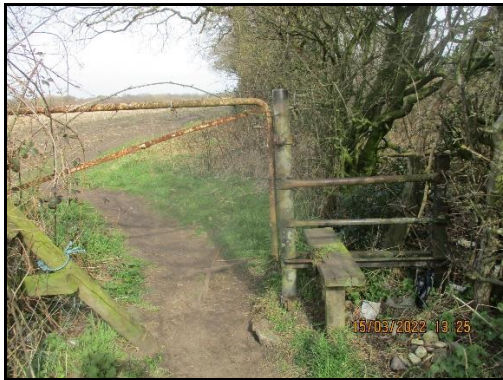
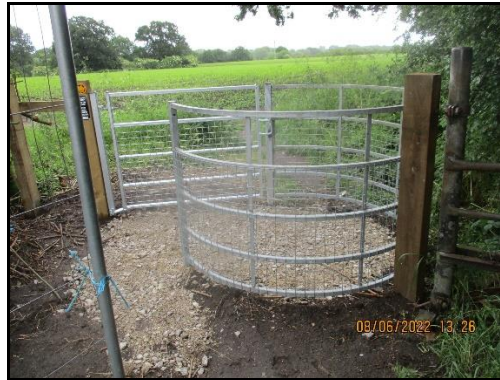
Sandbach Footpath No. 14: A very popular walk on the urban fringe of Sandbach Town.

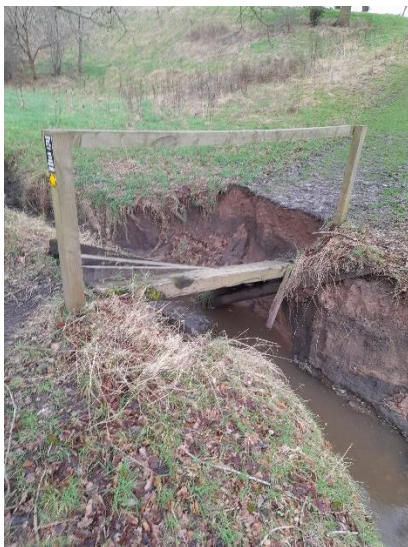
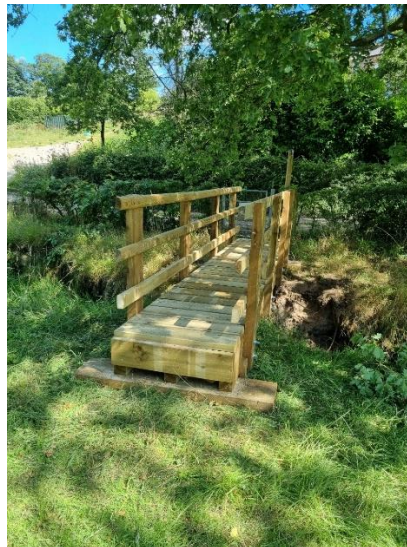
Mottram St Andrew Footpath No. 22: A footbridge washed away in storms and was replaced with a larger footbridge with handrails.
