Appendix 1 – Network Management and Enforcement

Appendix 1 – Examples of improvement projects delivered

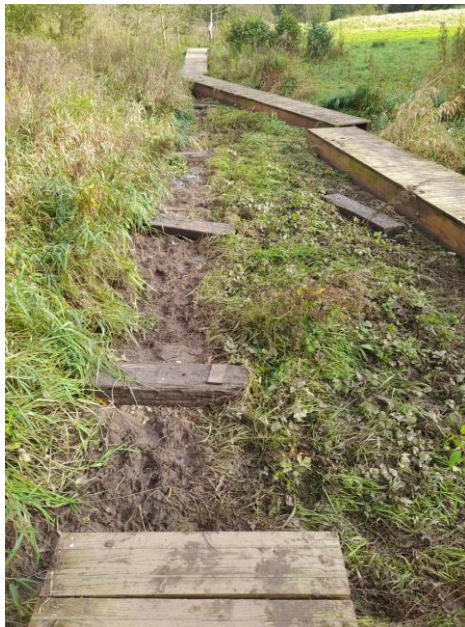
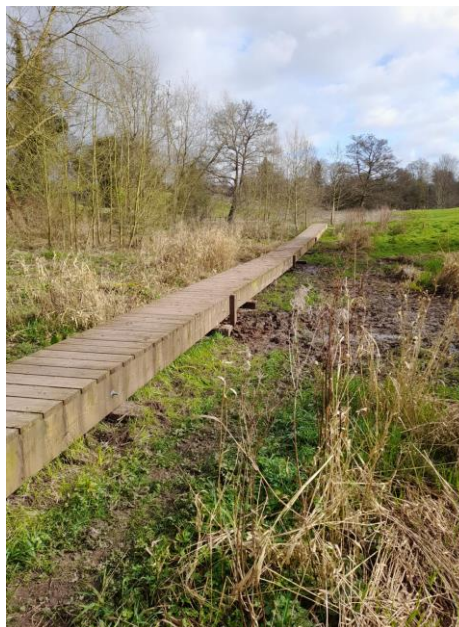
Audlem Footpath No. 26:

A recently installed boardwalk was damaged by flood waters. The boardwalk was repositioned and resecured by a Council contractor.

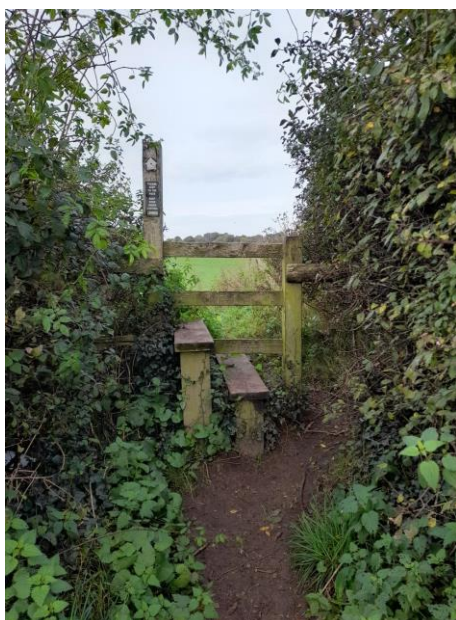
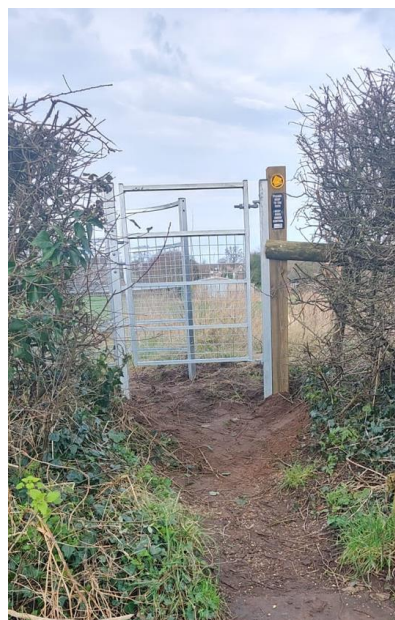
Audlem Footpath No. 3A:

A rotten stile was replaced by a steel kissing gate on a popular route in Audlem.

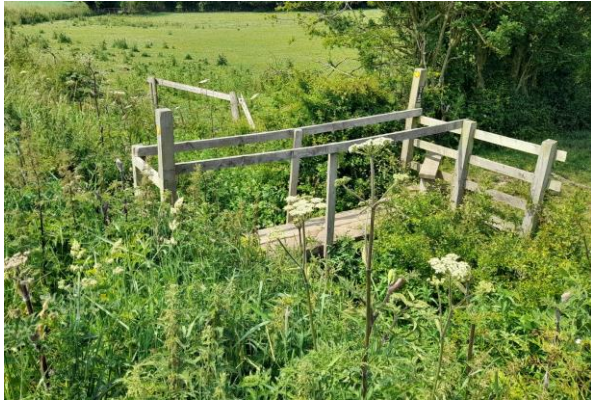
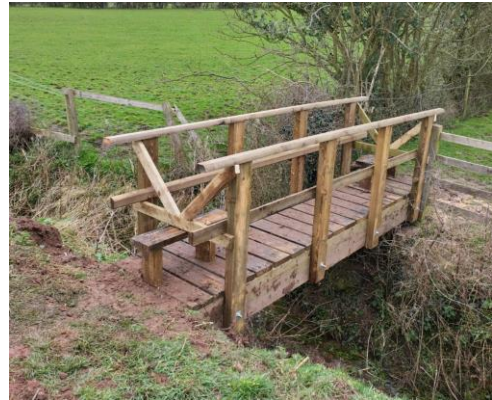
Bickerton Footpath No. 13:

A sleeper bridge was being undercut by the water flow in the ditch, so was replaced with a longer, 5 metre bridge to position the crossing higher up the bank.

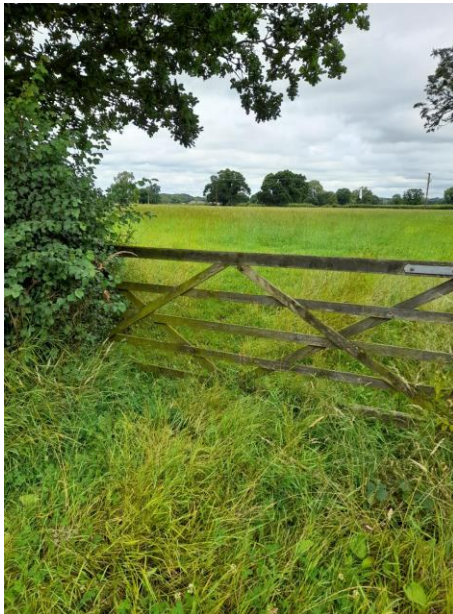
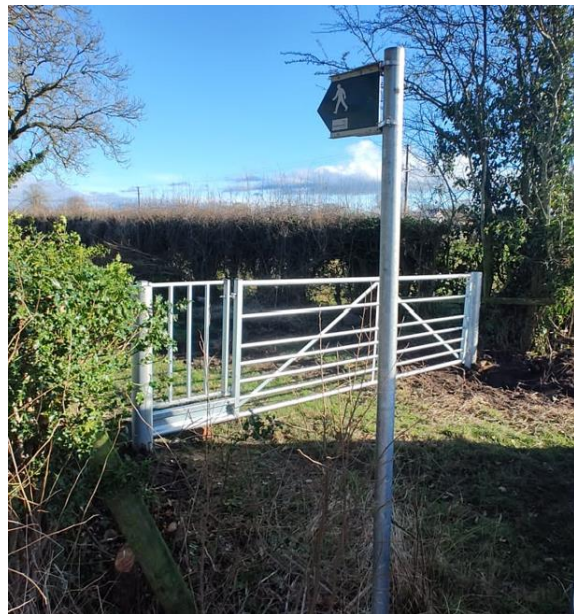
Brindley Footpath No. 21:

A partially overgrown and difficult to access field gate has been replaced with a 2 in 1 gate that will improve accessibility for the public and also the landowners livestock security.

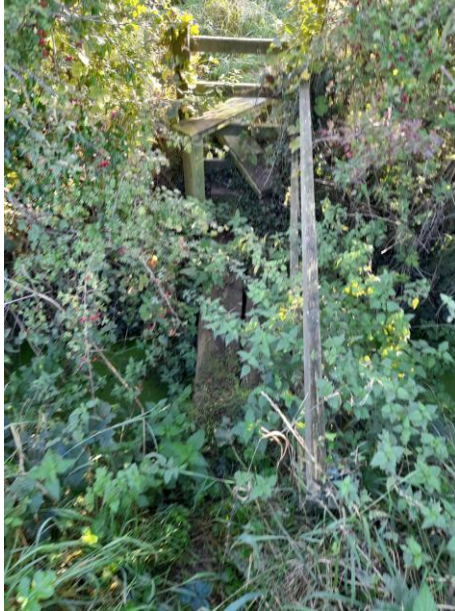
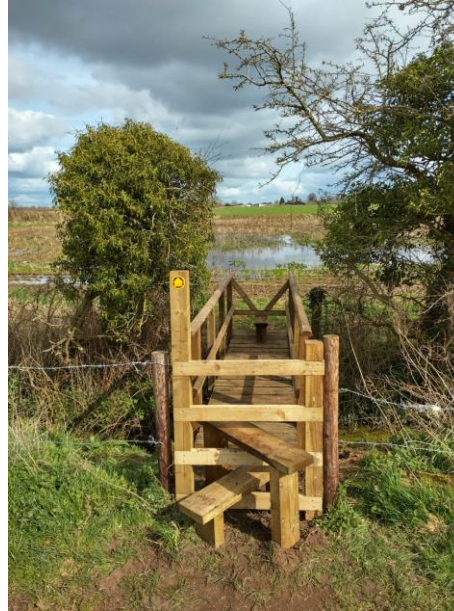
Marbury Footpath No. 16:

An existing sleeper bridge was replaced with a longer, 5 metre bridge that removed a steep drop from the stiles on both ends of the previous bridge. The new, larger bridge will make crossing the ditch safer by being higher up the bank.

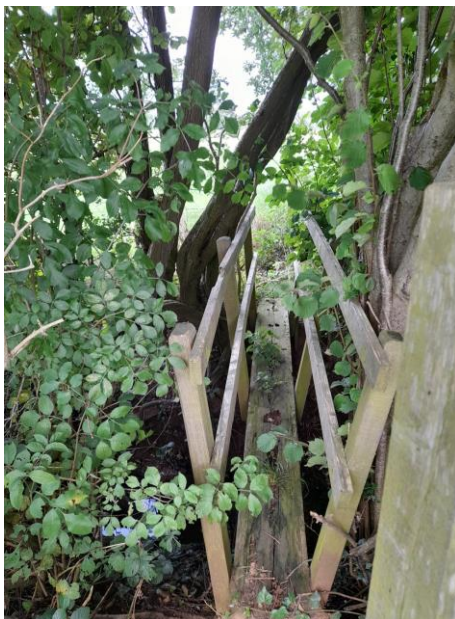
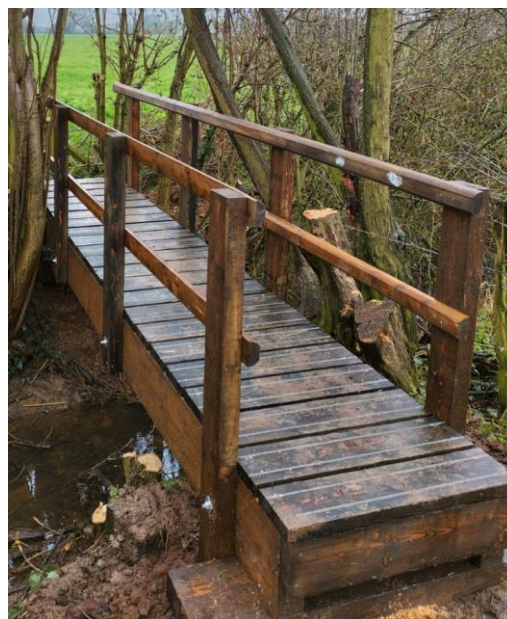
Norbury Footpath No. 9:

A rotten, narrow, single sleeper bridge has been replaced with a wider 5 metre bridge to improve accessibility.

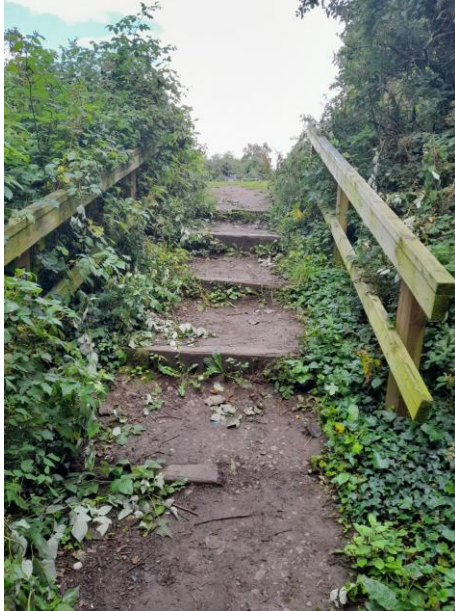
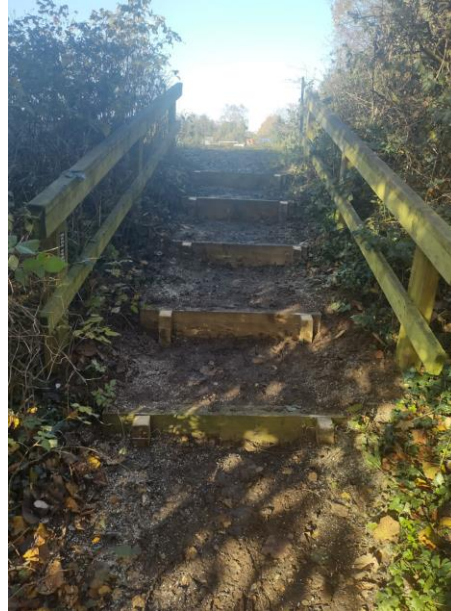
Wybunbury Footpath No. 8:

A series of timber step risers were rotten and have been replaced to improve accessibility.

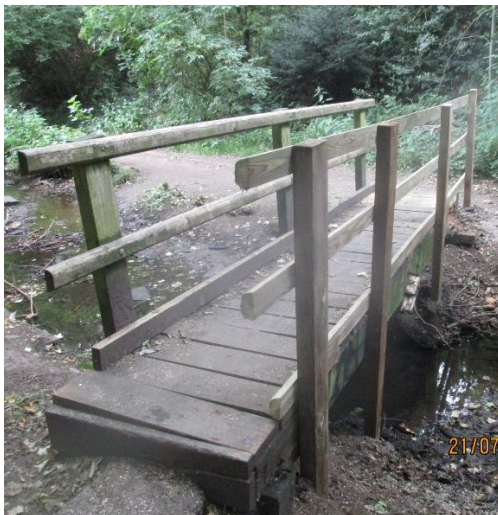
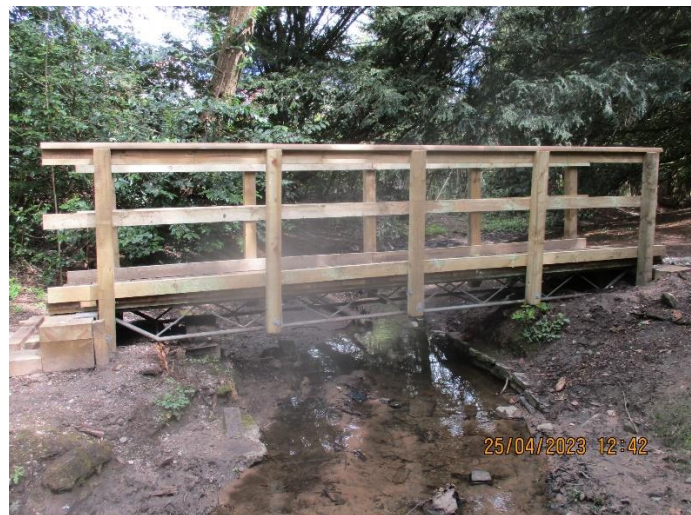
Macclesfield Footpath No. 94:

A severely rotting 5m bridge replaced with a steel frame bridge.

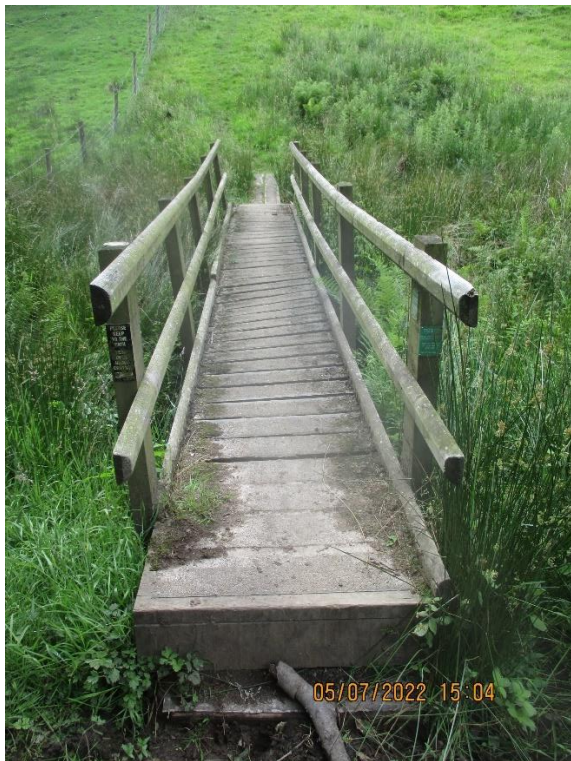
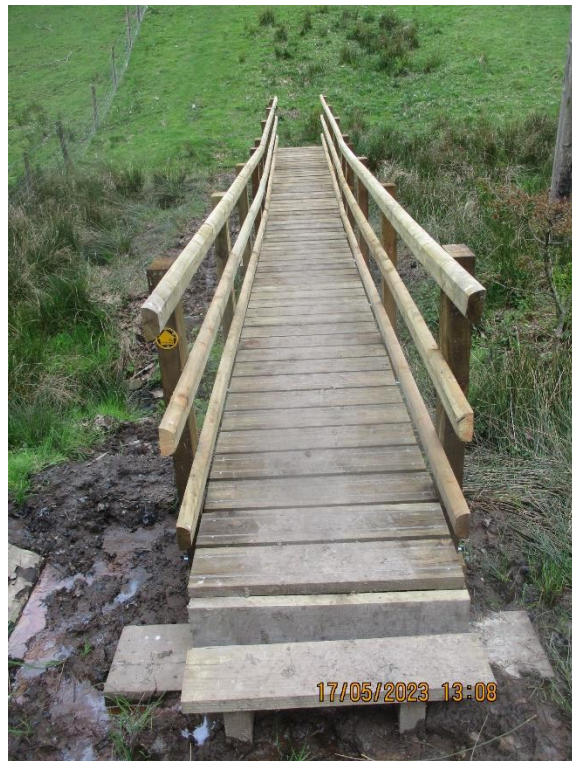
Bosley Footpath No. 5:
A severely rotting bridge replaced.

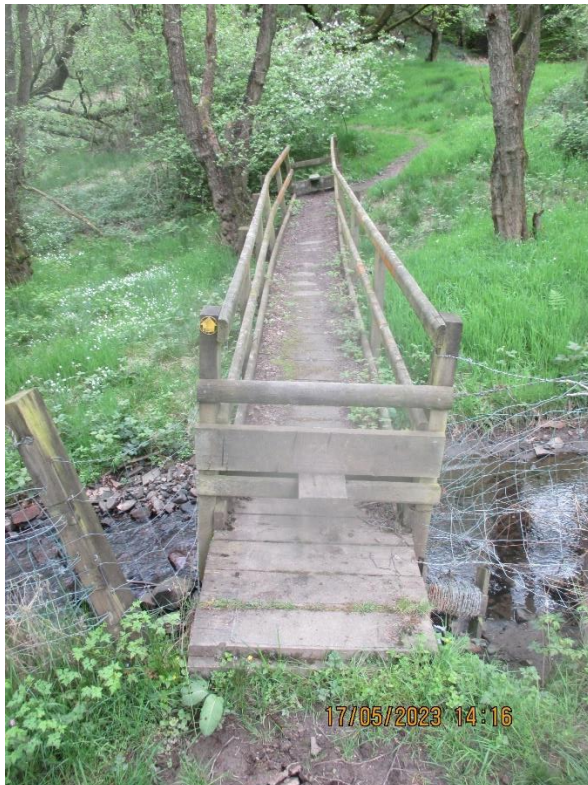
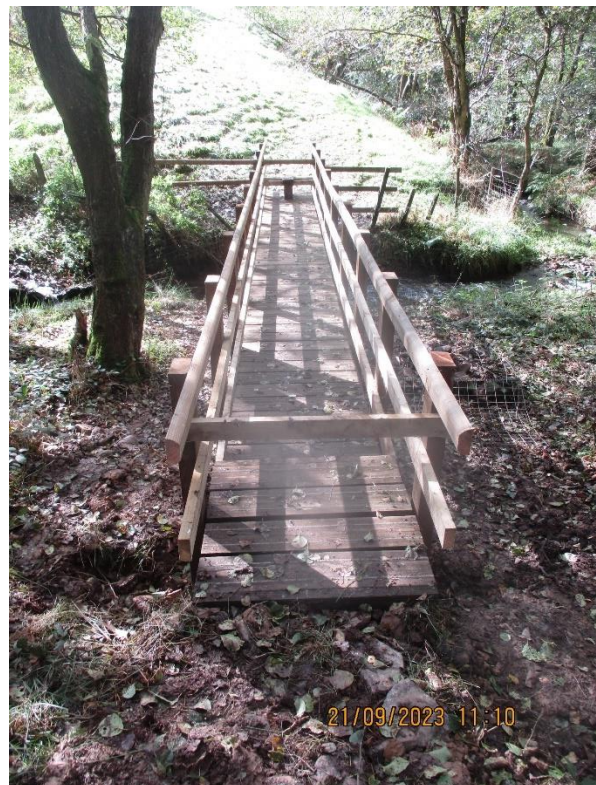
Wincle Footpath No. 8:
A severely rotting bridge replaced.

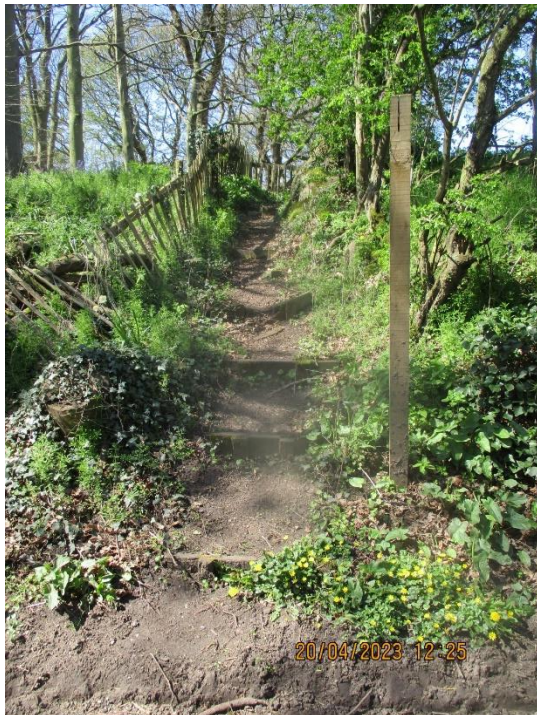
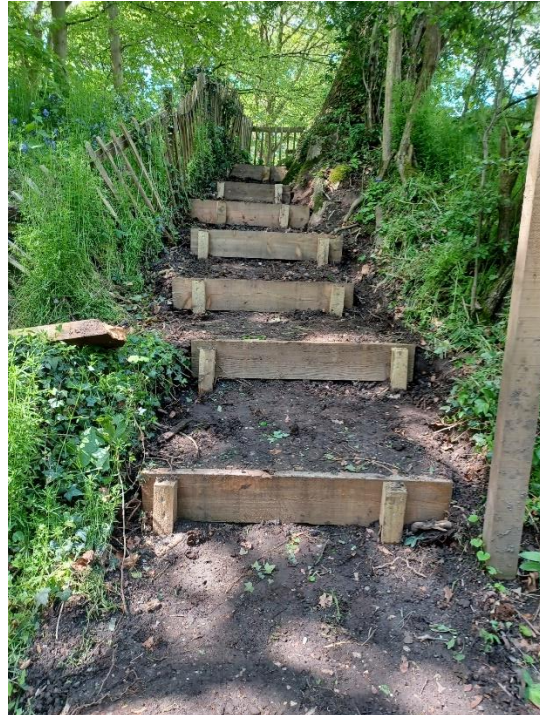
Betchton Footpath No. 10:

A flight of steps replaced to improve accessibility.

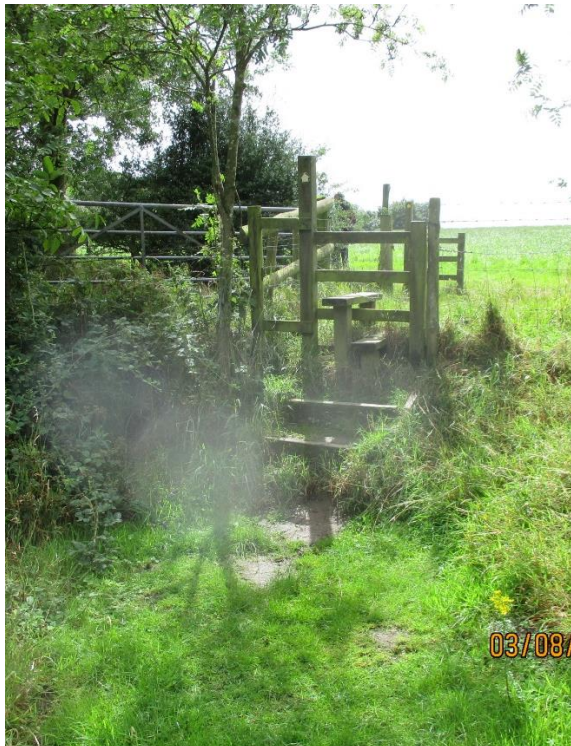
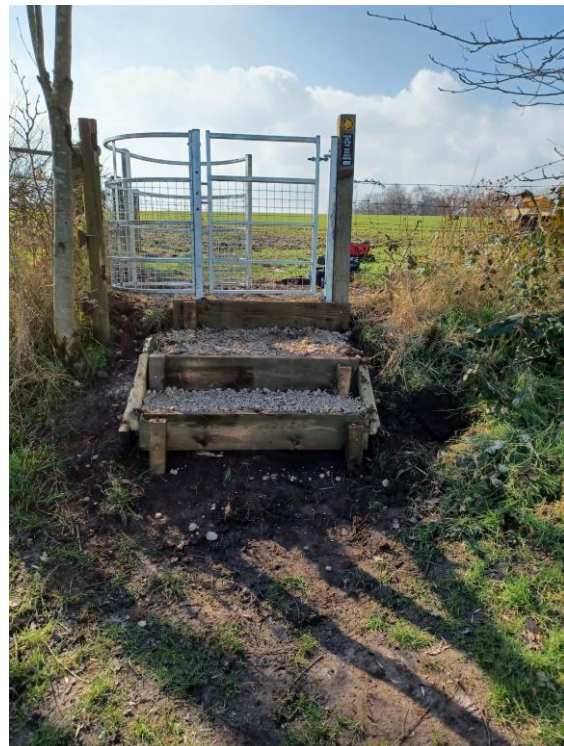
Gawsworth Footpath No. 10:

The last three stiles have been replaced with more accessible steel kissing gates on this 1¼ mile scenic route.

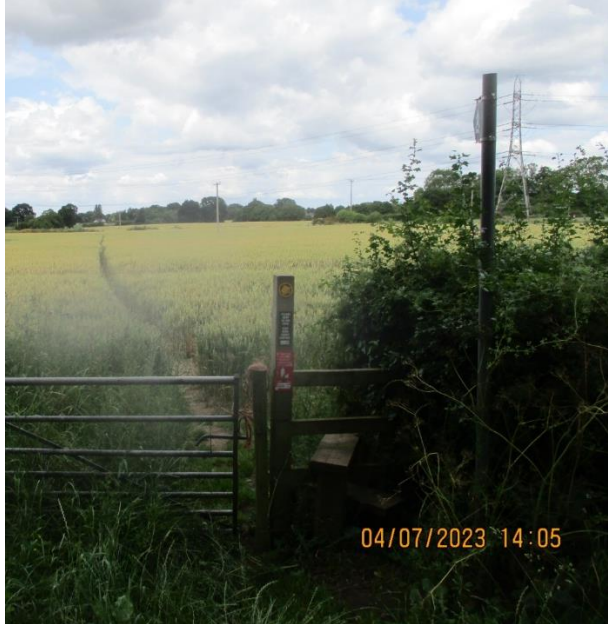
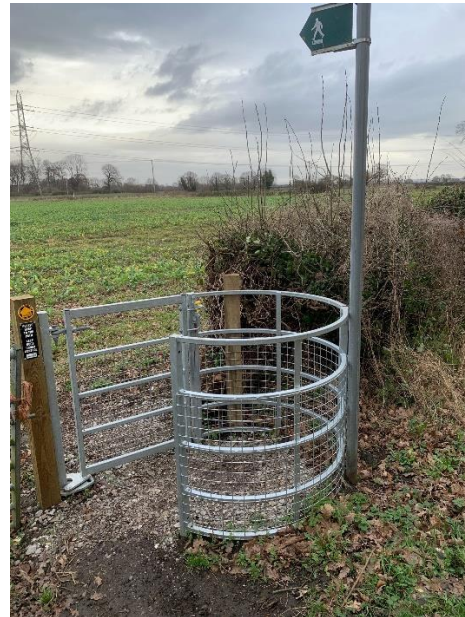
Haslington Footpath No. 32:

A poor stile replaced with kissing gate to increase accessibility.

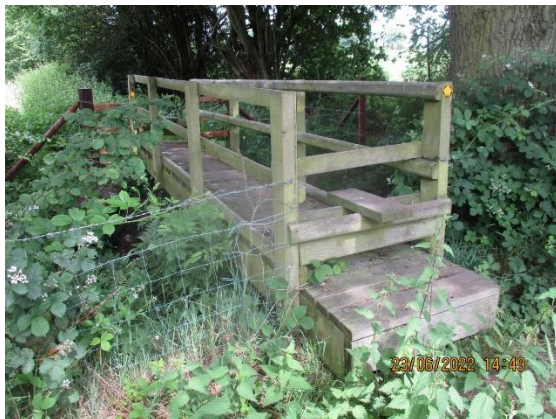
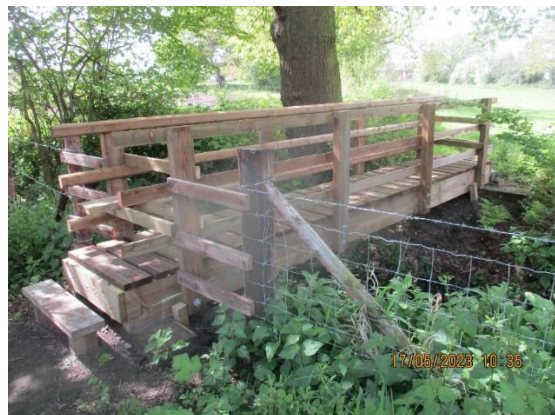
Lower Withington Footpath No. 5:

A severely rotting bridge replaced.

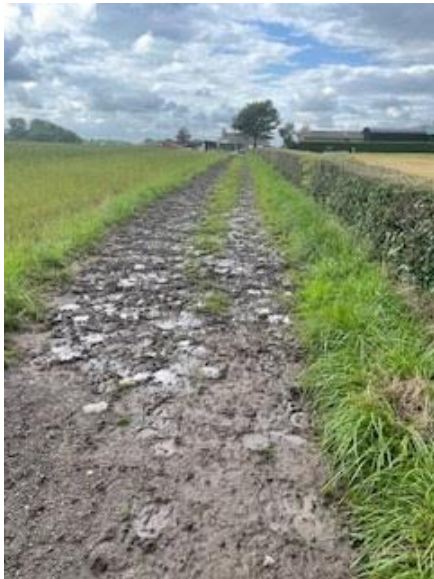
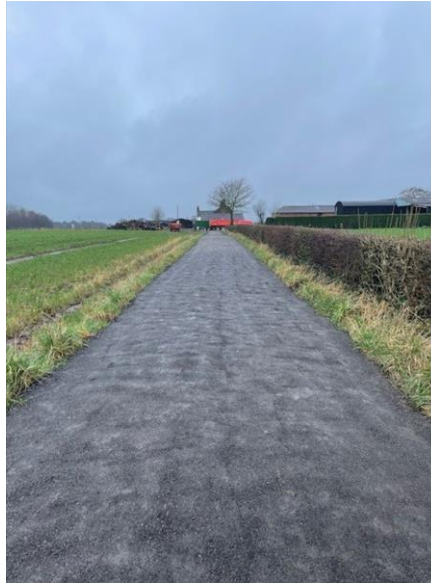
Ollerton Bridleway No. 6:

The last section of surfacing on the route has been completed, undertaken with the support of the Border Bridleways Association who kindly contributed.

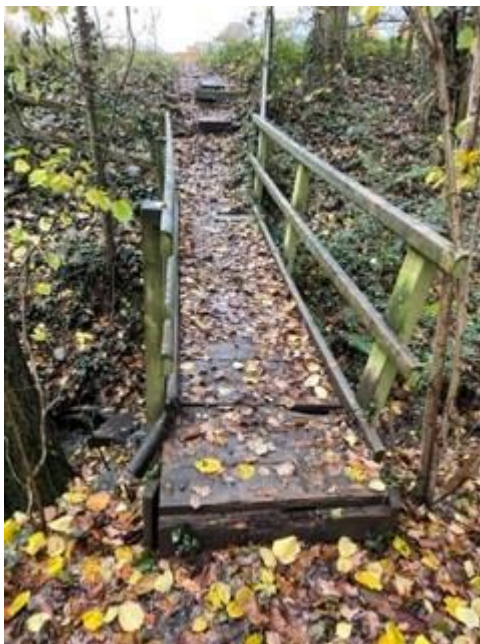
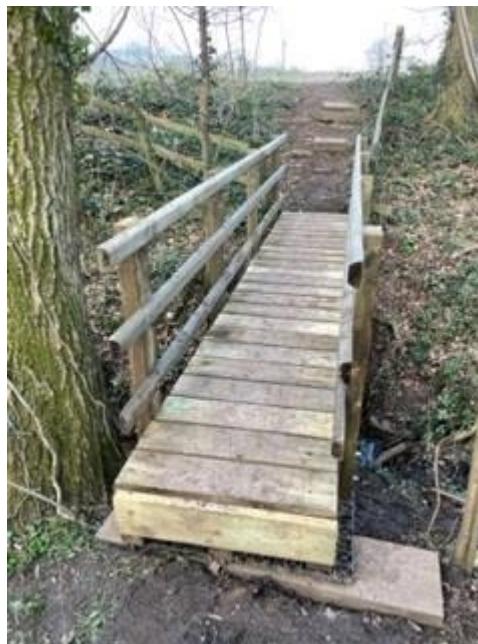
Wilmslow Footpath No. 102:

A rotten footbridge replaced.

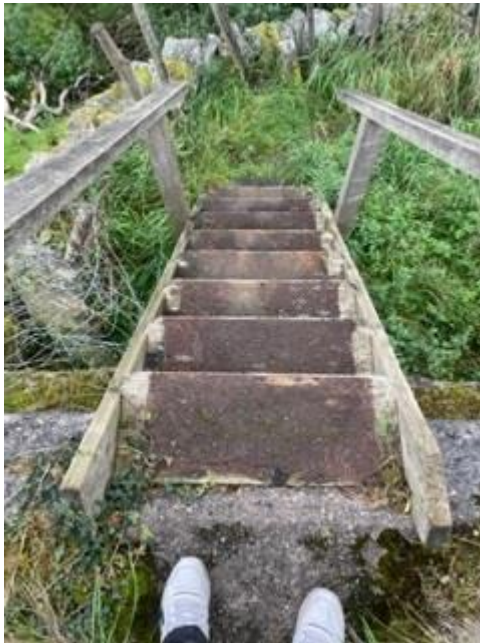
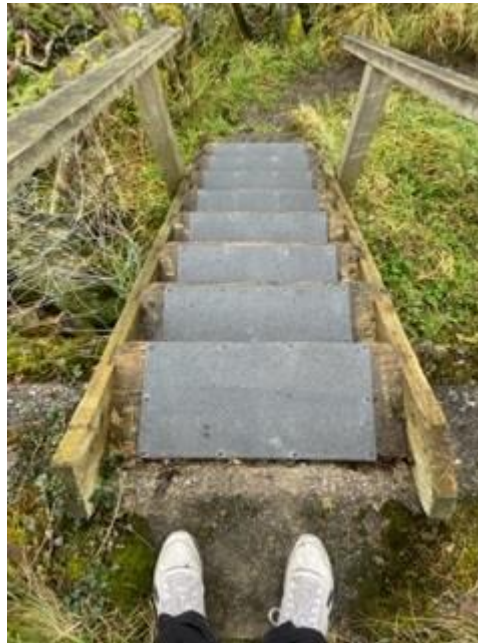
Rainow Footpath No. 76:

Material used as anti-slip had rotted and was coming away – replaced with new anti-slip strips as the timber remained in good condition.

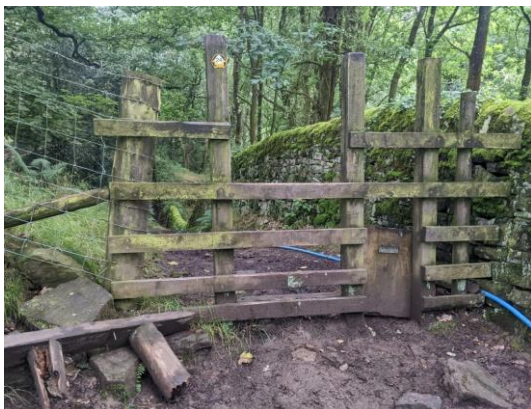
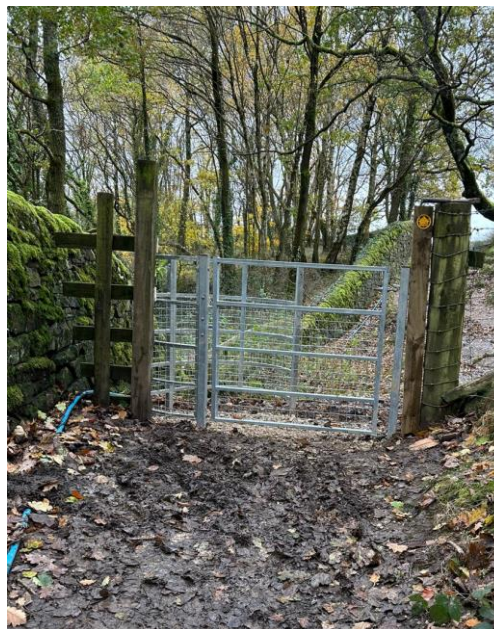
Disley Footpath No. 24:

The last difficult stile on this long route linking to the Gritstone Trail was replaced with a kissing gate.
