HERITAGE STATEMENT TO ACCOMPANY THE PLANNING APPLICATION
TO EXTEND AND REFURBISH ROSE COTTAGE, CASTLE HILL,
MOTTRAM ST. ANDREWS SK10 4AX

HERITAGE STATEMENT TO ACCOMPANY THE PLANNING APPLICATION TO EXTEND AND REFURBISH ROSE COTTAGE, CASTLE HILL, MOTTRAM ST. ANDREWS SK10 4AX

APPENDIX 2. Photographs of Rose Cottage

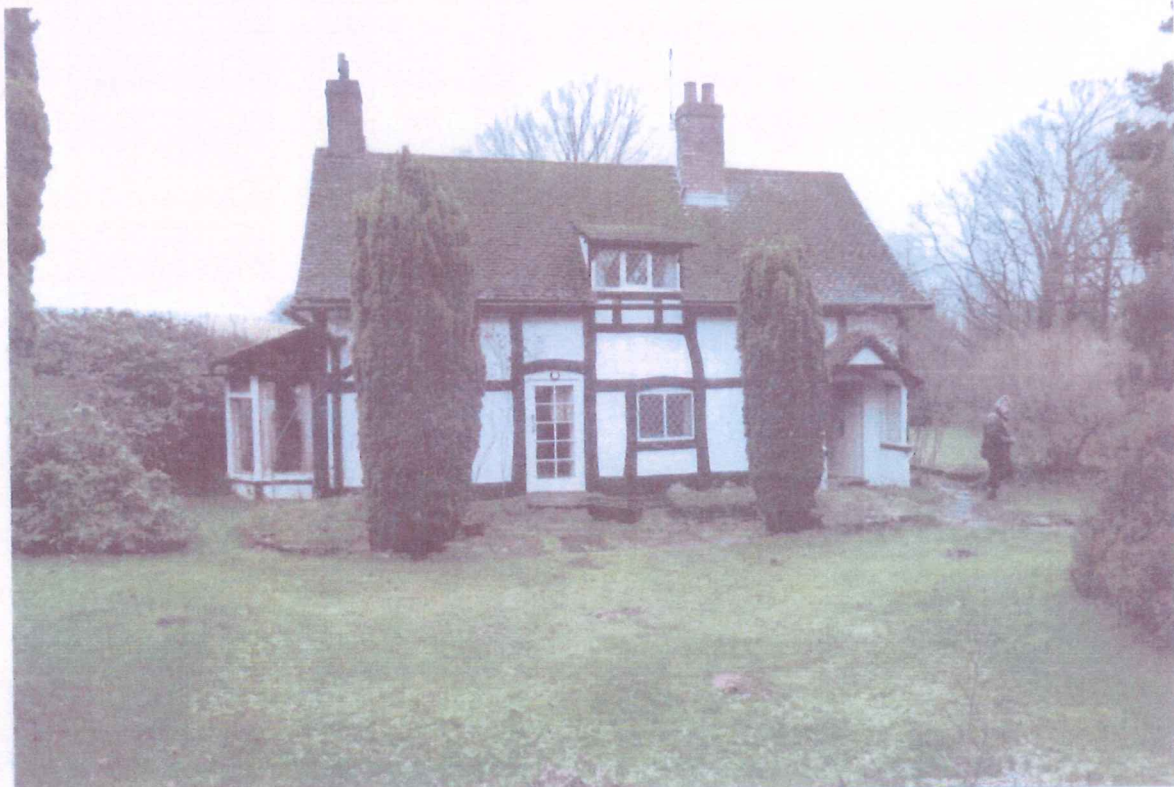
Photograph	1	Front (south) elevation
	2	Sun room addition to the left of the front elevation
	3	Rear (north) elevation
	4	Detail of living room window and surround on rear elevation.
	5	Low ceiling and lower beam, entrance hall.
	6	Living room, low door height; dampness in corner; and showing false floor joists spanning the wrong way, should be from external wall to (false) central beam corner of chimney breast
	7	Interior view of living room; inside of north facing elevation photo 4, showing ingress of dampness
	8	Flank wall of above view showing dampness
	9	First floor central bedroom, low door height; false purlins
	10	Central bedroom showing low wall height rendering space next to wall unusable

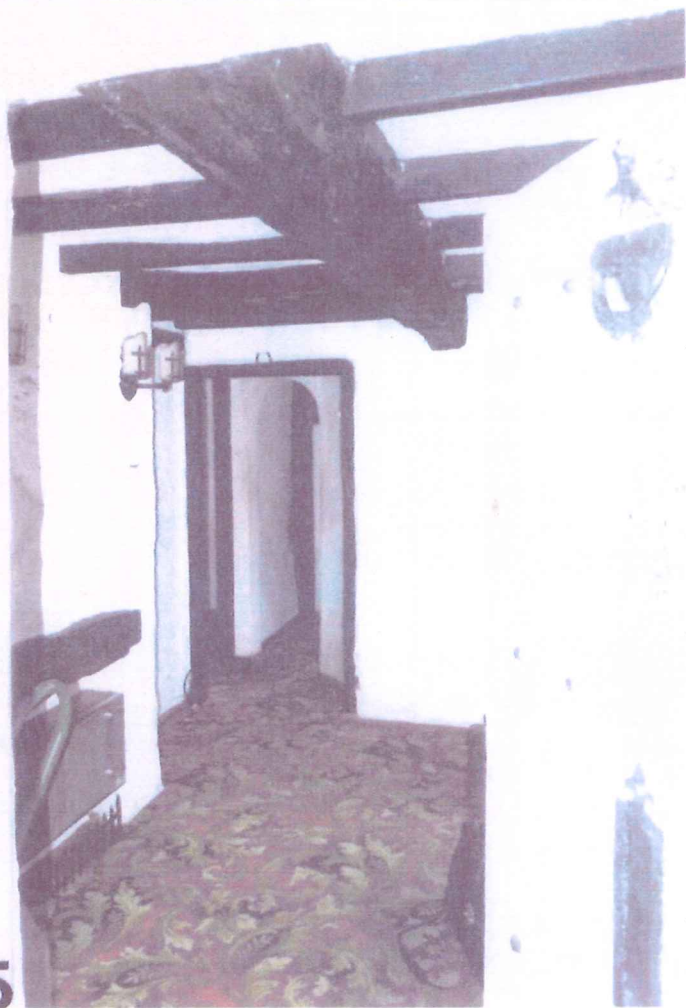
5

The ceiling beams above the ground floor rooms appear to be old oak beams, but only the one in the hall is genuine and the ceiling height in the hall is less than 2.0m. The other beams are of unknown, (probably steel,) construction and faced with stained planking, inserted in the process of raising the ground floor ceiling height, to the detriment of the first floor ceiling height.

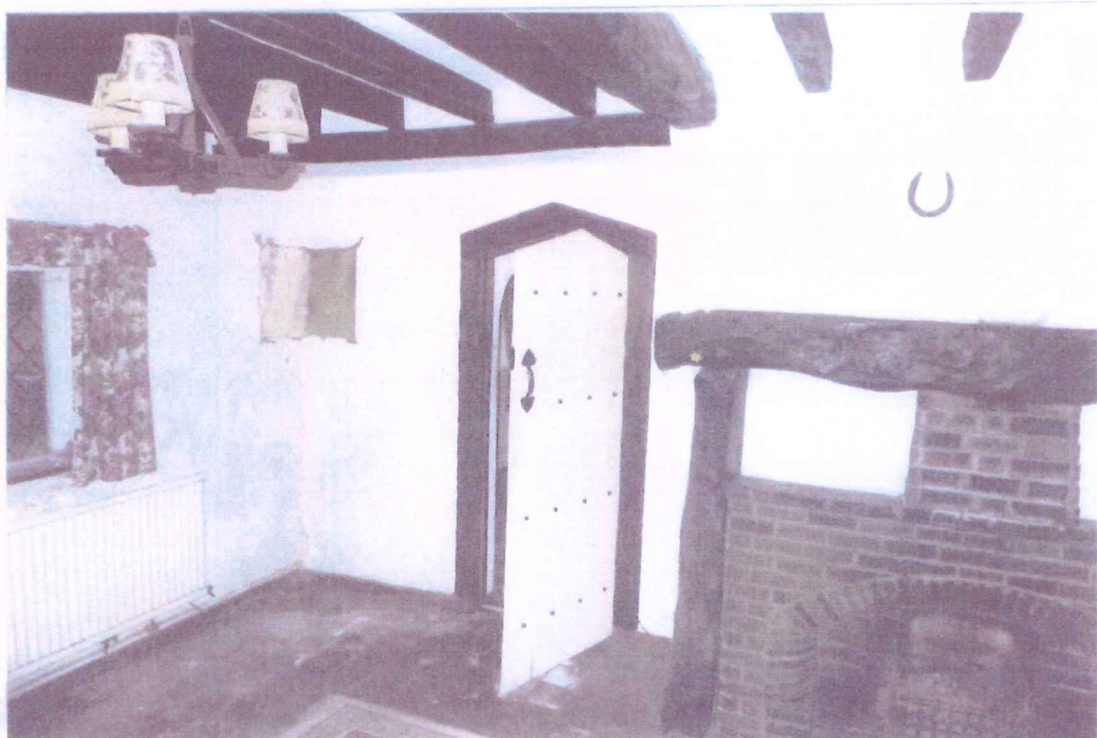
6

The outside walls are simply solid 9" (200mm) brick construction without insulation. The internal floor level is less than 100mm above the external floor level and the ground floors are more than likely a thin cement layer on beaten earth. The Vinyl floor tiles are generally becoming detached from the ground floor, a sure sign of the presence of dampness. (Photographs in appendix 2 show other signs of dampness penetration also). The internal door heights are less than 2.0m (Photographs *ibid.*)

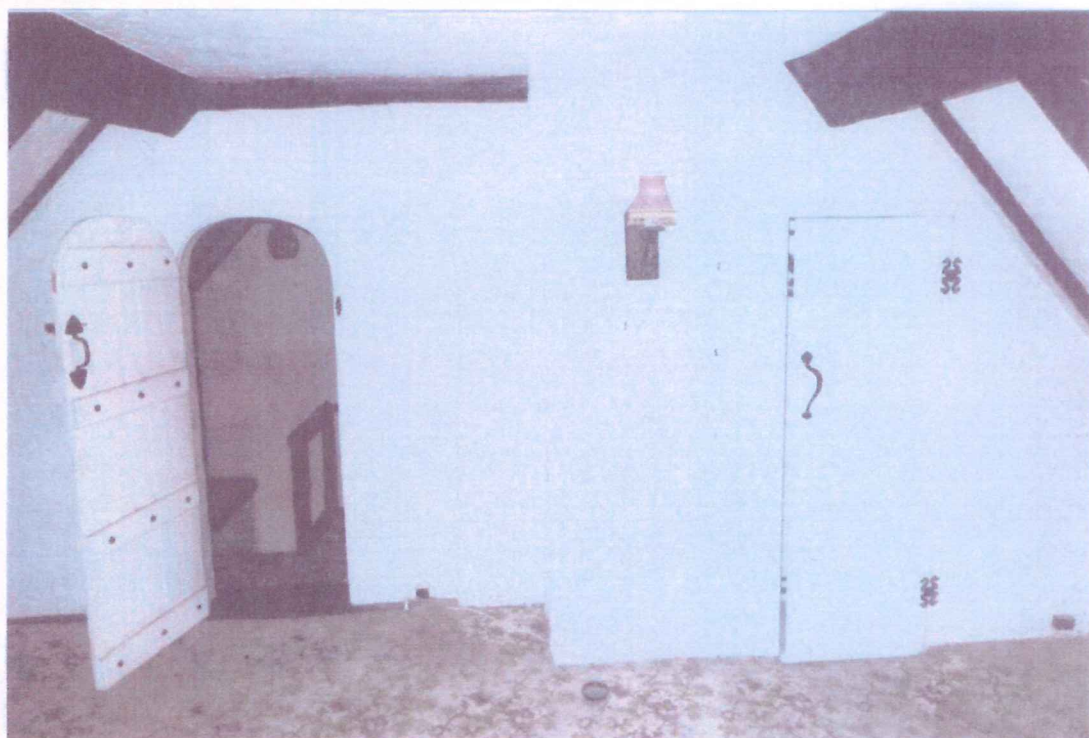
The first floor rooms are partly in the roofspace and the eaves level is low and the space next to the wall is of limited use. (Photographs 9 and 10 in appendix 2). There is one main bedroom (photographs 9/10) through which is accessed the bathroom and a small studio. There is a second small bedroom off the landing, which shares its only window with the landing, but without direct access to the bathroom. These rooms have ceilings following the slope of the roof, and the space between the roof tiles and inner surface are not insulated (See Appendix 3 for specification of 1950 reroofing)
