Donald Insall Associates
Chartered Architects and Historic Building Consultants

Macclesfield Conservation Area
Gazetteer

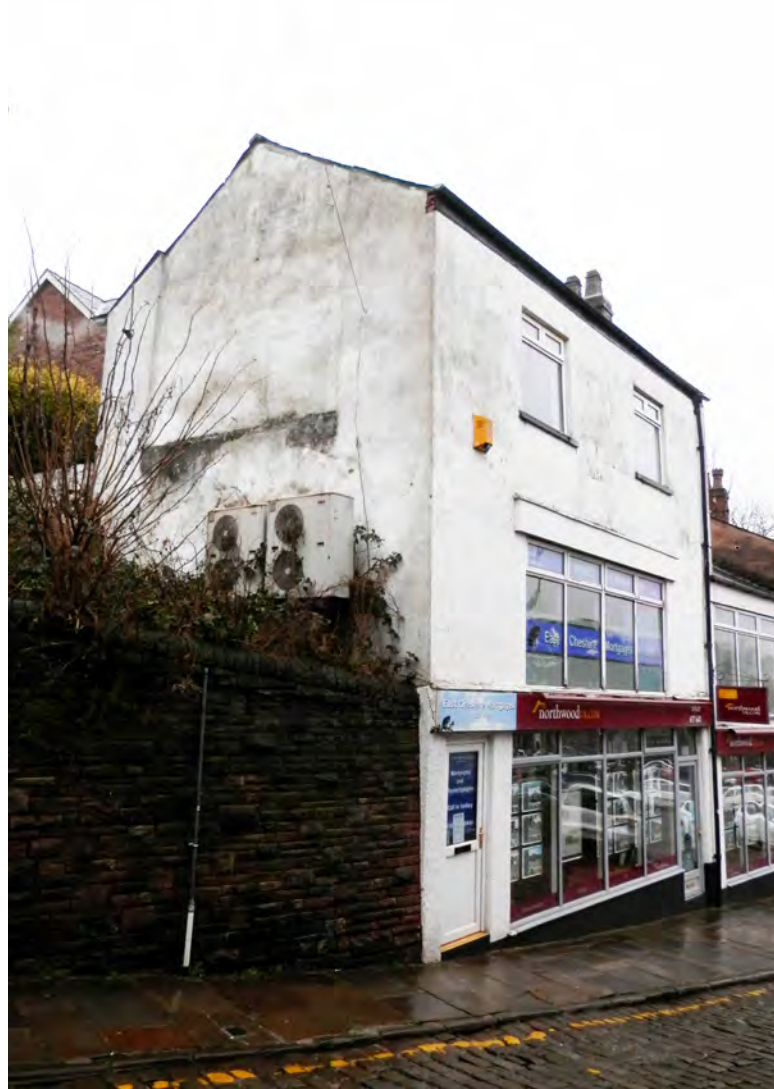
22 Church Street, west elevation

Overall condition: Fair

Notes: The building comprises two elements; three storeys to the left and two storeys to the right. The proportions of the building suggest an original link to the silk industry however the rendered façade and modern windows and openings have eroded all apparent evidence with two bays of UPVC casements at second floor; large window openings at first floor. Shopfronts are well-proportioned modern insertions with restrained fascia signage; projecting sign would be better located at fascia level. uPVC door to upper floors with additional signage which detracts. Pitched roofs with chimney stacks to gabled ends of taller element; exposed return facades also rendered with a small window at first floor to the east façade; wall mounted a/c units to west façade detract.

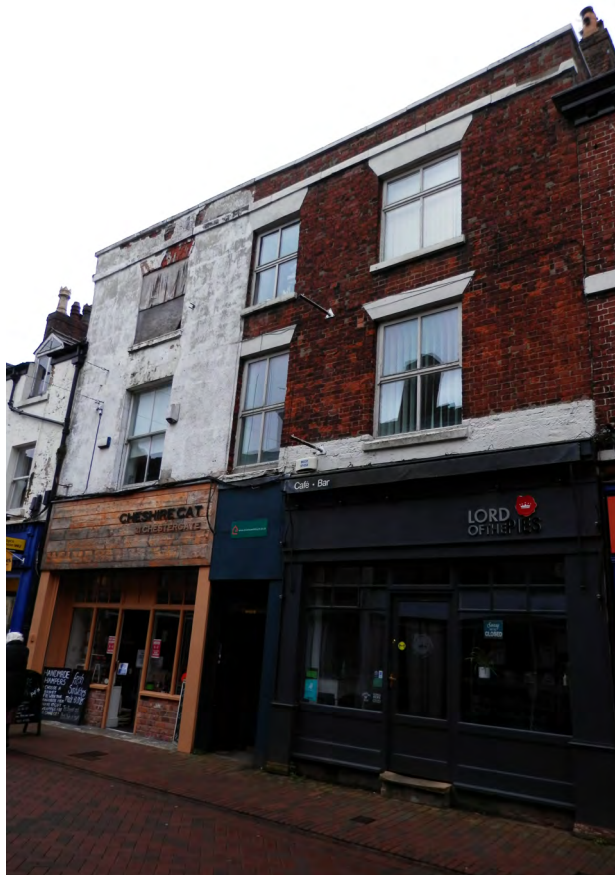
19-21 Chestergate

Overall condition: Good (no.19) / poor (no.21)

Notes: A three storey building arranged over three bays; constructed in red brick and rendered at no.19 which is in a poor condition and detracts. To no.19 two bays with modern casement windows which detract, painted stone sills and lintels. Banding below the parapet and painted above the ground floor. The shopfront is a good traditional example with stallriser, pilasters, transom lights, restrained fascia signage and an awning with iron support brackets. The passageway to the rear has a recessed door, detracting roller shutter and an oversized blank signage area above. The render to no.19 detracts from its historic character although some of the detailing is evident below. One-over-one timber sash at first floor, window boarded to second. The shopfront and fascia are a good example of a modern replacement, replicating traditional features but with a sensitive contemporary aesthetic. To the rear an M-pitched roof with gable ends and projecting wings, part painted with a mix of original and altered openings, a/c unit fixed to the façade.

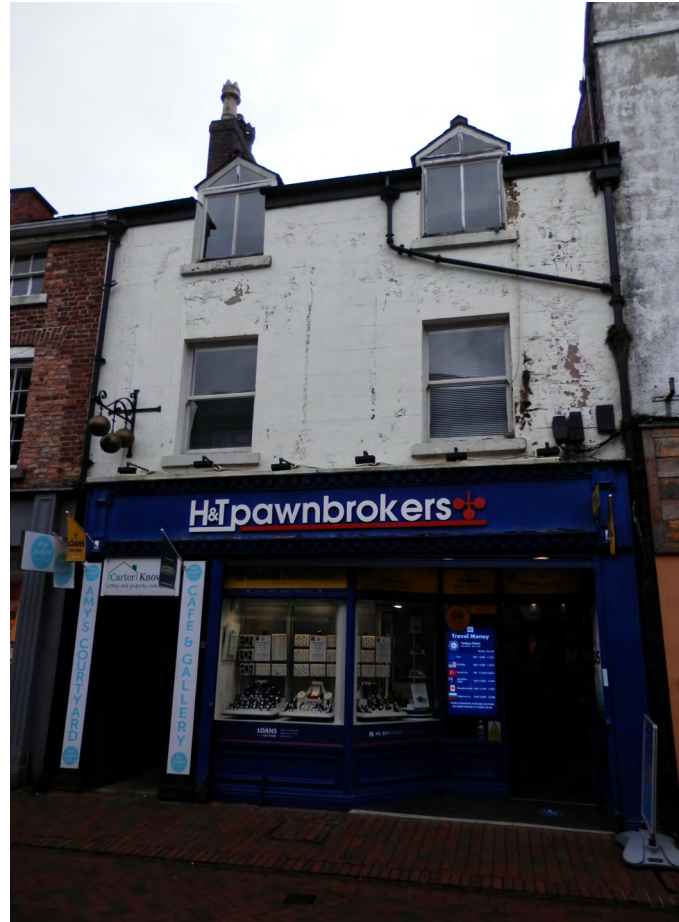
23 Chestergate

Overall condition: Poor

Notes: A three storey building which steps down in scale; arranged over two bays with a rendered façade – the condition of which detracts as well as fixtures and fittings which clutter the façade. Dormer windows to the attic storey puncture the eaves line with gabled roofs and casement windows. At first floor are one-over-one timber sash. At ground floor is a traditional shopfront with stallriser, mullions, transom lights and a recessed entrance which is overpowered by the crass branding and proliferation of signage and flags. The passageway to the rear is has a door, surrounding signage is excessive and detracts – particularly to the pilasters. To the rear is no.23a a three storey brick building with pitched roof which forms the rear of the courtyard accessed via the passageway.

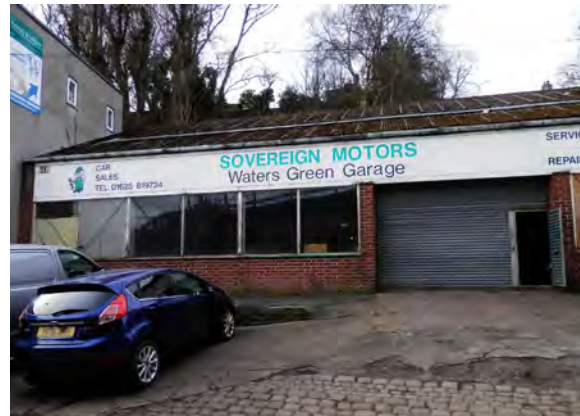
Waters Green Garage, modern range

Overall condition: Fair

Notes: A simple red brick building comprising two recessed bays framed by blank flat pilasters and set on a black brick plinth. Return to Brunswick Hill comprises four bays with window openings at ground floor (three light to first two bays and square four light window to third) entrance door to rear. Glazed clearstory at roof level, some panes now boarded. Whilst the red brick detailing is of some interest the general condition, roller shutters and high level signage all detract. A modern range is set back from Gas Road, in red brick with large simple windows openings and a corrugate metal roof – the general condition and roller shutter again detract.

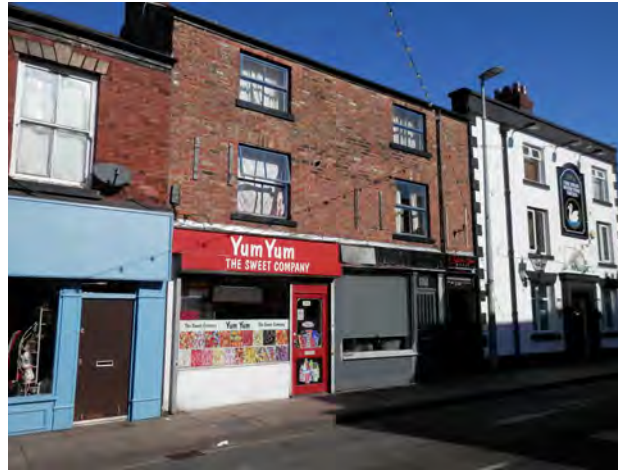
67-69 Chestergate

Notes: Simple red brick, three storey building with brick lintels to first floor and two-over-two timber casements. The shopfront at no.67 is a good example, fascia in poor condition; shopfront and shutter housing at no.69 detract. Timber fixings on the façade and flue all add clutter and detract. Passageway to the right-hand side provides access through to the rear when a large three storey wing projects with timber sashes and further small scale modern outbuildings. Chimney stacks to the gable ends of the pitched roofs.

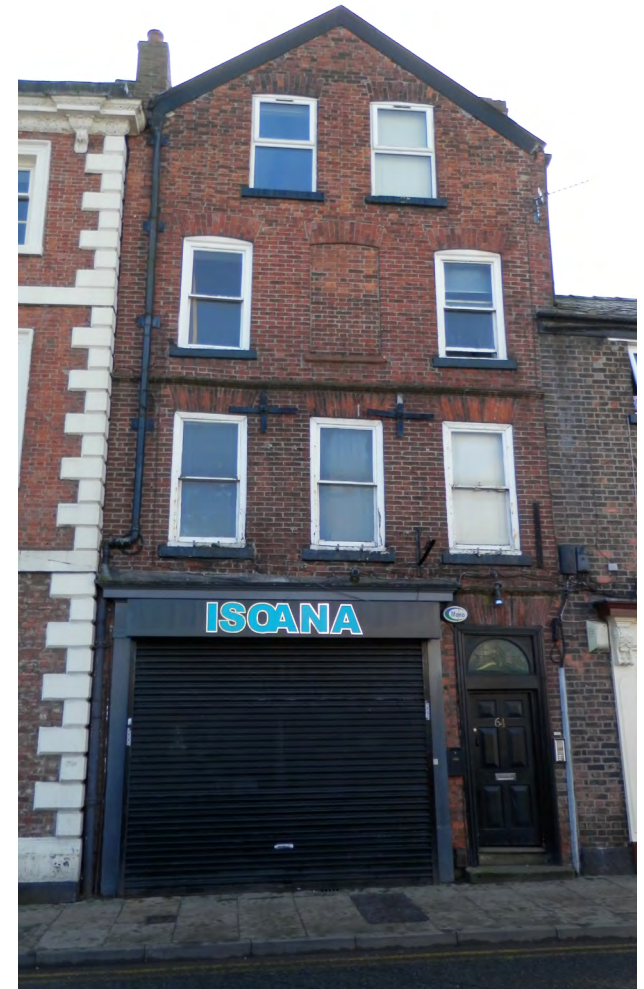
64 Chestergate

Overall condition: Fair, ties give evidence of structural movement

Notes: A four storey building with gable of an industrial character puncturing the roofline; windows are later replacements – poor quality plastic casements at third floor. Roller shutter and signage at ground floor and generally clutter of wires detract (shopfront not viewed).

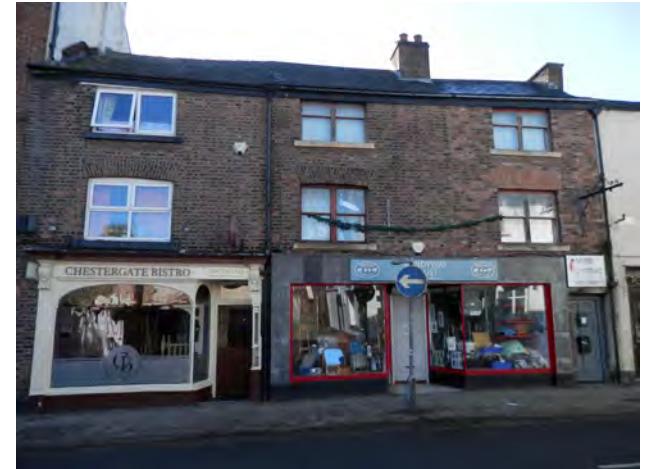
66-68 Chestergate

Notes: A handsome domestic scaled, three storey pair, later alterations including replacement windows, shopfront and signage at no.68 and poor brickwork repair and first floor lintel at no.68 detract. Roof is pitched with chimney stack. Rear has an entirely modern character with no sense of original plots or rear gardens.
