# **Walking Route to School Assessment**

# Assessment number CE 358 Mobberley to Knutsford Academy Route assessed April / September 2017

- Walking Route to School Assessment Mobberley to Knutsford Academy
- Assessment number CE 358

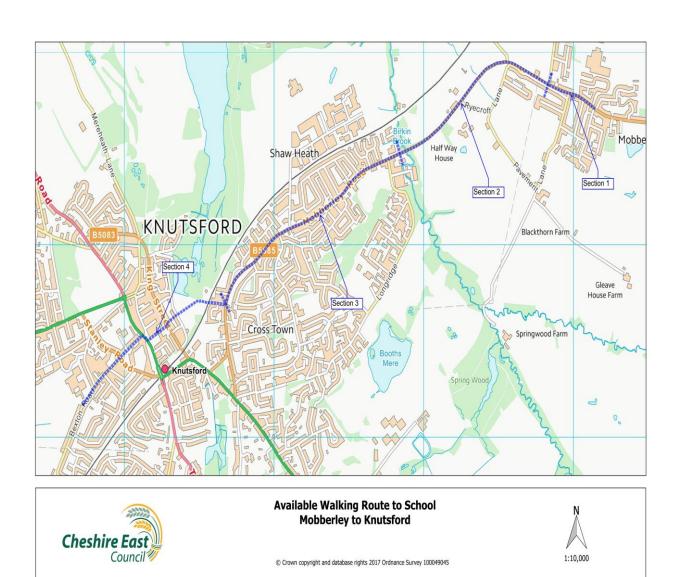
Section	Description	Distance
1	Starting at the Puffin Crossing on Town Lane (B5085) adjacent to Oldfield Drive ending at Smith Lane.	0.241 of a mile
2	Starts at Smith Lane and follows Knutsford Road to Rookswood Way.	0.731 of a mile
3	Starts at Rookswood Way and continues along Mobberley Road to Middle Walk.	0.888 of a mile
4	Middle Walk passes under the rail bridge and walk diagonally across The Moor to King Street, Church Hill and crossing Toft Road into Bexton Road and Knutsford Academy.	0.546 of a mile

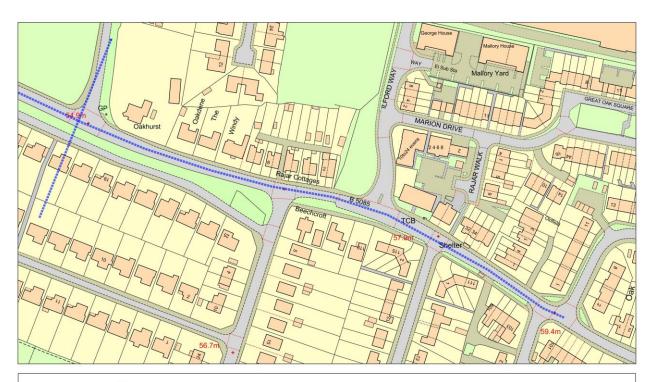
#### Available Walking Route to School Mobberley to Knutsford Section 1

- The route assessment starts on Town Lane and pupils who live to the south of this road can cross using the Puffin Crossing.
- Town Lane is a 2 way single carriageway in an urban area with shops and houses on either side of the route.
- The speed limit is 30 mph and there is street lighting along the route until Pavement Lane.
- There is an automatic speed warning sign.

Footway Assessment:				
Is there a pavement/	Yes			
footway segregated				
from traffic?	Pavements are in good condition and are of adequate width, although the assessor noted that width could be improved if house owners cut their hedges back to prevent any encroachment. If these cause a problem then the issues should, in the first instance, be reported to the landowner or secondly to Cheshire East Council 0300 123 5020

Crossing Assessment:		
Is a crossing required?	Town Lane – Puffin Crossing and no assessment required. Oldfield Drive – Side road and no further assessment required. Ilford Way – There is a traffic island that pedestrians can use to cross this road. This is also a side road and no further assessment required.	
Sighting time	There is adequate sighting time at all crossing locations.	
Traffic volume Gap times	n/a due to controlled crossing in place.  n/a due to controlled crossing in place.

This section of the route is the urban area of Mobberley and is a well-lit route with continuous pavement. The assessor noted that there was one pedestrian collision at the Puffin Crossing on Town Lane.

This section has been assessed as available.

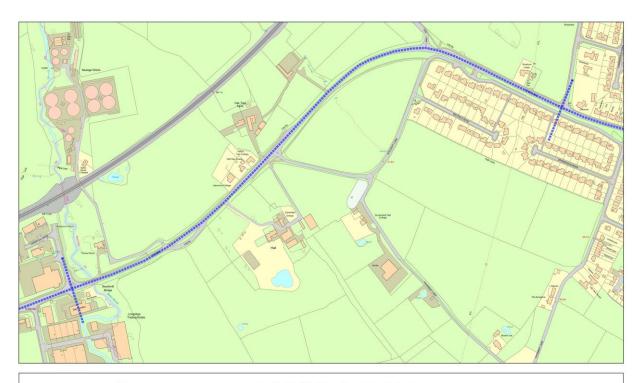
#### Available Walking Route to School Mobberley to Knutsford Section 2

- A new pavement has recently been constructed along Knutsford Road and is 2 m wide.
- Knutsford Road is along a rural section with fields and a few houses adjacent to the road.
- There is no street lighting and the speed limit is national speed limit.
- The speed limit changes to 30 mph approx. 100 m prior to the traffic lights at Rookswood Way.

Footway Assessment:				
Is there a pavement/	Yes			
footway segregated				
from traffic?	Pavements are of adequate condition and width.			
Is there a need to	No			
walk on the				
carriageway?

Crossing Assess	ment:
Is a crossing required?	Smith Lane – Side road no further assessment required. Broad Oak Lane – The assessor noted that the recent addition of dropped crossings away from the mouth of the junction meant that pedestrians were crossing at the narrowest part of the road and that no further assessment was required.
Sighting time	There is adequate sighting time at all crossing locations.
Traffic volume	n/a due to low volume
Gap times:	n/a due to low volume

This section of the route had previously been assessed as unavailable due to the lack of path with hard paved surface; however, the construction of the new path has created a walking route between Mobberley and Knutsford.

This section of the route has been assessed as available.

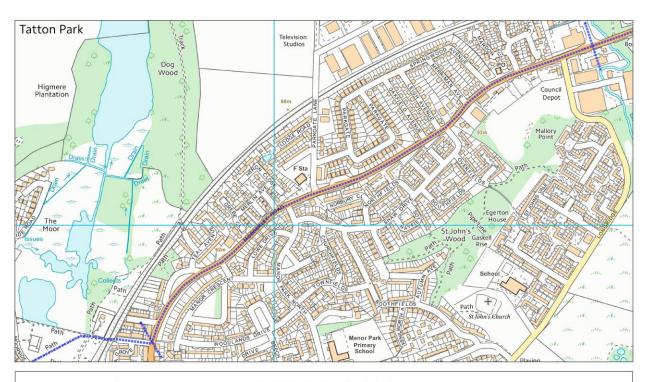
#### Available Walking Route to School Mobberley to Knutsford Section 3

- The section of the road is along Mobberley Road and is in an urban area with houses and local businesses on either side of the road.
- The first section is a shared path and both cyclists and pedestrians can use the pavement.
- The speed limit is 30 mph and there is street lighting.

Footway Assessment:		
Is there a pavement/ footway segregated	Yes	
, ,		
from traffic?	The pavement is in generally good condition; however, in a number of locations the surface is uneven, with the probable cause being tree roots. This could cause a tripping hazard for pedestrians, especially those with impaired vision or who have difficulty walking, and will be a particular issue during the hours of darkness. The footpath is of adequate width.

Crossing Assessment:		
Is a crossing required	Rookswood Way – Pedestrian phase in traffic lights, no further assessment required.  Montmorency Road – Side road and no further assessment required.  Springwood Ave – Side road and no further assessment required.  Merriman Ave – Side road and no further assessment required.  Leigh Ave – Side road and no further assessment required.  Oakfield Avenue – Side road and no further assessment required.  Parkgate Lane – There is a traffic island but not designed for use as a crossing point. Pedestrians are directed to the dropped crossing. This is a side road and no further assessment required.  Kestrel Ave – Side road and no further assessment required.  Moordale Ave – Side road and no further assessment required.	
Sighting time	There is adequate sighting time at all crossing locations.	
Traffic volumes	n/a due to low volume	
Gap times	n/a due to low volume

This section is in an urban area with street lighting and on continuous route.

This section has been assessed as available.

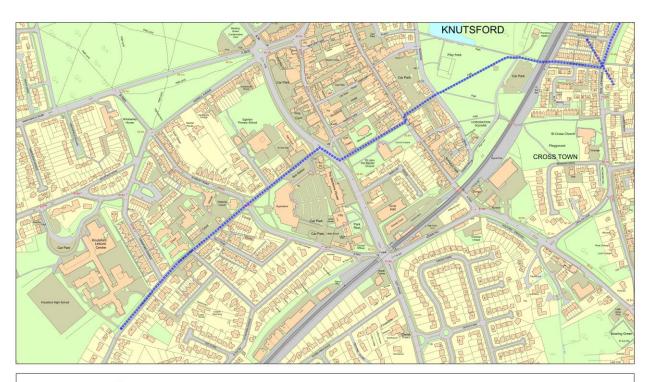
Available Walking Route to School Mobberley to Knutsford Section 4

- All of this section is in a 30 mph zone, unless noted and there is street lighting for the most part, unless noted.
- The section passes through Knutsford town centre and is used by pedestrians and pupils travelling to and from local schools.

- The first part of this route passes down Middle Walk and under the railway bridge – the assessor noted that although the short tunnel under the railway bridge (approximately 11 metres) is unlit, it is a well-used route.

- There is lighting on Middle Walk and annual traffic counts are undertaken as part of the monitoring programme for Cheshire East's Cycling Strategy.
- The route then passes diagonally through The Moor which is a popular local park. This path is not lit although the assessor noted that there are other paths in the park that are lit.

- There is a channel for a small stream running adjacent to Moorside which could cause a trip hazard but the assessor noted that there is an adjacent street light and it is also a well-used route.

- The route then passes through the King Street car park. There is a section in the car park where there is no pavement but the assessor noted that pedestrians freely walk around the car park where traffic speeds and volumes are low and very few pedestrians used the pavement.

- The route crosses King Street which is a road busy with pedestrians and some traffic. There is good visibility on this crossing point and traffic speed is generally low.
- The route follows Church Hill Walk which is a cobbled road and pavement on one side of the road.
- Pedestrians then need to cross Princess Street to access the traffic lights on Toft Road.
- Toft Road can be crossed using the pedestrian phase in the traffic lights.
- The route follows Bexton Road crossing Stanley Road.

Footway Assessment:		
Is there a pavement/ footway segregated	Yes	
from traffic?	Good quality pavement with adequate width for the majority of the route except the section in the King Street car park.	
Is there a need to	Yes	
walk on the carriageway?	There is a small 10 metre section in the King Street Car Park where there is no pavement, however, the assessor noted that pedestrians walk freely in the car park and do not appear to use the existing pavement as traffic speeds and volumes are low.

Crossing Assessment:		
Is a crossing required?	Moorside – This is a quiet road with low traffic flows – no further assessment required.  King Street is a one way street well used by pedestrians as it is a shopping centre, the road has good visibility, traffic speeds are low and no further assessment required.  Princess Street is a one way street. Pedestrians can cross using the dropped crossing points and the road has good visibility and traffic speeds are low as vehicles are approaching a junction.  Toft Road – There is a pedestrian phase in the traffic lights and no further assessment required.  Stanley Road – Side road and pedestrians can cross using the raised table.	
Sighting time	There is adequate sighting time at all crossing locations.	
Traffic volume	n/a - Moorside, King Street and Princess Street due to low traffic volumes. Toft Road due to a controlled crossing in place and Stanley Road due to traffic calming and uncontrolled table type crossing.

The route was assessed as available.
