Re: Public Footpath, Goostrey No 12 - Diversion Proposals - Access Assessment & Report

Author: Philip Chambers 6th April 2016

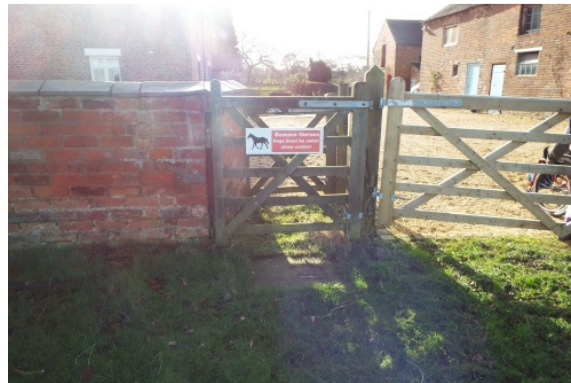
The path which is then constructed of loose grave intersects the main buildings and leads to a field gate on an existing residential/equestrian area. The field gate leads to an earth track which follows a field boundary and eventually towards Mill Lane, Goostrey.

Figure 1 Exit gate from the farm/stable yard.

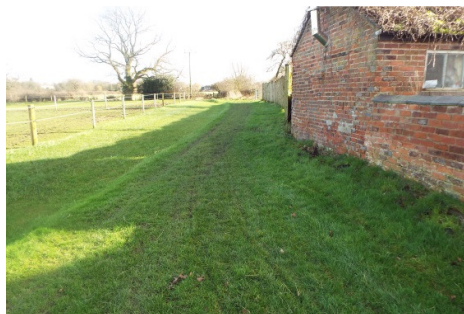
After the gateway the footpath turns and runs parallel to the boundary of the house and garden and a field fence -line. It is initially a grass path before deteriorating into a less defined route.

Figure 2 Grass Route

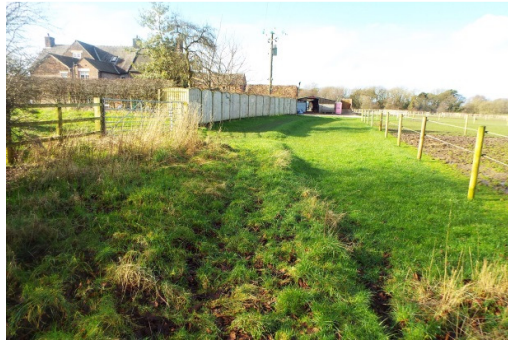
The subsequent rough grass and earthen path has some undulation and is not an easy going route for disabled people to access. A grass path can be suitable if, for example grazed by sheep, into a consistent firm swathe, but longer grass is difficult to access by people with mobility impairments and blind or visually impaired users. A grass path should be mown to keep a surface which meets the Standard.

Figure 3 Undulating Footpath

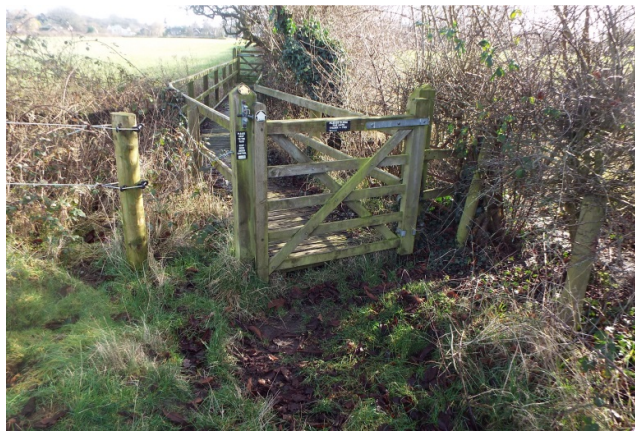
Pedestrians and in particular disabled people are soon confronted by a series of barriers; including two difficult to negotiate field gates and a board walk with stepped access. The entrance point to the boardwalk is restricted by an uneven and poorly maintained path with a step onto the boardwalk of approximately 20cm. The design of the field gate is a barrier to some people with mobility impairments and probably those with visual impairments, as it opens towards the user and the step access will impede independent wheelchair users and people with outdoor mobility scooters.

Figure 4 Field Gate and Step to Boardwalk

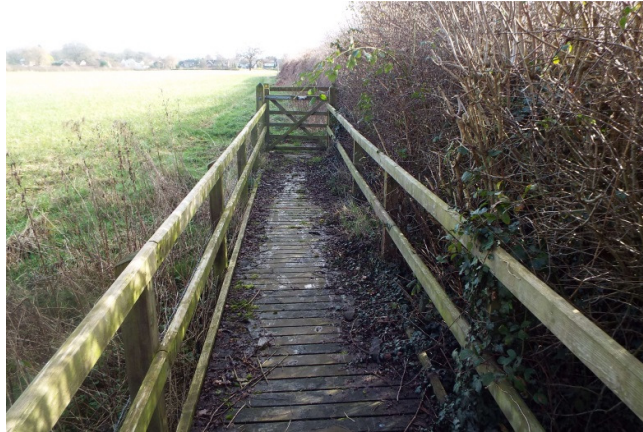
The boardwalk is not well maintained and moss, leaf litter, undergrowth and overgrowth encroachment have reduced the useable width and a clear walking tunnel of 1200mm x 2100mm is not provided, so the route does not meet the Countryside for All Standard. Boardwalks are prone to becoming slippery surfaces when leaf litter etc. accumulates and it is always best to provide a non-slip safety

surface on the decking to reduce the potential hazard, this has not been provided. The wooden hand rails which a visually impaired or blind person would grip are rough and abrasive.

Figure 5 Poorly Maintained Board Walk

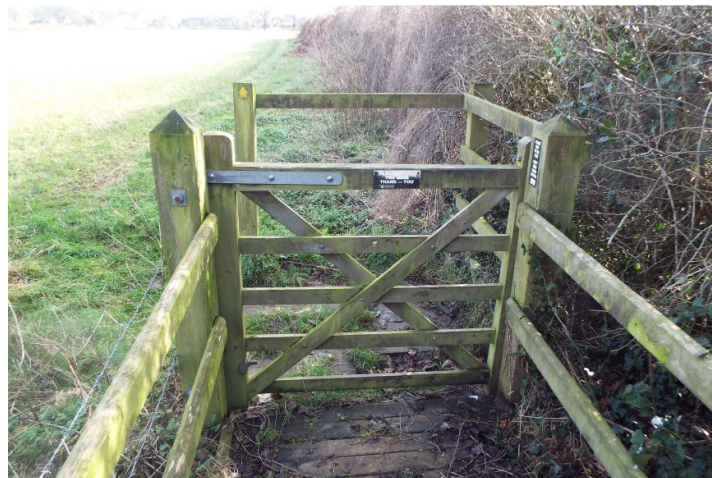
There is a second gate at the other end of the board walk. The second gate is an absolute physical barrier to most wheelchair and mobility scooter users as the box hurdle has been designed with insufficient space to permit a convenient turning space. A gate rail appears to have been broken off to try and create easier access to and from the boardwalk.

Figure 6 Difficult to Negotiate Gate

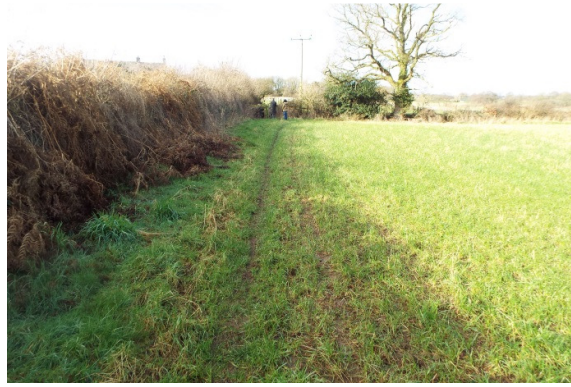
After the boardwalk the path continues alongside the edge of a field where it is reasonably level and made up of a mix of earth and grass. It does not meet the Standard. As an independent wheelchair user, I found that the combination of the Boardwalk and gates detract from the pleasure of the journey and I would normally have been dissuaded from this route, mainly due to the physical man-made constructions which cause access barriers.

Figure 7 Erath and Gras Path after Boardwalk

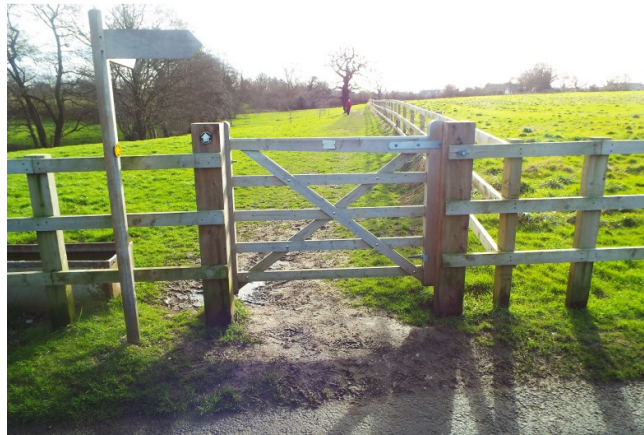
After approximately 200m, the permissive footpath was signposted and access provided to a pasture, through an accessible gateway where the path follows the field boundary and fence line.

Figure 8 Field Gate leading to Permissive Path

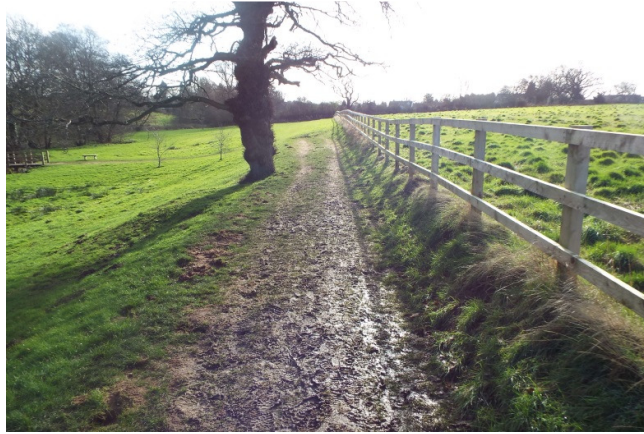
The path, which is a mix of earth and grass is fairly level, although at the time of the survey was quite muddy. This part of the route provides good views of the open fields and overlooks Shear Brook.

Figure 9 Level Muddy Earth Path

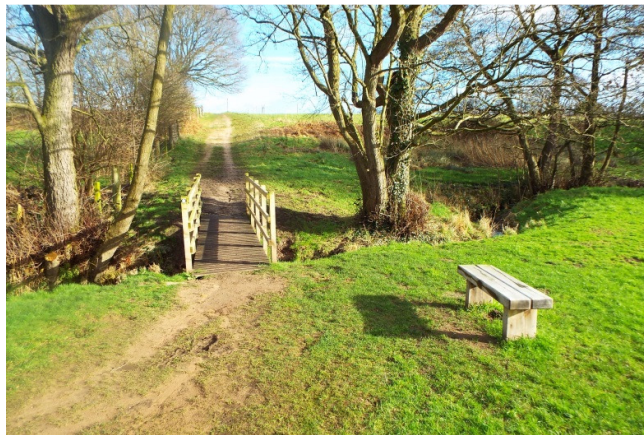
The path turns about 180degrees and the footpath slopes down to a footbridge over Shear Brook, situated in a pleasant valley setting. The slope is steeper than 1:10 and is an earth path so does not meet the Countryside for All Rural Standard. Seating has been provided to assist people who need to take a rest when or after approaching the slopes.

Figure 10 Seating Adjacent to Footbridge

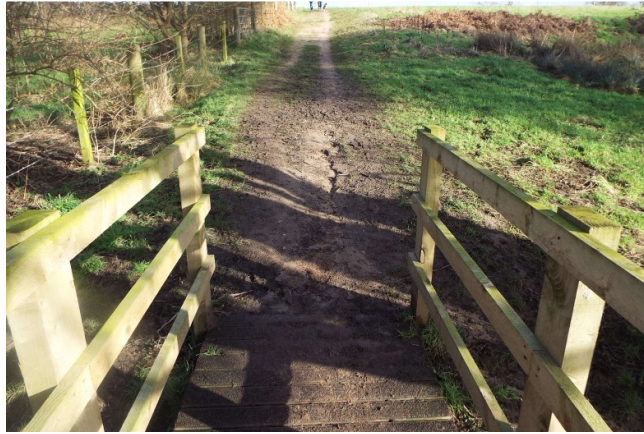
The footbridge is of a good quality with flush access to and from the footpath. The handrail should be extended to enable blind or visually impaired users to navigate more easily and to appreciate when they are leaving the bridge and returning to the footpath. On leaving the footbridge the footpath is muddy and rises at a gradient of steeper than 1:10, so does not meet the Standard.

Figure 11 After leaving bridge Path does not meet Standard

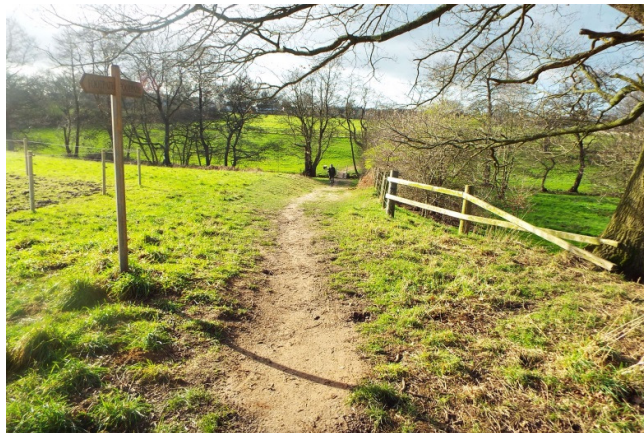
The path levels off and although remains an earth structure and it was firm. There are good views of the surrounding rural countryside and over an attractive nature pond which the landowner has opened up near to the path.

Figure 12 Path provides good countryside views and experiences

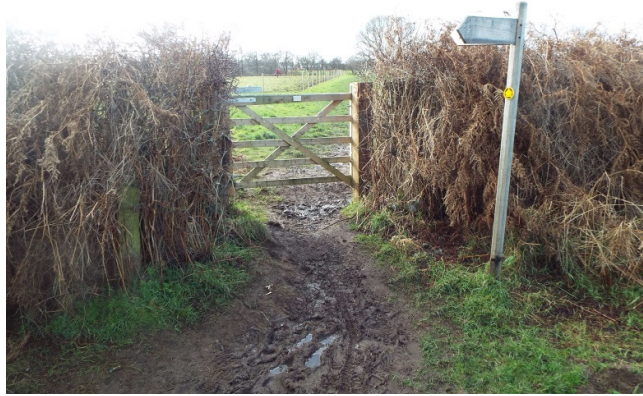
The earth path remains level and after approximately 1,000m from the start, the path culminates at an accessible field gate where recent wet weather and regular footfall had caused a muddy gateway. At this point the definitive footpath and the permissive footpath join.

Figure 13 Easy Access Gate – Restricted by Muddy surface

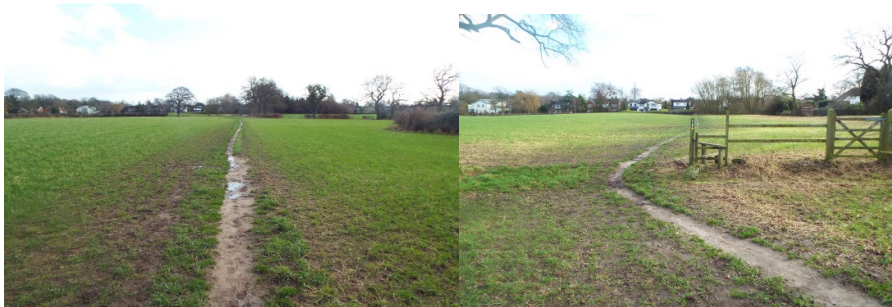
The adjoining footpaths continue towards Mill Lane Goostrey. The path width is narrower than 1000mm and is an earth path which is muddy in parts, but it is level, although it does not meet the Standard. The path meanders past a redundant fence line and stile, eventually culminating at a field gate adjacent to Mill Lane. The field gate is in good condition, but the design precludes wheelchair access.

Figure 14 Path Does Not Meet rural Standard

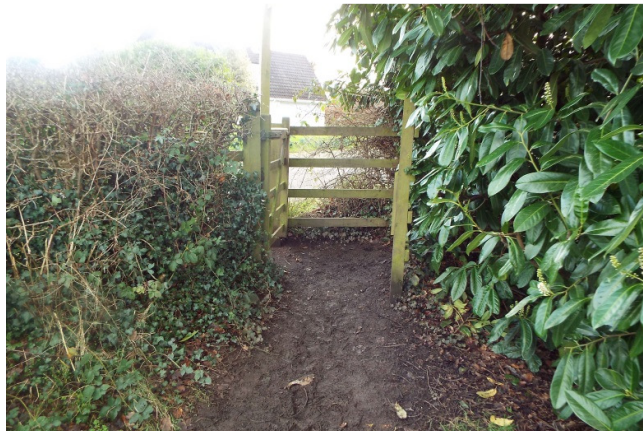
Figure 15 Footpath finishes at field gate - design restricts wheelchair access
