Flood Recovery Update

Overview and Scrutiny Briefing

Flooding Update – 31 July and 26th October 2019

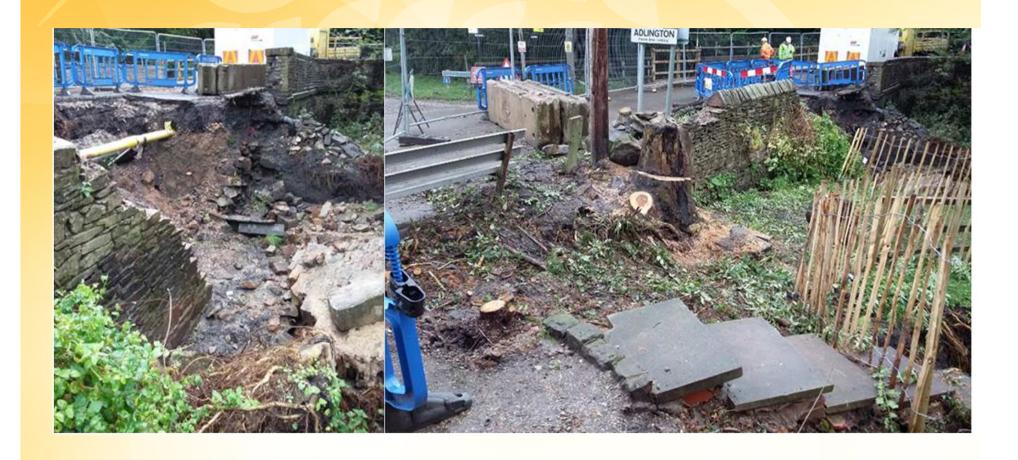
Major Works – Wards End Retaining Wall

- Scope of scheme currently under review
- Meeting with United Utilities requires them to temporarily divert the water main where the wall has collapsed. Main carries around 5000l/s (high risk). Anticipate 2 weeks for UU to complete works by which time repairs to the highway can be commenced.
- Environmental survey and risk review completed. All statutory undertaker site meetings complete.
- S Area of collapse cleared and stones recovered from both the river and the local land to be used in reconstruction.
- Trees removed from the top of the embankment to facilitate safe access for plant, labour and materials.
- Areas of land collapse made safe, area surveyed with ground penetrating radar to establish locations of any underground voids.
- Street lights repaired to illuminate new footpath.
- S Anticipate completion by end 2019

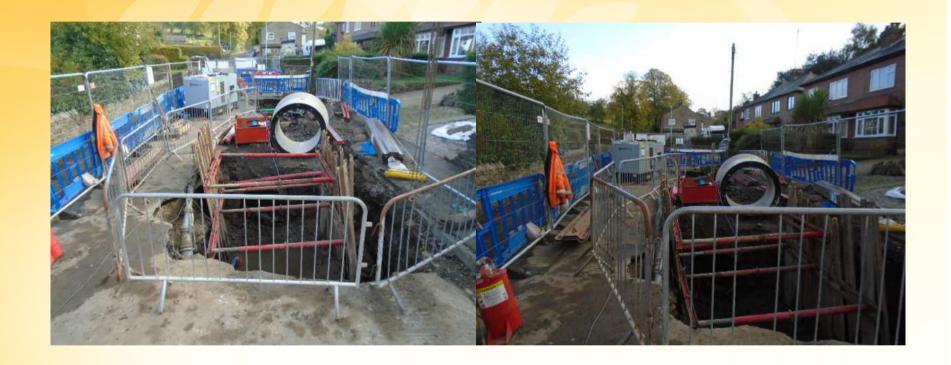
Major Works – Ingersley Road

- Scheme 1 week into re-construction from 10 week delivery.
- S Design agreed for temporary sheet piling to support area whilst culvert is replaced.
- § 3D model of services undertaken to assist with sheet piling and services location.
- S Pre-cast concrete pipes to replace culvert arrived and in storage.
- Full ground penetrating radar survey carried out to establish locations of all subsurface voids.

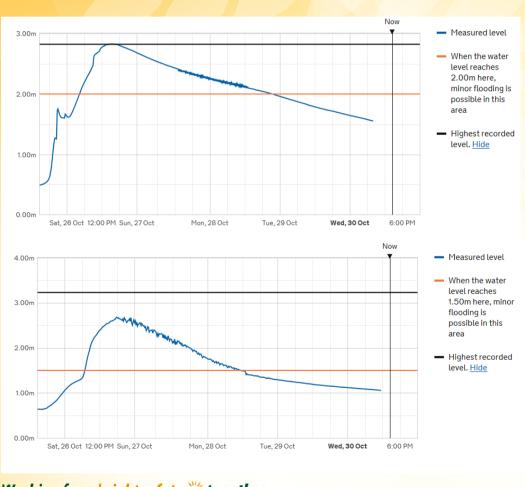
S Approx. 100mm rain in 24 hrs in Nantwich, 70mm in 24hrs Northwich

River Weaver level matched highest recorded at Audlem

River Weaver level reached 2.67m at Nantwich
