S19 Flood Investigation Report

July 2019 Flood Event

Flood Risk Management Team Cheshire East Council – Lead Local Flood Authority

Flood Investigation Reference Number: 2019/002

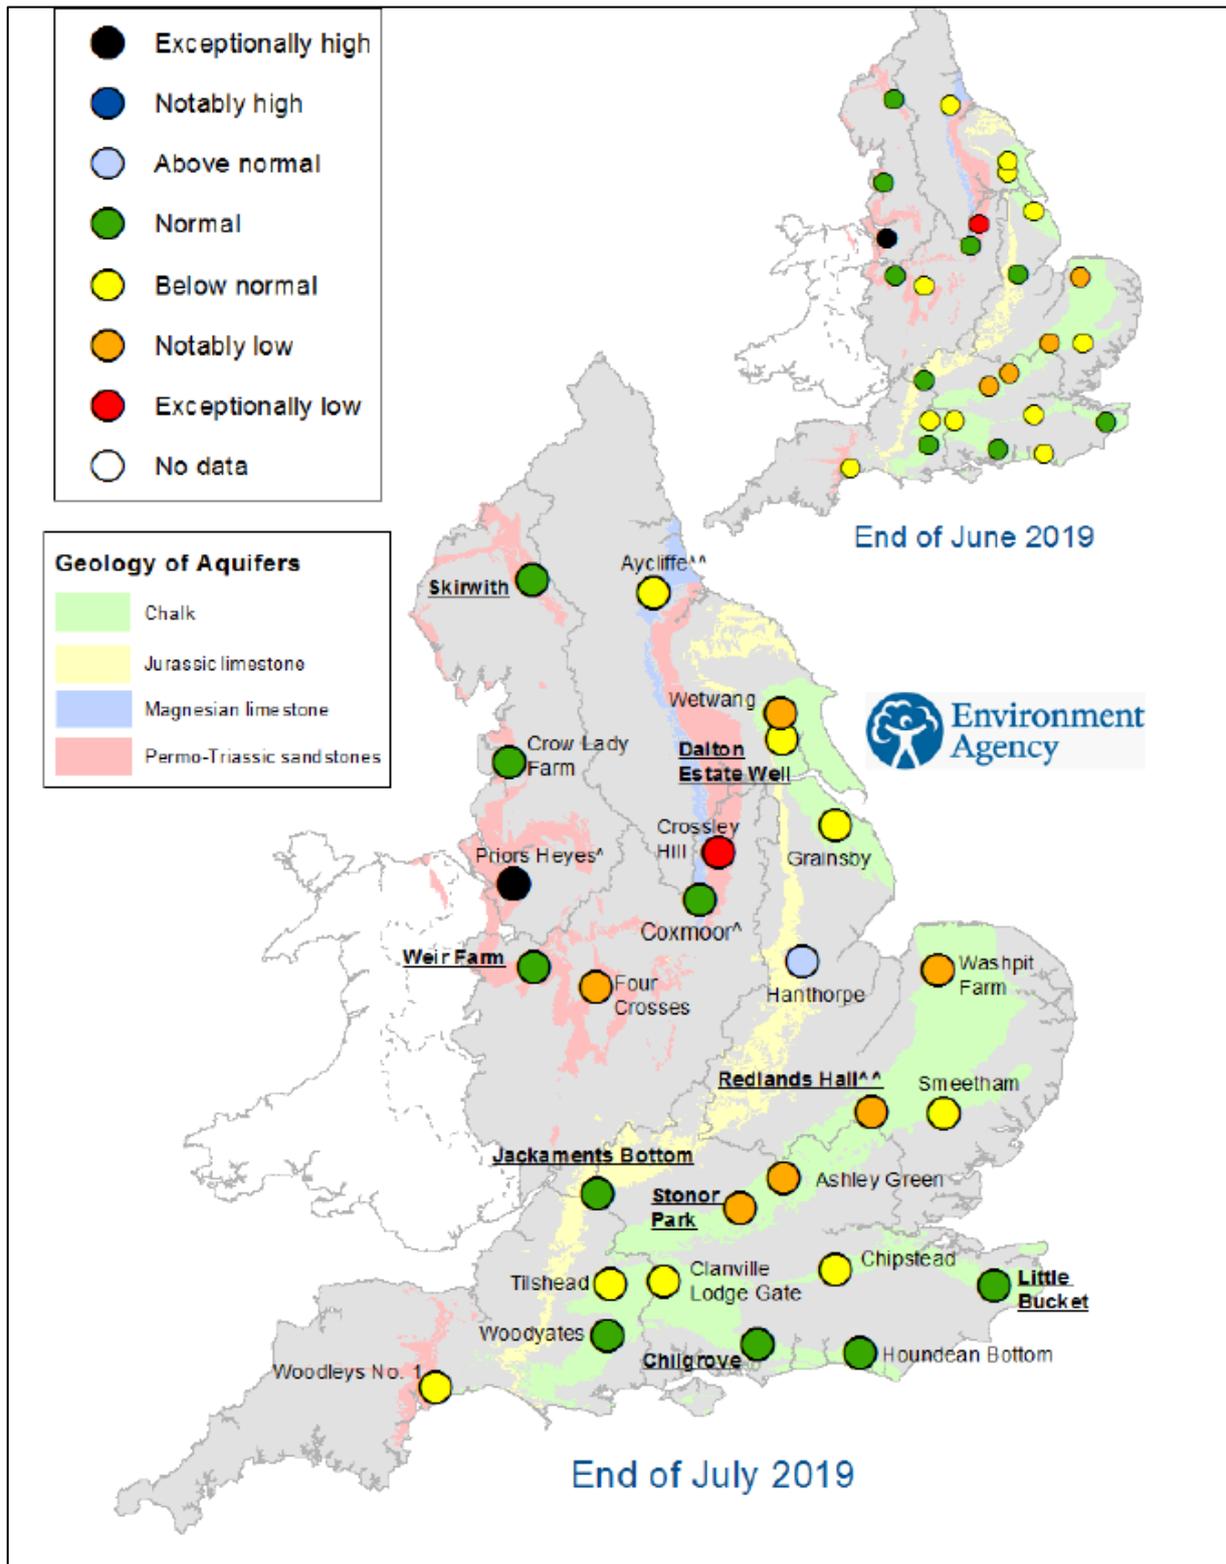
Figure 2 Groundwater levels for indicator sites at the end of June 2019 and July 2019

[^] The level at Priors Heyes remains high compared to historic levels because the aquifer is recovering from the effects of historic abstraction

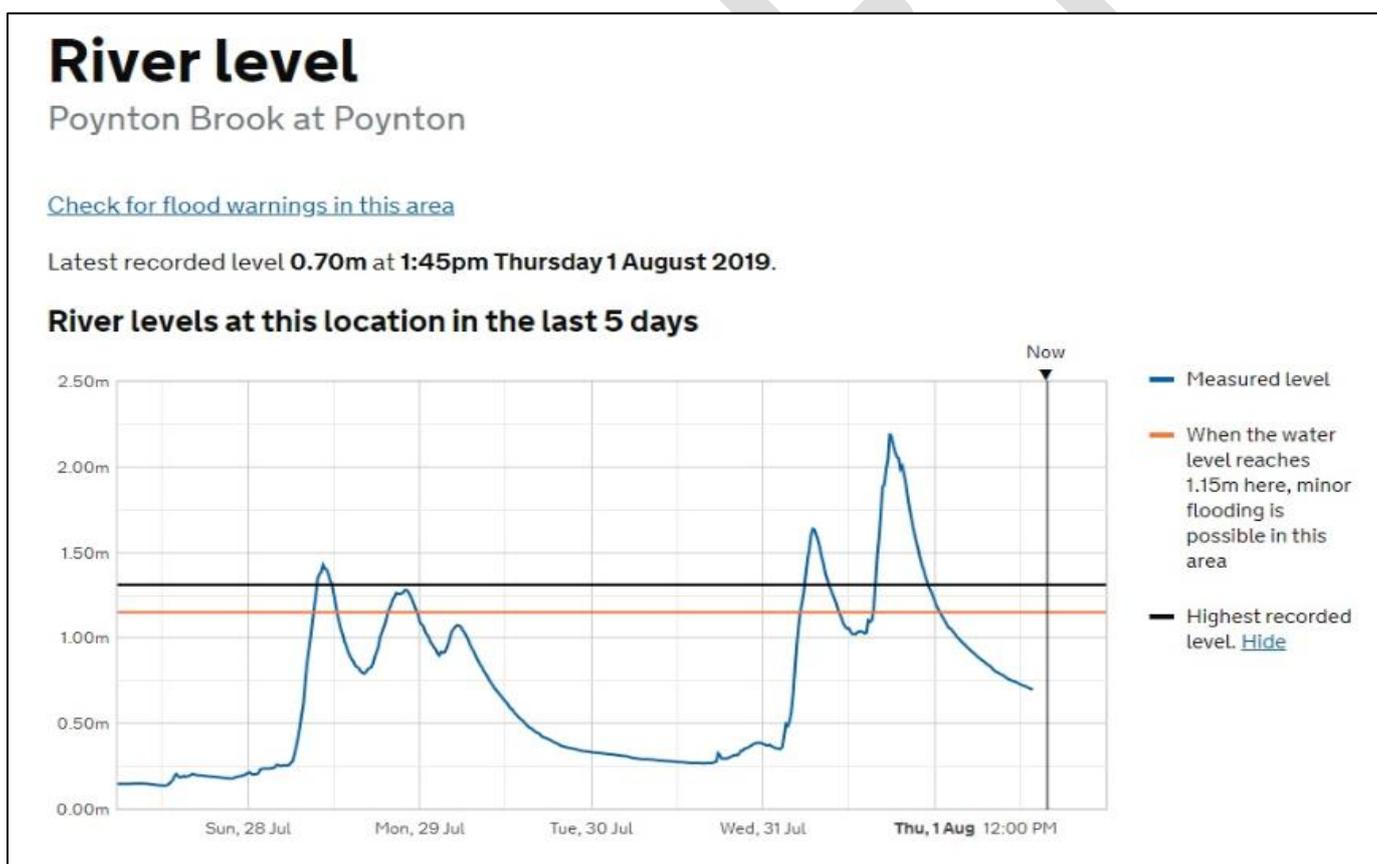
Figure 6 Measured River Level at Poynton Brook

For the Poynton catchment a water level gauge is situated on Poynton Brook near midway at grid reference: 391600, 382718. Water levels at this gauge rose on Sunday 28th July following heavy rainfall, remaining elevated prior to further rain on Wednesday and Thursday. Records were broken on Thursday 31st July 2019 at 5:45pm when recorded river levels at Poynton Brook reached 2.195m, nearly a metre higher than the previous highest recorded on the 11th June 2016 (1.2m).

Records were broken on Thursday 31st July 2019 at 5:45pm when recorded river levels at Poynton Brook reached 2.195m, nearly a metre higher than those recorded on the previous flood event of 11th June 2016. (1.2m).

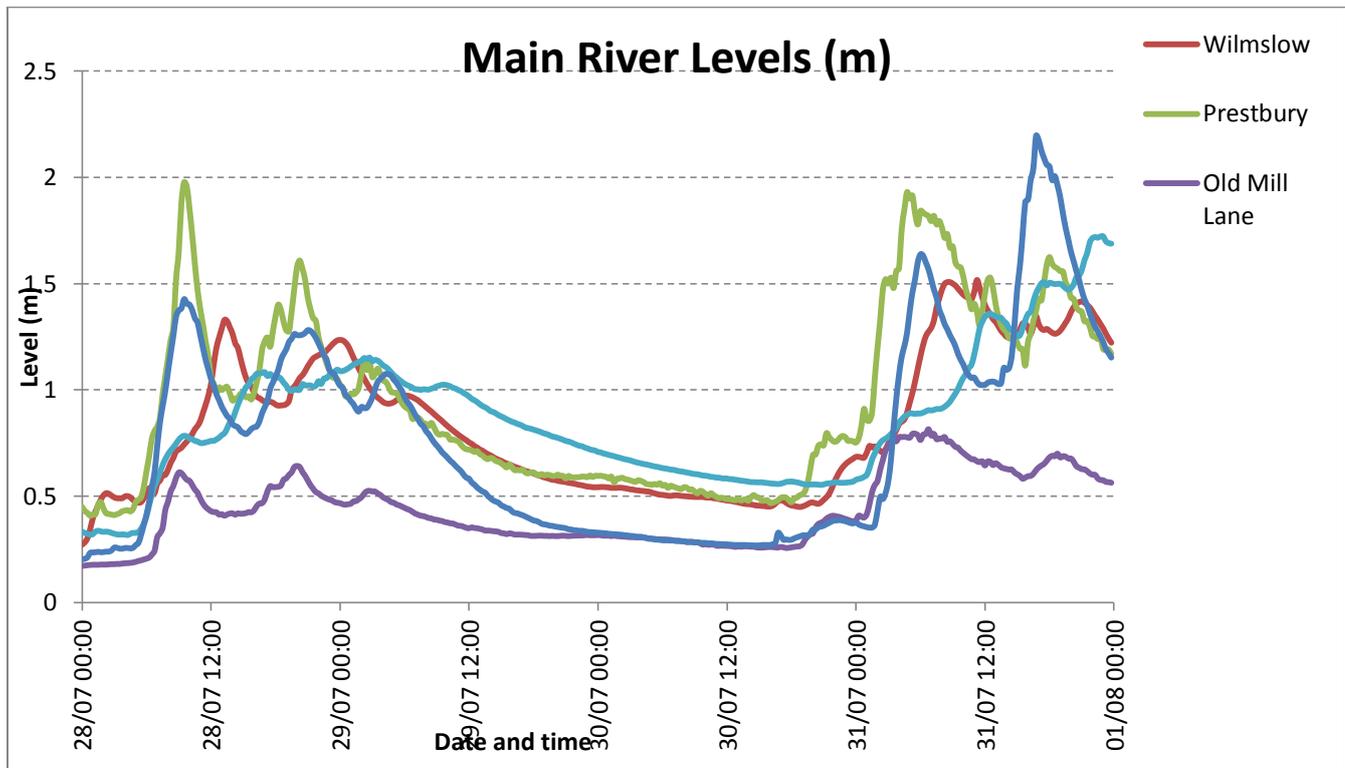
Figure 7 Main River levels (m)

The other river water level gauges all showed a similar pattern as the catchments responded to the rainfall event. The catchment responses will vary and dependant on the physical characteristics of the river catchment, barriers to flow, artificial drainage and any additional inflow/outflows to the system.

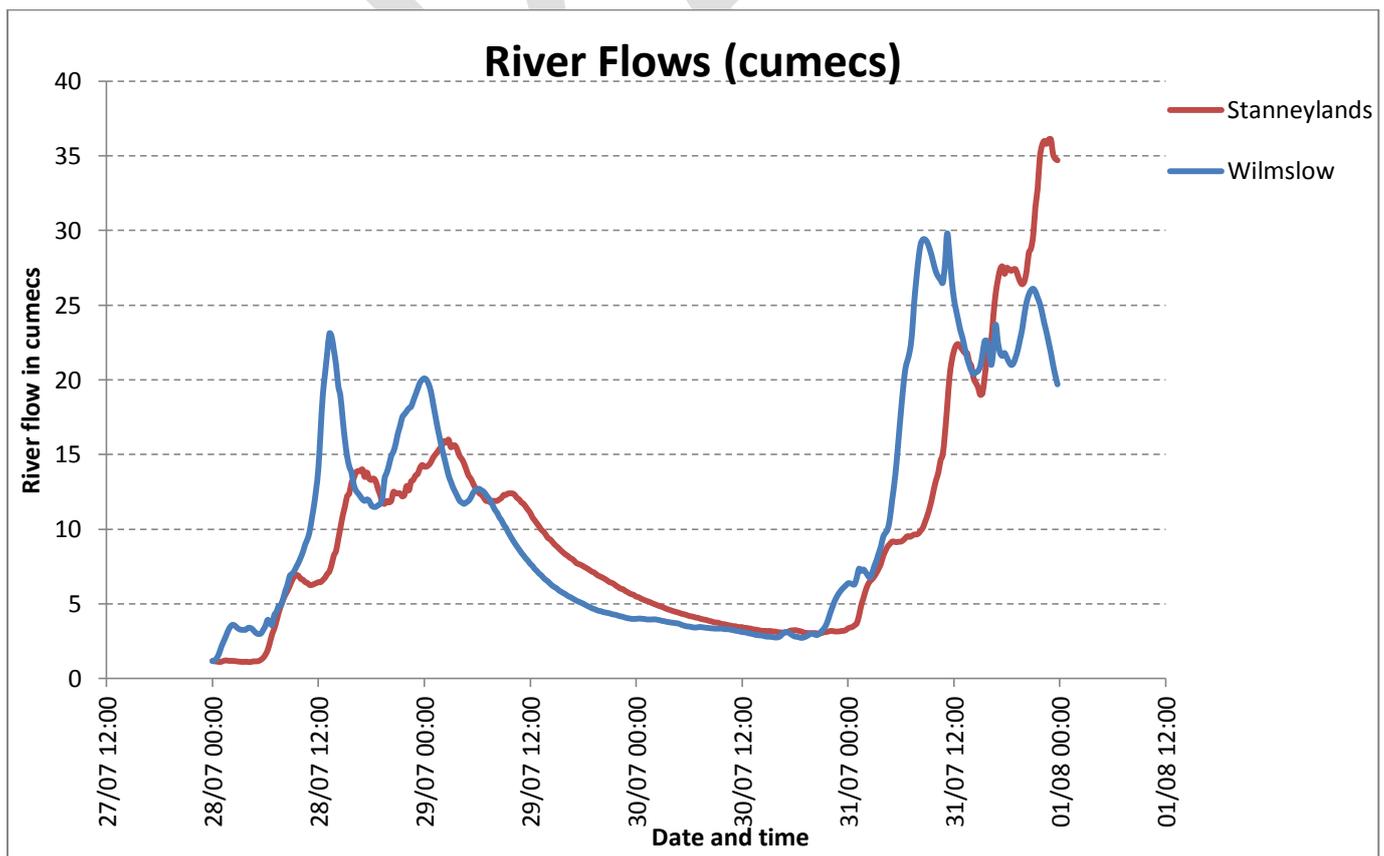
Figure 8 Main River Flows (cubic metres per second / cumecs)

Across the catchments river flows are recorded on the River Dean at Stanneylands and River Bollin at Wilmslow. There are no flow gauges on the rivers on the Poynton Brook, Todd Brook or Harrop Brook catchments.

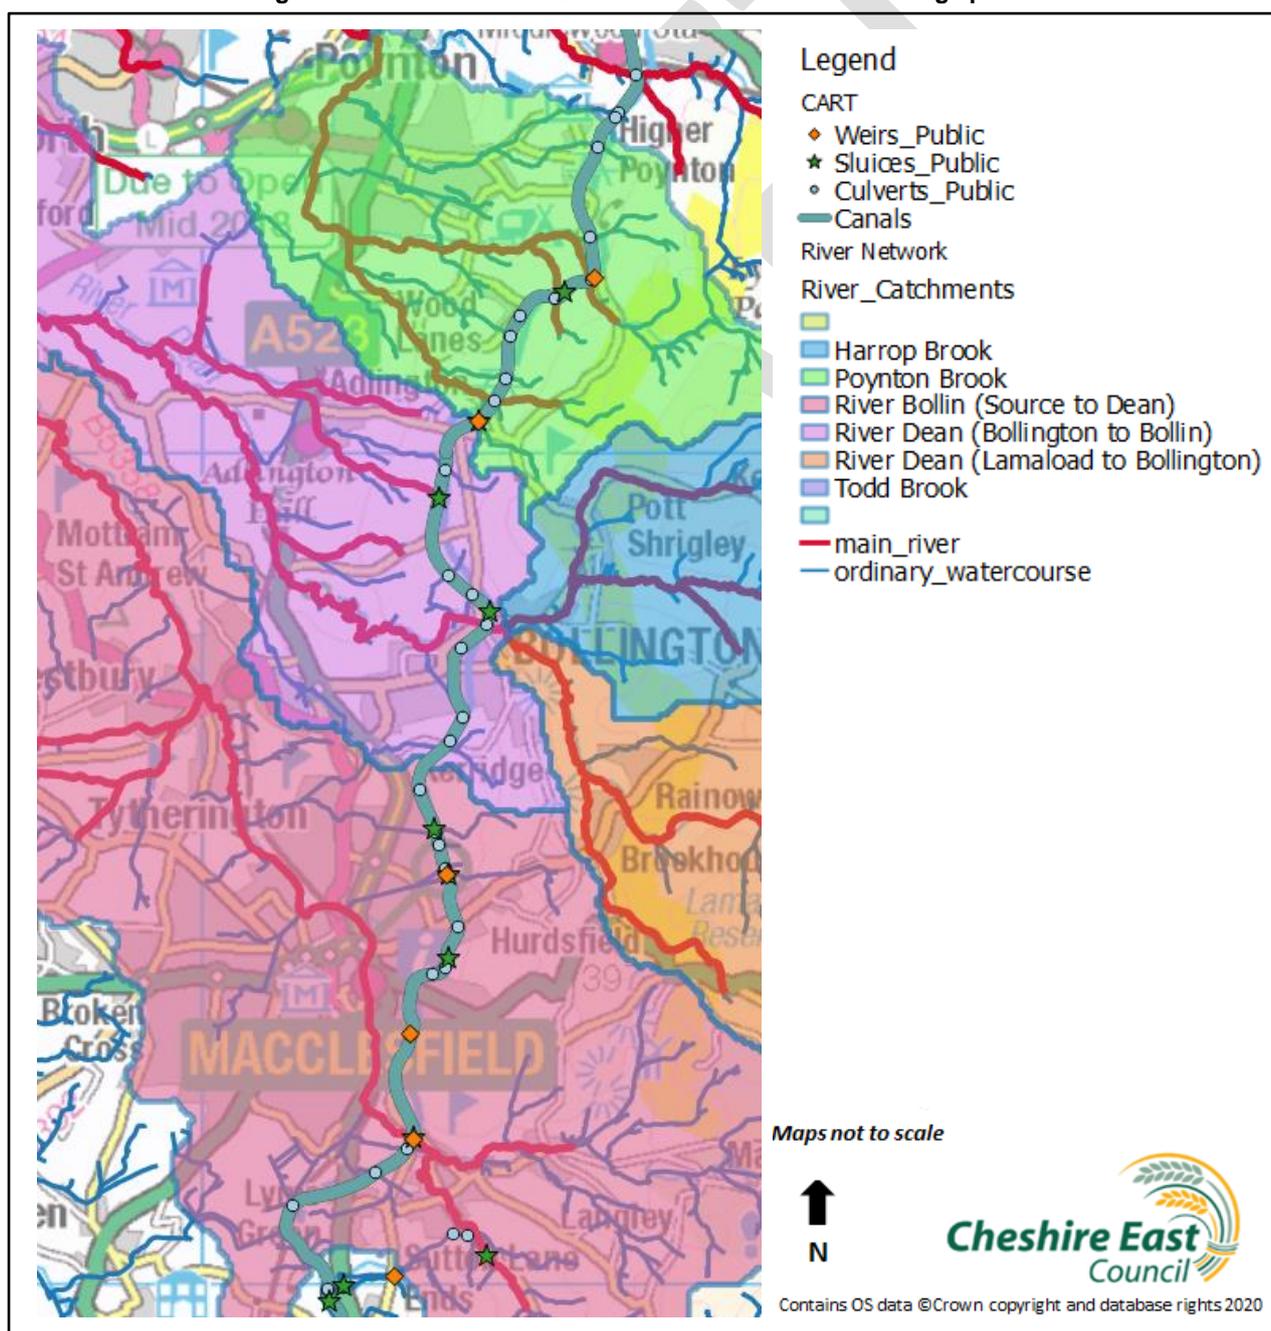
Figure 9 Macclesfield Canal Interactions with natural drainage paths

The canal network is managed by the Canal and River Trust. Canals are not designed or constructed to carry significant flood flows. The Macclesfield Canal runs from a junction with the Peak Forest Canal at Marple in the north, in a generally southerly direction, through the towns of Macclesfield and Congleton, to an end-on junction with the Hall Green Branch of the Trent and Mersey Canal. Four reservoirs feed water into the canal system. Four reservoirs feed water into the canal system.

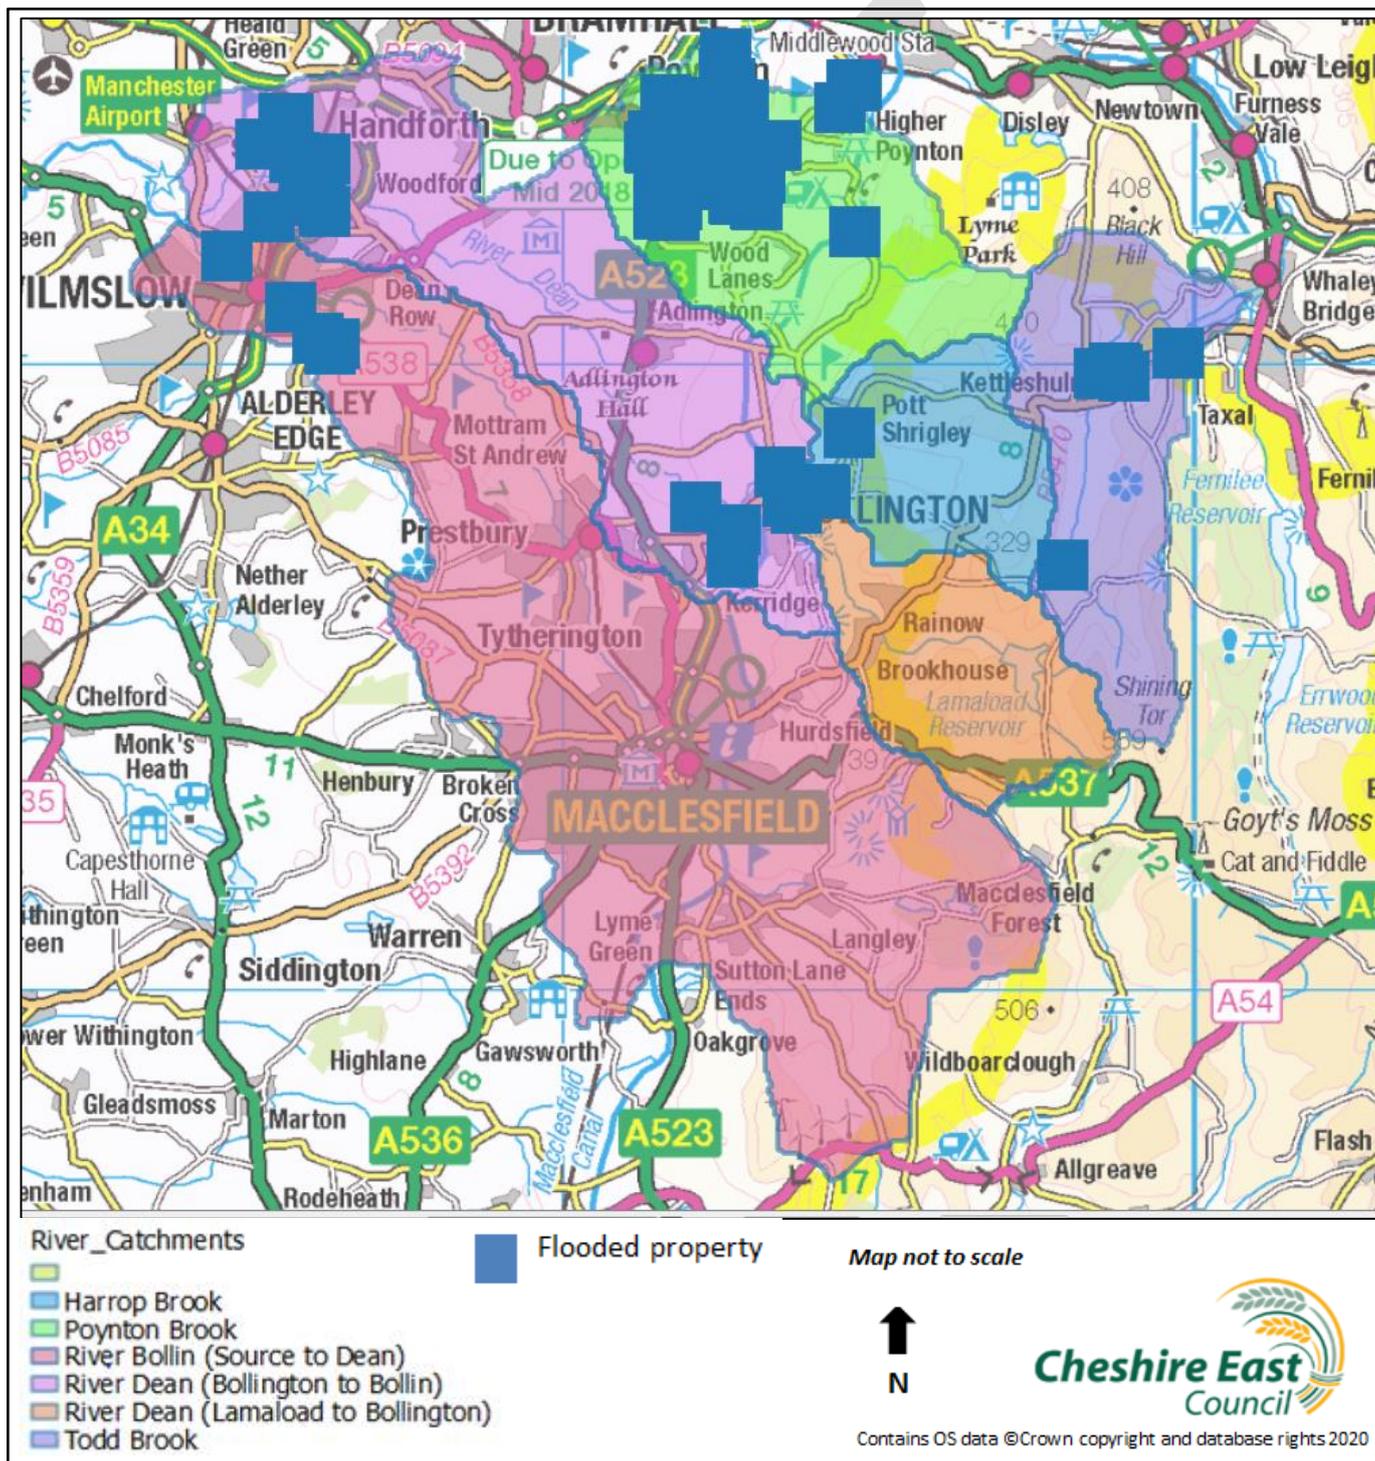
Figure 11 Flooded Locations

The blue squares on the map below shows the locations which reported experiencing internal property flooding to the LLFA, United Utilities or the Environment Agency (either residential or commercial) during the period of 28th-31st July 2019.

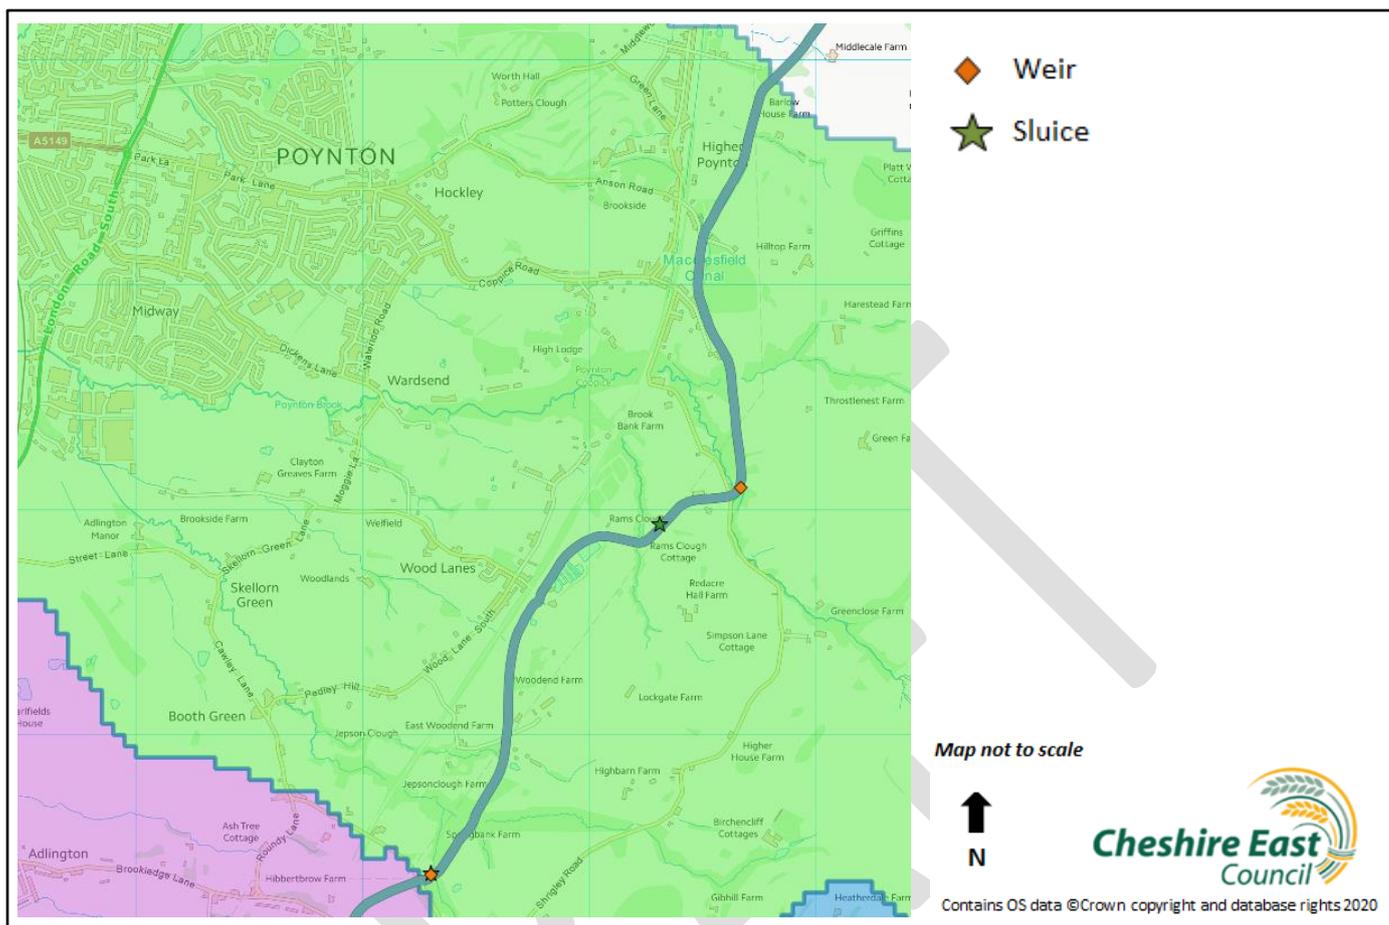
Figure 13 Canal Interactions with Poynton catchment

Symbols weir: orange diamond, sluice: green star

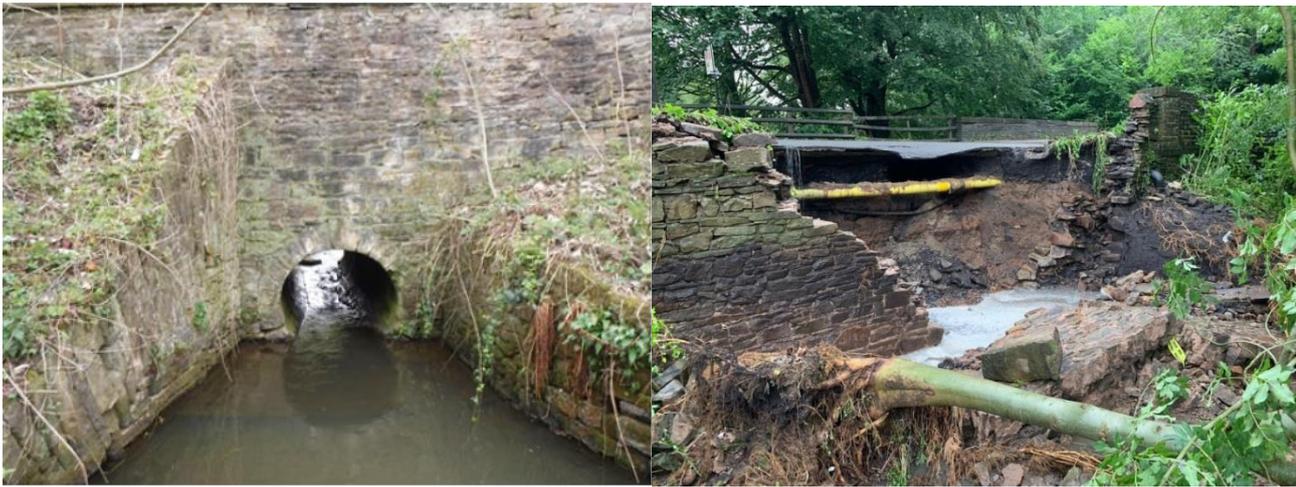
Property flooding from Main River and surface water overland flow occurred adjacent to Wards End bridge. Water levels were reported to be high upstream of the bridge, and then rose quickly. The high water levels overtopped the bridge, and caused the downstream parapet to fail, along with considerable erosion of adjacent land. The limited size of the aperture of the bridge opening and its high headwall suggests it acted to retain water and reduce flows downstream, and may have been specifically designed to reduce flooding further downstream. It was reported that the rapid water level rise was due to a blockage in the bridge opening. At some point the blockage cleared through the opening. Both gas and mains water pipes flow across this structure which has been considered in its redesign by Cheshire East Highways, the Environment Agency was consulted to as part of these works.

Photograph 1 Wards End Bridge retaining wall upstream (left photo) and downstream (right photo) after the flood.

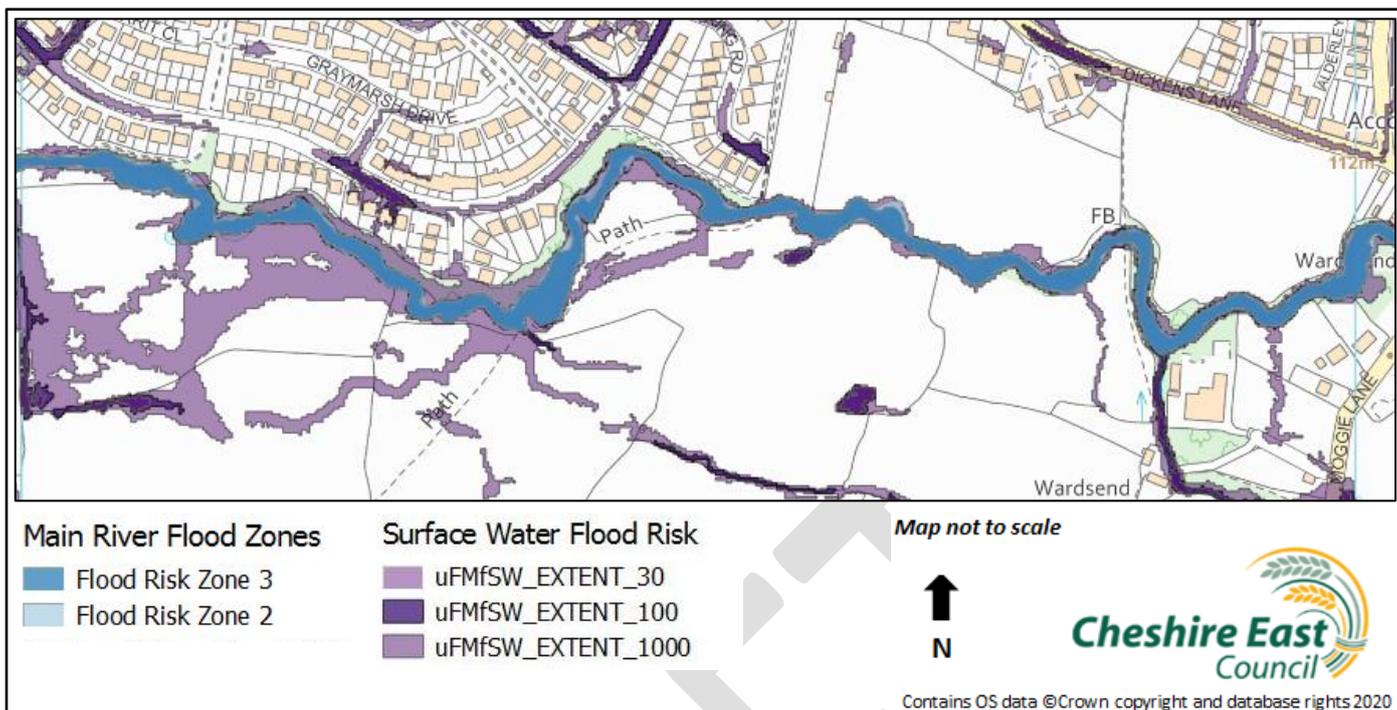
Figure 16 Flood risk* along Poynton Brook between Ward End bridge and industrial estate

Poynton Brook then flows west, naturally filling up its natural floodplain. Much of the corridor adjacent to Poynton Brook remains undeveloped; there were no reports of property flooding until the urban area. Flood wrack was observed on the right bank at several locations, indicating water out of bank on the right bank (to the north) of Poynton Brook.

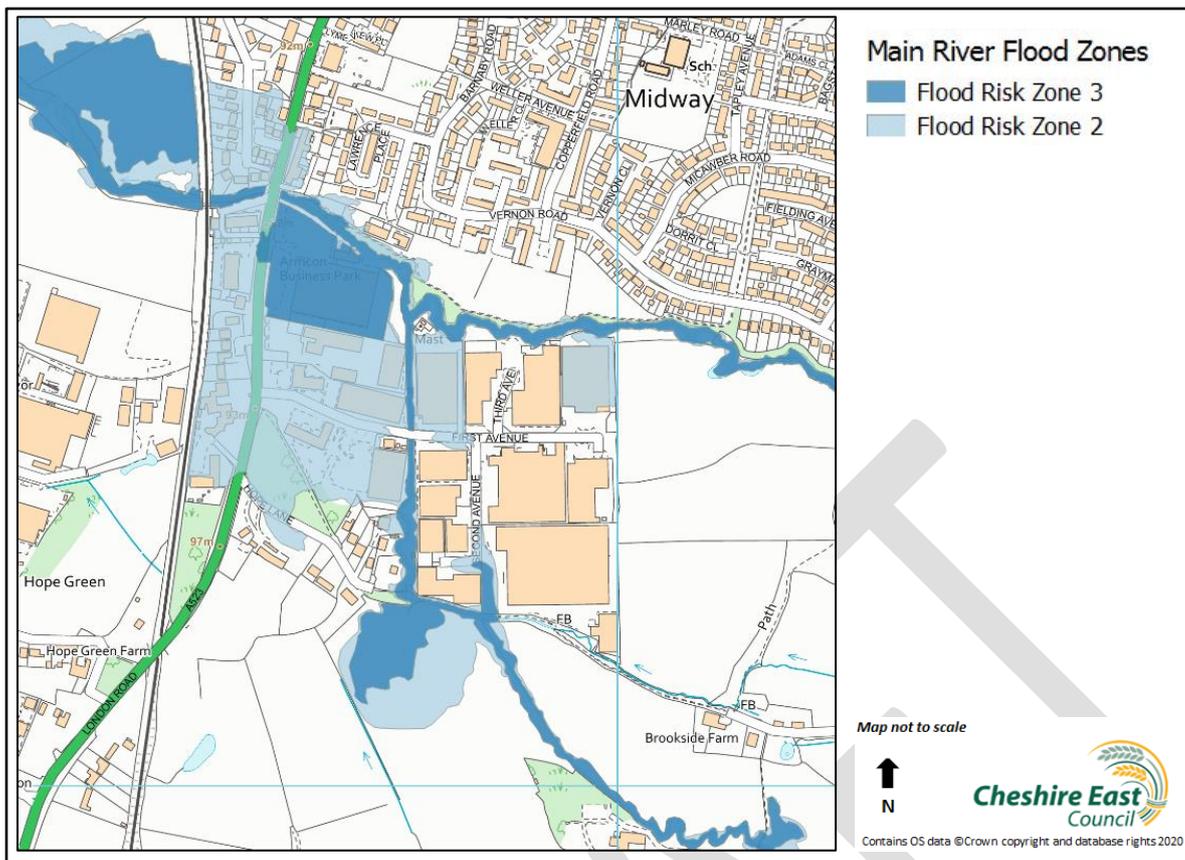
Figure 17 Poynton Brook Floodzones 2 & 3 (Industrial Estate)

On the left bank (south side) of Poynton Brook next to Armcon industrial estate upstream of the Booth Green confluence, flood wrack marks were observed to be contained in-bank (but only just) for the majority of the section, apart from a low spot where out of bank flows across the back of a industrial unit were observed for around 20 metres and an exit route for flows (back to Poynton Brook) was observed.

Downstream of the confluence with Booth Green Brook, Poynton Brook was contained in channel on the left bank (south side) along the rest of the industrial estate perimeter due to an embankment that is approximately 5 feet higher than floor levels in industrial estate. The river was contained the river side of the embankment until a low spot adjacent to the corner of industrial unit, where the bank is considerably lower and wrack was observed indicating that flows entered the Armcon Industrial Estate at this point from Poynton Brook. This low spot runs for around 40 metres. Downstream of here, flood wrack indicated that the remaining flows were just in-bank on the left bank, probably in part due to a large portion of the flows flowing out through the industrial estate.

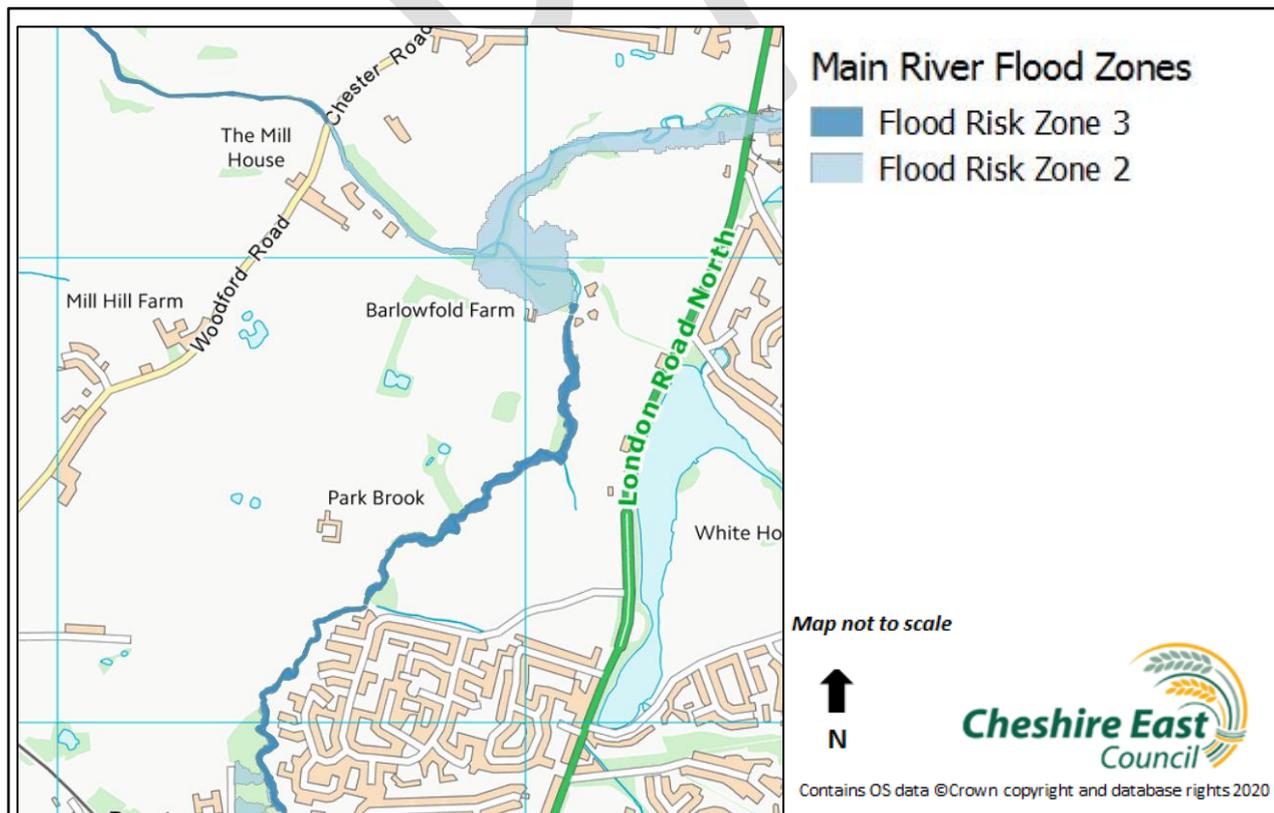
Figure 19 Poynton Brook Flood zones 2 & 3 (Confluence with Norbury Brook)

As Poynton Brook continues north, Park Lane Stream joins the Main River downstream of Philips Bridge. Poynton Brook then flows to join Norbury Brook. Main River levels were elevated along this reach, with water spilling out of bank onto the natural river floodplain.

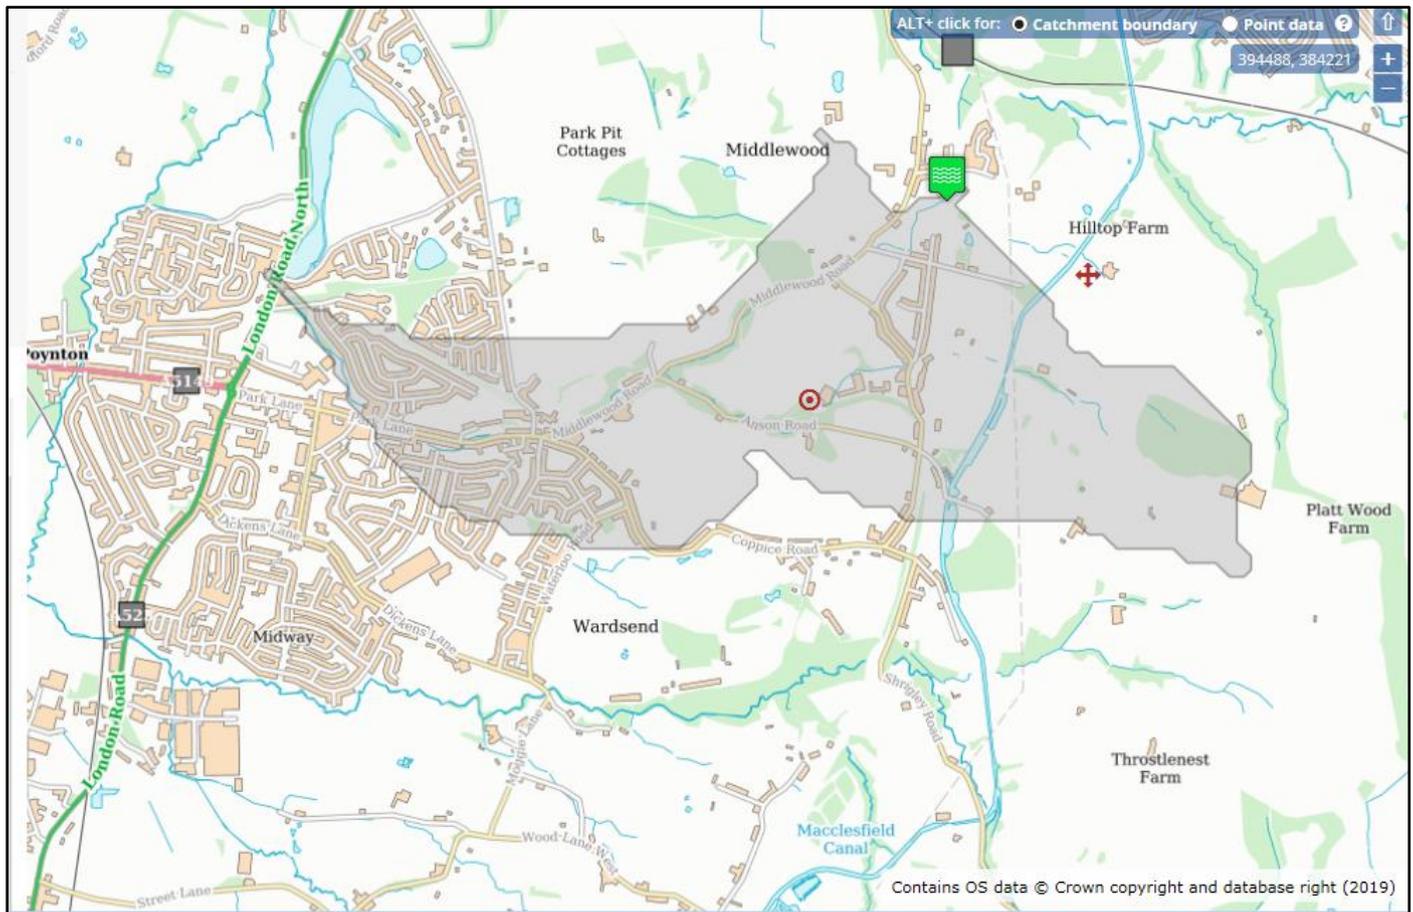
Figure 20 Indicative natural catchment of Park Lane Stream

In Higher Poynton the catchment of Park Lane stream extends East beyond the Macclesfield canal as shown in the figure above. The river flows west following the natural topography of the land making its way across the surface, land drains and through the soil and rocks underground.

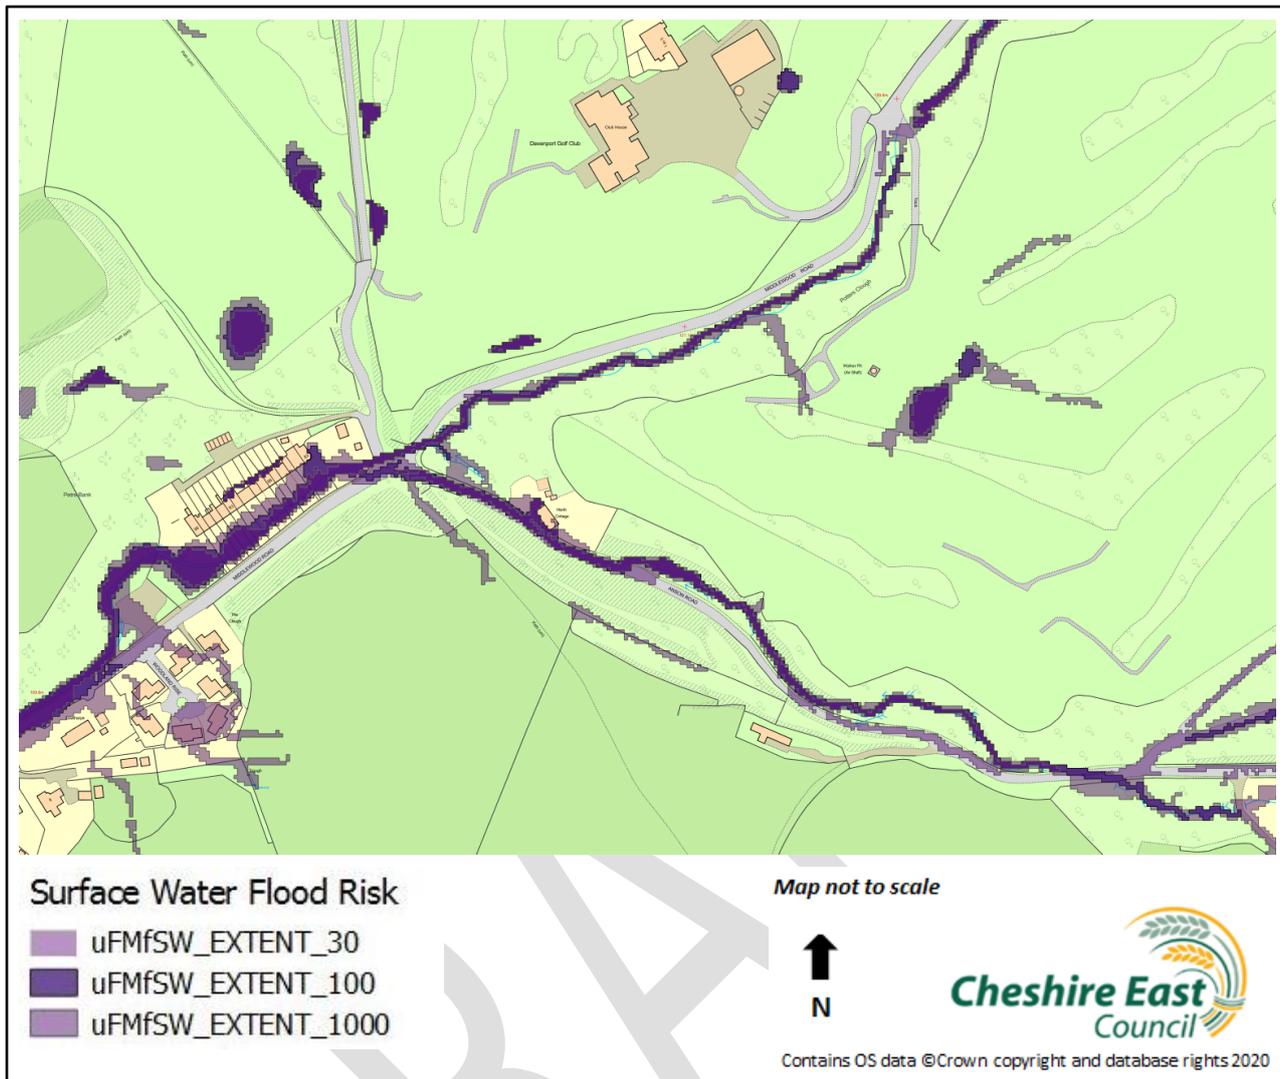
Figure 22 Flood Risk Map Middlewood Road / Anson Road area

Downstream of this location the surface water continued to flow off saturated fields downhill onto Middlewood Road, which became a channel for flood waters, overwhelming surface water drainage systems. Reports and footage of saturated surfaces (fields) generating large volumes of runoff were received in this area, as the capacity of the land to store water was exceeded. In some instances where properties are located downslope, flooding occurred.

RMA	Recommended Action
Cheshire East Council and Stockport Borough Council	Investigate local flooding associated with Poynton garden centre from Norbury Brook location
Cheshire East Council	Work with Town Council and Flood Action Group to update Community Resilience plan for Poynton (held by Poynton Town Council and first established in 2015)
Cheshire East Highways	Investigate drainage on Dickens Lane, highway drainage, in conjunction with property East
	Investigate London Road (North and South) Completed March 2020
	Investigate Anglesey Drive drainage. Completed March 2020
	Investigate Clifford Road highway drains – discharge into Main River at Hazelbadge Bridge
	Investigate Brookfield Avenue – discharge to Main River
	Investigate Pickwick Road
	Investigate Dicken Lane/Yew Tree Lane
	Investigate Clumber road
	Reconstruct Wards End retaining wall. Due to be completed July 2020.
	Investigate drainage on Middlewood Road

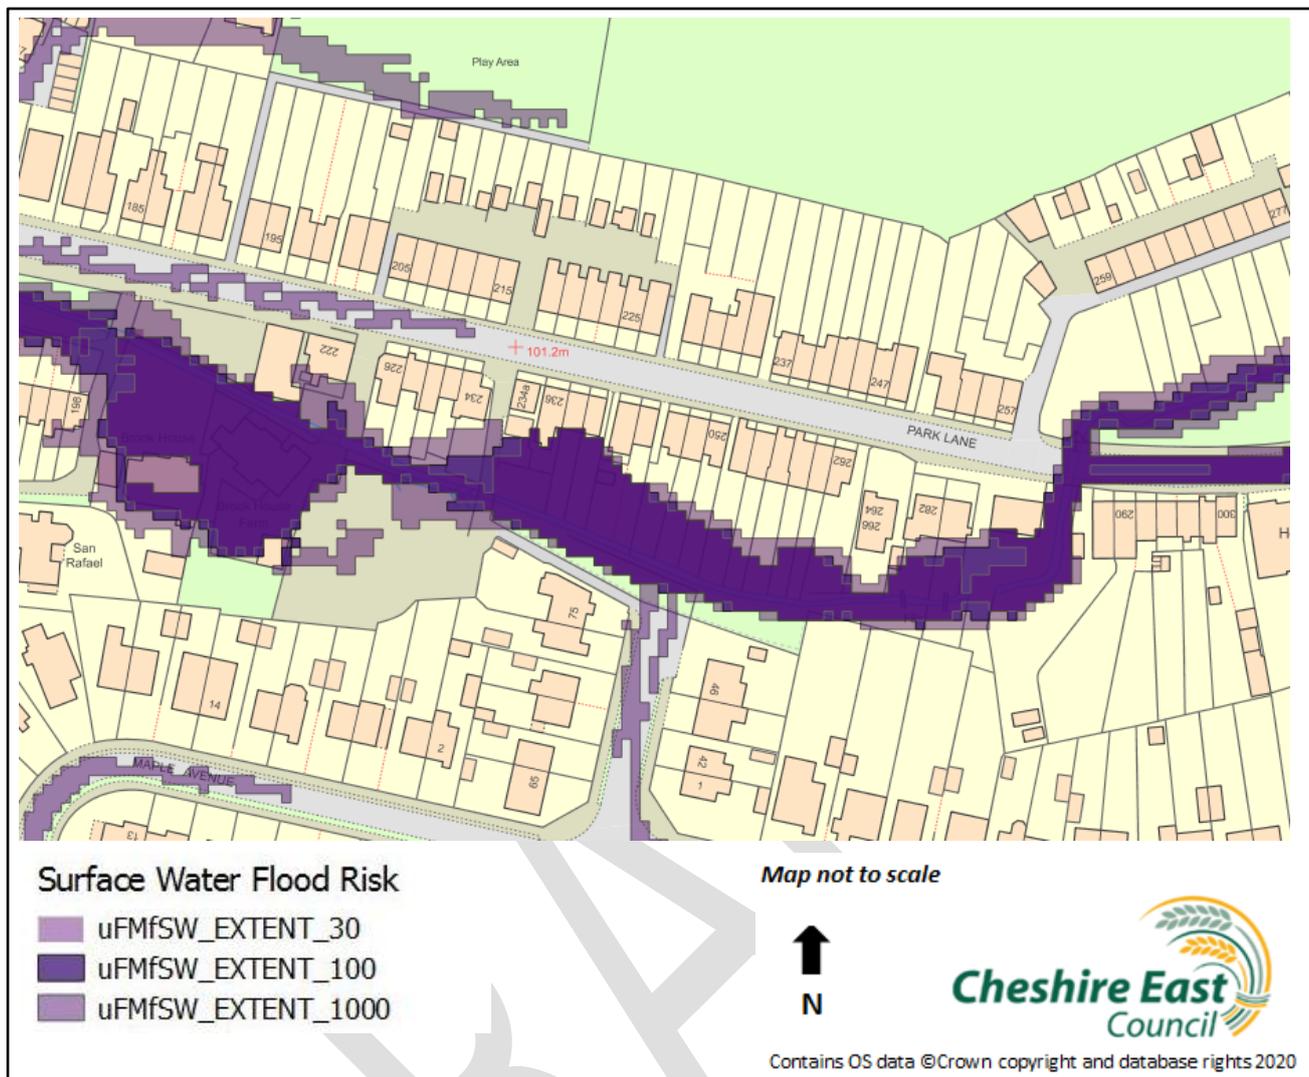
Figure 23 Flood Risk Map Park Lane area

Park lane Stream flows in a westerly direction, flowing to the north of Middlewood Road, crossing under Towers Road and flowing parallel to Park Lane. Flood waters appeared to use the highway as an overflow channel, reducing flows along Park Lane stream. As the stream turns and flows south under Park Lane the two systems merged and downstream of this point, the combined flows resulted in out of bank flooding along Park Lane stream affecting properties and business. Sewers were also overwhelmed in these areas driven by the high water levels in the stream and property owners directing flood water into the combined sewer. In this area the stream flows through a number of residential gardens.

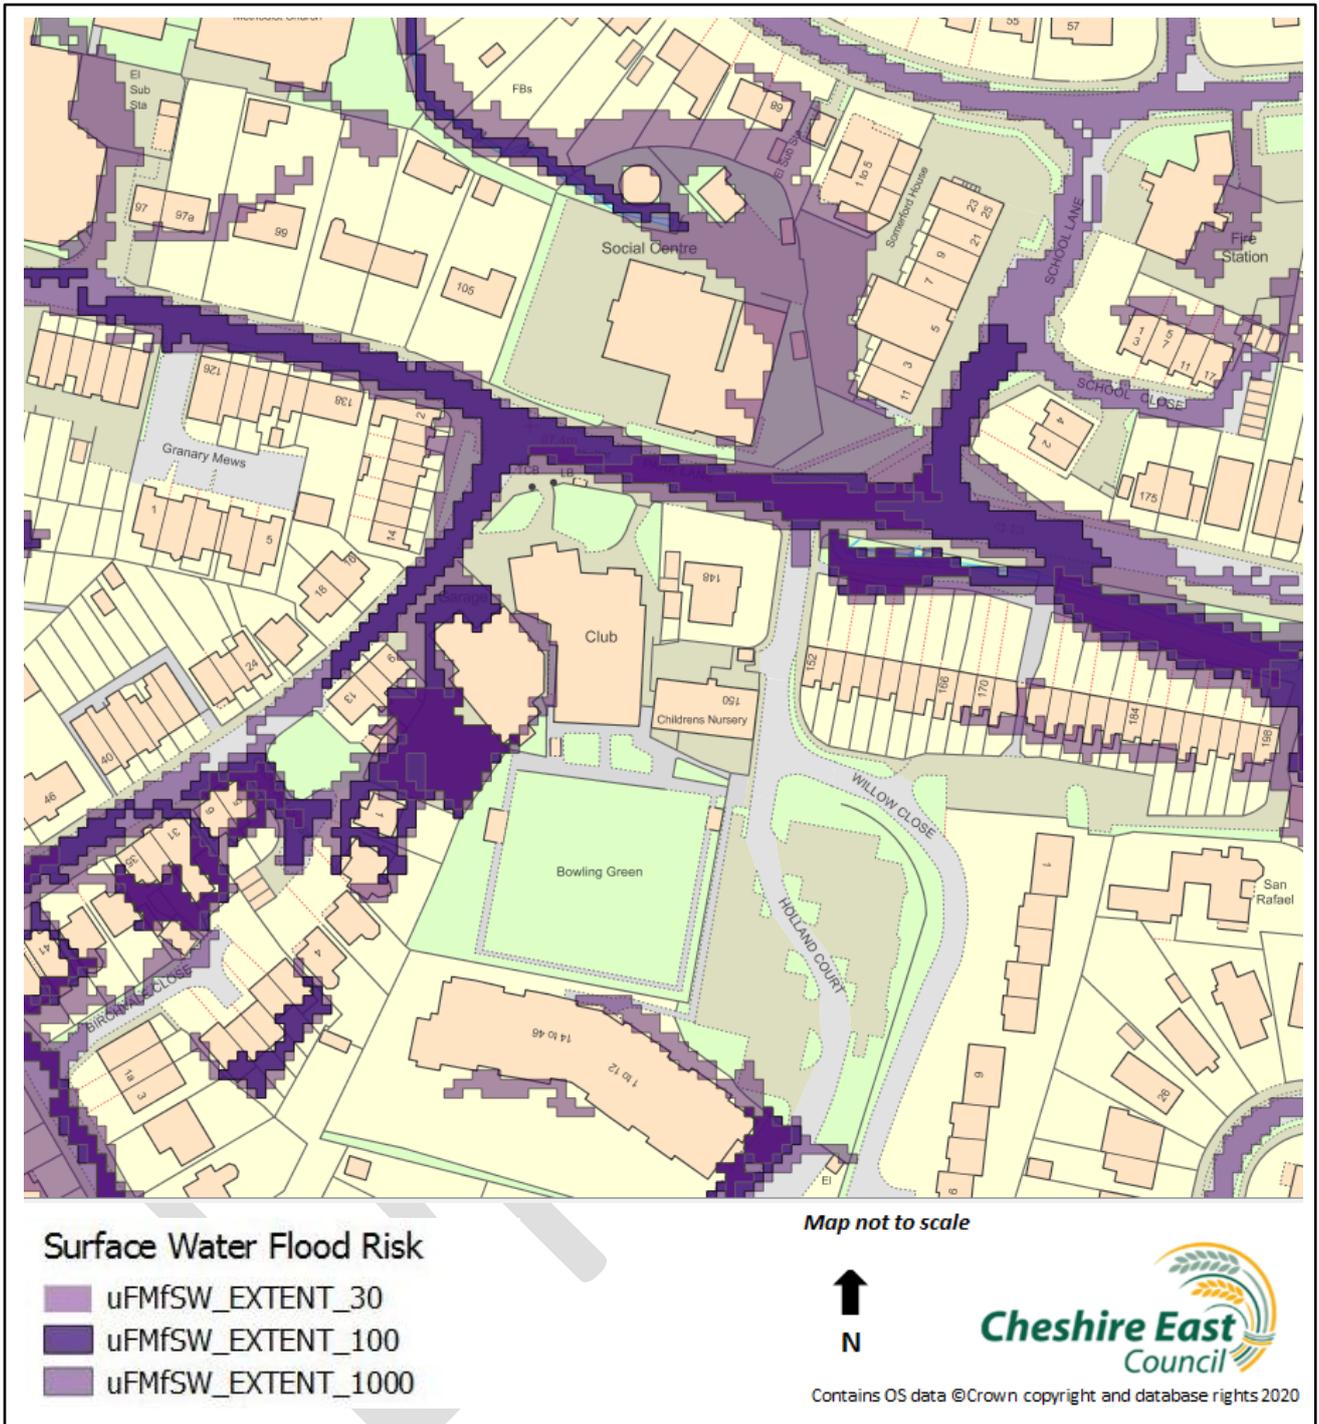
Figure 24 Flood Risk Map Park Lane / Clumber Road area

Park Lane stream continues to flow west towards Willow Close, this section surcharged and water flowed out of bank, following the ground levels to find the lowest point, down highways, footways and driveways towards properties and gardens. As the stream flows north in culvert around the social centre out of bank flooding was also reported.
