S19 Flood Investigation Report

July 2019 Flood Event

Flood Risk Management Team Cheshire East Council – Lead Local Flood Authority

Flood Investigation Reference Number: 2019/002

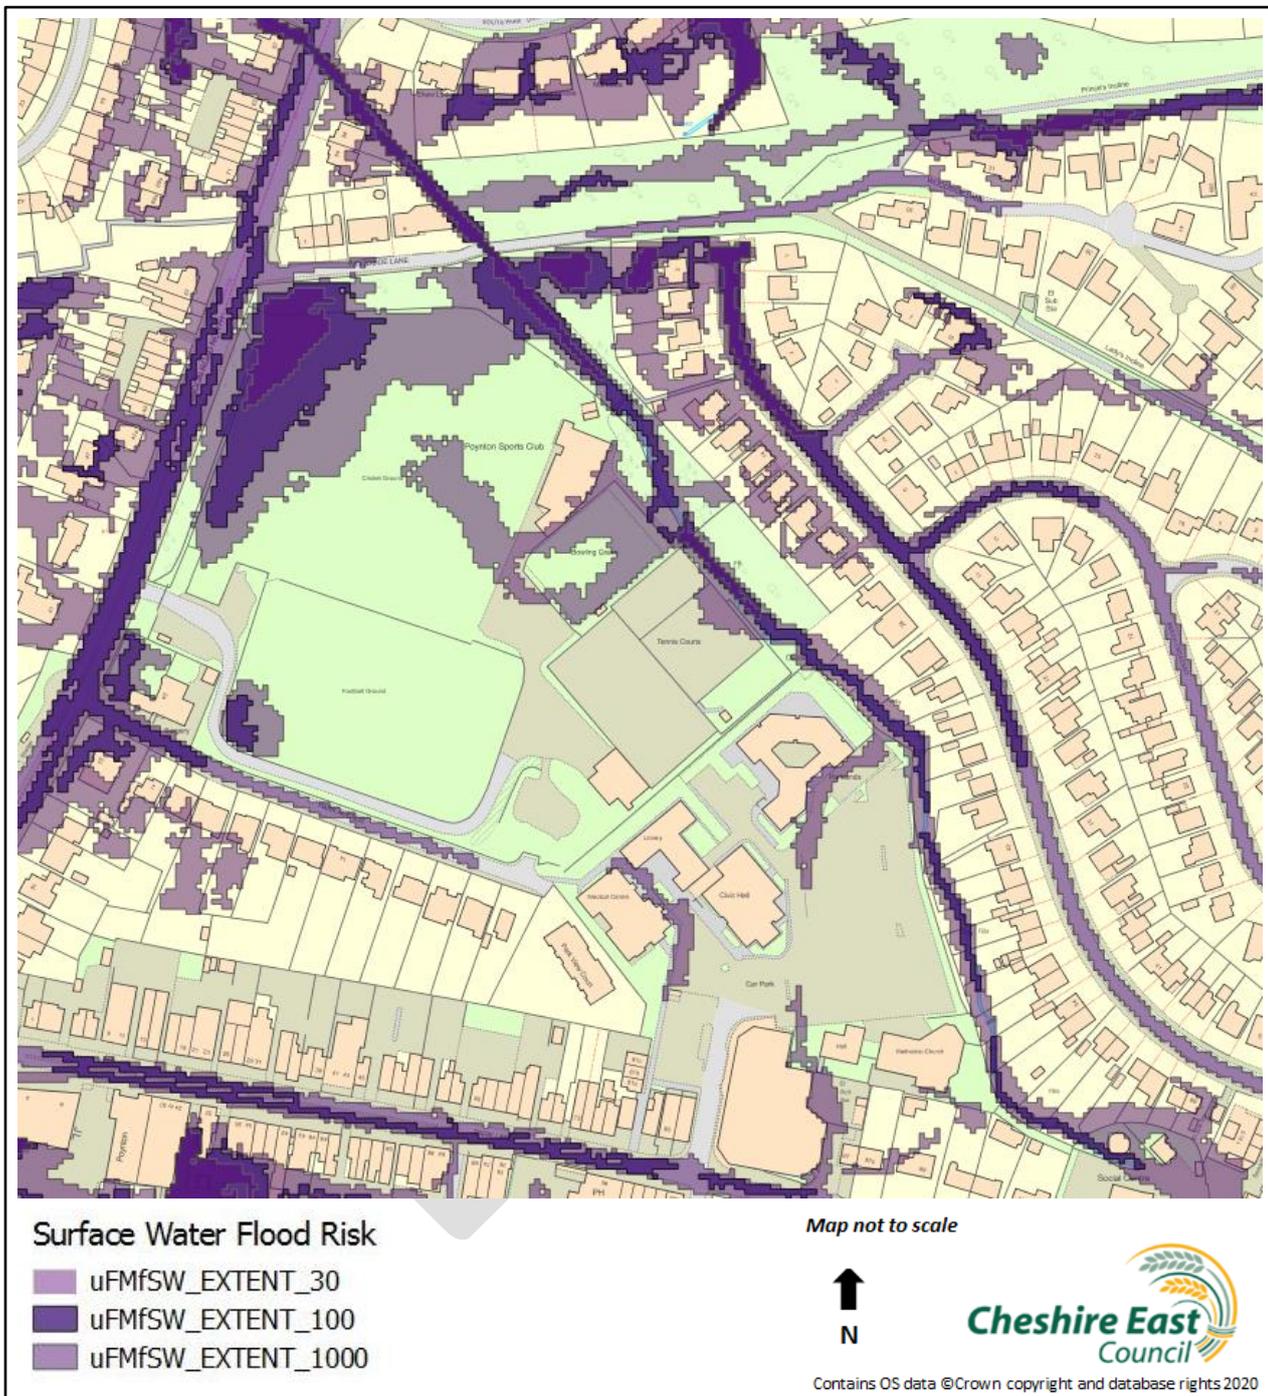
Figure 25 Flood Risk Map Poynton Sports Club area

The stream flows north through the gardens of a number of properties, then alongside Poynton Sports club, where it splits into two (bifurcates). A walkover of this area was undertaken after the flooding and wrack marks suggested that the risk maps provided a good approximation of the pattern of flooding experienced at this location.

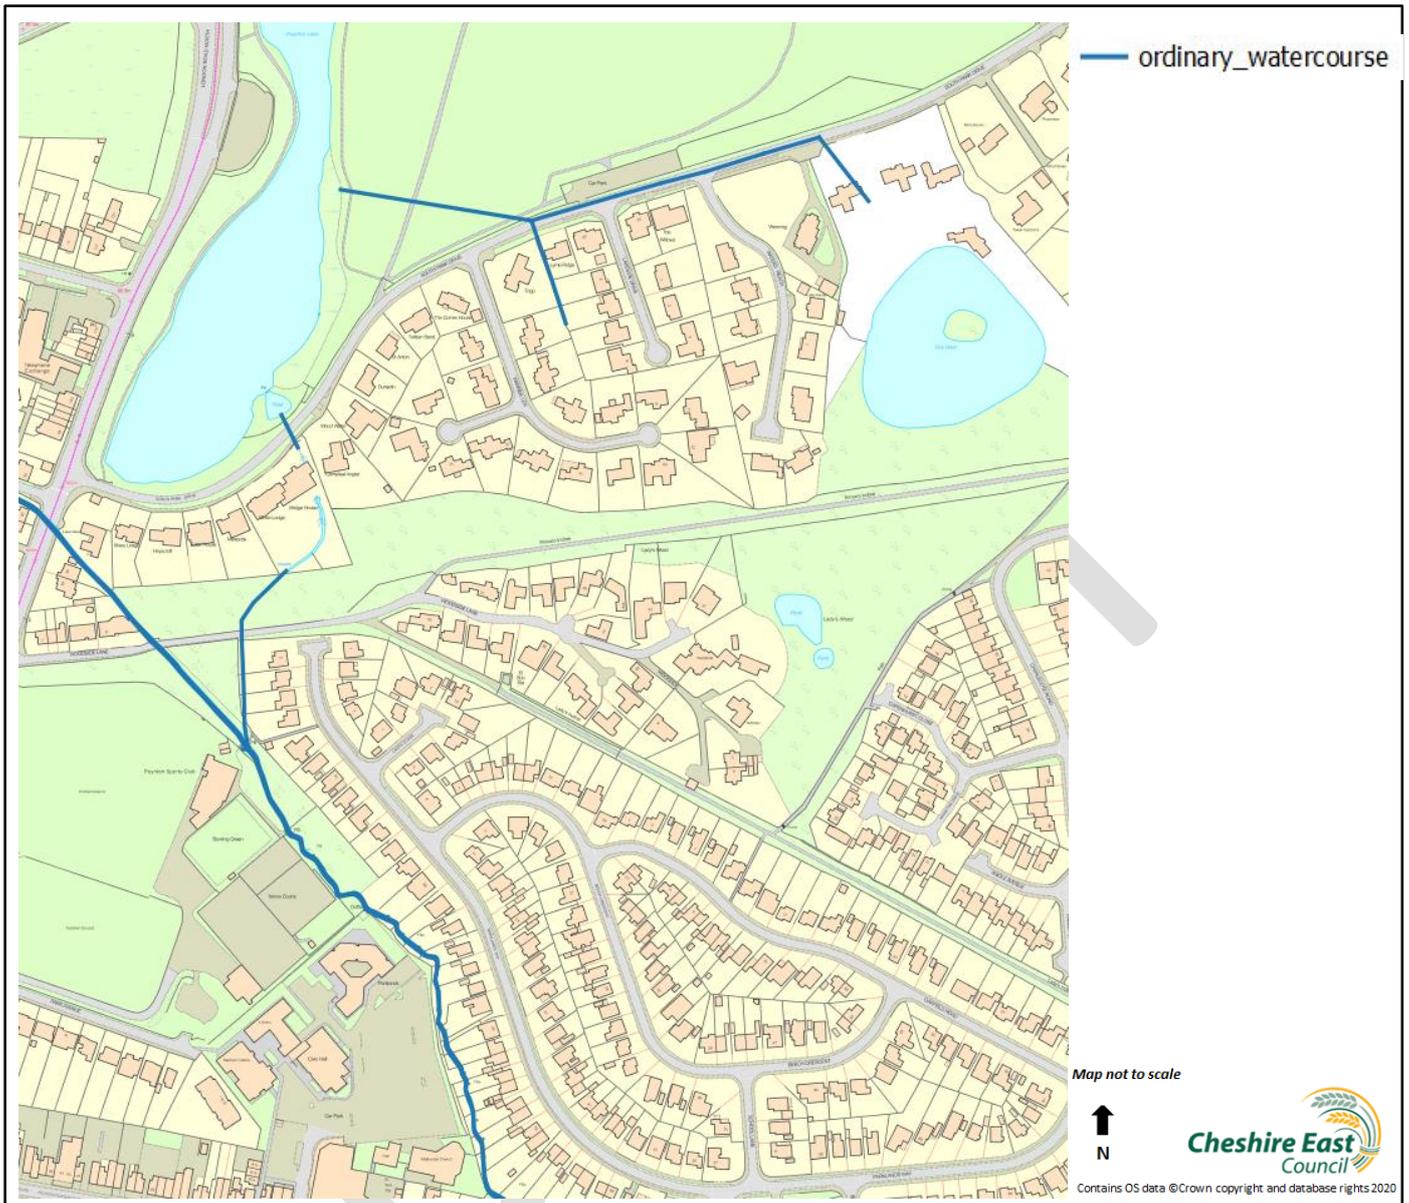
Figure 26 Bifurcation of Park Lane stream towards Poynton Pool

The main channel continues north to Woodside Lane and under London Road North towards Mayfair Close, with a secondary channel, which is largely culverted flowing a short distance north through a number of gardens to discharge into Poynton Pool. This channel has been observed a number of times since the 2016 event, and was blocked temporarily without consent from Cheshire East Council in 2017. Since this date the system has been passing a flow, allowing excess water from the channel to flow to Poynton Pool. Access onto this riparian system is

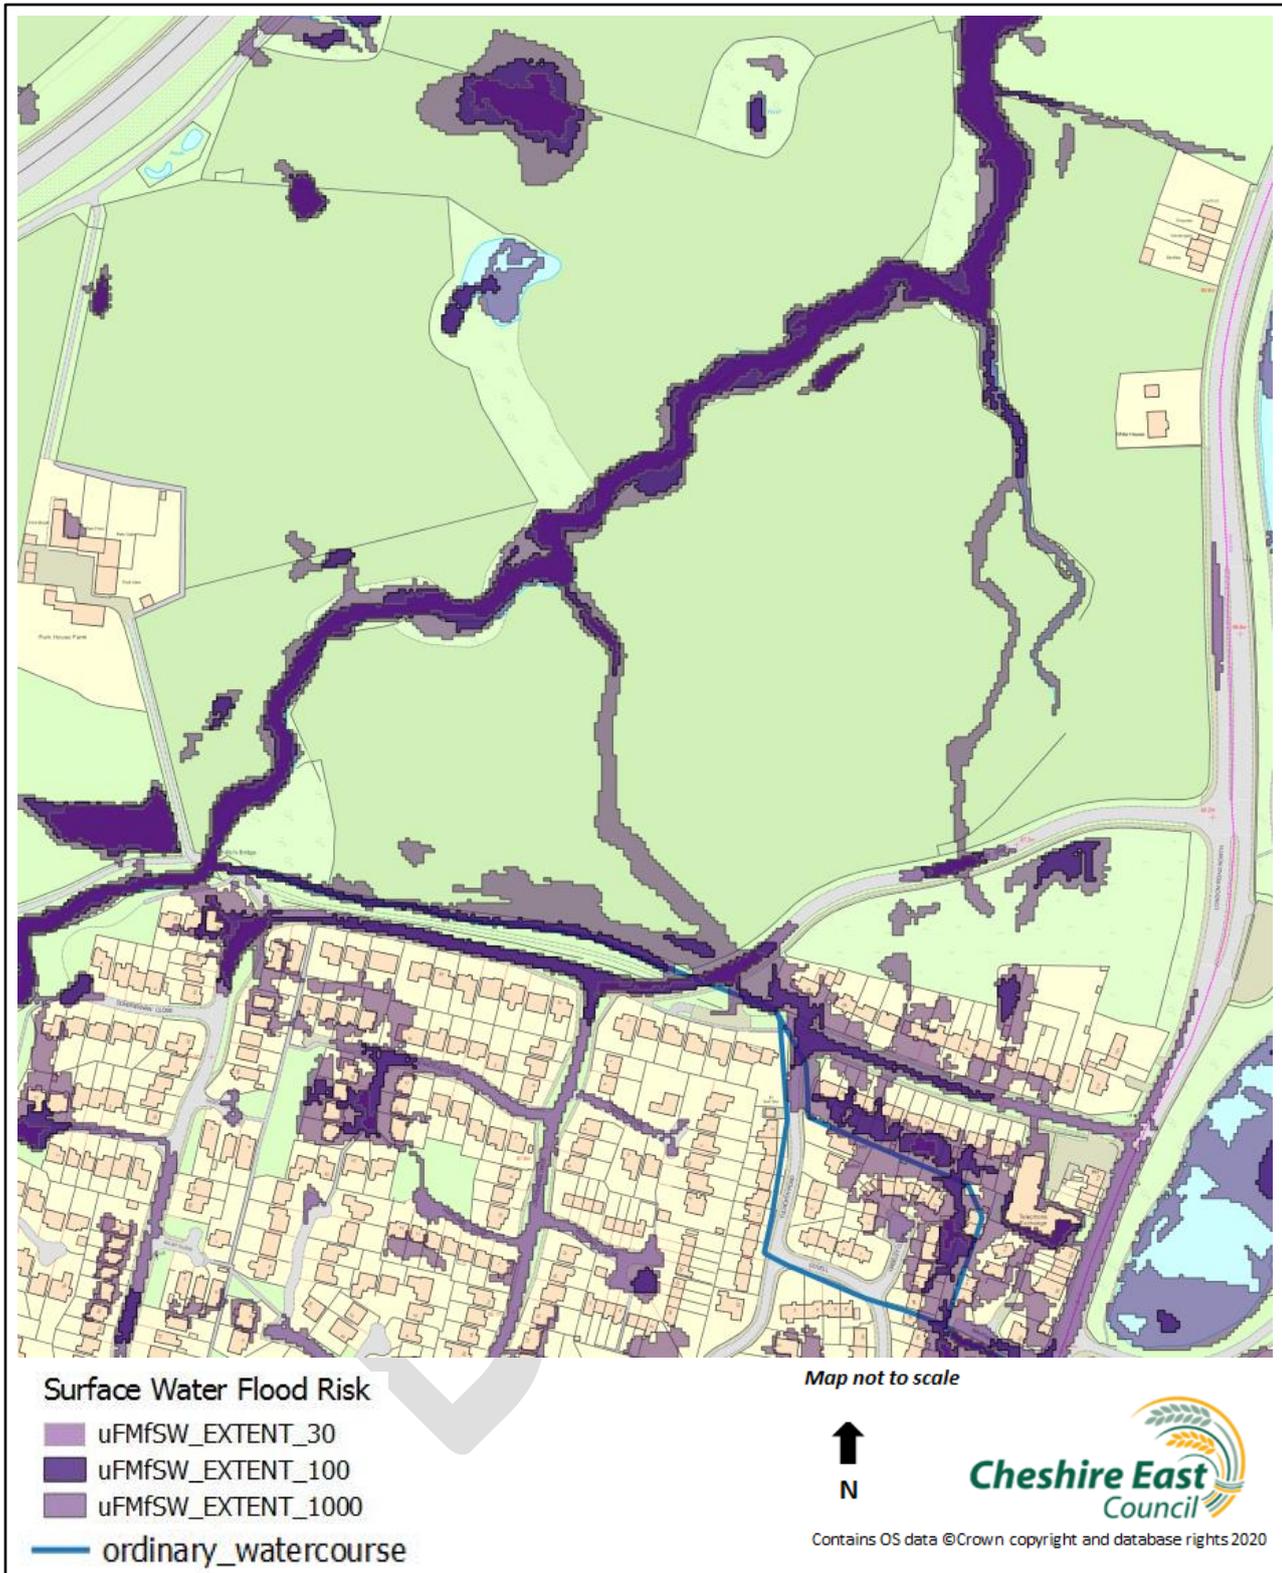
Figure 29 Flood routes to Poynton Brook north of Glastonbury Drive

The natural course of the river then flows west joining Poynton Brook at Phillips Bridge. The natural overland flow routes across the adjacent fields show the paths floodwater is expected to accumulate and flow.

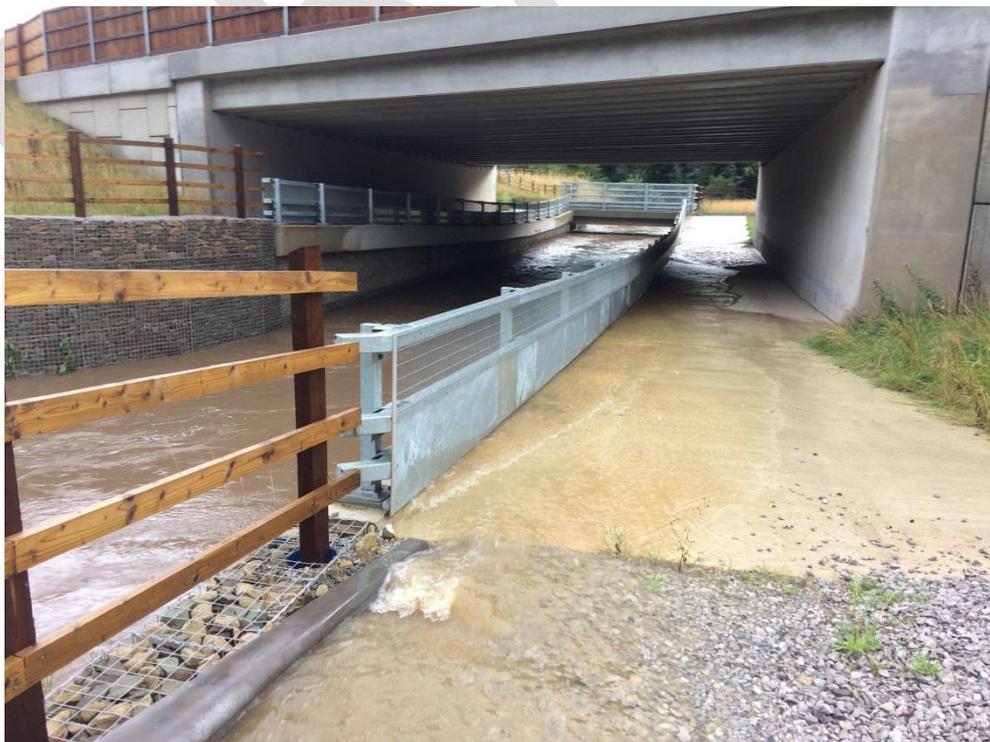
Further downstream no obstructions to flow was reported at the A555 bridge where Poynton Brook joins Norbury Brook, although the river level was high and spilling out of bank.

Photograph 2 A555 Bridge over Norbury Brook, image taken: 18:16 on 31/07/2019

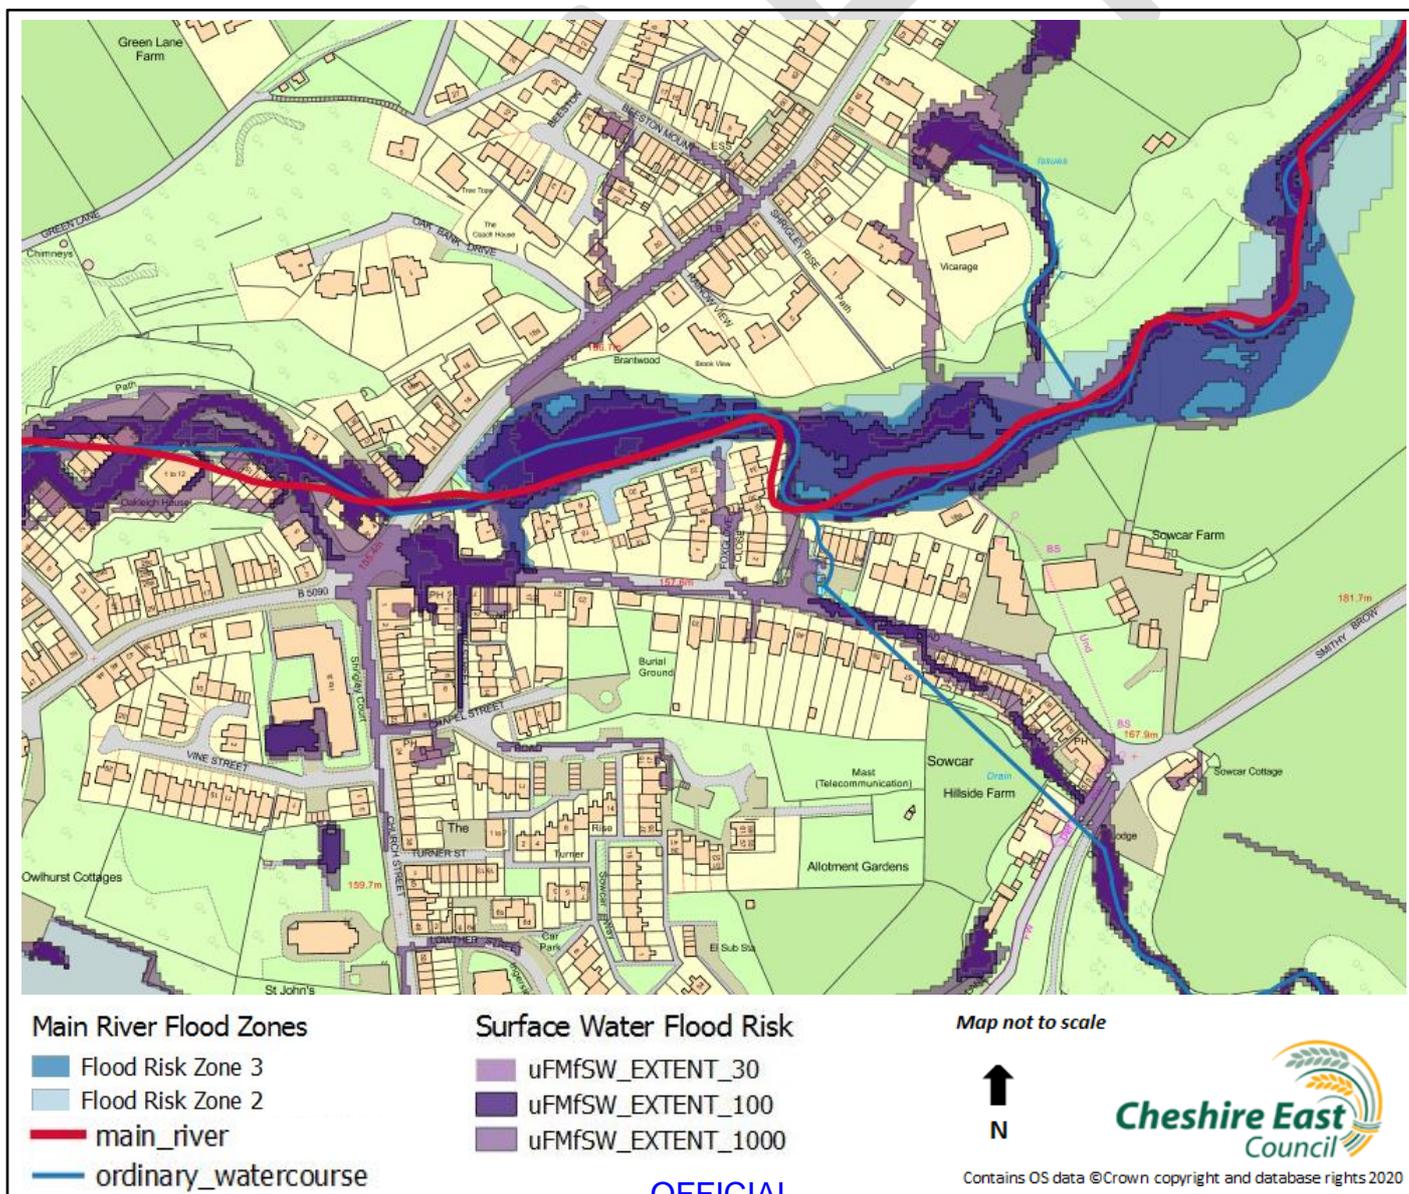
Figure 42 Risk map for Ingersley Road, Bollington

On Sunday 28th July a resident reported a crack appearing in Ingersley Road, they stated that the tarmac was lifting up along the crack and also the pavement appeared to have been lifted and sunk in places. It was stated that water was running out of these cracks down the road. This was reported to Cheshire East Highways, the Police and United Utilities. The site was inspected on Monday 29th July by the highways team. It was suggested to the residents that the culvert underneath the road surface may be blocked.

RMA	Recommended Action
Cheshire East Highways	A condition survey is to be conducted on the ordinary watercourse from Mill Lane to outfall into Harrop Brook.
	Review the extent of erosion to the embankment and the effect it could have on the structure of the road (brook at Mitchelfold)
	Kerb raising work, on request and with permission of property owner completed.
	Work ongoing to alleviate immediate impact of the culvert collapse and to determine the nature and extent of the repair work required.
Environment Agency	The Environment Agency served notice on the owner of the culvert to improve the culvert intake and works to improve this are underway and ongoing. The EA have commissioned Mersey Rivers Trust to implement Natural Flood Management (NFM) interventions upstream of Pott Shrigley.
Riparian Owners	Ensure that you have access to any watercourses that flow through your land, by installing suitable access chambers or seeking an agreement with neighbours to use theirs for access to inspect and maintain the watercourse.

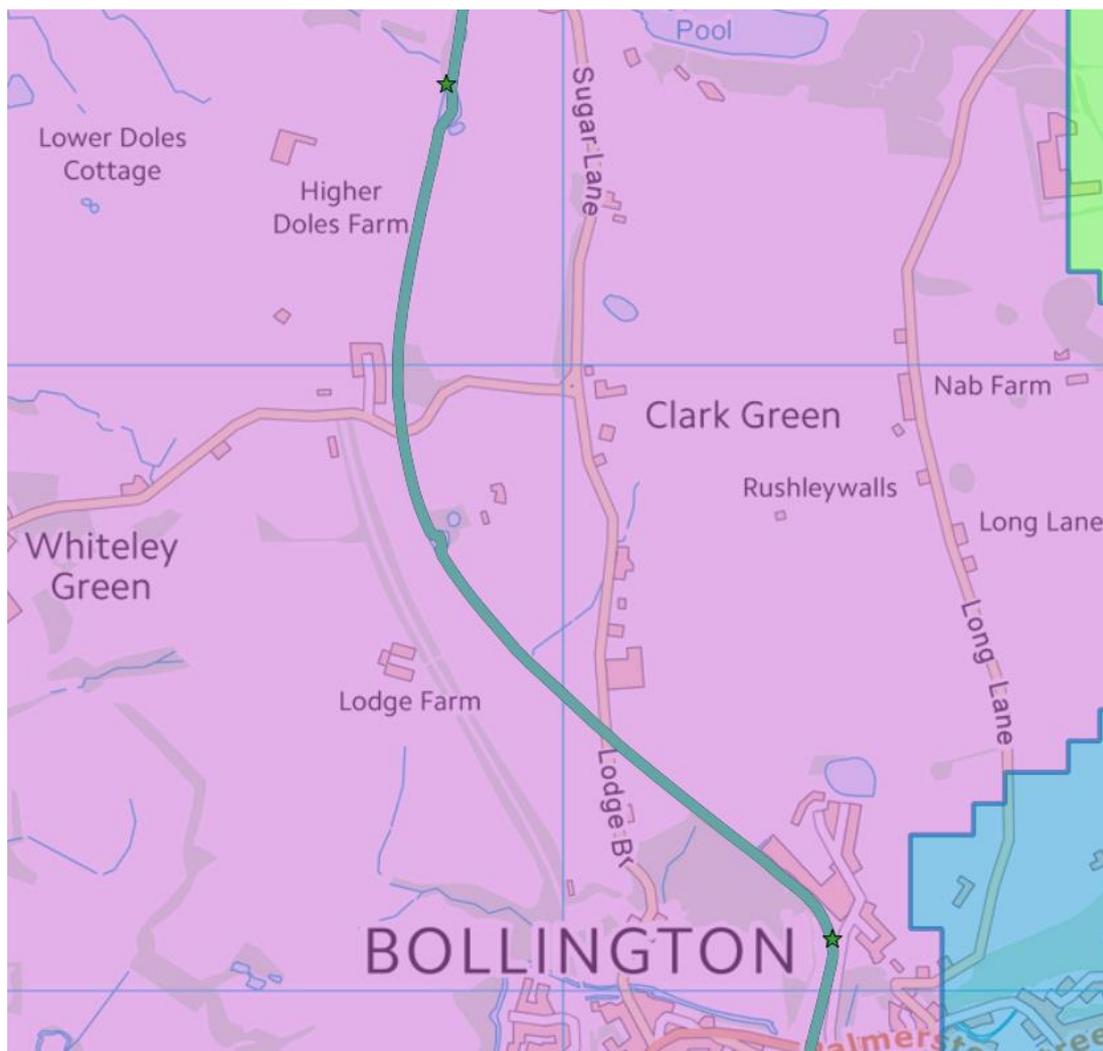
Figure 44 Canal Interactions with Dean catchment

Symbols: Sluices shown as green stars near Clark Green and Clarence Road, no overflow weirs in the catchment.

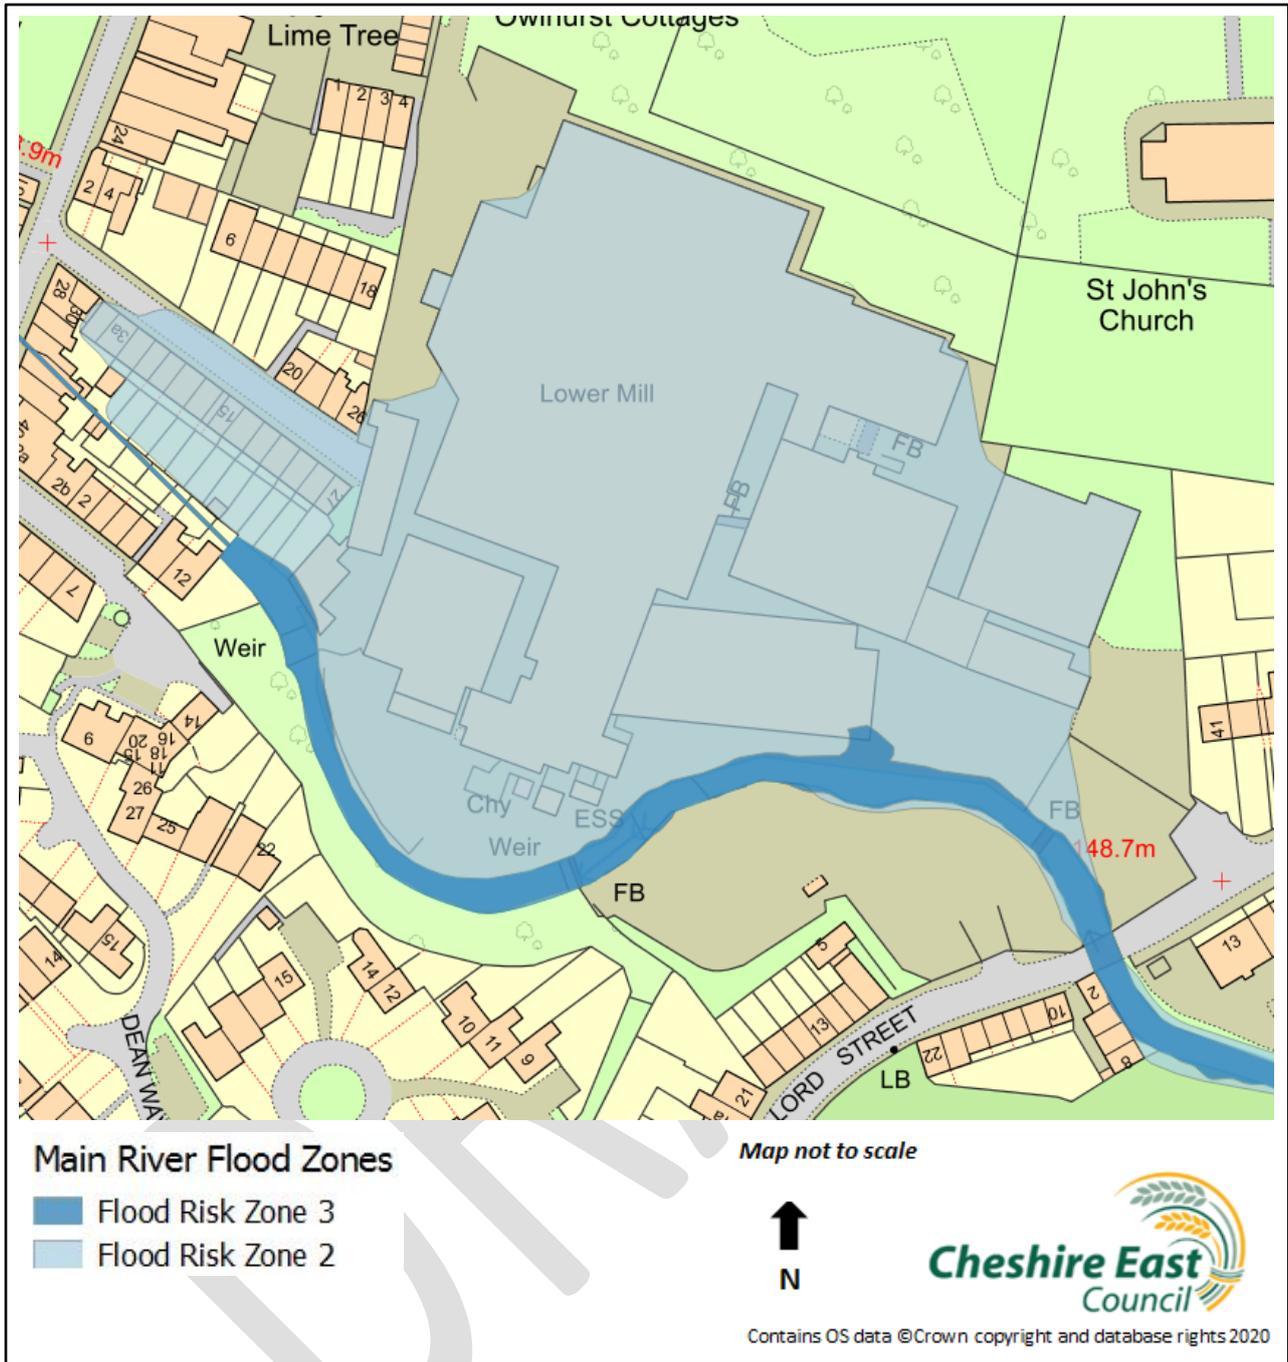
Figure 45 Lower Mill, River Dean, Bollington

Lower Mill sits adjacent to the River Dean in the floodplain. During this event it was reported that flooding mechanism was caused by the Main River, River Dean. Water levels rose and breached the banks of the river flooding a nearby factory. The flood water then built up against the back wall of the factory (bordering Oldham Street) and finally caused a door to blow, allowing flood water to escape, flowing with some velocity. In a previous event (1998) a similar mechanism was reported.
