HERITAGE STATEMENT TO ACCOMPANY THE PLANNING APPLICATION
TO EXTEND AND REFURBISH ROSE COTTAGE, CASTLE HILL,
MOTTRAM ST. ANDREWS SK10 4AX

HERITAGE STATEMENT TO ACCOMPANY THE PLANNING APPLICATION TO EXTEND AND REFURBISH ROSE COTTAGE, CASTLE HILL, MOTTRAM ST. ANDREWS SK10 4AX

APPENDIX 2. Photographs of Rose Cottage

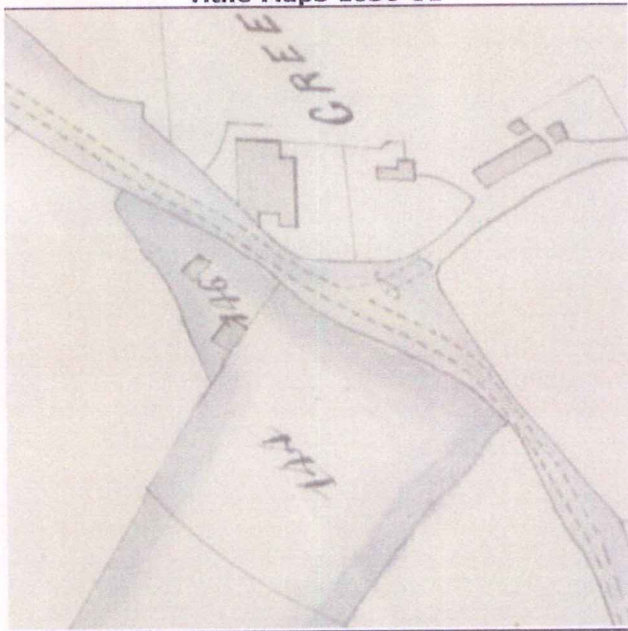
Tithe Maps 1836-51

It is therefore misleading to describe the building as an *unusual survival* as the building extant bears no relationship to a building that appears on the tithe map. A comparison of the modern map with the tithe map shows that a much larger building has been replaced by the smaller garage. At present a pastiche half timbered cottage replete with tiled roof, long dormers and added porches has replaced a brick thatched roof cottage.
