Donald Insall Associates
Chartered Architects and Historic Building Consultants

Macclesfield Conservation Area
Gazetteer

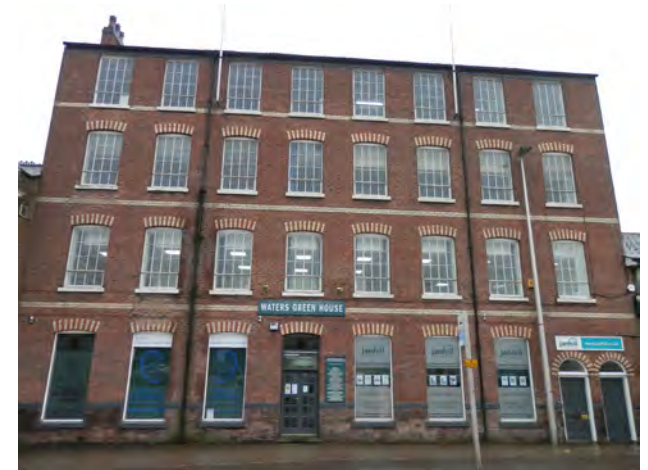
Overall condition: Good

Notes: A former silk mill, converted into commercial premises in the late 20th century it is a good example of the adaptive reuse of industrial buildings. It is constructed in brick with a stone-flagged roof; set over four storeys and eight bays with white brick string courses. Chimney stack remains to south gable. The twelve-over-four sash windows at upper floors are set under red and yellow banded brick heads. Ground floor windows are modern replacements with one enlarged to form a new entrance door, to the right-hand side are paired doors - decorative heads retained to all. Signage to the front elevation is restrained but doesn't fit with the architectural composition. Piecemeal extensions to the rear, part rendered, part painted brick – windows are replacement uPVC casement and high level sign detracts.

Waters Green House, Albert Place

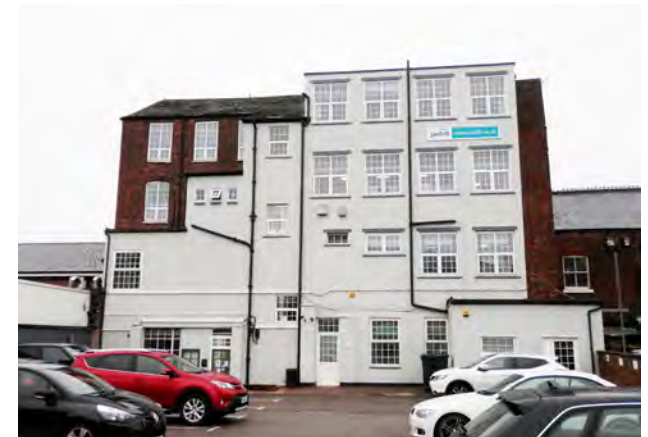
Waters Green House, Albert Place, rear

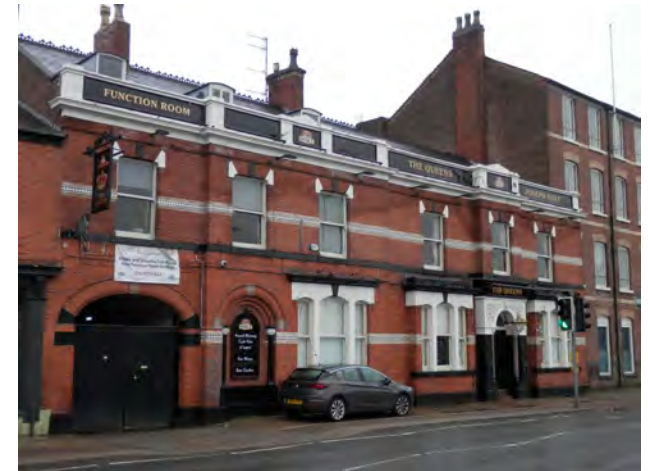
Notes: A two storey public house arranged over six bays and faced in red brick with cream terracotta string courses. The façade is stepped with a rendered frieze and cornice surmounting; at ground floor three shallow bays project with a decorative arched entrance flanked by arched tripartite windows with rendered mullions and architraves. The window is repeated before an arched opening (now bricked in) and a larger arched opening with board timber gates and strap hinges. First floor windows have brick heads with keystones and rendered curved edges. The roof is pitched with single dormer windows and brick chimney stacks with white brick dentil detailing. The signage and lighting is characteristic of a public house; however the banner sign to the left-hand side detracts. To the rear windows are two-over-two timber sashes with simple brick heads; rooflights in the rear roofslope and a substantial chimney stack to the rear of the projecting wing.

Queens Hotel, 5 Albert Place

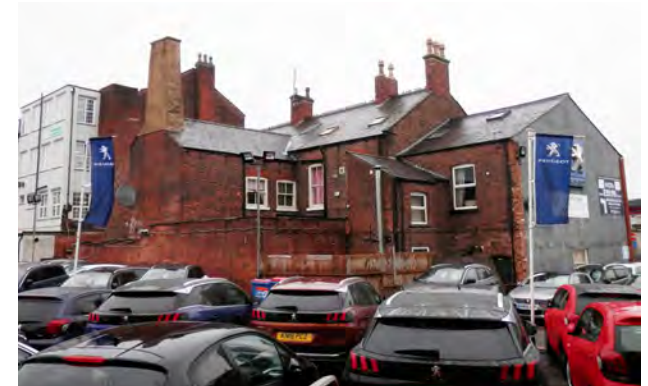
Queens Hotel, 5 Albert Place, rear

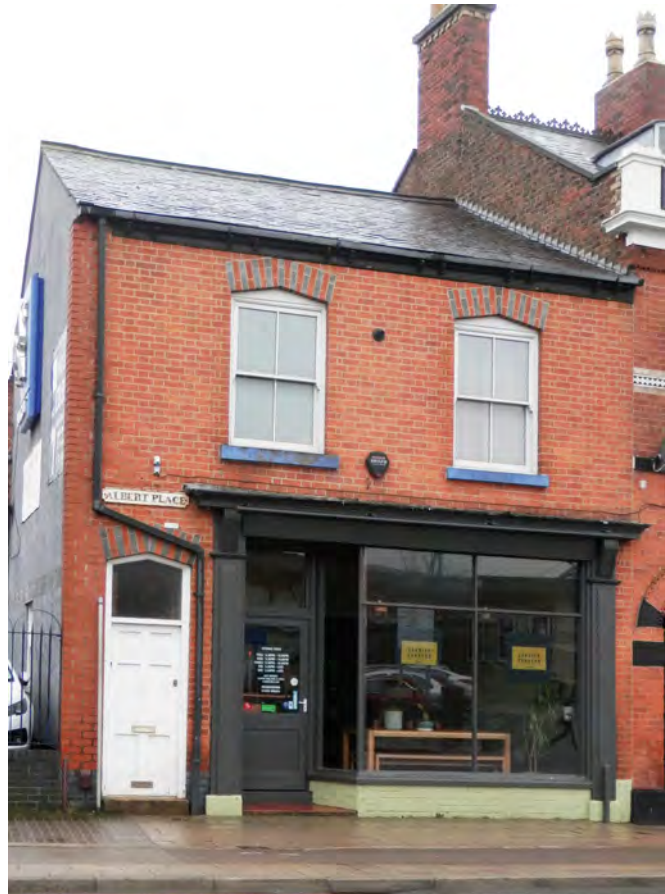
Notes: Two storeys constructed in red brick with pitched roof. Windows at first floor are two-over-two sash under the red and black brick pointed heads with stone lintels. Head is repeated to the ground floor entrance door, set to the side with large fanlight and panelled door. Good example shopfront with restrained signage. To rear, projecting wing with perpendicular pitched roof; windows are uPVC casements. The gable end is rendered with detracting high level signage relating to the garage forecourt with extends round to the rear.

7 Albert Place

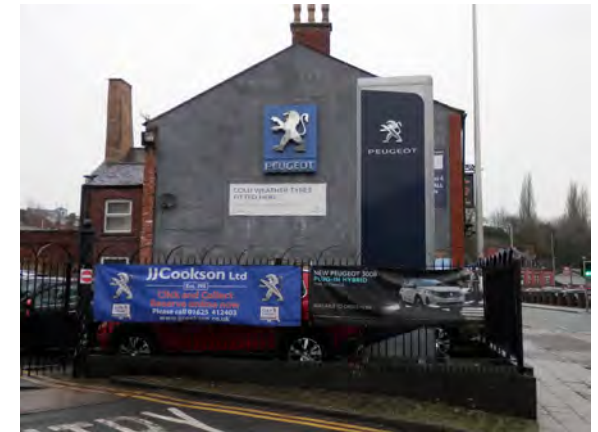
7 Albert Place, flank elevation

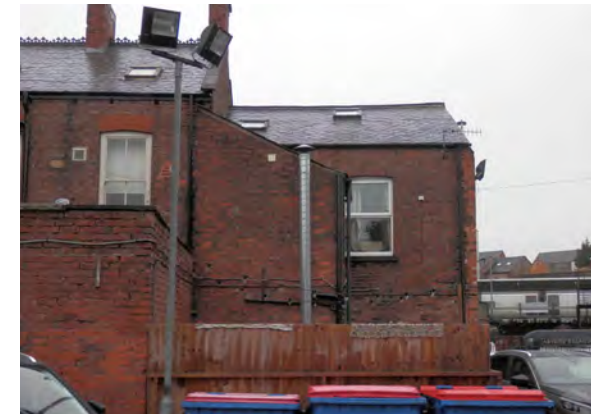
7 Albert Place, rear

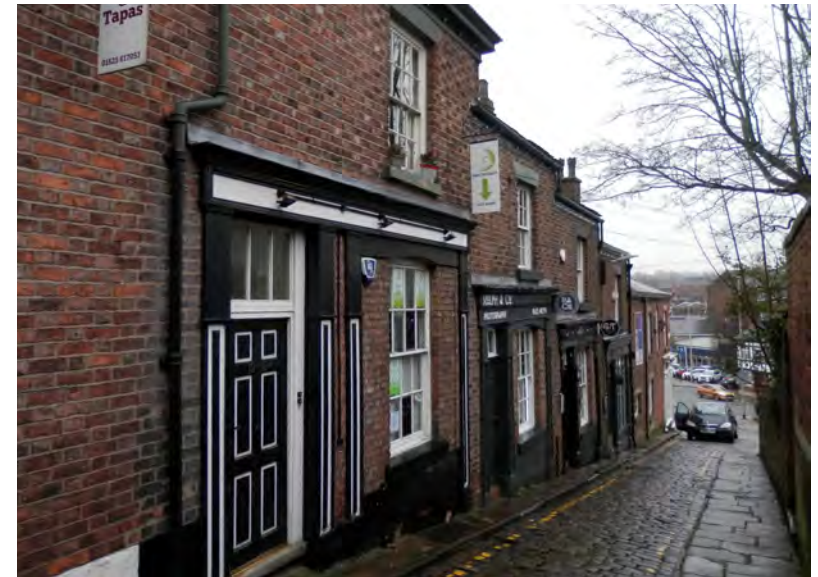
19-25 Back Wallgate

Notes: Terrace of brick, small-scale two storey double-pile buildings with pitched slate roofs which step up to address the sloping hill creating an interesting roof profile. Single bay compositions with flat arched painted stone heads to eight-over-eight timber sashes at first floor. At ground floor are traditional-style shopfronts with moulded pilasters to side entrance door with fanlight above and central eight-over-eight sash windows with brick surrounds, flanking pilasters and curved timber panels above. No.25 has a full shopfront which contrasts but retains the pilaster detailing. Signage is retained across the group; high level sign at no.19 would be better located at fascia level. No.17 addresses the corner with Church Street; the shopfront returning for one bay with a further bay with six-over-six sashes at ground and first floors.

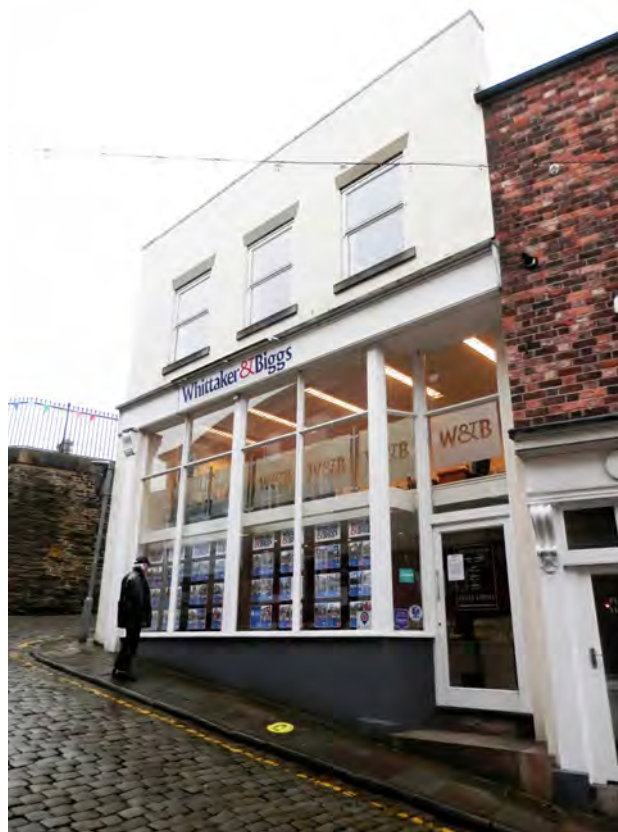
2 Church Street

Notes: A shallow fronted, two storey building which returns to Churchside. It has been rendered and windows to the three bay composition are uPVC casements with painted heads and sills. The tall proportions of the shopfront are largely in part due to the change in level but otherwise has a traditional character, with transom lights and a moulded corbel. uPVC casements in single bay of windows to return elevation with simple sill detail and tall painted plinth.

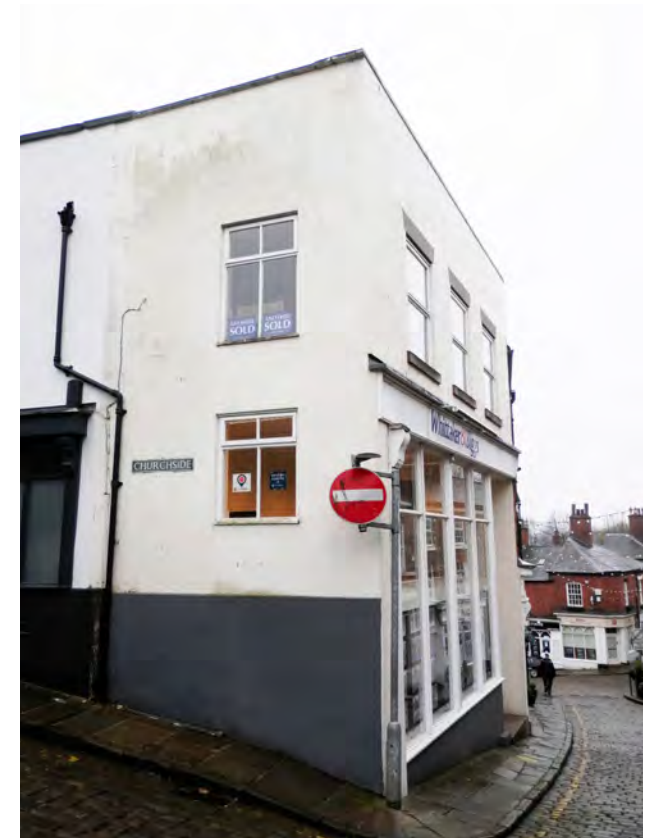
2 Church Street, side return

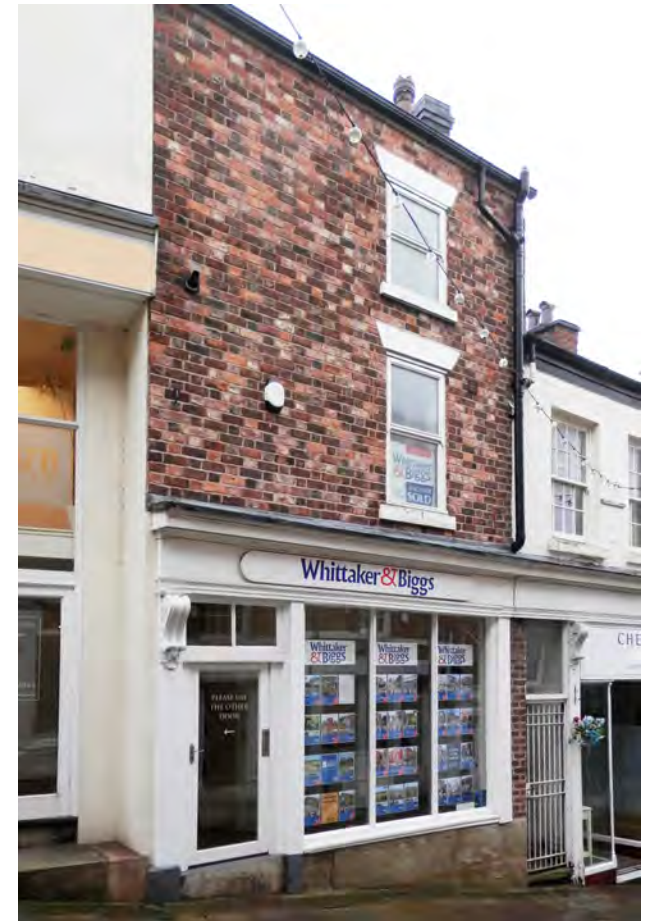
4 Church Street

Notes: Red brick, single bay, three storey building which steps down the street. Windows are modern uPVC casements which detract with painted heads and sills. The shopfront is traditional with corbel, mullions and a fascia which extends across into no.6 adjoining blurring the distinction between the two buildings despite their change in scale and accommodating two separate businesses. Pitched roof and chimney stack to the gable end.

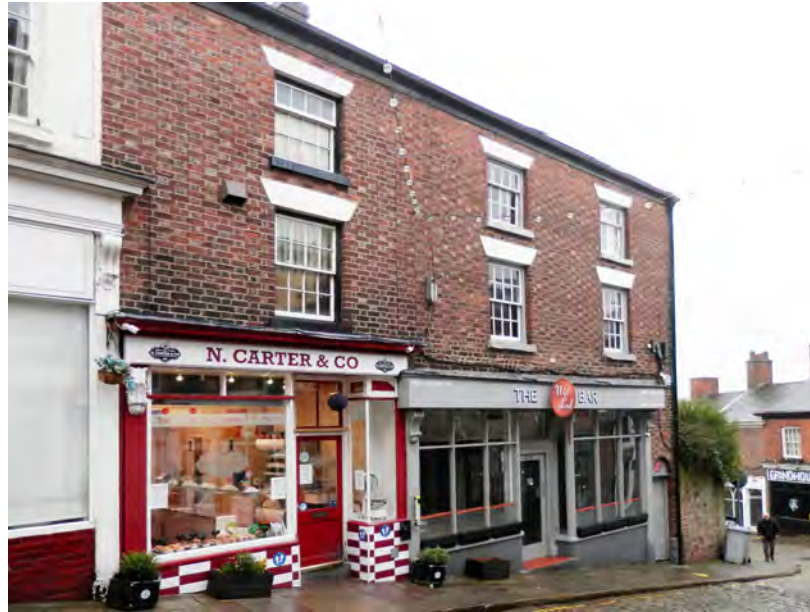
8-12 Church Street

Notes: A group of three properties within the terrace; red brick and three storeys with pitched roof and chimney stack to brick gable end. Single window bays to each with eight-over-eight timber sashes at first floor and four-over-eight to second floor, all with painted heads and sills. The ground floor commercial use at nos.10 and 12 spans across the two buildings; the shopfrontages to both buildings are good examples of traditional design with transom lights, mullions, recessed entrances and appropriate signage. The tiled stallriser and general colourway at no.8 makes it a distinctive building. Passageway to right-hand side of no.12 is set under brick arched opening with panelled door. Wiring to nos.10 - 12 clutters.

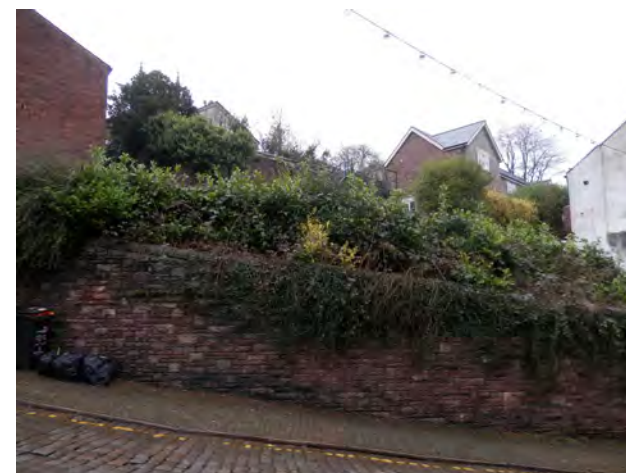
1-4 Church View, Church Street

Notes: A modern residential development within the backland area behind Church Street and Waters Green. The building infills a previously open gap, bound by a tall historic stone wall which has a modern timber gate now inserted, and rises above the buildings in Waters Green, blurring the definition that the steep topography brings to the conservation area. It comprises an interlocking gable roof with two pronounced gabled bays. Constructed in red brick with slate roof and stone heads and sills; windows are uPVC casements set flush with the brickwork. The side elevation addresses Church Street with a large side garden and single window opening, utility boxes and a utilitarian metal stair set to the rear garden wall.

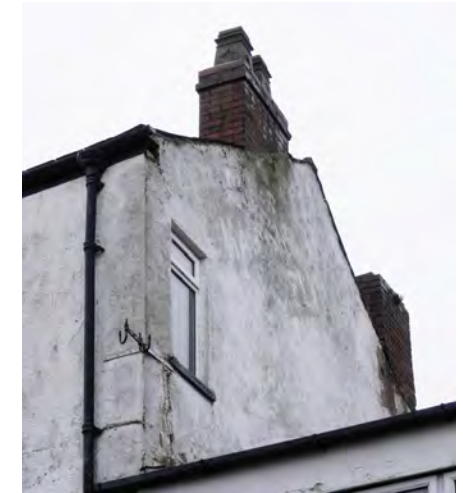
Overall condition: Fair

22 Church Street, east elevation

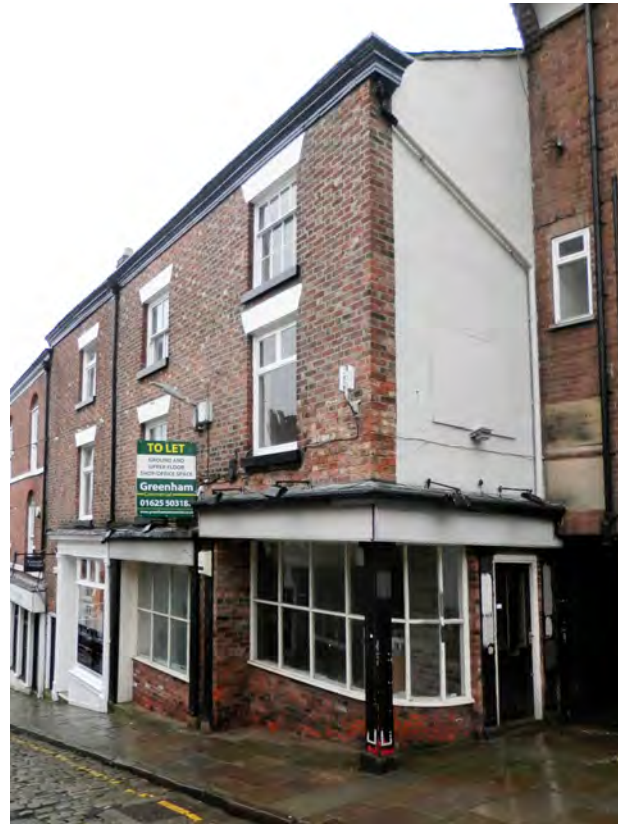
Nos. 5 - 9 comprise single bays at upper floors with painted heads and sills; original four-over-eight sash at first floor to no.5 – otherwise all modern replacements:

5-7 Church Street

detracting casements to no.5 at first floor and no.9 – two-over-two sashes at no.7. Passageway to left-hand side at no.9. Nos.11 - 13 have a grander character with eight-over-eight windows set in round-arched recesses brick arches at upper floors and painted banding. To nos.15 - 21, single

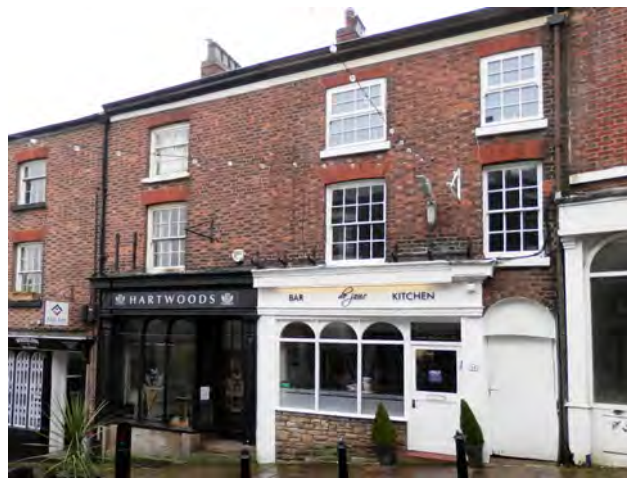
bay window composition comprising are eight-over-eight sashes at first floor and four-over-eight at second floor; all with flat-arched heads. Additional narrower bay over round arched passageways flanking either end. Detracting uPVC casements at first floor to no.15.

15-17 Church Street

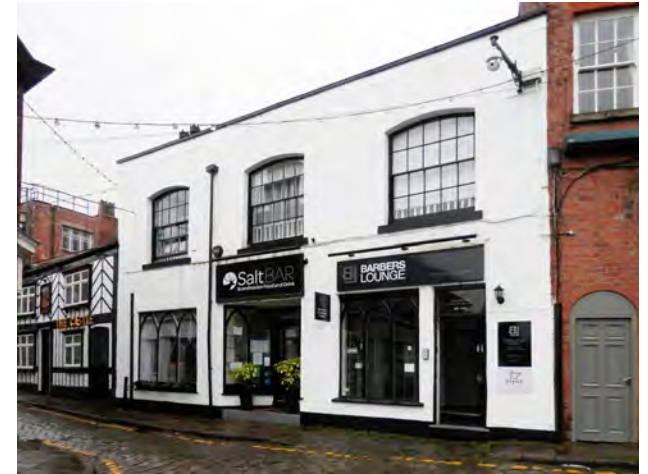
23 Church Street

Notes: A two storey building arranged over three bays, now rendered and painted. Large window openings at first floor with arched heads with ten-over-ten sashes windows. Coping to the parapet at roof level. At ground floor the central bay has a splayed recessed entrance with large window openings with pointed head mullions; further entrance to the right-hand side unit with fanlight above. The main signage is oversized and the various lights fixed to façade adds clutter.

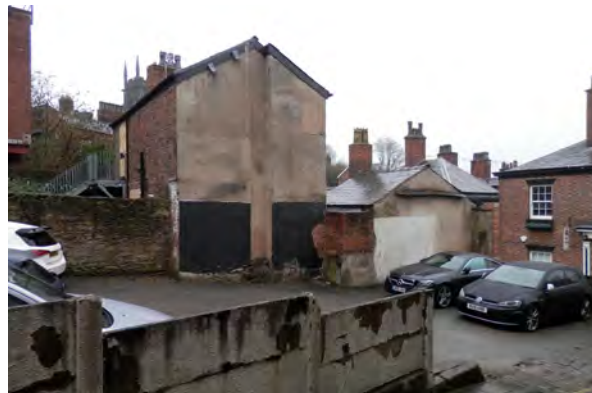
Notes: The public house is likely to have been remodelled from late-18th century dwellings in the 19th century and comprises a large extension constructed at that time to the rear. Comprises two storeys with painted brickwork and painted faux-timber framing. To the main part of the building windows are tripartite casements with leaded lights; to right-hand side at ground floor is a double window with extract vents not completely infilling opening to the side. Main entrance has panelled door with leaded light fanlight; signage is suited to the use as a public house. The roofline of the side wing steps up but otherwise the detailing repeats other than at ground floor where windows are small with a large entrance and panelled door. Pitched roof with brick chimney stack; render to gable end. Tall wing to the rear with pitched roof, brick façades and rendered gable end; metal fire escape stair and blocked openings detract; car park to the side also detracts.

25 Church Street, The Castle, rear wing and car park

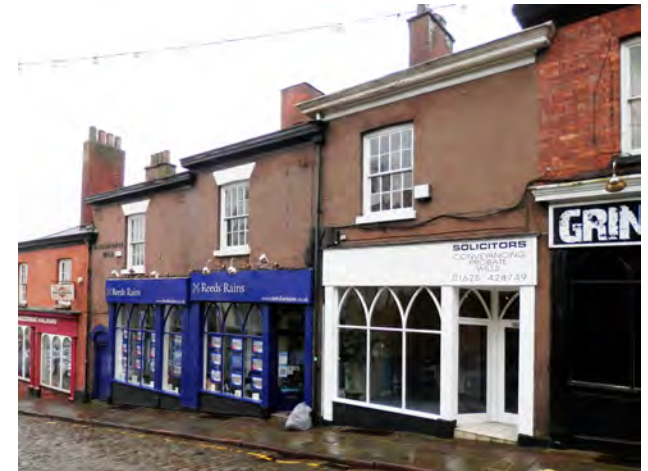
35-39 Church Street

Notes: Former residential terrace with inserted shopfronts. Constructed in red brick, now painted, over two storeys with an attractive stepped, pitched roofline with modelled cornice and prominent chimney stacks. Single bays at first floor with brick heads, painted to nos.37 and 39 and eight-over-eight timber sash windows. Shopfronts are good examples with stallrisers, pointed mullions and transom lights and recessed entrances. Unit at 37 - 39 now spans both buildings and there is no entrance at no.39; otherwise the distinction between the two buildings is maintained. Signage is appropriately located at fascia level; wiring across no.35 detracts. Passageway to left-hand side of no.39 with arched opening and timber door.

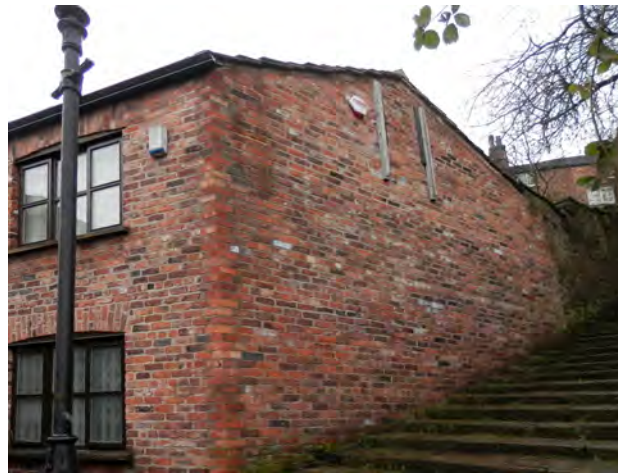
Notes: A two storey, light red brick building comprising four bays built hard up against the pavement edge. Off-centre main entrance door with cambered brick head and two light modern casement above; window openings are otherwise three-light modern casements all set under cambered brick heads. Signage is restrained. Plain brick façade to return elevation set off the 108 Steps – fixings for previous signage detract. Openings in the south façade have modern doors and stone steps providing access to side garden.

1-5 Short Street, north elevation

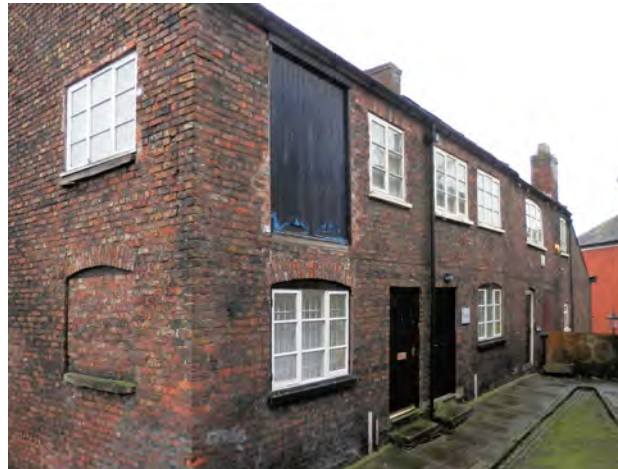
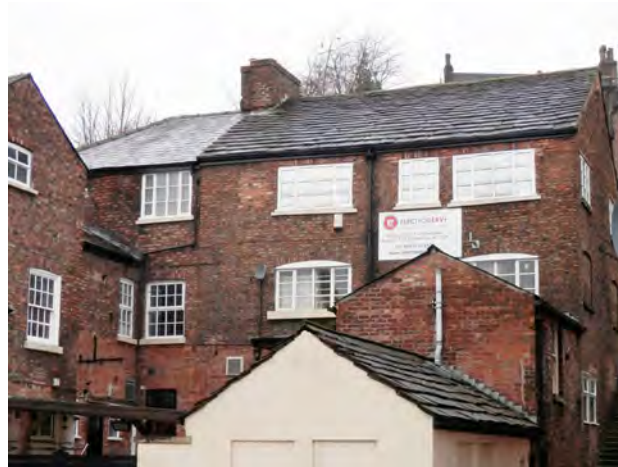
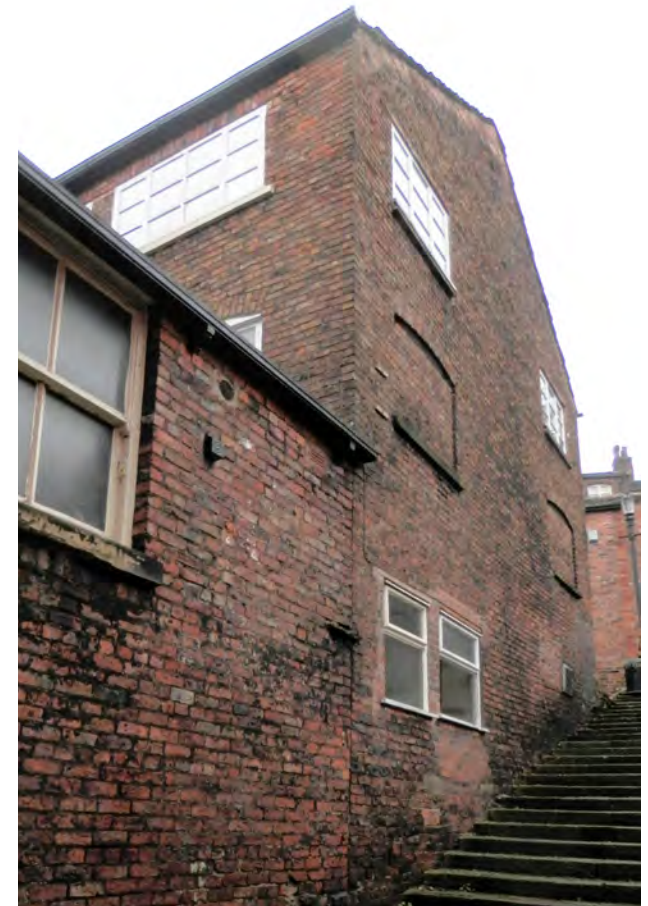
2-6 Short Street

Notes: Former silk mill, possibly built with a weaver's garret, converted to residential cottages. Adjoining public house – the Old Millstone was added in 1840-50. Constructed in brown brick hard up against the stone flagged pavement edge with pitched slate roofs and chimney stacks – set in the front wall at no.6. Fronting Short Street two storey cottages; four storeys to the rear – now part of the public house. Six window range built in two phases with no.6 added at the same time as the public house. Wide loading door at first floor to no.2 – now block with timber board with a two-light casement adjacent. Windows at first floor are otherwise three-light casements with brick heads – arched at ground floor. Two window bays to the return elevation at no.2 set hard up against the 108 Steps; ground floor windows now infilled with brick and new casements inserted at lower ground floor. Doors are timber plank with plain brick lintels. The window openings repeat to the rear façade with new stone lintels, eight-over-eight timber sash to the rear ground floor at no.6 – high level signage detracts. An interesting remnant of the

town's industrial past and the link between domestic and industrial uses characteristic of the silk industry.

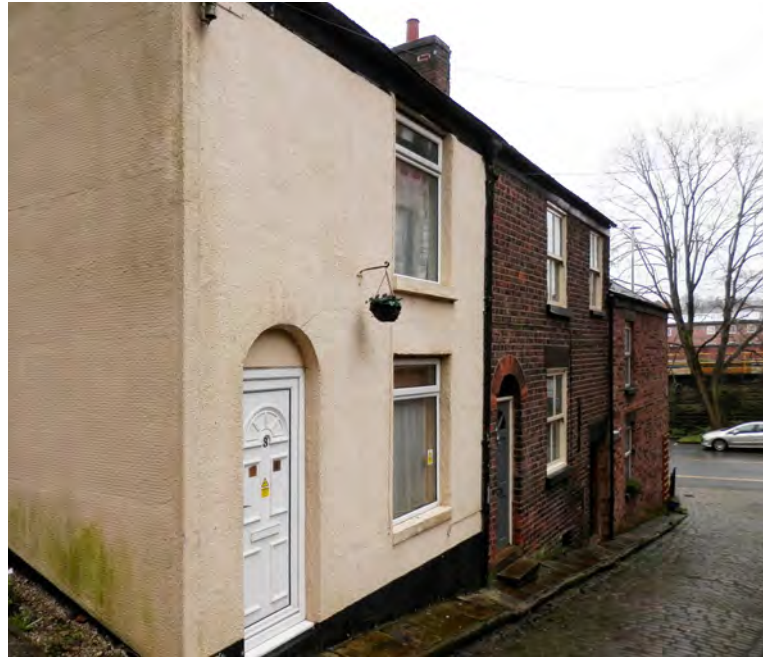
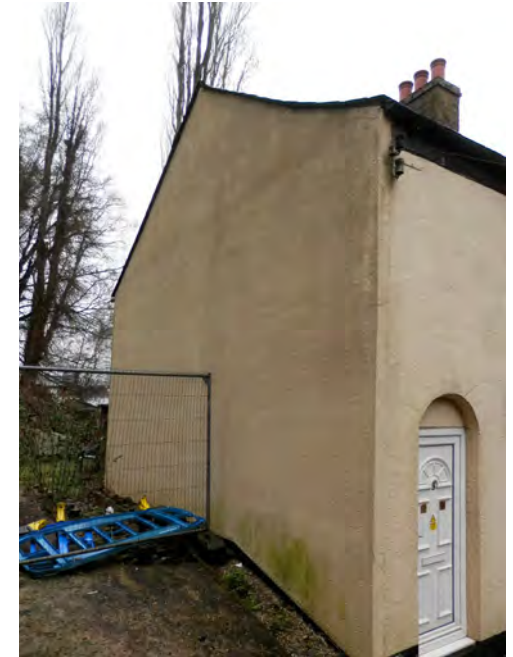
3-5 Step Hill

Notes: A pair of small scale cottages which form a block with 16 - 20 Waters Green. Build hard up against the pavement on plinths with a step up to the entrance. No.5 is the only remaining example within the block that retains its historic character, constructed in red brick with brick arch to the ground floor doorway, replacement door. Windows are two-over-two timber sash in a single bay with a further smaller sash over the entrance to the passageway set to the right-hand side – brick head at ground floor. No.3 has been rendered with uPVC door and casement windows; return elevation is also rendered – all of which detracts. Roofs are pitched with chimney stacks.

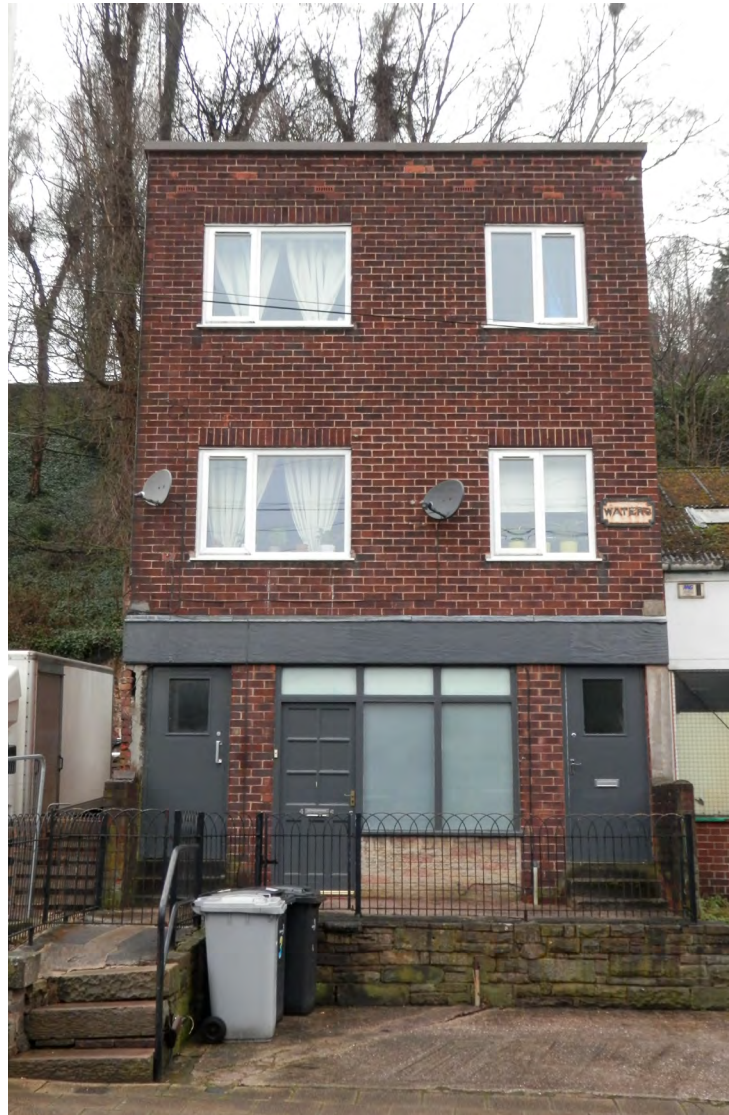
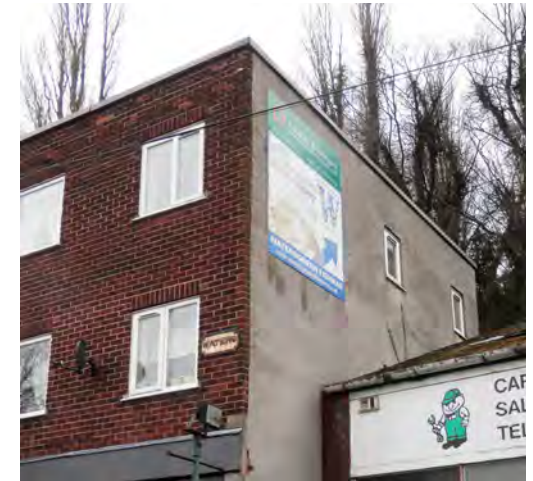
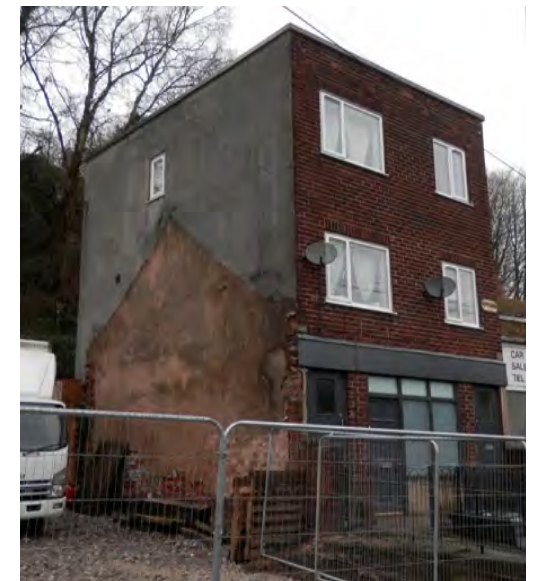
4-6 Waters Green

Notes: A three storey red brick building set back from the street with raised terrace, stone retaining wall and step /railings. Simple detailing, two and three light uPVC casements with brick heads. Coping to parapet at roof level. Ground floor has a central door set within a shopfront-style windows with mullion and transom lights; flanking modern doors with steps. Plain fascia board spans full width. North elevation rendered with small casements at second floor, high level signage detracts; south elevation also rendered with single small casement – scars of now demolished building at no.8 evident below.

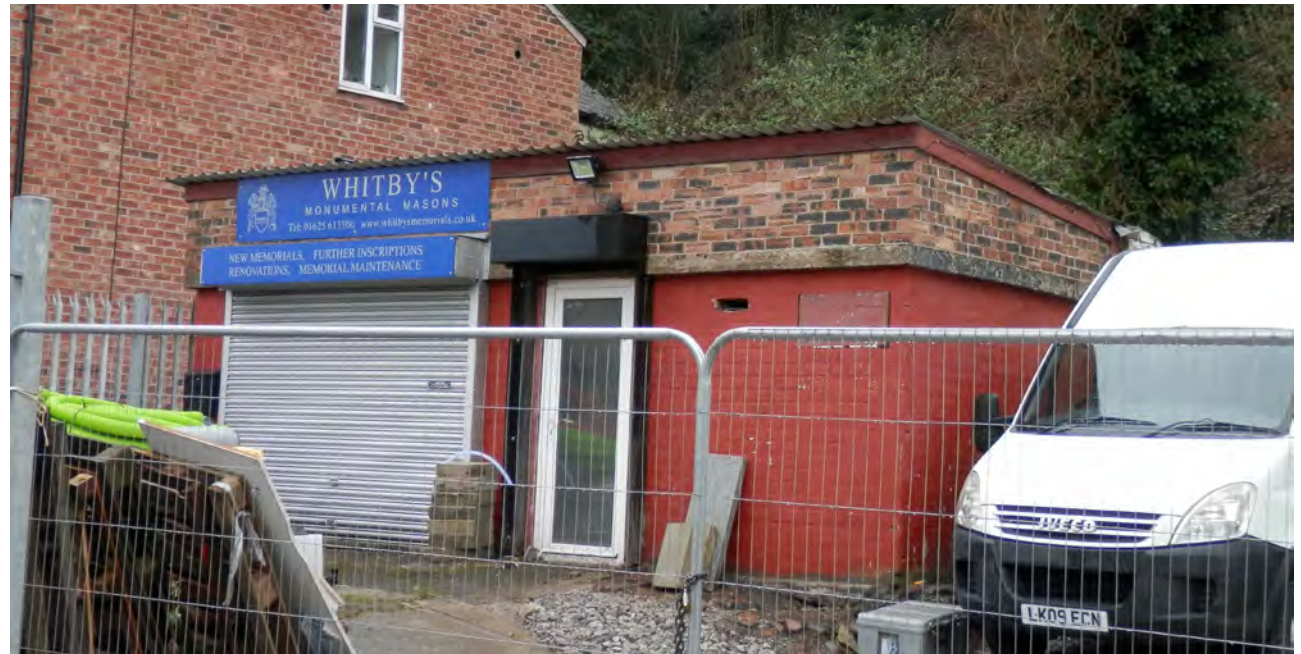
10 Waters Green

Notes: Single storey building with mono-pitched corrugated metal roof, red brick exposed above what appears to be a remodelled façade with painted brick work. Central glazed entrance door with detracting roller shutter and box; adjacent roller shutter and box also detracts – signage is awkwardly located.

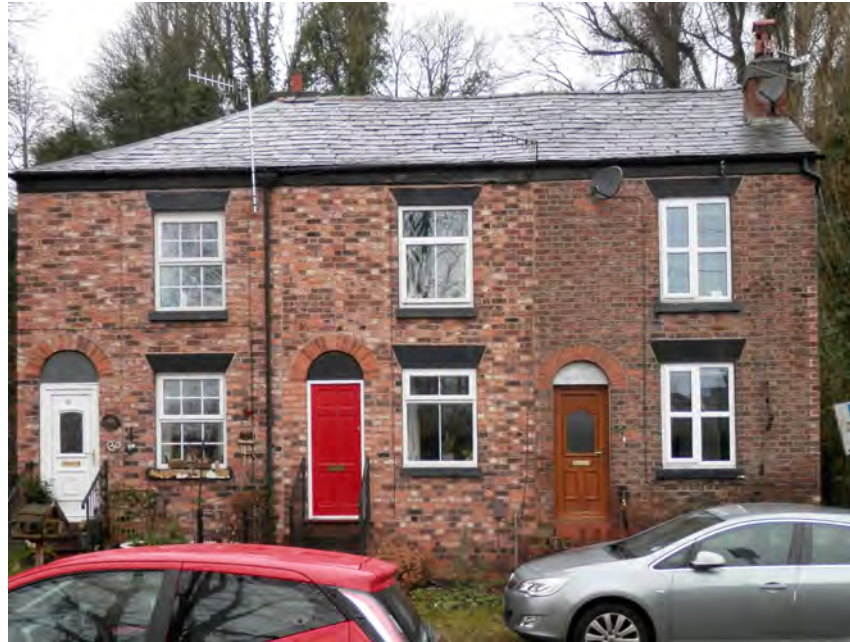
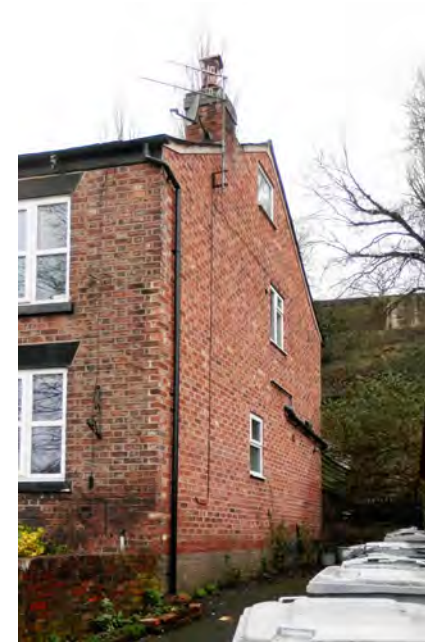
16-20 Waters Green

Notes: A small terrace group of cottages – truncated roof and keyed brickwork to no.16 show that the terrace used to extend further. Forms block with nos.3 - 5 Step Hill to rear. Comprises two storeys with pitched roof and chimney stacks. Set back from street with hard landscaping in front; raised ground floors with steps leading up. Brick arched openings with blocked fanlights and replacement doors. Windows are all uPVC casements with painted heads and sills. Return elevation to Step Hill with single bay of windows to rear which repeats detailing from front elevation. Side elevation to no.16 in later contrasting red brick with modern casements inserted, including in the roof storey.

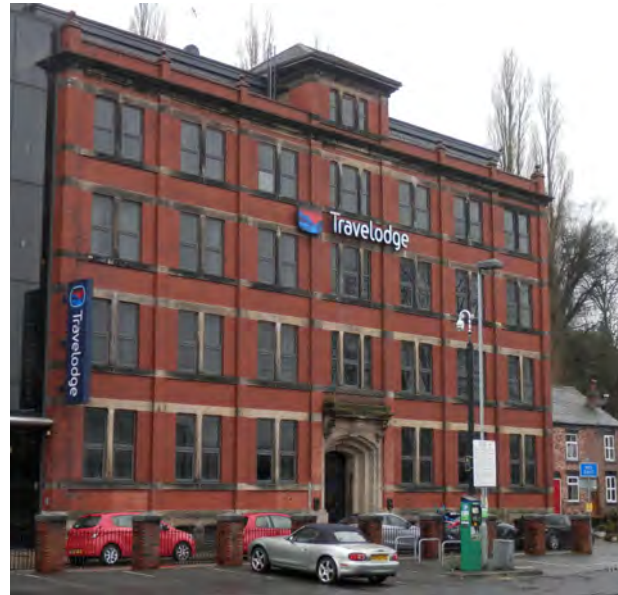
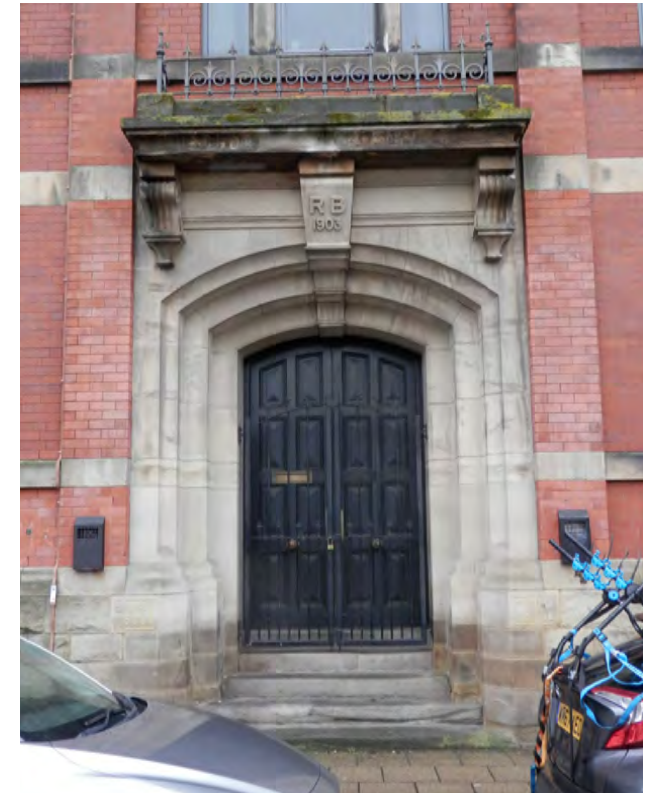
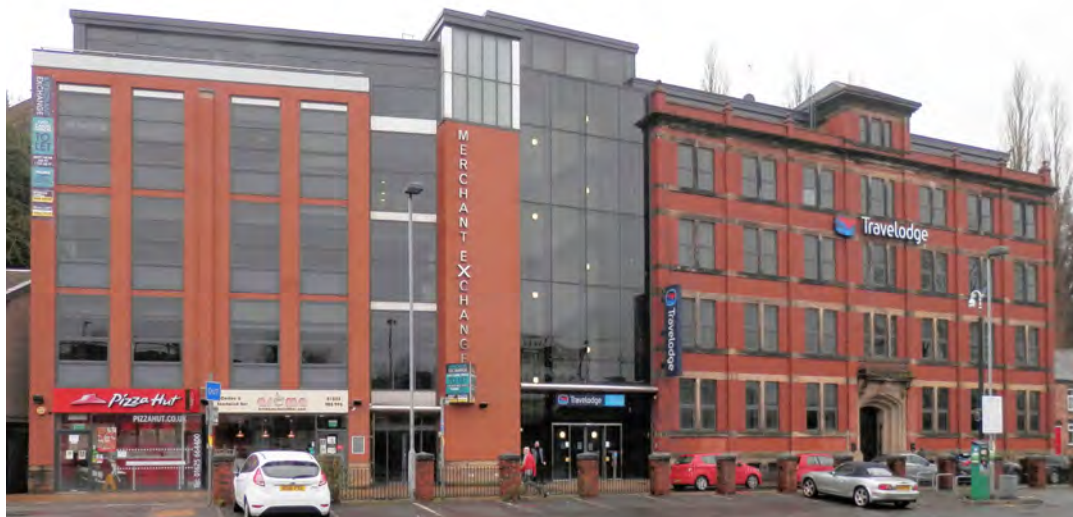
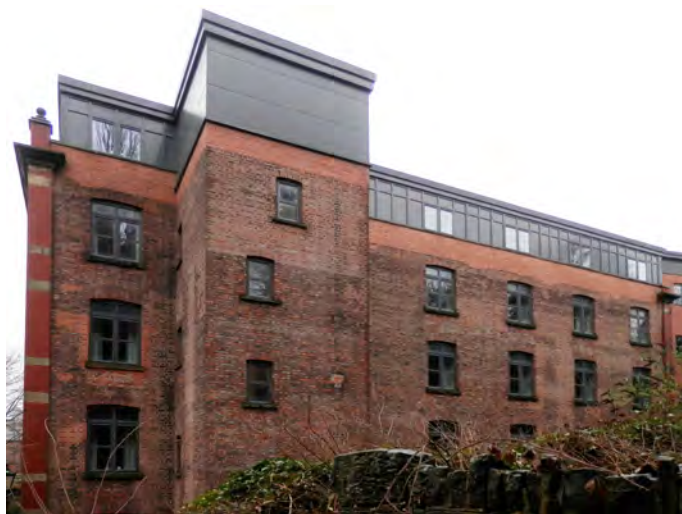
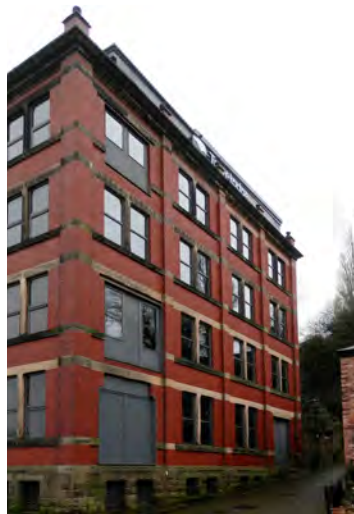
Castle House, Waters Green

Notes: A former silk mill subject to a scheme of adaptive reuse in the early 21st century (consented 2008). The building comprises four storeys arranged over seven bays set on a stone plinth with exposed basement openings now infilled with vents. The central bay has a stepped stone, arched doorcase with surmounting bracketed pediment with date stone and timber panelled door; the windows above are tripartite with a projecting clock tower at roof level. Cornice and parapet to roofline with ball finials. The remaining windows are paired openings with flat stone mullions, heads and sills form part of continuous string courses. The side return to Step Hill comprises four bays which continues the detailing from the front elevation; former loading bays in the first bay at ground, first and third floors and to the rear at ground floor have modern infills; windows are all modern casements. At roof level is a recessed extension; more pronounced to the rear where the brickwork of the top floor has also been reconstructed/extended. The

rear elevation has a plain brick façade with cambered brick arches to window openings. Contemporary extension to the south as part of the 2008 consented scheme with roof extension spanning the two (see Merchant Exchange). High level signage detracts. An example of the adaptive reuse of former industrial building which to the historic building is successful; the relationship with Merchant Exchange, less so.

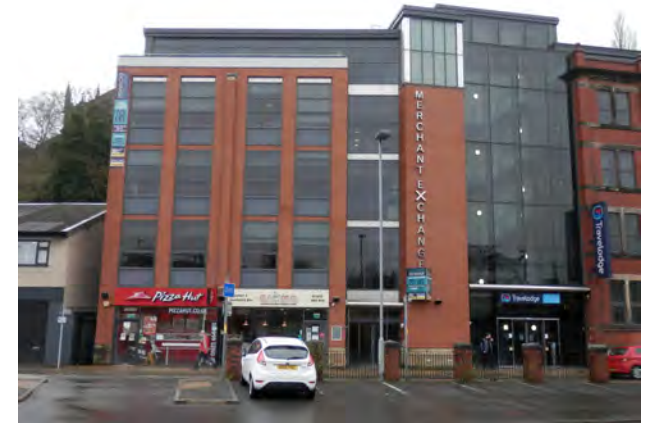
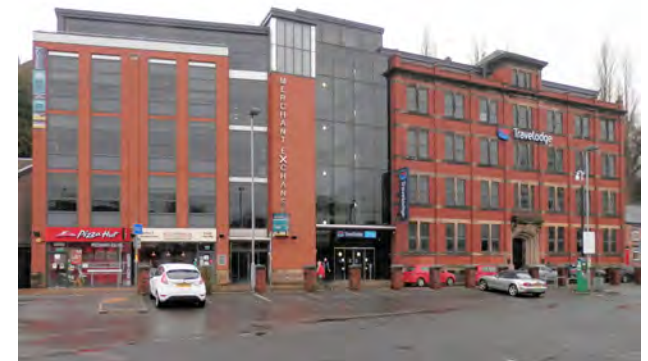
Merchant Exchange, Waters Green

Notes: Replaced subsidiary buildings serving the mill as part of a redevelopment scheme consented in 2008. The building has sought to form a sensitive extension to the former mill, however owing to its scale and the height of the central glazed section it competes with the main building. The overall architectural aesthetic, a mix of red brick and large sections of glazing relate poorly to the mill and the local context. Retail frontage is simple with fully glazed shopfronts characteristic of modern developments. High level signage detracts.

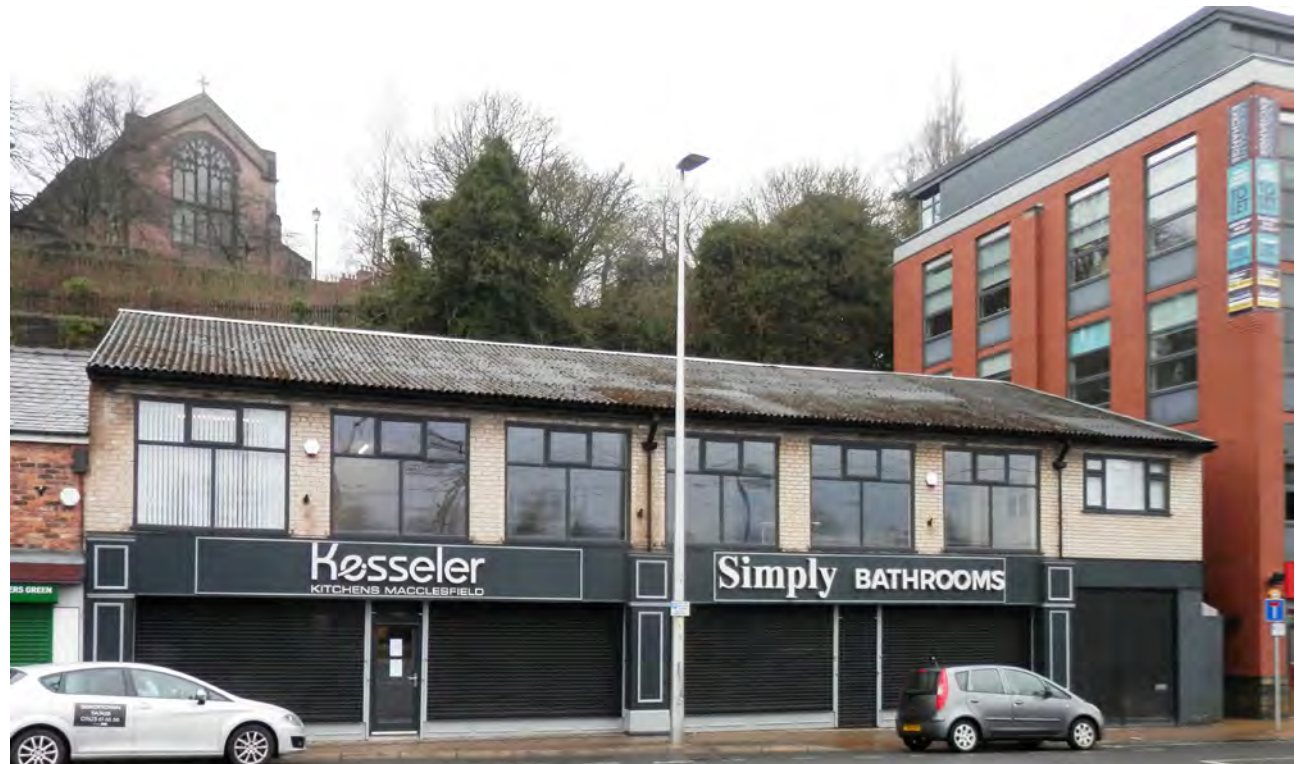
40-44 Waters Green

Notes: A two storey block with showroom to the ground floor. White brick to first floor with pitched corrugated metal roof. Seven bays with large window openings to six bays with two lights and three light transoms; seventh bay has smaller casement over vehicular access with plain doors. Shopfronts not inspected but external roller shutters detract. Arranged as two wide shopfronts each with a central door, low stallrisers and wide moulded pilasters/consoles.

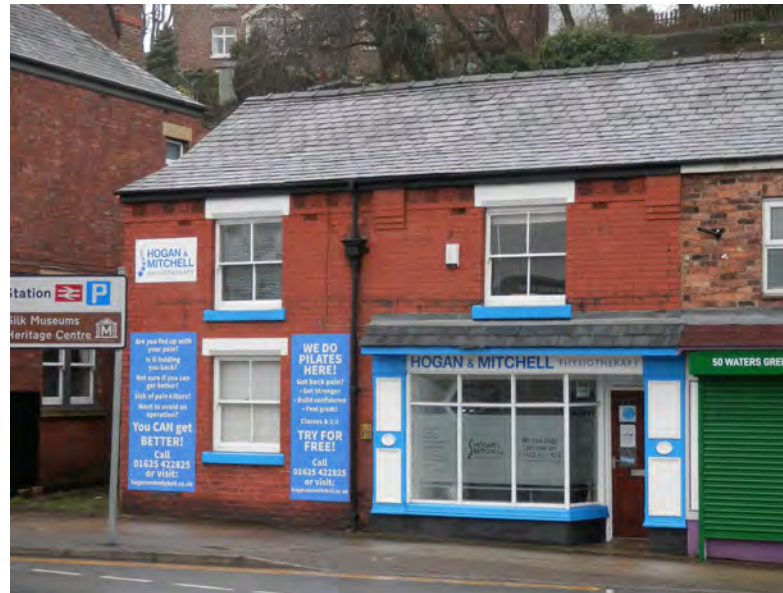
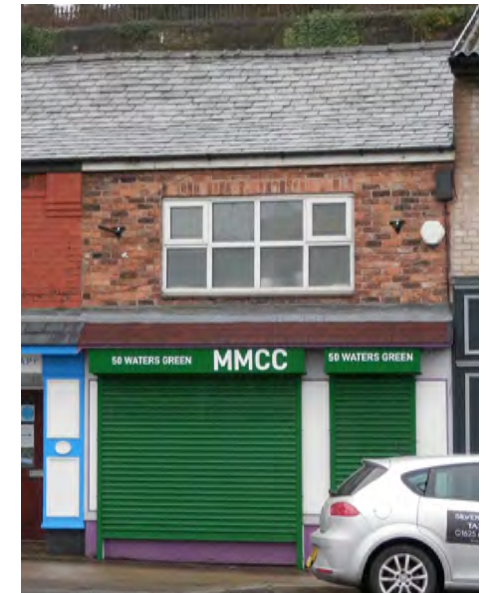
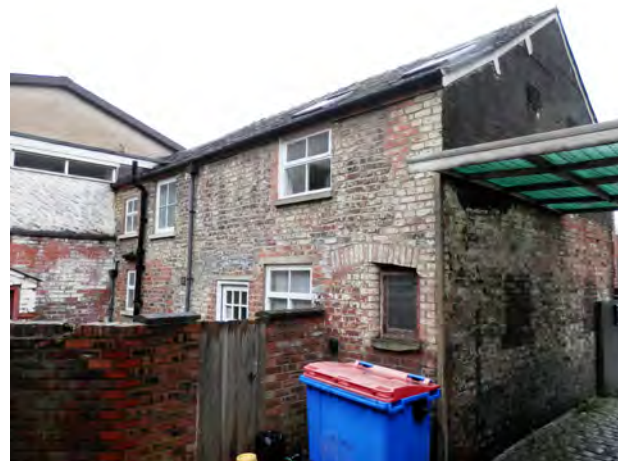
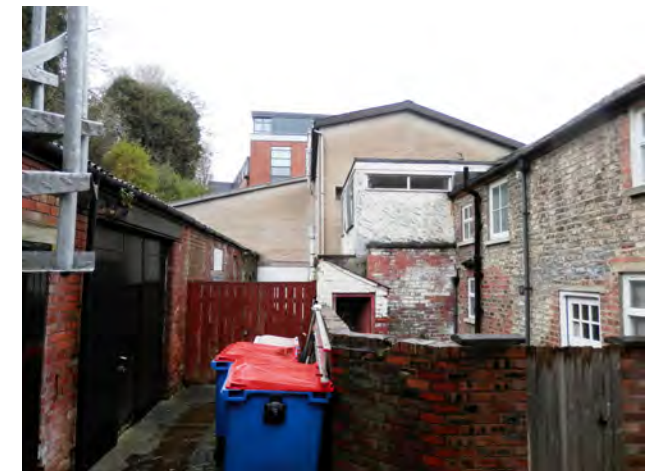
Notes: A pair of two storey buildings with a shared pitched roof but differing facades which suggest a remodelling to no.50 – supported by the large full width rear extension. First floor at no.50 is red brick with wide casement window and simple brick head. Shopfronts are later insertions with shallower pitched roofs – tiled to no.50, slate to no.52. Shopfront at no.50 not inspected, roller shutters detract. No.52 comprises two bays with flat brick corbels to the roof and a decorative band under the eaves. Windows are large two-over-two timber sashes with painted lintels and sills. Shopfront is a good example with stallriser, mullions and transom lights; moulded flat pilasters and recessed entrance. Signage to shopfront is restrained, to the adjacent bay detracts. Rear and side elevations at no.52 has a contrasting character with mix of windows and altered openings, canopy to side access which detracts and tall boundary red brick wall to rear.
