Donald Insall Associates
Chartered Architects and Historic Building Consultants

Macclesfield Conservation Area
Gazetteer

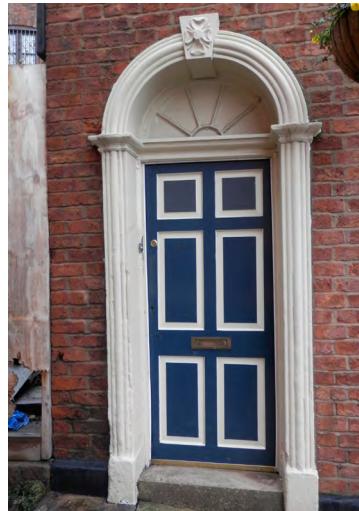
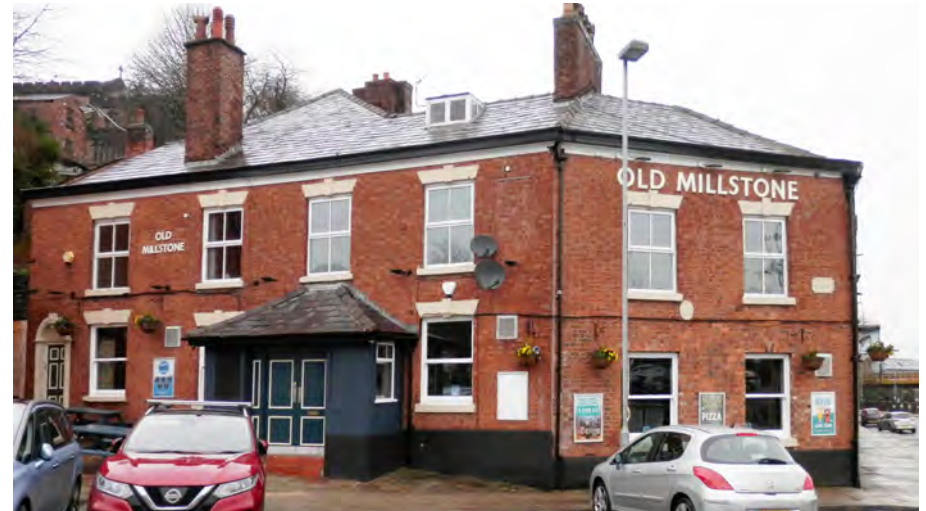
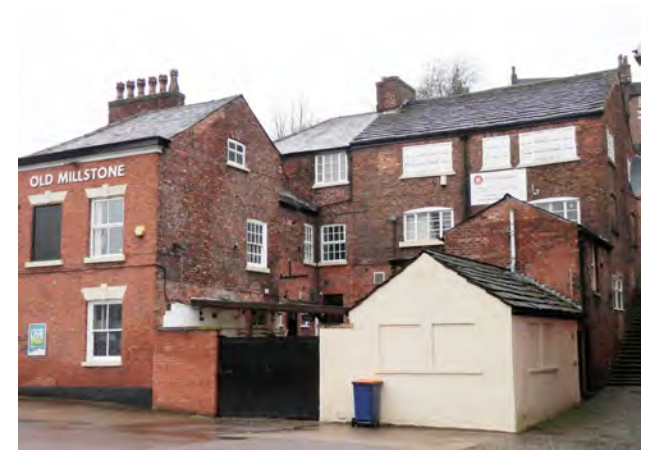
Old Millstone, 62-68 Waters Green

Notes: Part of the former silk mill complex on Short Street to the rear - added in 1840-50 adjoining no.6 Short Street constructed at the same time. Four bays to principal façade with two angled returns to the south and south-east on the corner – each with two bays. First floor windows are modern uPVC casements whilst at ground floor are one-over-one modern sashes (two-over-two to east façade); all set under flat-arched gauged, painted brick heads with keystones. First bay to east façade with no opening at ground floor and blocked at first. The original doorway remains to the western end with architrave with clustered shafts and roll moulding; blind fanlight above. Pitched slate roofs with prominent chimney stacks, small high level dormer and moulded eaves cornice. Porch to centre of main façade is a later addition and detracts. North elevation has a gable end and connects to Short

Street terrace. Boundary wall with gate to east, canopy to rear beer garden and small outbuildings with pitched roofs; rendered on the corner with blocked windows and stepping up to a red brick structure with a single window opening.

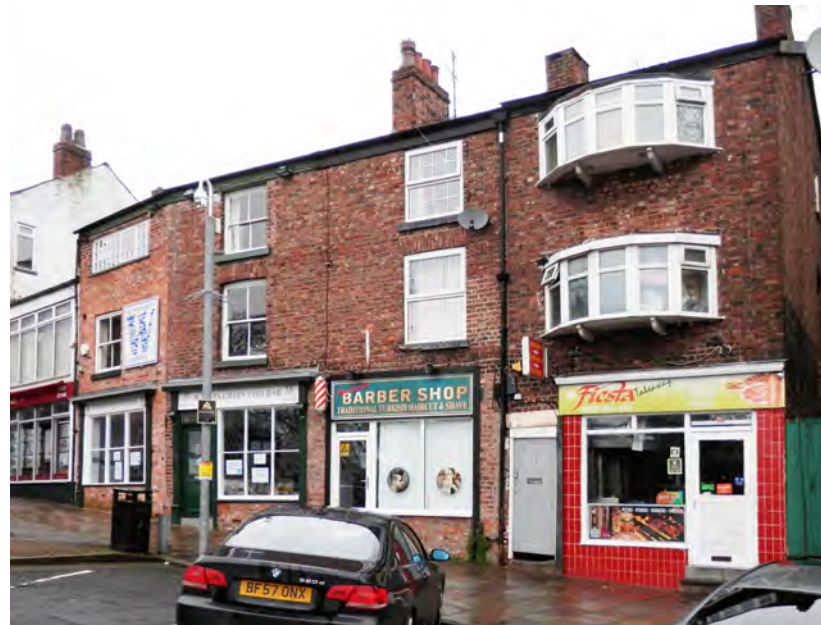
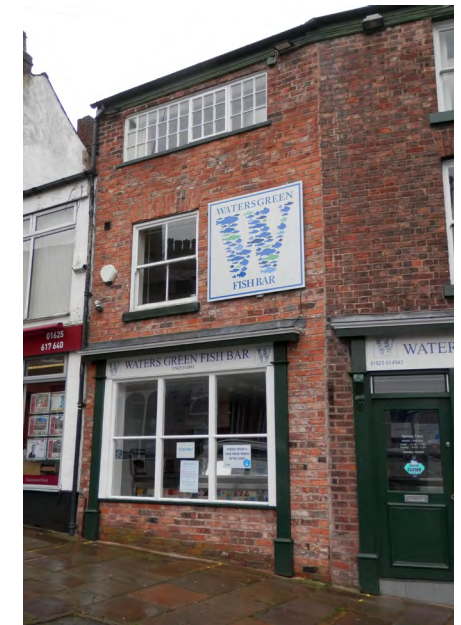
70a-76 Waters Green

Notes: A terrace group of four, constructed in brown brick – no.76 in red - and comprising three storeys with pitched roofs and chimney stacks. The wide window opening with multi-pane timber casements at no.76 suggestive of their former role in the silk industry. At first floor is a two-over-two timber sash with brick head; repeated at first and second floor to no.74. Otherwise the windows to the upper floors detract with uPVC casements to no.72 and projecting bay windows with uPVC windows at no.72a on brackets. Shopfronts inserted at ground floor; at nos.74 - 76 now serving a single business but aside from the loss of the entrance to no.76 retains the definition of the individual buildings with traditional shopfronts including stallrisers, pilasters, mullions and appropriate fascia signage. The high level sign at no.76 detracts. The shopfront at no.72 is simple contemporary unit which repeats traditional

detailing including stallriser, mullion and fascia signage; the barber's pole adds interest. The red tiles to the contemporary shopfront at no.70a is unsympathetic and the projecting sign would be better located as fascia level. Passageway to the left-hand side of no.70a with door. Satellite dishes at nos.70a and 72 detract.

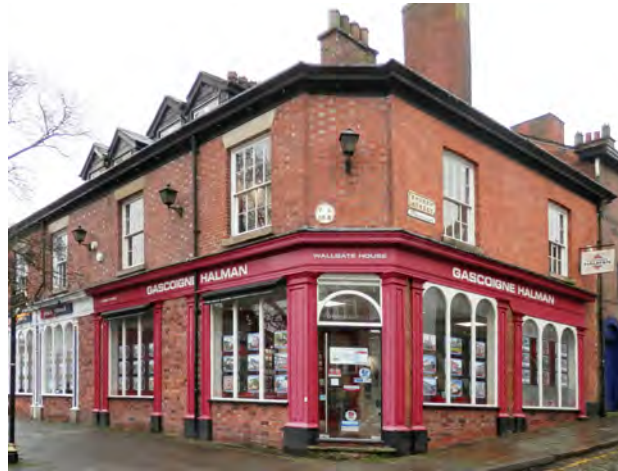
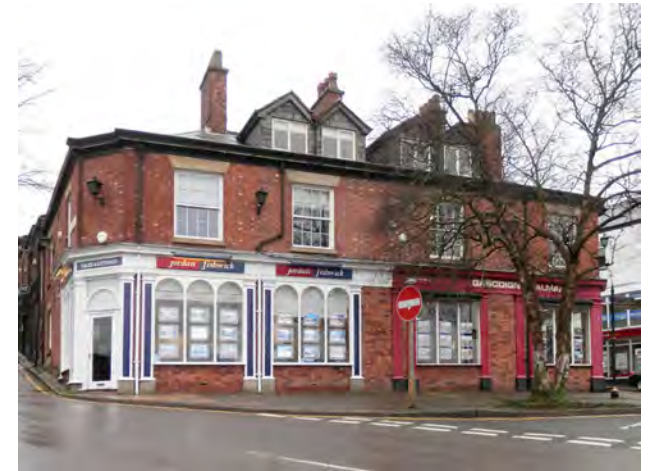
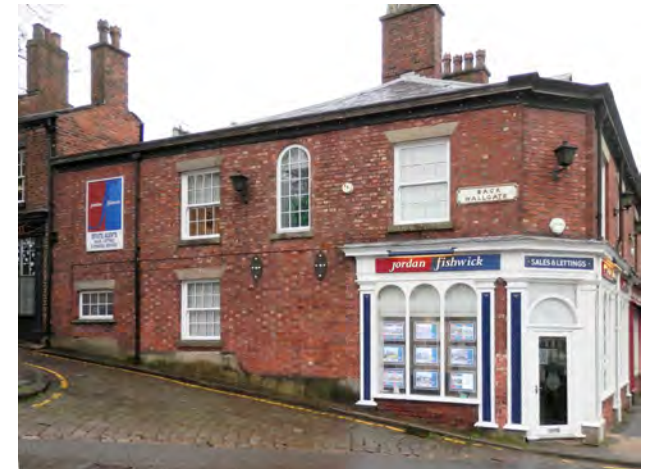
80-86 Waters Green

Notes: Two storey group which bookend the terraces on Back Wallgate and Church Street and mark the top of Waters Green. Constructed in red brick with pitched slate roofs, paired gabled dormers with timber casements and prominent chimney stacks. Single bays at first floor retaining eight-over-eight timber sashes with stone heads and sills. Inserted shopfronts are a good example with fluted pilasters, mullions forming three-lights (curved to all but front elevation of nos.80 and 82), stallrisers and appropriate fascia signage with cornice. The internal units each span two properties with entrances on the canted corner with glazed fanlights – door to no.80 is overtly modern. Shopfront extends one bay on side return to back Wallgate with sash window repeated at first floor and at ground and first floors in third bay to the rear. An arched window has been inserted and high level signage to the

rear detracts; small multi-pane casement with stone head below. To Church Street shopfront extends full façade; sashes repeated over two bays at first floor; albeit with brick heads. Lantern lights are suited to character of building; high level projecting sign to Church Street would benefit from being lower to fascia level.

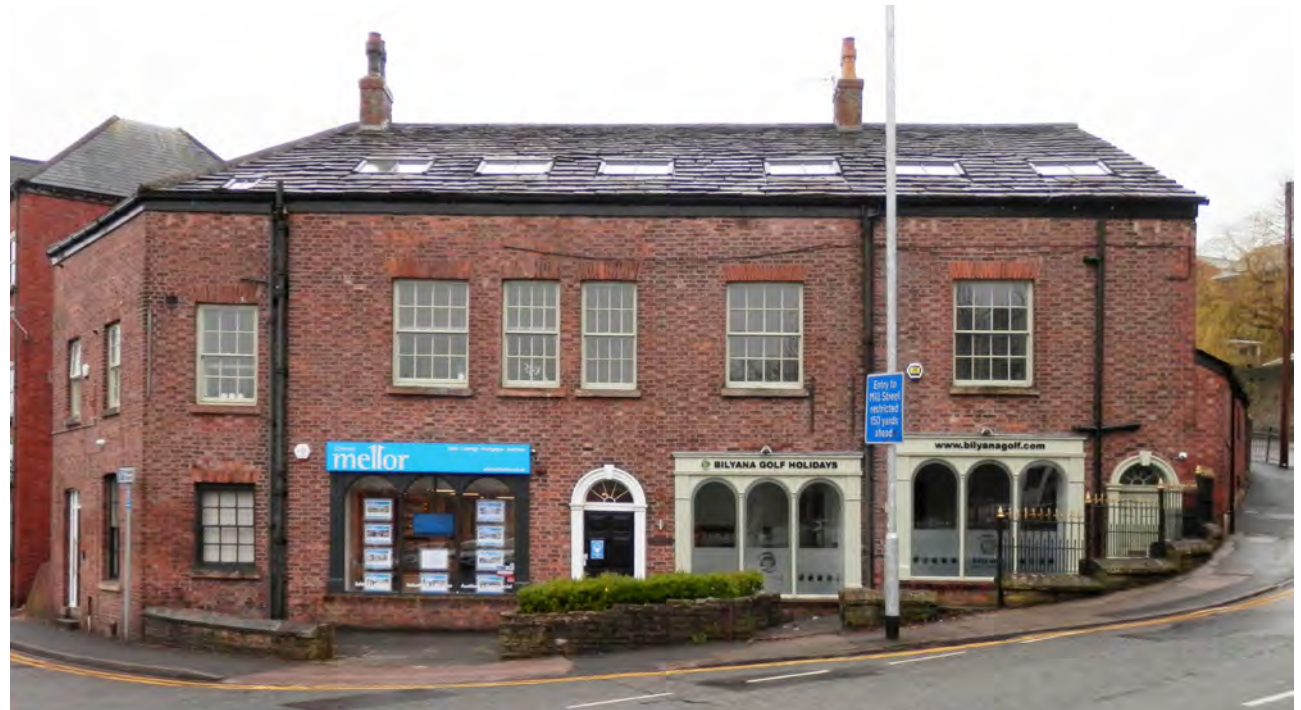
90-92 Waters Green

Overall condition: Good

Notes: Formerly a row of houses which may have houses domestic workshops; set back from the street behind dwarf stone wall. Constructed in brown brick with stone-flagged roof with axial chimney stacks and inserted conservation-style rooflights. Comprises two storeys to the front and three to the rear. Front elevation is arranged over six irregular bays with eight-over-eight sash windows at first floor with stone sills and flat-arched heads. To the left-hand bay, six-over-six sashes at ground and first floors which repeats for two bays in side return to Boden Street (with rear modern entrance door at ground floor). Two doorways with radial fanlights in moulded stone round-arched architraves to centre and right. Inserted shopfronts to traditional design with pilasters, stallrisers and three arched lights with mullions. Signage to no.90 is sympathetic, to no.92 detracts. The roof extends over a rear range with overhang in stepped elevation to Boden Street and with small single storey wing with pitched roof to Queen Victoria Street. Rear range

expresses likely original domestic industrial use with four bays of wide window openings to the attic storey with multi-pane, three light timber casements. At first floor gothic arched windows with interlace tracery and six-over-six sashes below with brick heads. Central doorway and single storey brick extension with pitched roof to left-hand side; car parking to rear which is set down from Queen Victoria Street.

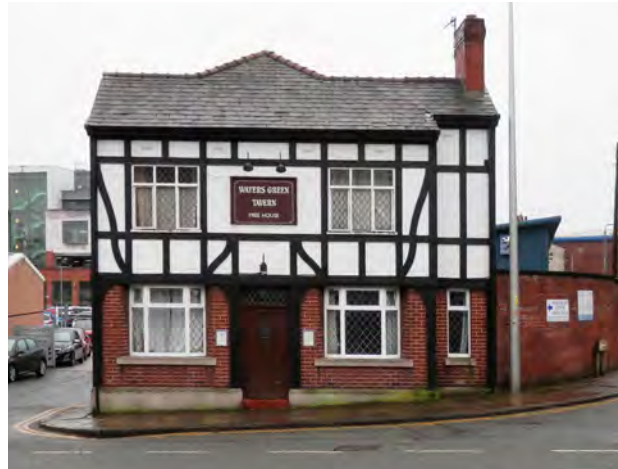
Waters Green Tavern, Waters Green

Status: Positive contributor
Date: Mid-19th / early-20th century
Overall condition: Good
Use: Public House

Notes: A two storey public house set on stone plinth with red brick ground floor and mock-Tudor render and timber frame to first floor. Pitched slate roof with red brick chimney stack. Windows at first floor are two bays timber casements with leaded lights. Window design is repeated at ground floor within two canted bays set on stone sills – single light opening to right-hand side. High level signage is characteristic of the public house use. Render and timber continues to the side elevation on Boden Street whilst a substantial two storey, three bay wing projects to the rear with interlocking pitched roof constructed in brown brick with timber sash windows (mix of two-over-two and one-over-one, stone lintels and red brick reveals) which is of an earlier date. Tall red brick boundary wall extends along Boden Street with timber gate.

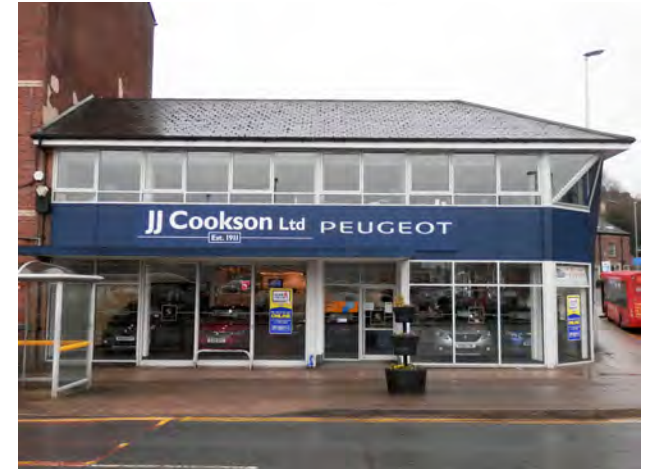
JJ Cookson Garage, Waters Green

Overall condition: Good

Notes: A two storey building with a largely glazed façade to Albert Place and pitched roof characteristic of a car showroom. Single storey wing extends along Waters Green, again substantially glazed with forecourt parking in front. Signage is large but appropriately located in terms of the composition of the building. Extensive forecourt area extends to the rear, behind buildings fronting Albert Place.

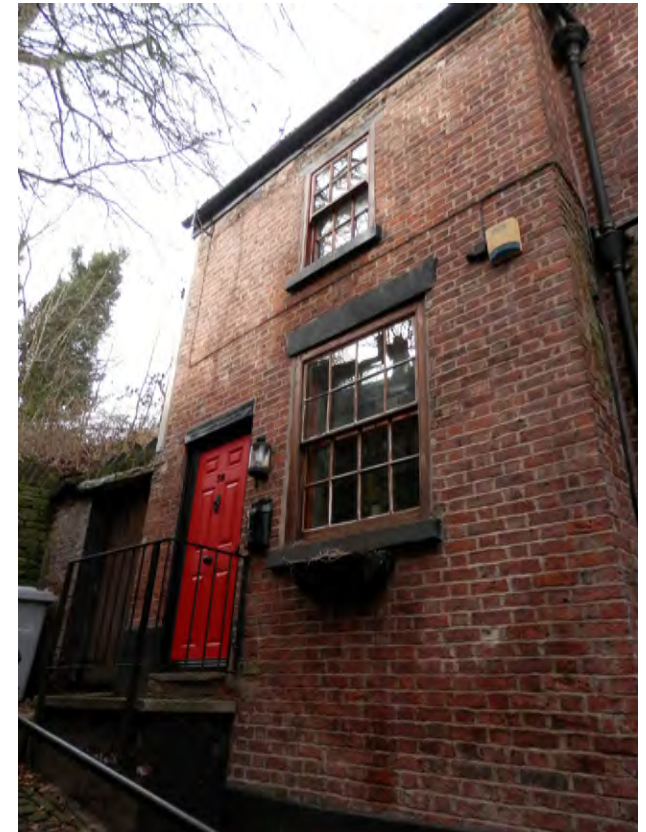
38 Brunswick Hill

Overall condition: Good

Notes: A two-storey red brick building with steps and railings serving raised entrance door with simple architrave and modern panelled door. Windows are eight-over-eight and six-over-six timber sashes at ground and first floors respectively with painted head at ground and simple lintel to first – both with painted sills. Pitched roof and rendered west elevation with slot windows – side access set within stone wall.

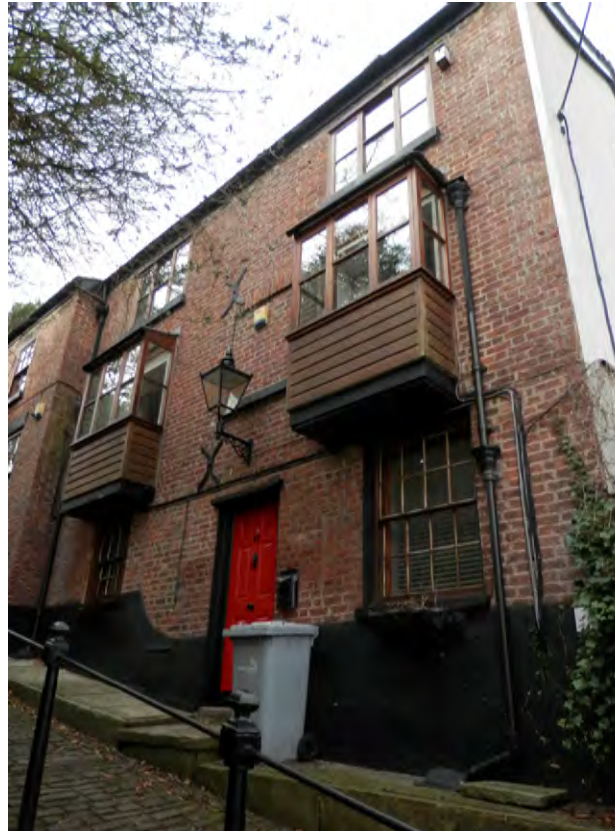
42 Brunswick Hill

Overall condition: Good

Notes: A three storey red brick building formerly two set on a plinth which mediates the steep slope. The facade has been altered with two projecting square bay windows at first floor which detract; glazed to all sides with timber panelling below. Windows at second floor are three-light casements with simple lintels and stone sills, at ground floor are eight-over-eight sashes, oversailed by the bay windows above. The central entrance door is a modern timber panelled door with stone step and large carriage lantern above. Roof is pitched with a chimney stack, west elevation is rendered with a double-height triangular bay window, again glazed with timber panelling.

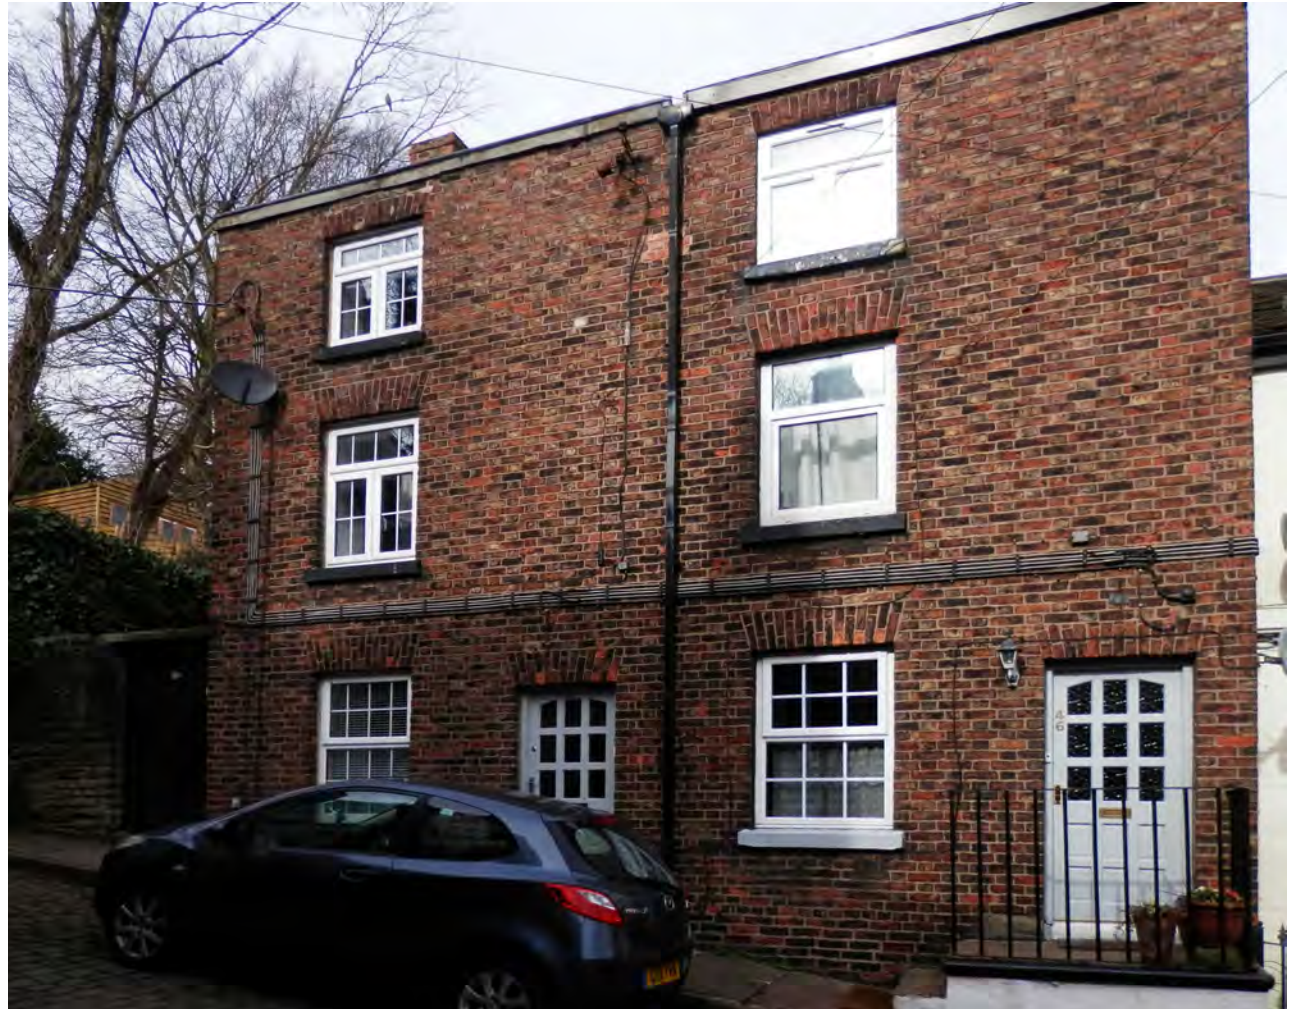
44-46 Brunswick Hill

Overall condition: Good

Notes: A pair of three storey, red brick buildings with a shared pitched roof and chimney stack. Single window bays with gauged brick heads and entrance doors set to the right-hand side and with gauged brick heads. Windows are all uPVC casements to a variety of designs which detract whilst doors are modern albeit more sympathetic. Steps to entrances and a side access gate set in the stone wall serving no.44.

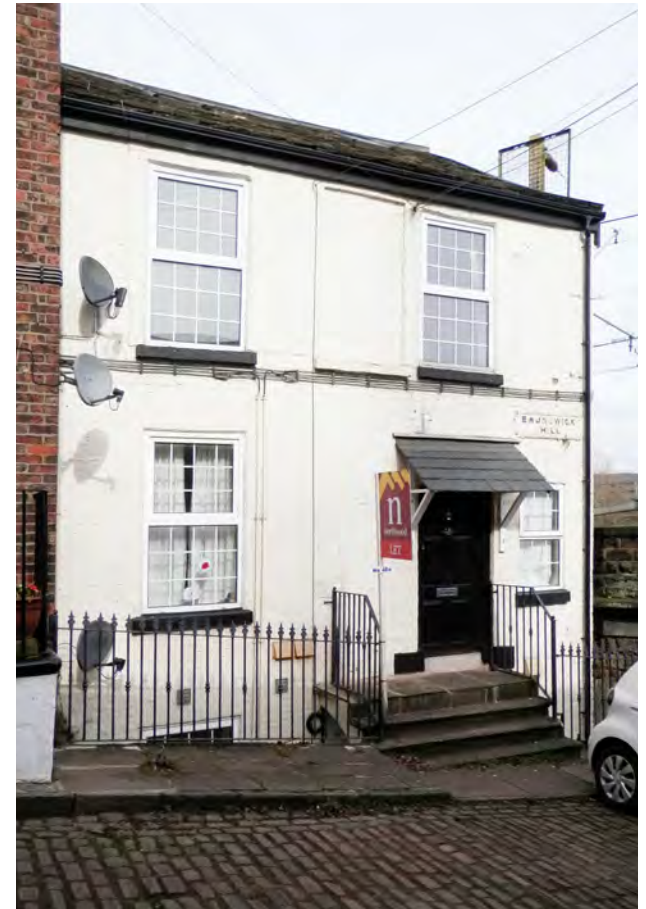
48 Brunswick Hill

Overall condition: Good

Notes: A two storey building with additional lower ground floor served by lightwells with railings. Crossover steps provide access to the off-centred entrance door which has a detracting slate canopy. Originally three window bays at first floor, central opening now in filled; two flanking have stone sills and detracting modern uPVC windows which are repeated at ground and lower ground floors. Constructed in brick now painted with a pitched roof. Satellite dishes and cabling add clutter and detract.

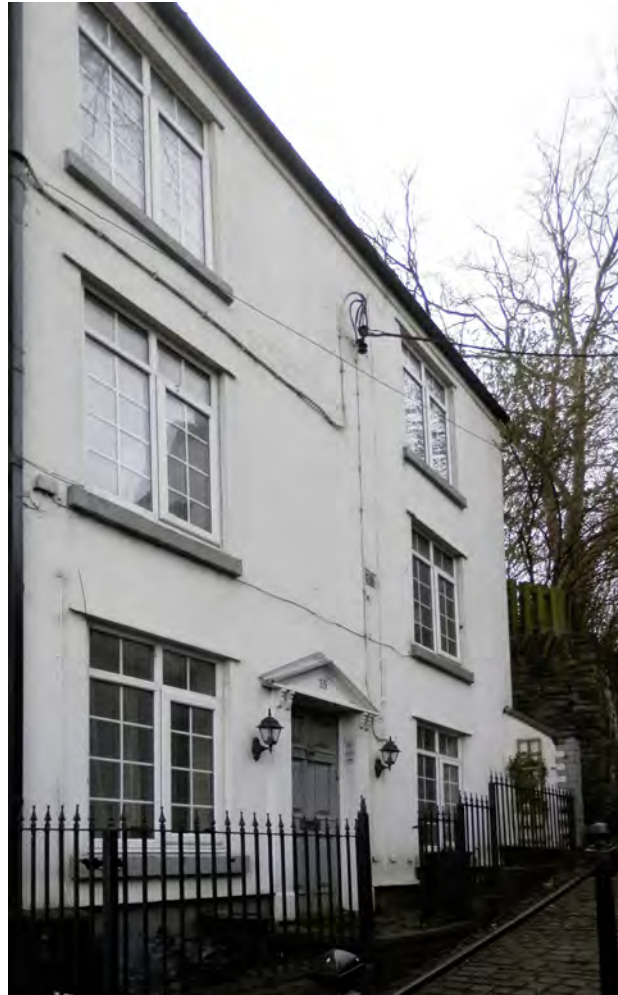
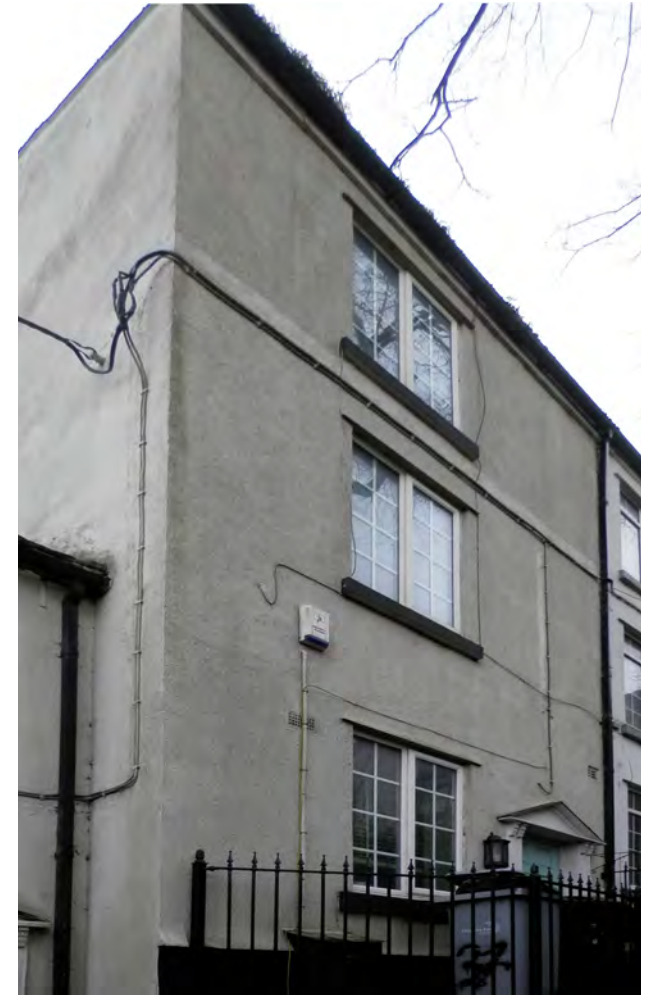
Overall condition: Good

Notes: A pair of three storey buildings set back from the street with railings, no.35 is double fronted and may have originally been two dwellings. Both with later doorcases with bracketed pediments and panelled doors. Lights to the side of the doors are appropriate. The facades are rendered and painted which detracts; three bays of evenly sized window openings with stone sills and modest lintels; uPVC casements detract. Pitched roof with chimney stacks.

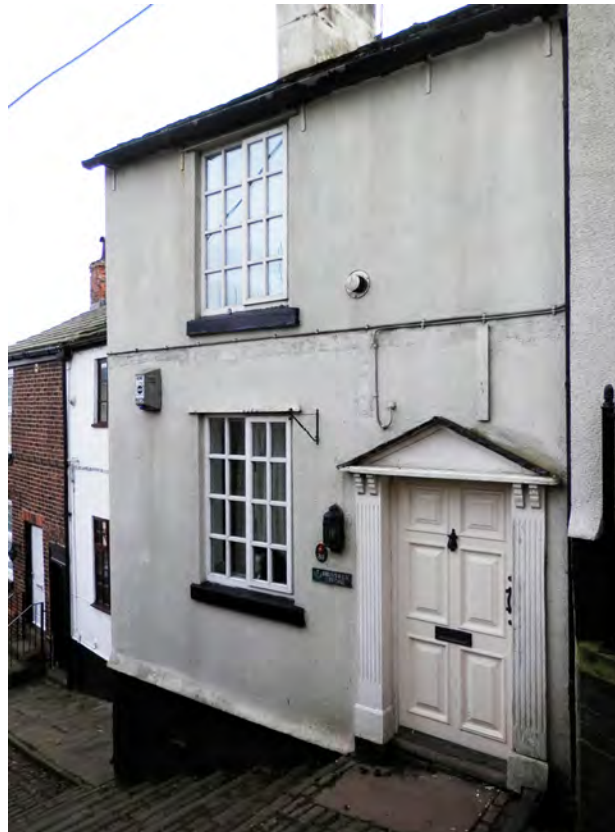
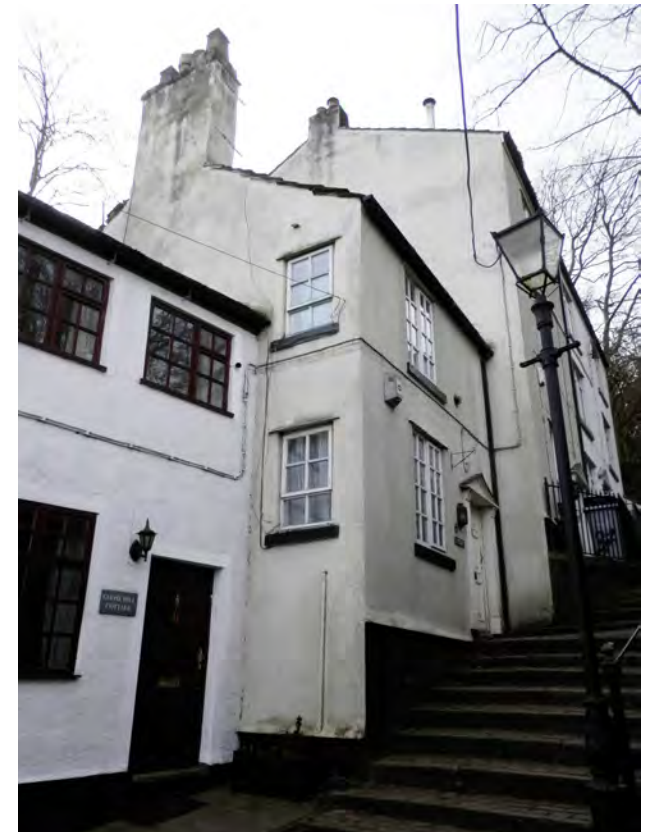
Overall condition: Good

Notes: A two storey building built hard up against the pavement edge; plinth mediates the change in levels. Later doorcase with bracketed pediments and panelled door. The façade is rendered and painted which detracts; single bay sized window openings with stone sills and modest lintels; small windows in return elevation. uPVC casements detract. Pitched roof with gable end and chimney stack. Single light to side of doorway appropriate but other fixings, flue etc. detract.

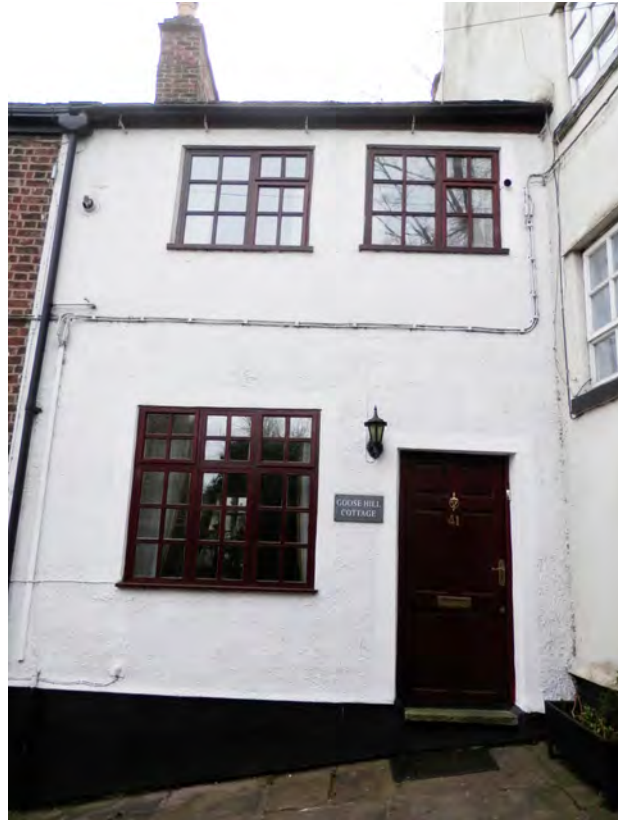
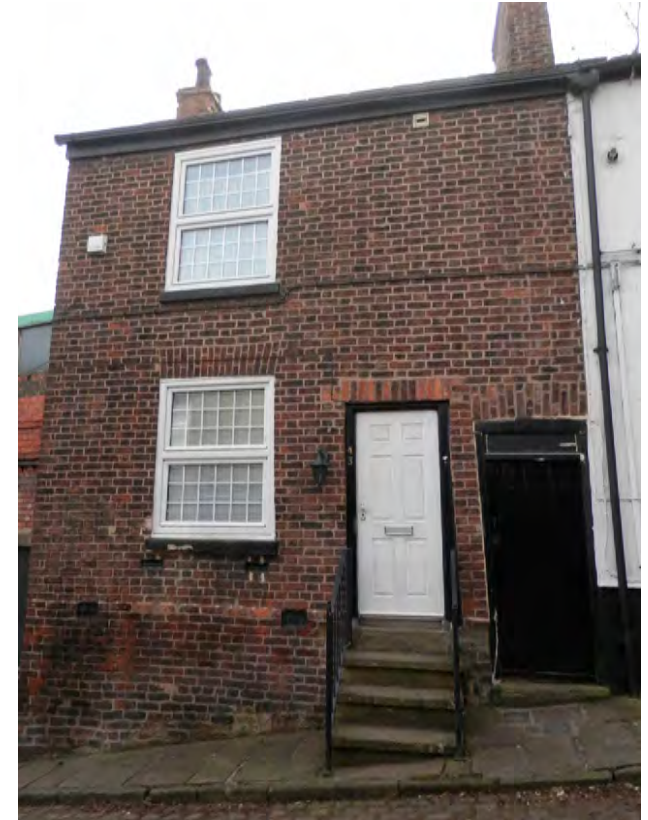
Overall condition: Good

Notes: Two storey pair built hard up against the pavement edge; plinth mediates the change in levels with stone steps leading to raised ground floor at no.43. No.41 has been rendered and painted with modern casements and simple sills; modern panelled door. Aside from its shared scale with no.43 and shared pitched roof with chimney stacks its historic character has been largely lost. No.43 remains in red brick; single window bay with brick gauged arch at ground floor and simple sills to both. Modern panel door with brick head; passageway to right-hand side with brick gauged head, boarded timber door and fanlight. Windows are modern uPVC which detract. Wires across both buildings add clutter.

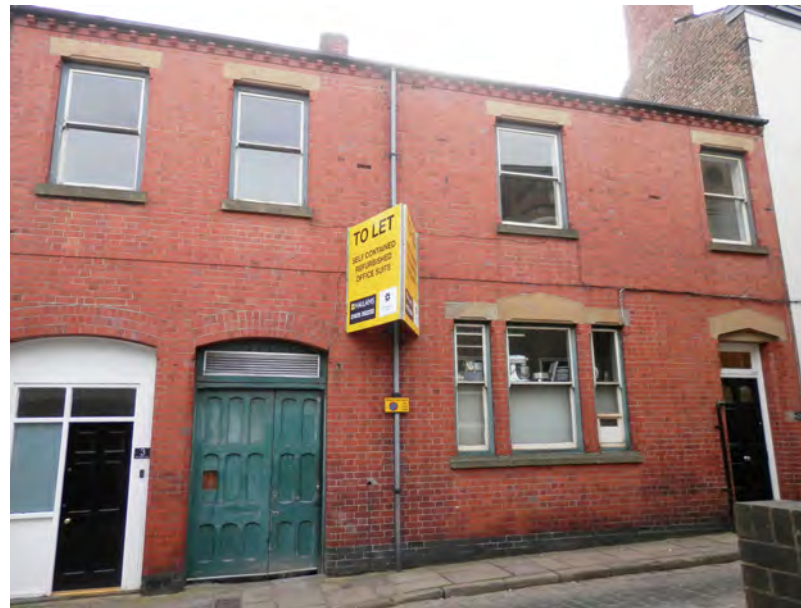
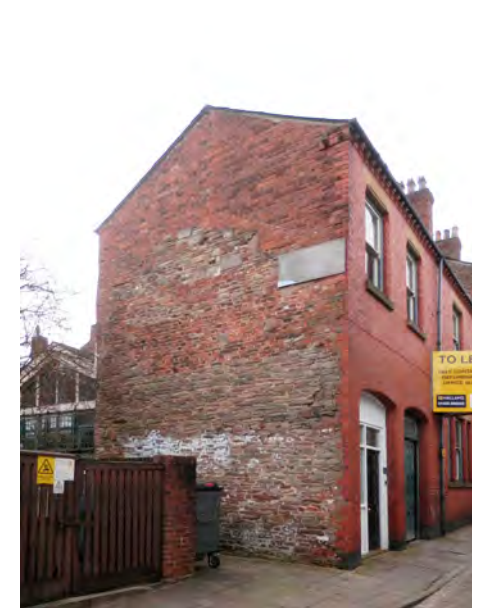
Overall condition: Good

Notes: A red brick pair set over two storeys located to the rear of buildings fronting Market Place and formerly part of a continuing building frontage. Four bays of windows to first floor with stone heads and sills and dentil cornice to eaves. At ground floor to Oak House the entrance door is set to the right-hand side with pointed stone head with a tripartite sash windows with repeated stone head design and brick mullions. Windows are one-over-one timber sashes. To no.3 two large brick arch entrances' one with panelled timber door and fanlight now with extract vent and the other with modern doorway infill. Roof is pitched; the east elevation shows evidence of previously adjoining two storey building.

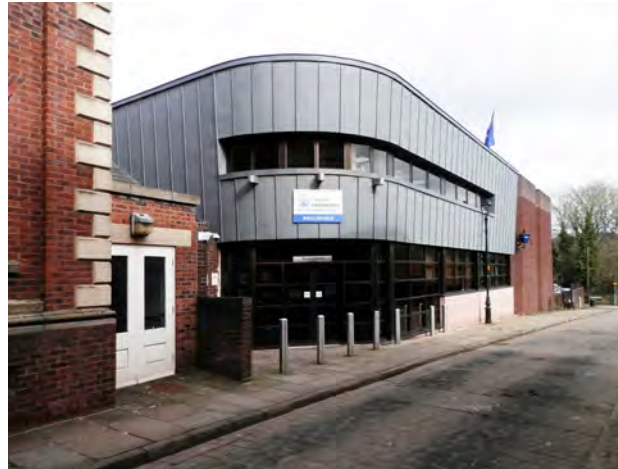
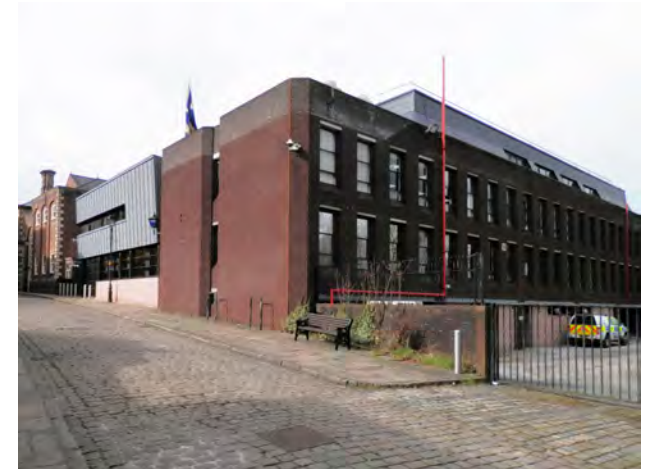
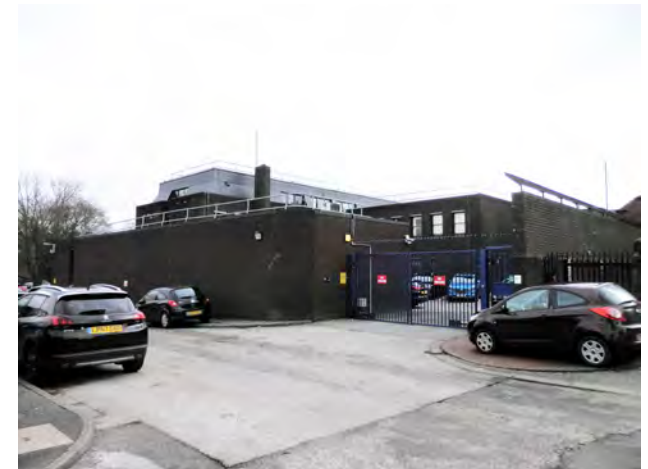
Overall condition: Good

Notes: The Police Station occupies a large plot, with a large car park to the east. It is a modern brick complex which fronts Brunswick Street with access to the car parking via the access road to the north. It is constructed in red brick and is very much of its time with a 20-bay composition to the east with glazed openings and a contrasting brick parapet. A large metal-clad roof storey has recessed dormer windows whilst a two storey extension was added following permission granted in 2003. This element is faced in metal at first floor with a slot window; curved to the corner with a largely glazed ground floor façade. Whilst it sits comfortably in the conservation area in terms of its scale, its materials, monolithic scale and car parking all detract.

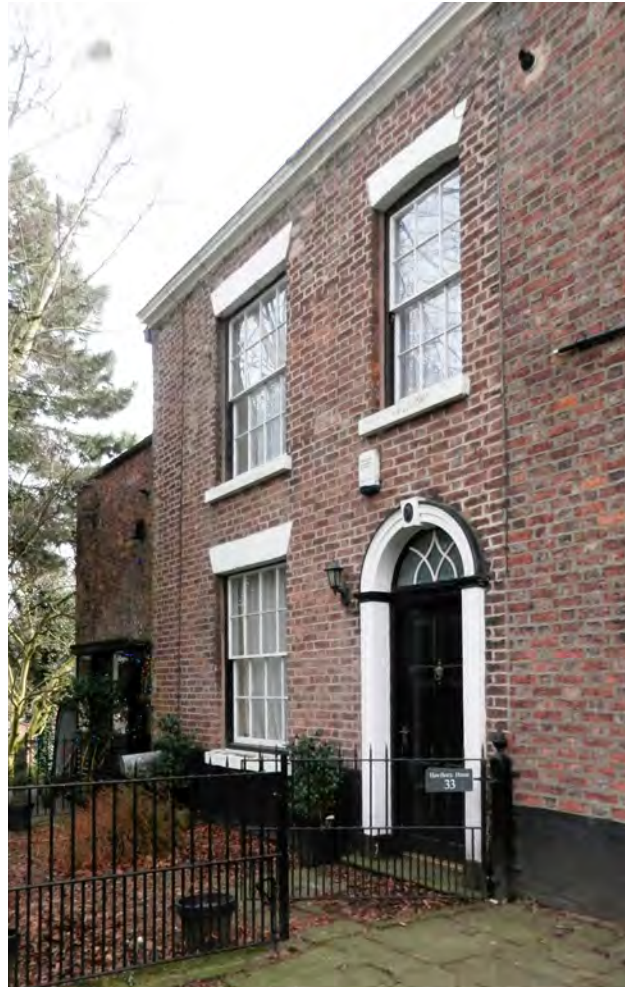
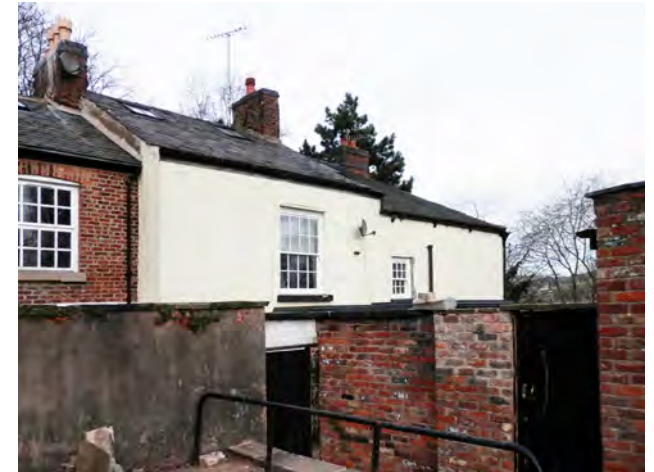
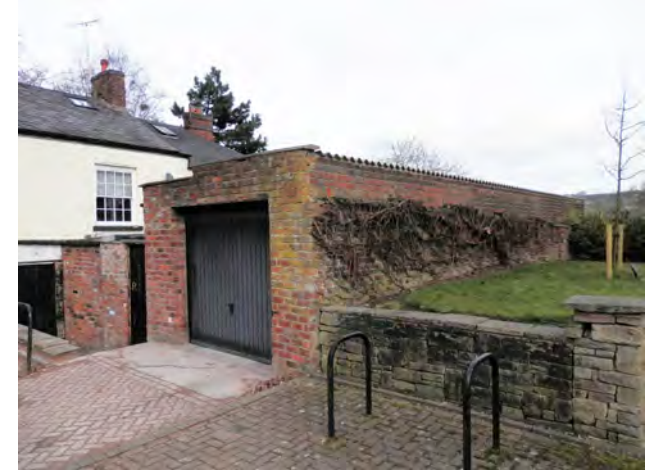
Notes: A terrace of six houses constructed in brick with slate roofs and chimney stacks. Two storeys aside from no.25 at the west end which is three storeys. Single window bays with eight-over-eight sash windows with stone painted voussoir heads, painted lintel to attic storey windows at no.25 (leaded canopy above at first floor to no.27; additional window over doorway at no.33). Doorways have reeded round-arched architraves with interlace fanlights and six-panelled doors. Moulded stone cornice to eaves. Basement lights, now infilled at nos.25 and 27. Railings at end of terrace provide no.33 with a front garden area. Flues in the front elevations detract. The west elevation to no.25 is plain brick with gable end, outbuildings to the side detract. Rear elevation is visible with largely two bays of eight-over-eight sash windows set under a variety of heads. No.25 with two bays;

smaller windows to the left-hand side appear later insertions; simple brick arch head at second floor to main window; meeting the eaves to the attic storey. Nos.33 and 33a single window bays; façades rendered which detracts and single storey red brick garage and access to south.

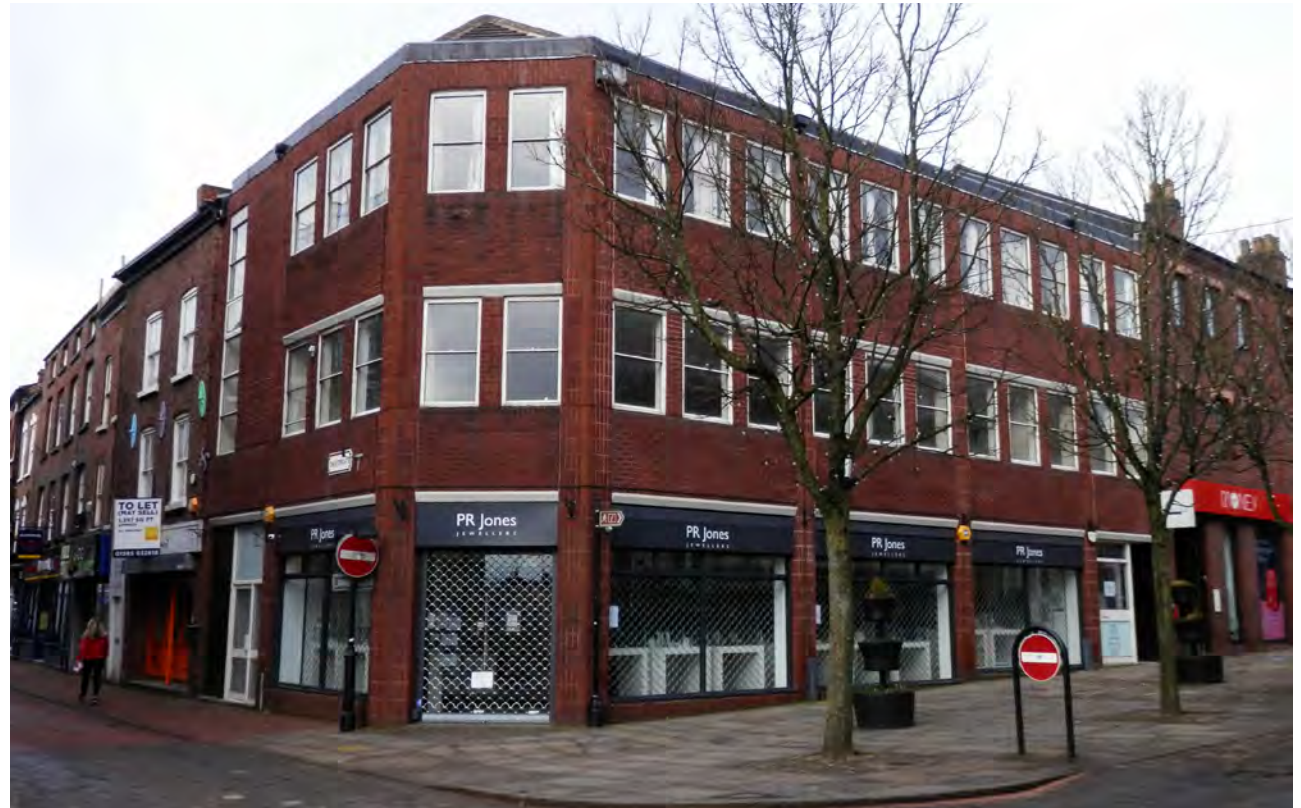
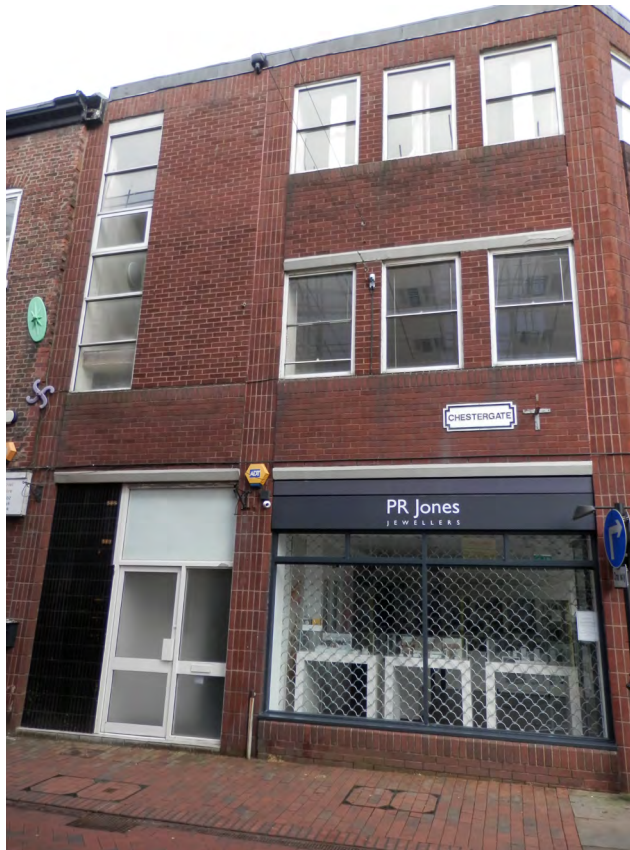
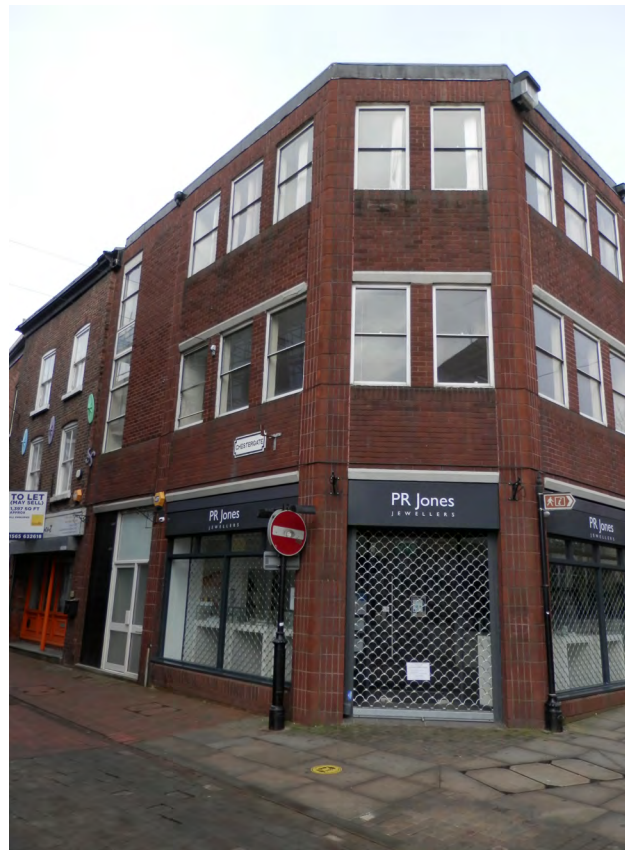
Overall condition: Good

Notes: As a modern development the building sits comfortably in the townscape in terms of its scale and the rough alignment of its composition. However its design bares no relationship to its context and owing to its prominent location on Market Place and at the eastern end of Chestergate it detracts from the historic character of the conservation area. It comprises three floors, constructed in red brick with lead capping to the parapet and a pitched roof behind. Facing Market Place it comprises four bays with a canted bay to the corner and two bays returning to Chestergate; each defined by brick columns, set on need. Each bay comprises three one-over-one casements with brick mullions and lintels above at first floor; the canted bay and northern bay to Market Place have two windows whilst the staircore to Chestergate has a vertical window spanning the two floors. The modern shopfronts and signage are largely appropriate to the character of the building however the projecting box sign on

Market Place detracts. The two entrances to the north and west and restrained although the recess to Market Place has the potential for anti-social behaviour and the painted brickwork panel to Chestergate is peeling. The lattice internal roller shutter is a good example.

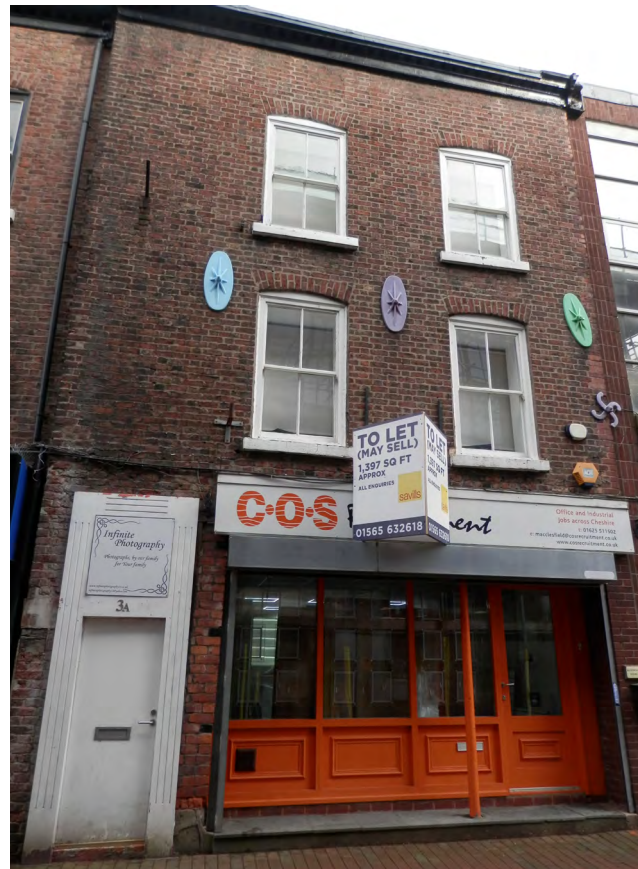
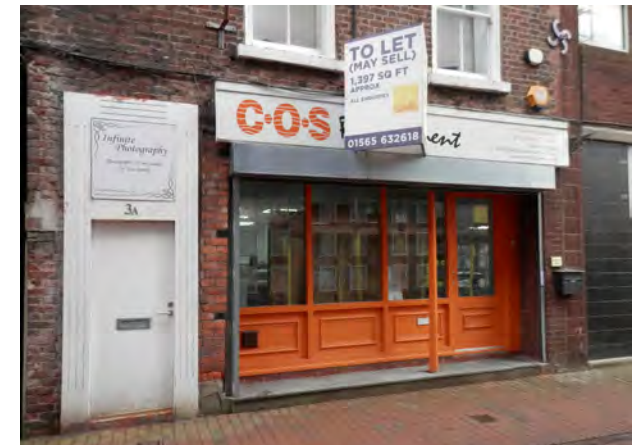
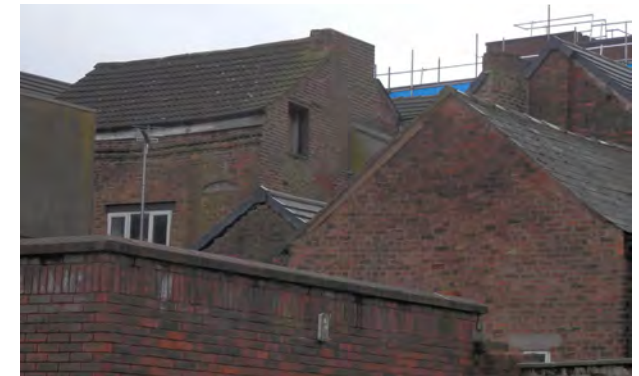
Overall condition: Good

Notes: A three storey building constructed in red brick and comprising two bays – each with two-over-two sash windows, stone sills and cambered gauged brick arches. Moulded timber to cornice to roof eaves with pitched roof behind. Strengthening wall ties have been painted which adds visual interest despite contrasting with the historic character. Other fixtures and fittings add clutter and detract. At ground floor the shopfront is a traditional design with moulded stallriser and mullion, it is however setback from the main facade with an unsightly roller shutter and box housing which detract. The setback also creates a disconnect with the fascia signage. The passageway to the rear is blocked with a modern door; signage above is accommodated within the fanlight area and there is a modern reeded architrave – both of which are fairly successful. A large wing stands parallel to the rear with a pitched slate roof and gable end with truncated chimney stack, infilled historic openings and a modern inserted window are visible from the rear.

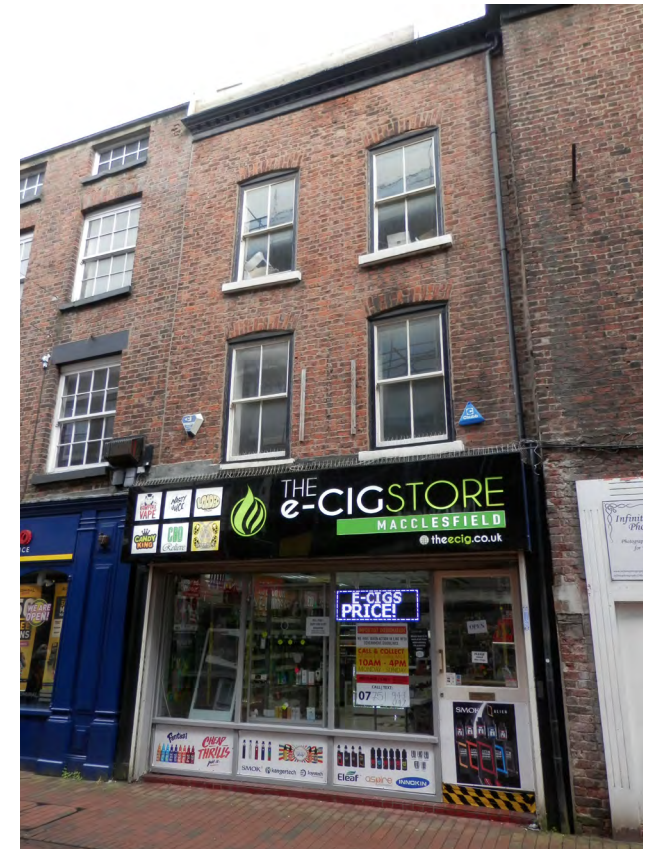
5 Chestergate

Notes: A three storey building constructed in red brick and comprising two bays – each with two-over-two sash windows, stone sills and cambered gauged brick arches. Moulded timber to cornice to roof eaves with pitched roof behind. Fixtures and fittings on the brickwork add clutter and detract. At ground floor the modern shopfront has sought to follow a traditional composition with mullions and a stallriser however its contemporary appearance, oversized box fascia sign with pigeon spikes on top, signage to the door and stallriser and illuminated sign internally all detract.

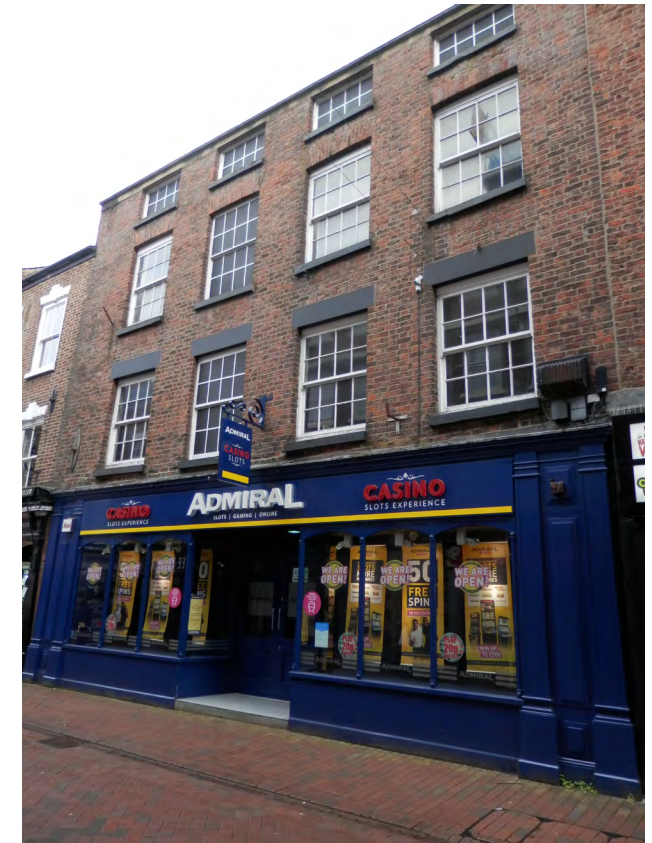
7-9 Chestergate

Notes: A four storey building, constructed in red brick and arranged over four bays. Windows at first and second floors and eight-over-eight timber sashes with painted stone sills, painted lintels at first floor and gauged brick arches to second. The attic storey has fixed windows which appeared to be boarded and painted – including replica glazing bars; this is repeated in the 3rd bay at first and second floors. Whilst the casino branding and lettering to the fascia give the shopfront a rather brash appearance, it otherwise follows a traditional design with stallriser, mullion and flanking pilasters, a recessed entrance and projecting sign on a traditional iron bracket. A projecting wing with pitched roof and gable end is visible to the rear.
