Donald Insall Associates
Chartered Architects and Historic Building Consultants

Macclesfield Conservation Area
Gazetteer

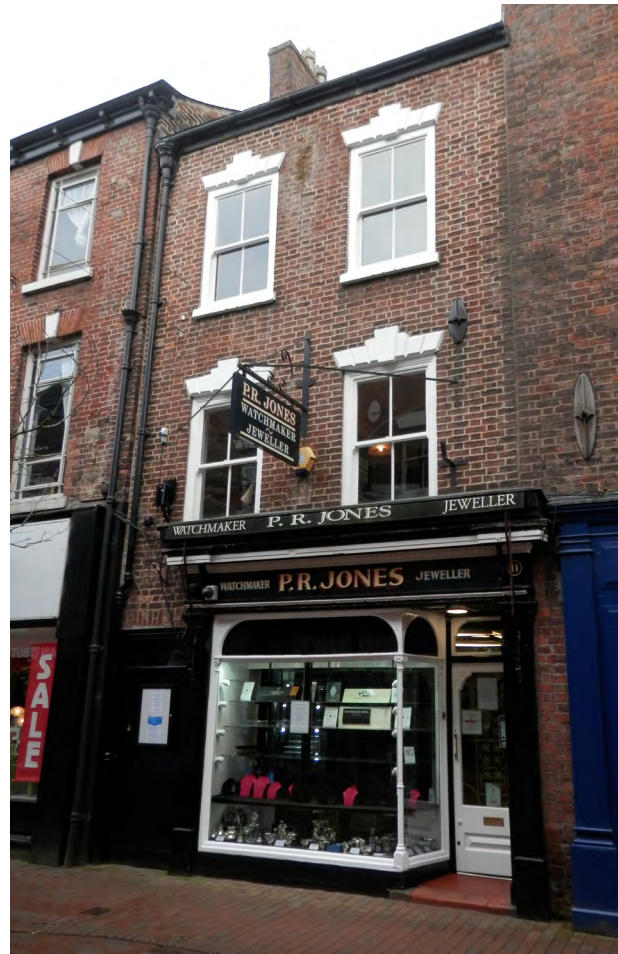
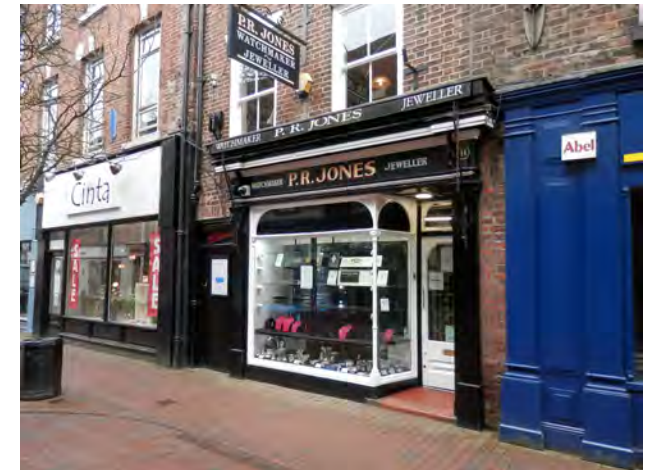
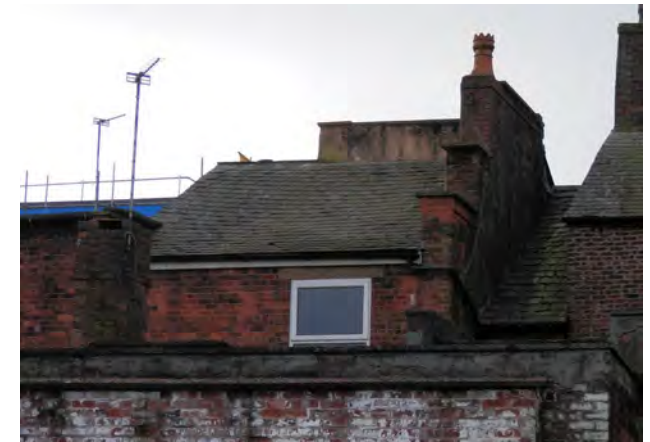
Notes: A three storey building constructed in red brick and comprising two bays – each with two-over-two timber sash windows, stone sills and fluted heads with keystones. Moulded timber to cornice to roof eaves with pitched roof behind. Fixtures and fittings on the brickwork add clutter and detract. The shopfront is one of the best examples in the conservation area with decorative mullions, arched transom lights, pilasters and a recessed entrance. Above is a painted fascia sign and cornice with a traditional awning with iron support brackets; a painted projecting sign is located at first floor on a decorative iron bracket. The passageway to the side has a boarded door with fanlight and gauged brick head. A modern uPVC window has been inserted at high level to the rear with a concrete element projecting at roof level.

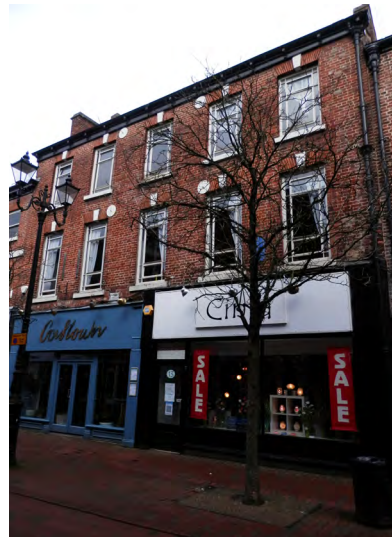
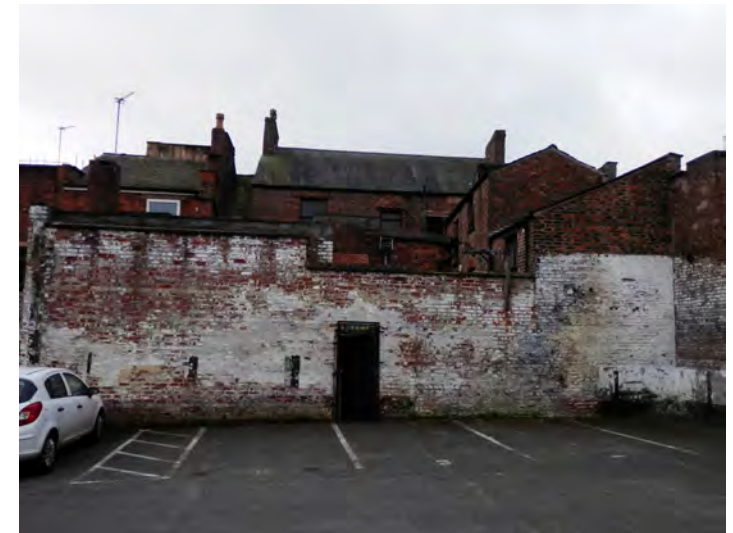
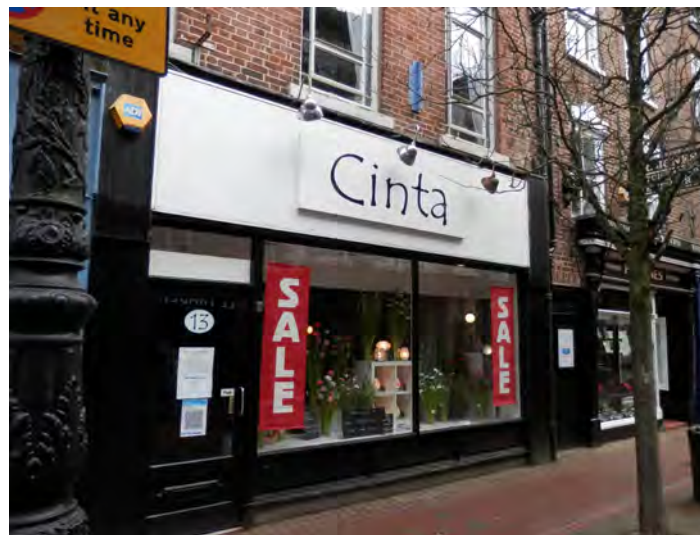
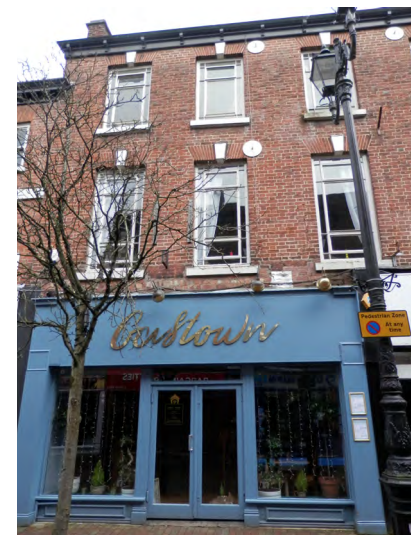
Notes: A three storey building constructed in red brick and arranged over five bays. Windows at first and second floors are decorative casements with margin and transom lights, painted stone sills and gauged brick heads with keystones. A bracket timber cornice to the eaves with pitched roof and tall chimney stacks to each end. Painted circular wall ties are located at first and second floors. The ground floor has two commercial units; both with appropriate traditional shopfronts however the signage is oversized; particularly to no.13 where it overlaps with the first floor. The cowl lights and wiring providing external illumination and disused fixings add clutter. To the rear are a series of projecting wings with a mix of window openings.

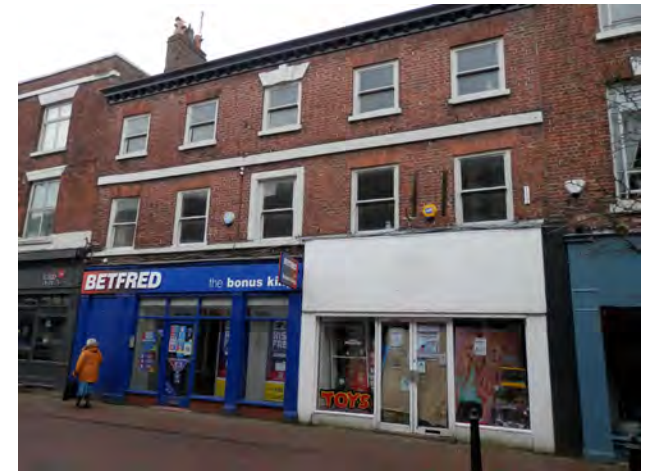
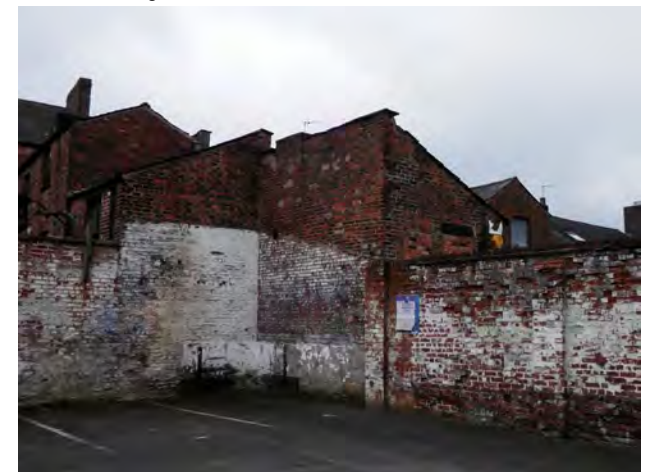
Notes: A three storey building which steps down in scale with smaller window openings arranged over five bays. The symmetrical arrangement has a central bay with painted architrave to the first floor openings and painted splayed head to the first floor above whilst the flanking window openings have gauged brick heads. Stone sills at second floor and banding at each level. Dentil cornice at roof level with pitched roof behind and visible chimneystack. The ground floor has two commercial units; to no.17 is a modern shopfront which is of no particular merit and a detracting oversized fascia above which overlaps with the first floor. To no.17a a traditional shopfront with stallriser, mullions and transom lights which is overpowered by the crass branding and signage. Disused fittings and other fixtures add clutter to the façade and detract. To the rear deep projecting wings.

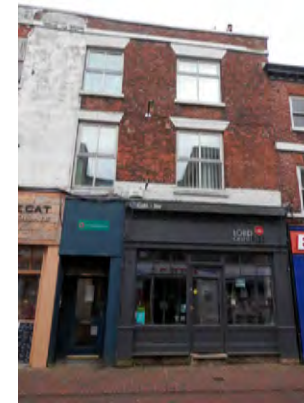
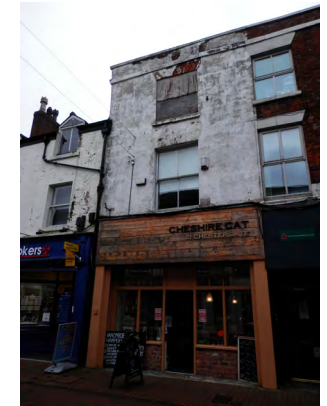
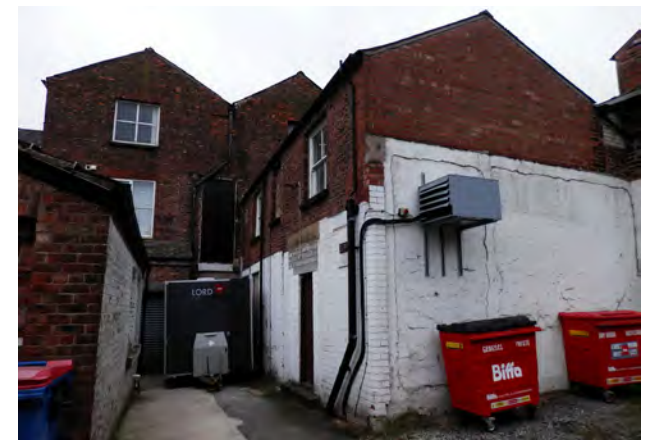
Overall condition: Good (no.19) / poor (no.21)

Notes: A three storey building arranged over three bays; constructed in red brick and rendered at no.19 which is in a poor condition and detracts. To no.19 two bays with modern casement windows which detract, painted stone sills and lintels. Banding below the parapet and painted above the ground floor. The shopfront is a good traditional example with stallriser, pilasters, transom lights, restrained fascia signage and an awning with iron support brackets. The passageway to the rear has a recessed door, detracting roller shutter and an oversized blank signage area above. The render to no.19 detracts from its historic character although some of the detailing is evident below. One-over-one timber sash at first floor, window boarded to second. The shopfront and fascia are a good example of a modern replacement, replicating traditional features but with a sensitive contemporary aesthetic. To the rear an M-pitched roof with gable ends and projecting wings, part painted with a mix of original and altered openings, a/c unit fixed to the façade.

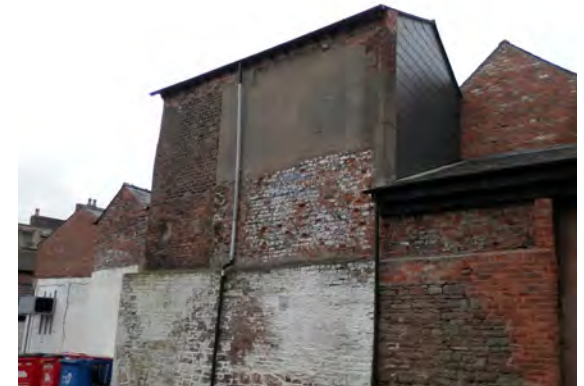
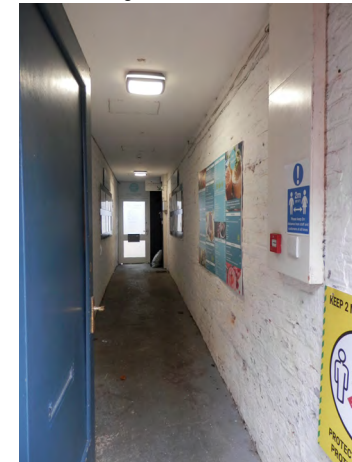
Overall condition: Poor

Notes: A three storey building which steps down in scale; arranged over two bays with a rendered façade – the condition of which detracts as well as fixtures and fittings which clutter the façade. Dormer windows to the attic storey puncture the eaves line with gabled roofs and casement windows. At first floor are one-over-one timber sash. At ground floor is a traditional shopfront with stallriser, mullions, transom lights and a recessed entrance which is overpowered by the crass branding and proliferation of signage and flags. The passageway to the rear is has a door, surrounding signage is excessive and detracts – particularly to the pilasters. To the rear is no.23a a three storey brick building with pitched roof which forms the rear of the courtyard accessed via the passageway.

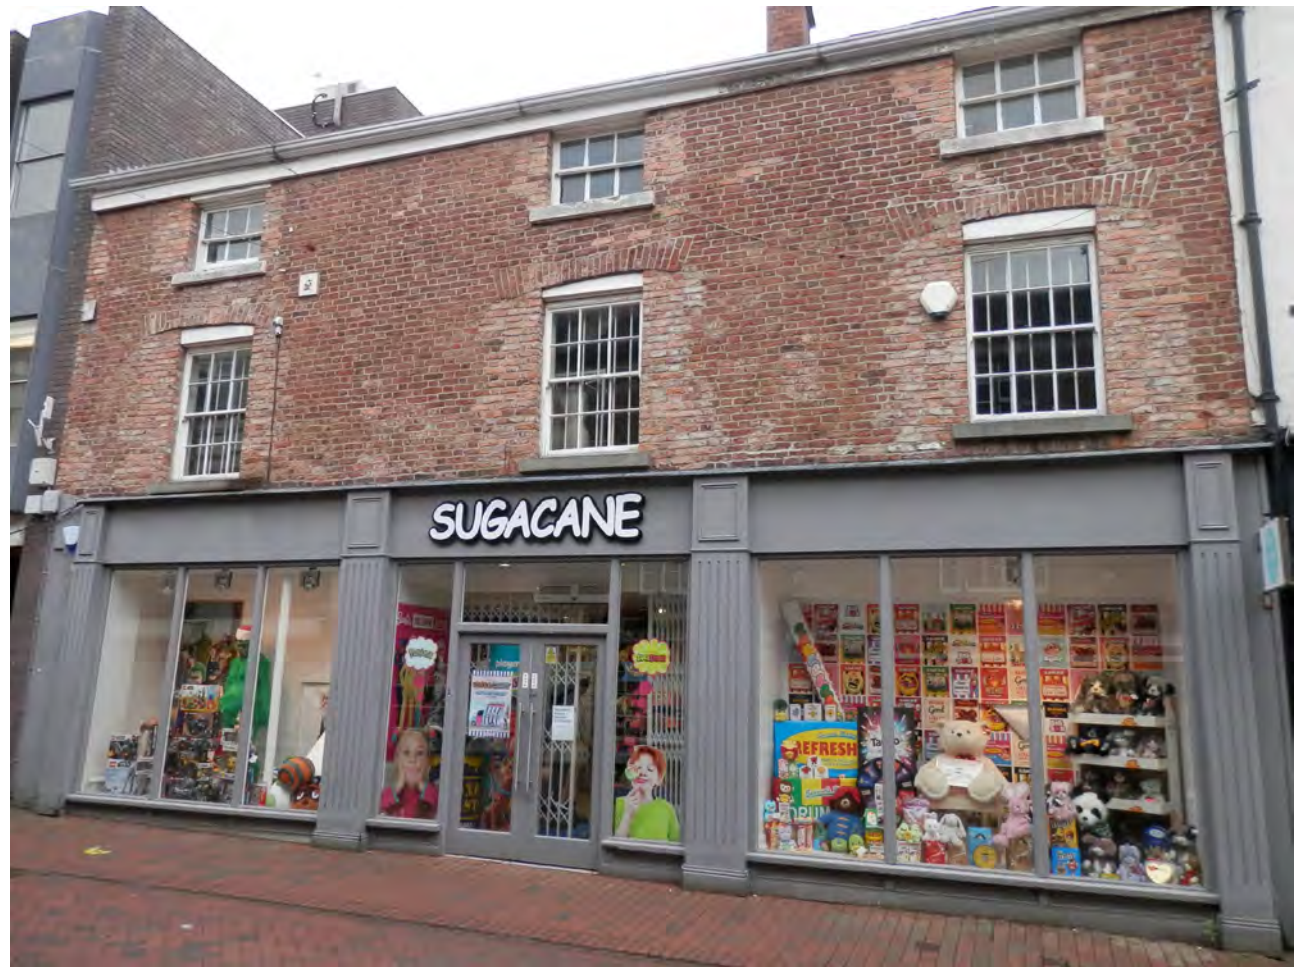
25-27 Chestergate

Notes: A three storey building with a lower scale, constructed in red brick and arranged over three bays. The window openings are later insertions with the larger original openings at first floor still evidenced in the facades with the gauged brick arches which remain giving the building a particular charm. Windows at first floor are now six-over-six timber sashes with stone sills and heads which infill underneath the original arches. Openings at second floor have also been altered, now with three-over-three timber sashes which meet the moulded timber cornice to the eaves. Roof is pitched with a visible chimney stack. The ground floor shopfront is a good example of a modern replacement; replicating traditional detailing including the pilasters, stallriser and mullions. The internal lattice grille to the entrance bay is also a good example. Fixtures and fittings to the facade detract and the fascia signage is overtly modern for the character of the rest of the building. To the rear a projecting wing, end wall now rendered.

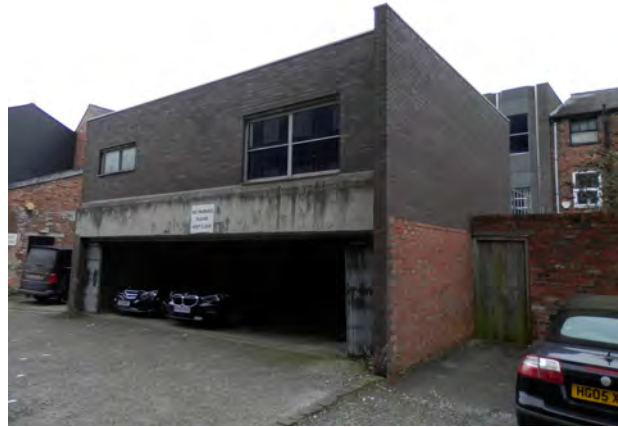
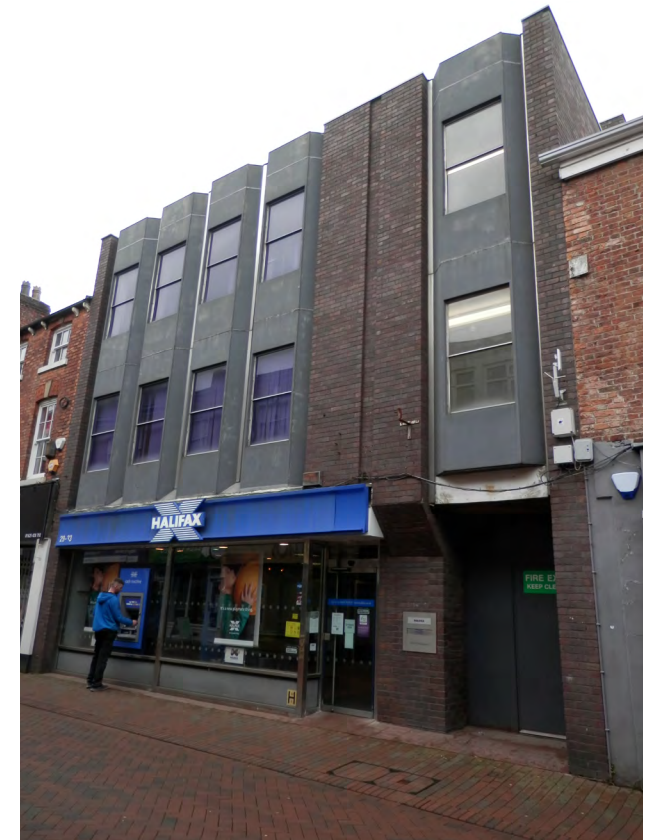
Notes: A three storey modern building arranged over six bays; four grouped with a plain brick bay before the final repeated bay. Each bay formed of concrete canted panels with casement windows; the upper two storeys set on a recessed plinth with a plain access door to the right-hand bay and a shopfront spanning the remainder. The shopfront is suited to the period of the building and repeats key details such as the stallriser; the signage however is poorly located between the ground and first floors and detracts as well as other redundant fixings on the façade. Whilst there is some merit in the architectural design of the building it is completely at odds with the prevailing character and detracts. To the rear is a two storey utilitarian building a mix of red and dark brick with a heavy concrete beam and modern casements above an open parking area.

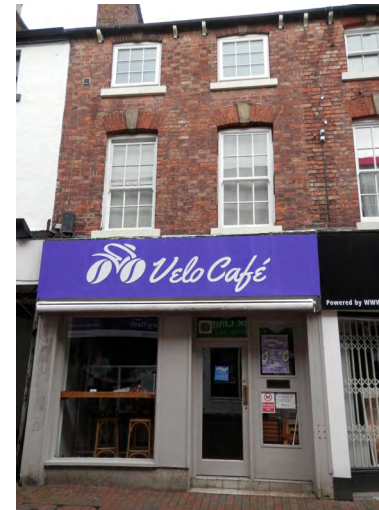
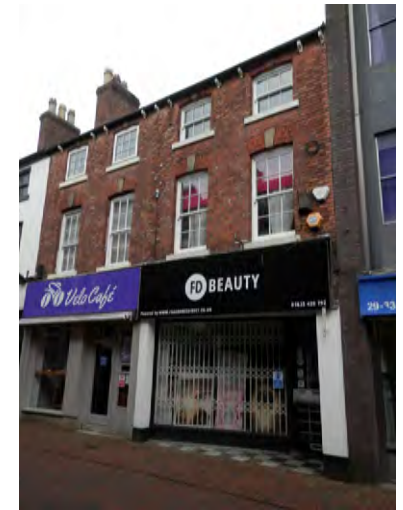
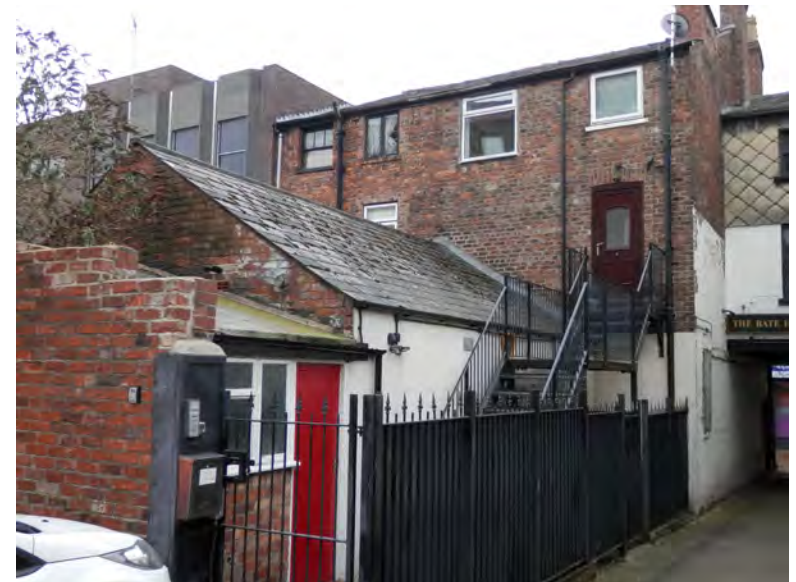
Notes: A pair of three storey buildings constructed in red brick, each two bays wide. To first floor six-over-six timber sash windows with stone lintels, arched brick heads and keystones. Attic storey windows repeat the detailing albeit smaller in scale with three-over-three sash windows. Bracket cornice to the eaves with a pitched roof and visible chimney stacks. Fixtures and fittings add clutter to the facade and detract. At no.35 the modern shopfront is set on angle recessing into the building with forms an odd feature, the fascia board is oversized and a redundant projecting sign fixing detracts; the internal lattice shutter however is a good example. The modern shopfront at no.37 is fairly sympathetic however the fascia sign is oversized and the modern canopy detracts. To the rear a single storey wing with a pitched slat roof, partially rendered and painted. A metal stair provides access to the upper floors whilst modern casements detract.

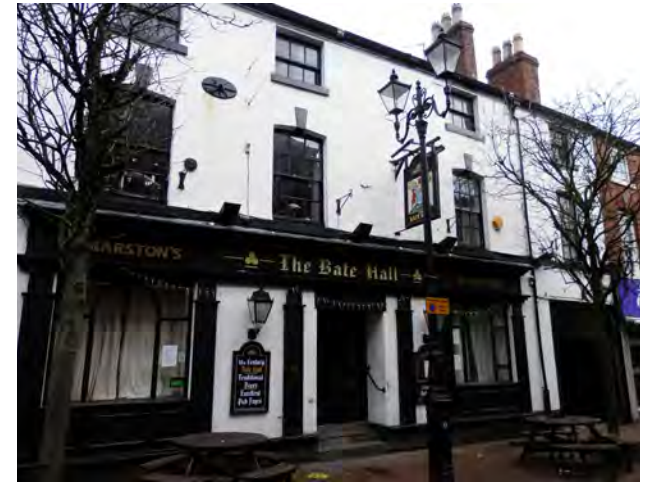
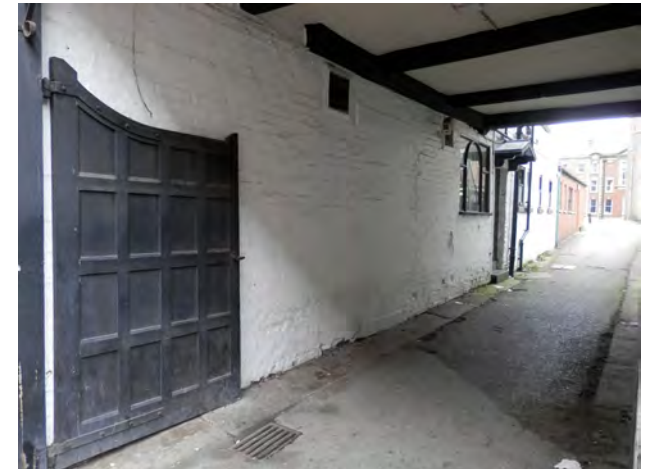
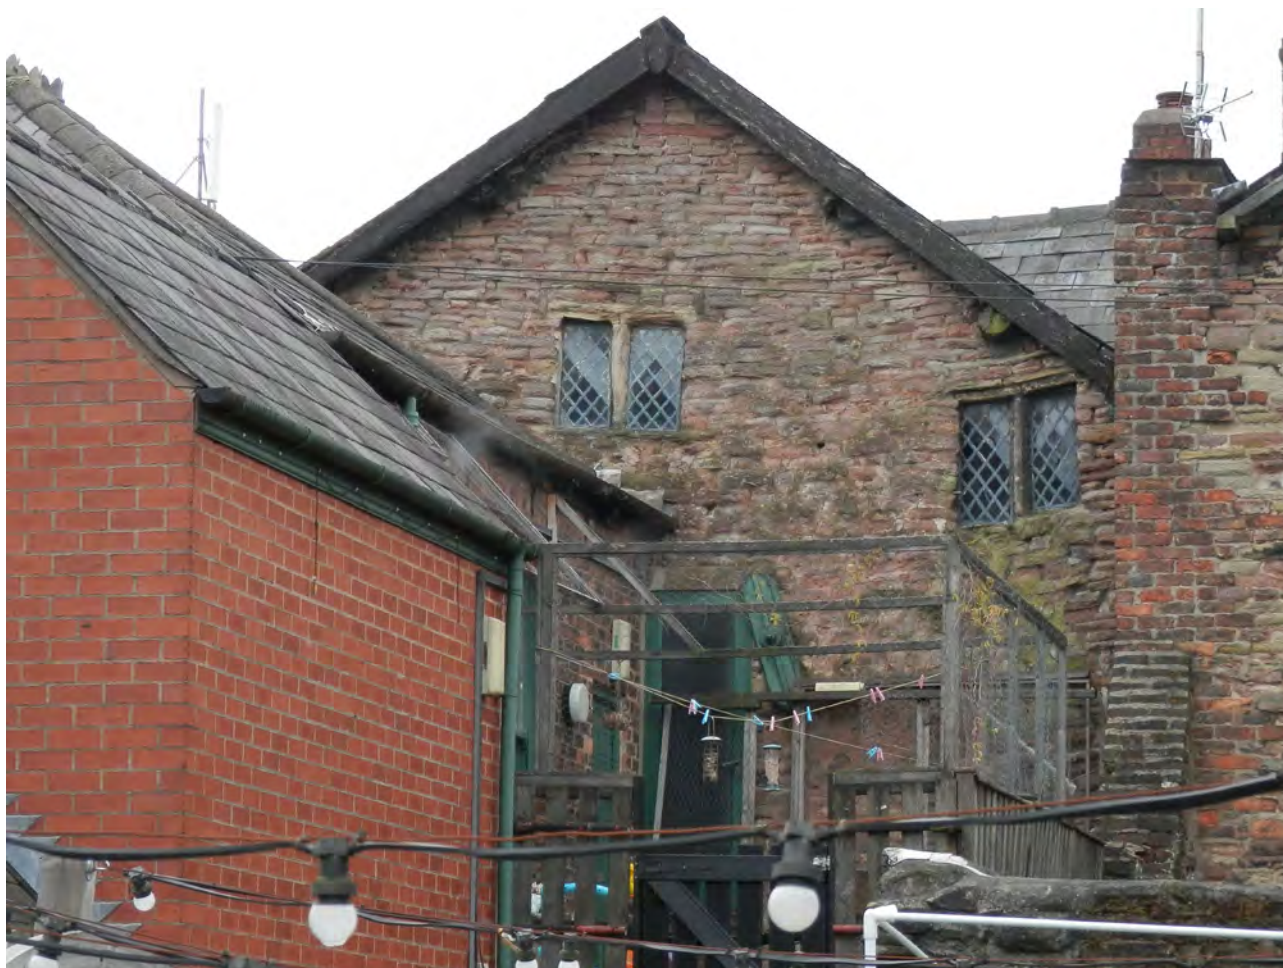
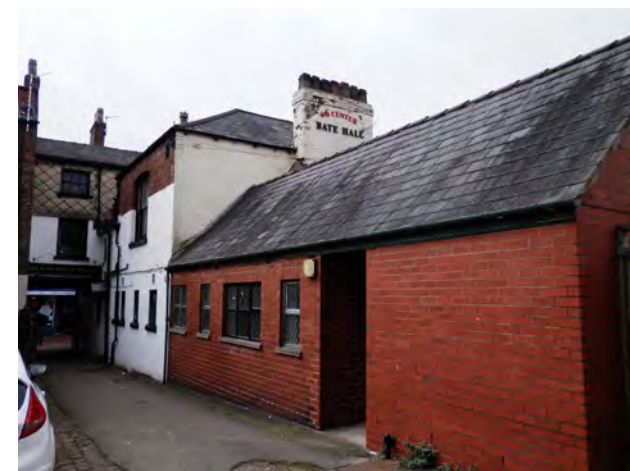
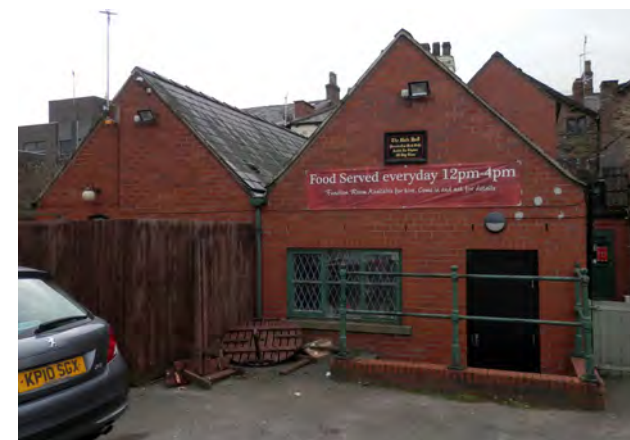
Notes: A public house likely to have been converted from an original dwelling. Internally it is timber framed, refronted in the early 19th century with render over brick and coursed rubble to the rear wing. It comprises three storeys arranged over four window bays which oversail the passageway to the right-hand side. Windows are six-over-six sashes at first floor with keystone lintels; at second floor three-over-three sashes with painted sills. The ground floor public house front is a late 19th century inserted with a central timber panelled doorway and traditional public house signage and lighting. Modern spotlights above the fascia and redundant fixings detract. The passageway has panelled gates with exposed beams to the oversailing ceiling; the rear is largely painted brick with a projecting wing with prominent chimney stack and side entrance, casements at ground floor and a large tripartite sash at first

floor. Adjacent is a modern two storey red brick with pitched roof which steps down to a single storey wing with an M-pitched roof, with a side infill adjacent. At upper level to the rear of the original building two stone mullion windows with iron lattice glazing are visible; otherwise they are timber sash as per the front elevation. A small beer garden area is located to the rear of no.41.

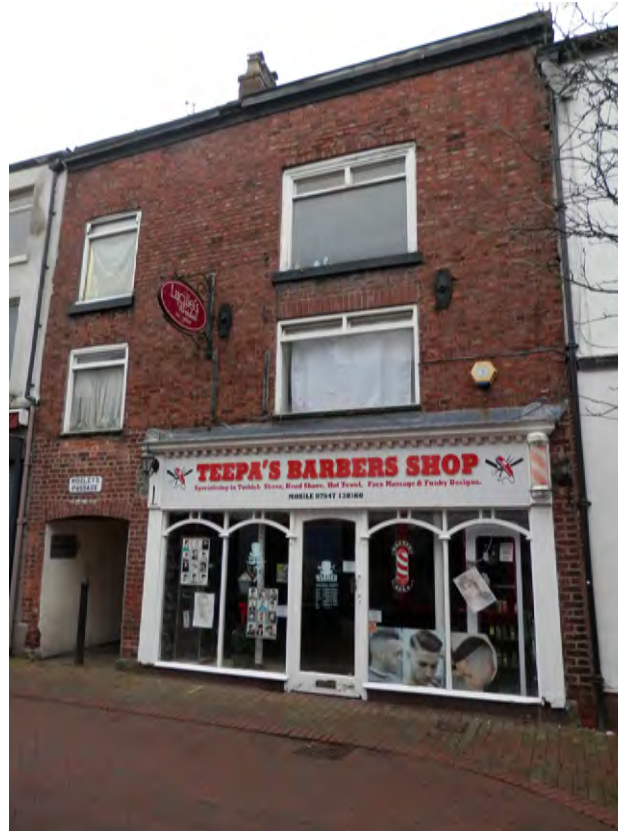
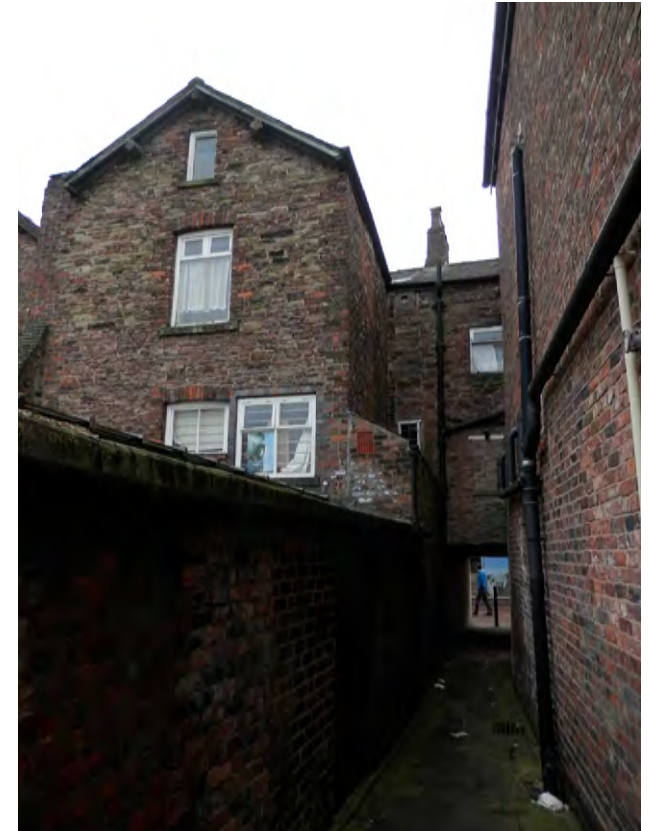
Notes: A three storey building with a red brick refronting which belies its historic character; coursed rubble to the rear. Windows are modern casement insertions with simple brick heads and stone sills. Originally a dwelling, a shopfront has been inserted at ground floor which is a traditional design with two arched lights flanking a central door and fascia with dentil cornice although slightly at odds with the simple character of the upper floors. The barber's pole adds interest. Riseley's Passage to the left-hand side leads through to the rear where the original building appears to stop short of the passageway, evidenced by a joint in the stone wall. Two inserted windows above the passageway, now infilled at first floor and a projecting gabled wing with casement windows under segmentally-arched brick heads and brick jambs; additional windows inserted at first floor detracts.

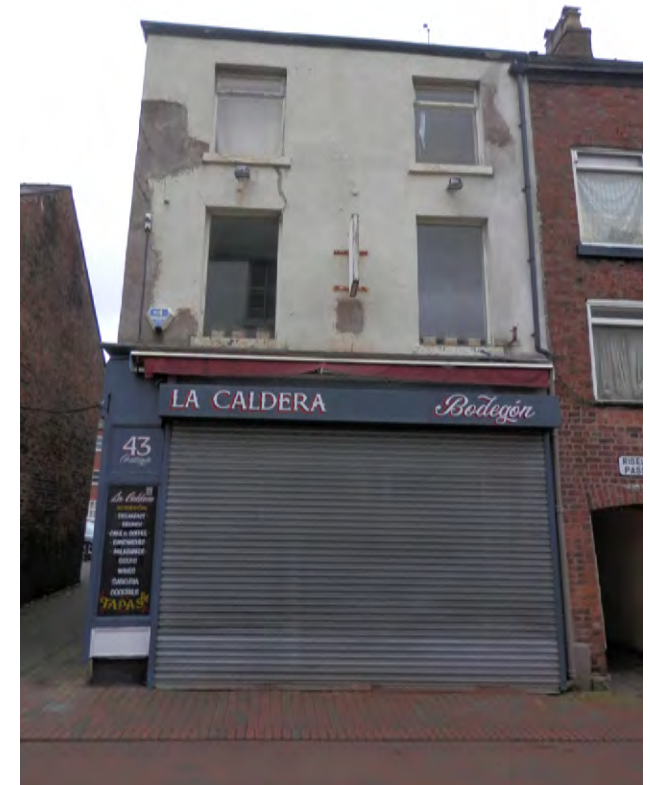
43 Chestergate

Overall condition: Poor

Notes: A three storey building arranged over two bays. The façade has been rendered, the poor condition of which is detracting whilst modern casements at first and second floors detract further. Whilst the shopfront was not inspected the roller shutter, box housing and modern canopy above all detract alongside the high level projecting sign. To the side elevation the red brick is exposed, with a gable end and three storey projecting wing with evidence of the original openings – all now infilled except one remaining three-over-three sash under gauged brick heads. The a/c units fixed to the façade detract.

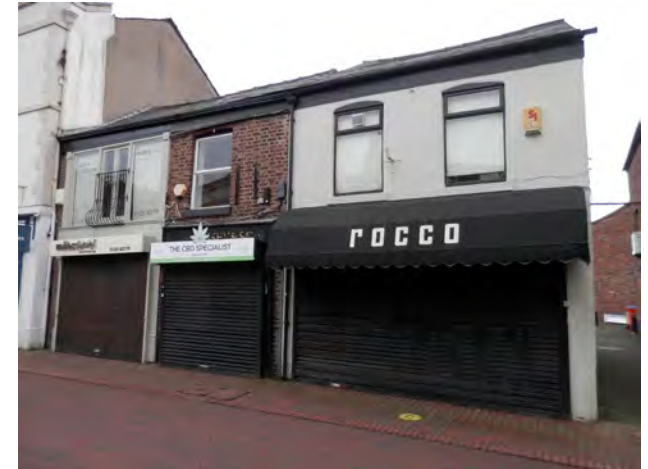
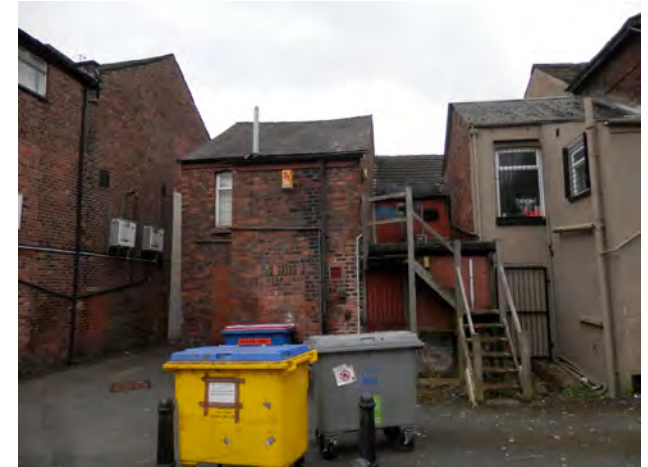
Notes: A group of small-scale two storey buildings with a shared pitched roof; two bays to no.45 and a single bay to nos.47 and 49. No.45 has a rendered façade, modern casements and Dutch canopy which all detract; shopfront not inspected but roller shutter detracts. No.47 retains its red brick front, with stone sill and modern casement. Shopfront not inspected but roller shutter and housing detract as well as fixtures and fittings to the upper floor. The pilasters at no.49 are suggestive of a traditional shopfront but not inspected; roller shutter and box housing detract. The large glazed opening at first floor, French doors and balustrade and advertising panels are all at odds with the original character of the building. Pitched roof wings to the rear, rendered to no.49 with modern casements; staircase located in-between proving access to the upper floor.

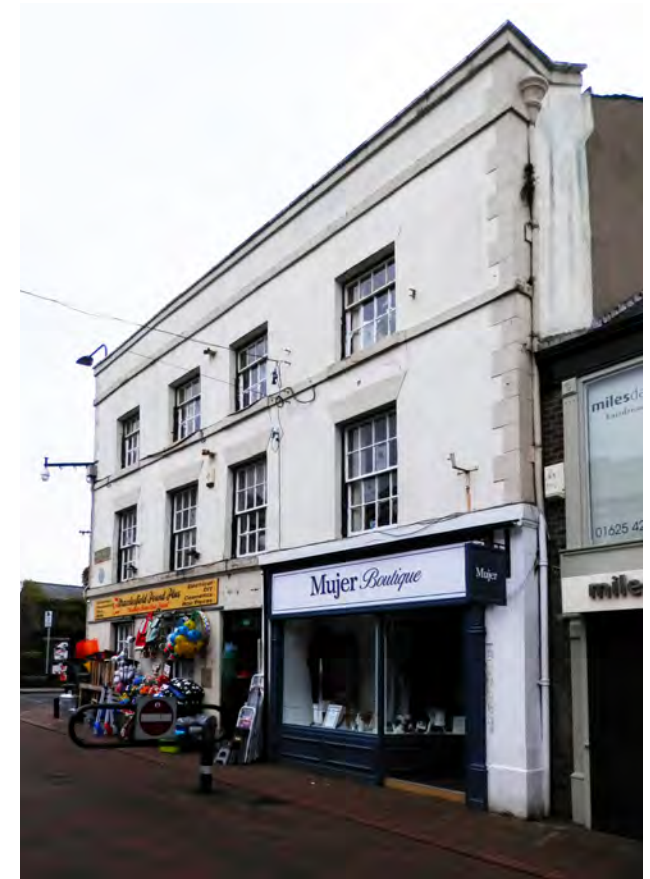
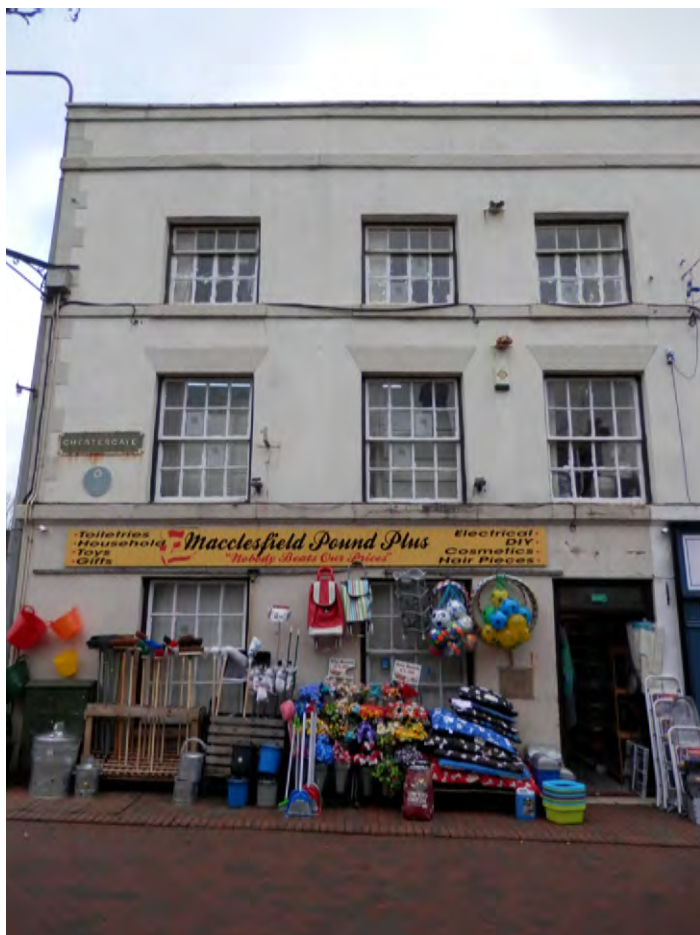
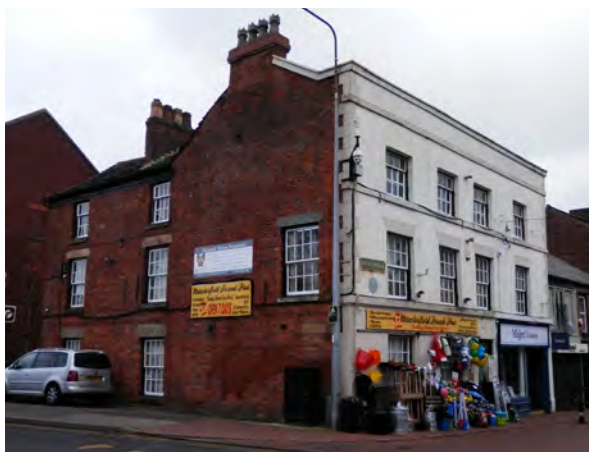
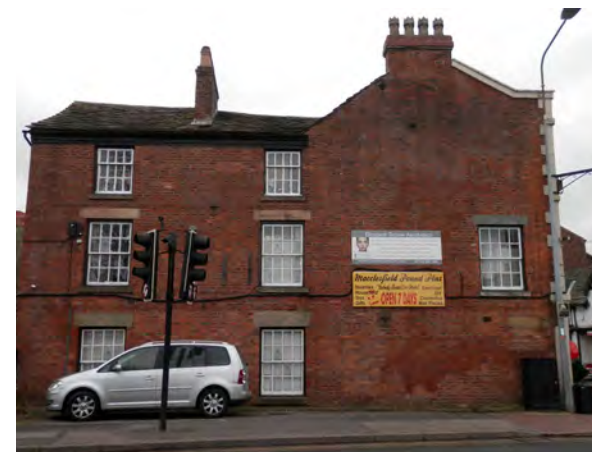
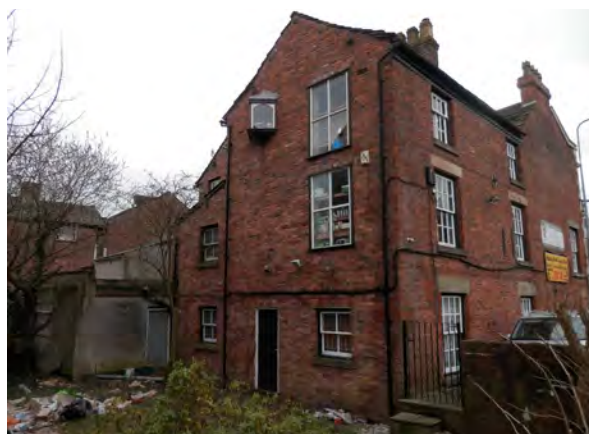
Notes: A three storey building, arranged over four bays with a now rendered frontage and exposed red brick gable end to the return elevations. Windows are eight-over-eight timber sashes at first floor with painted heads with four-over-eight to the second floor. Banding runs across the sill level at second floor and to the parapet; quoins to corners. Inserted shopfront at no.51 is a good example of a traditional design with panelled stallriser, pilasters, recessed entrance and fascia. No.53 (Tudor House) retains the original frontage with eight-over-eight sash windows, the signage and goods laid outside however detract. Fixtures and fittings across the facade add clutter and detract. A single window at first floor in the return elevation which follows the

design from the front, prominent chimney stack above; signage fixed to this elevation detracts. A wing projects along Churchill Way with a interlocking pitched roof and axial chimney stack; two bays of windows repeat the detailing to the front, with simple stone lintels and heads. To the rear large modern windows have been inserted and a smaller side wing projects with two-over-two sash (also at ground floor in the main wing). Further concrete outbuildings within the garden area detract.

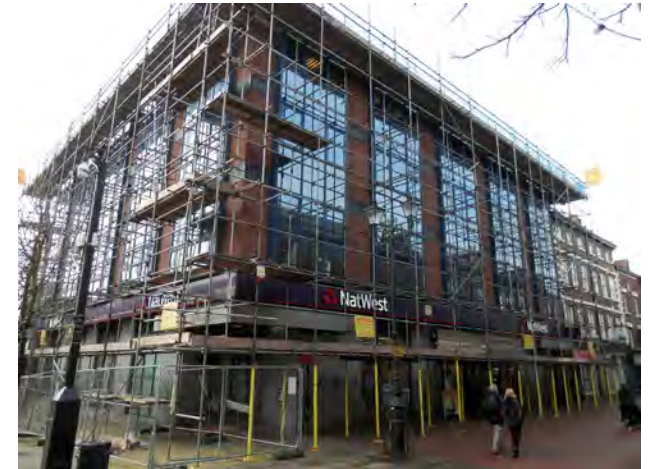
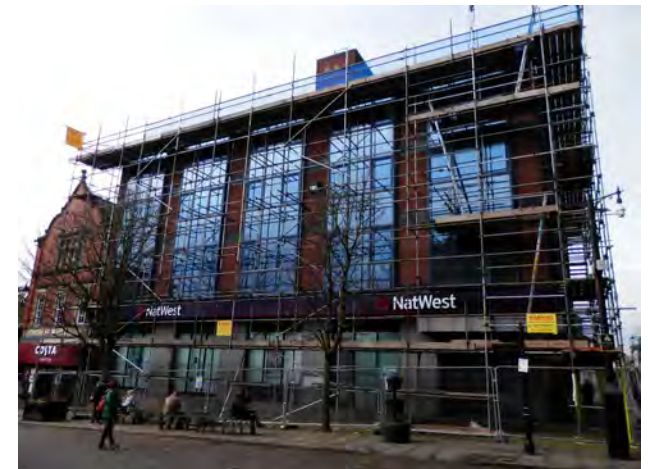
Notes: This modern development occupies a key position on the corner of Chestergate and facing the Town Hall. It comprises four tall storeys which step up from the prevailing roofline on both Market Place and Chestergate and its design bares little relationship to its context. As a consequence it detracts from the historic character of the conservation area and has a particularly negative impact on the quality of Market Place. It is faced in red brick with five shallow glazed bays to each elevation, the heads of which seek to replicate a gabled form. To the parapet is a heavy banded strip which is repeated between the floors. The ground floor is faced in granite panels with simple three-light glazed shopfronts with louvred transoms facing Market Place suited to the character of the building. To the corner is a recessed entrance with a projecting canopy; the same canopy design is repeated to the

rear entrance on Chestergate. Three further shopfronts are located on Chestergate; the first repeats the three-light design, the second has an entrance with margin lights and the third is blocked to accommodate ATM machines. Signage is a modern box fascia and projecting sign. At roof level is a projecting lift run or plant room.

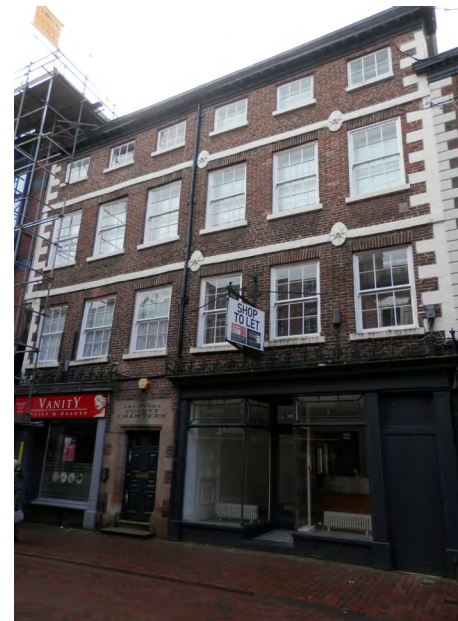
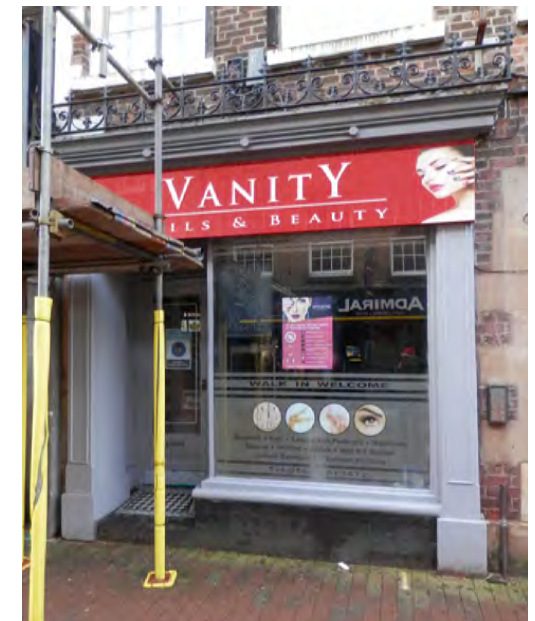
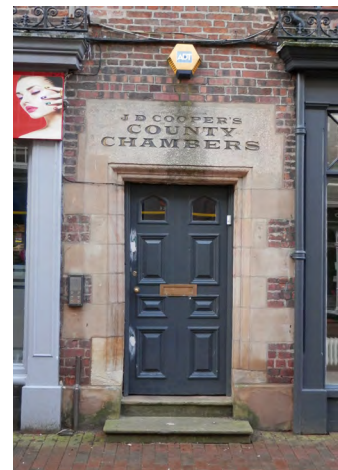
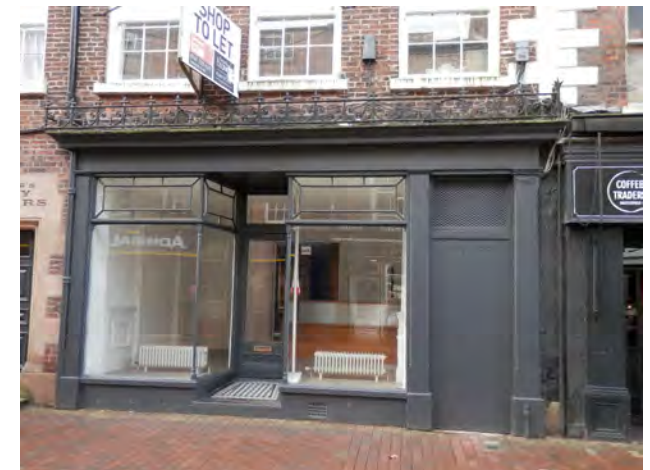
4-8 Chestergate

Notes: Originally a house the building comprises four storeys, constructed in brick with stone quoins, painted stone string courses, decorative wall ties to no.8 and a pronounced moulded eaves concealed a pitched roof behind. It is arranged over six bays with six-over-six timber sash windows to the first and second floors with flat-arched brick heads and painted stone sills; six-pane casements to the attic storey. At ground floor an off-centre entrance doorway has a moulded stone architrave with 'J D Cooper's County Chambers' carved into the stone and a panelled timber door. The doorway is flanked by two 19th century shopfronts with decorative ironwork on top of the fascias and tiling to the recessed entrances. The fascia sign at no.4 is overtly modern and detracts whilst the shopfront at no.8 is a good example with decorative transom lights and mullions. A decorative hanging sign bracket remains at first floor whilst modern fixtures and fittings add clutter and detract. The passageway to the right-hand side has a timber boarded door and grille to the fanlight above.

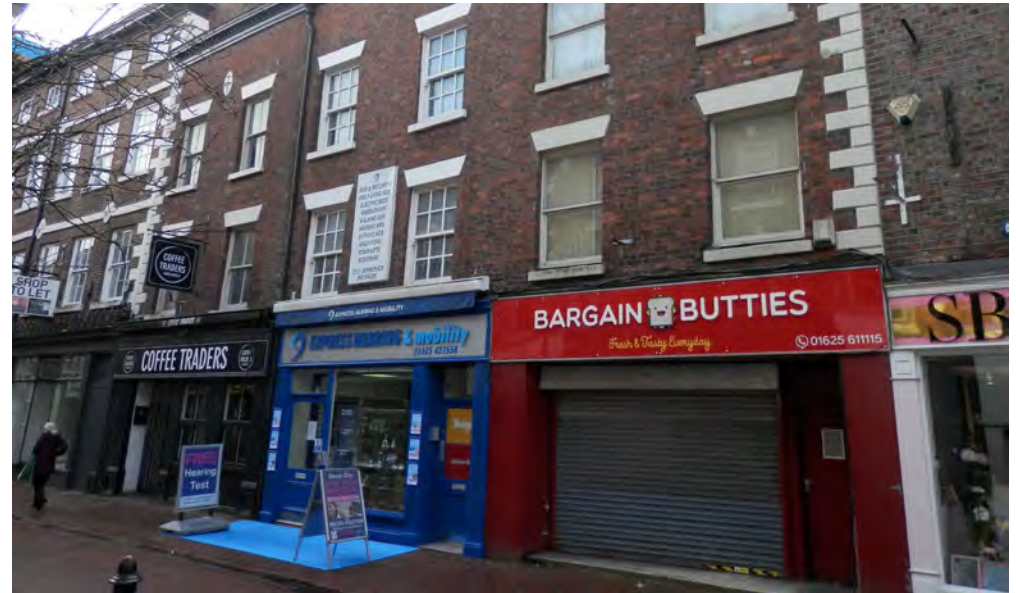
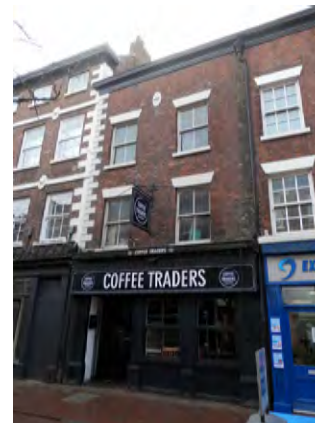
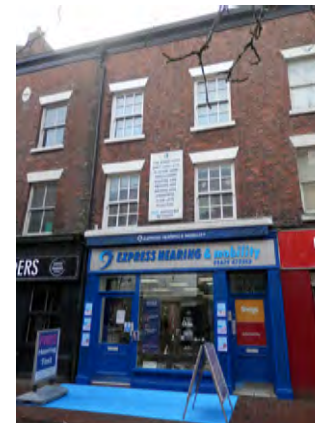
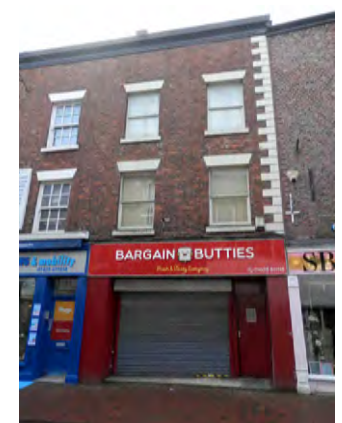
10-14 Chestergate

Notes: A red brick building, comprising three floors and arranged over six bays with a wood mullion eaves cornice to the eaves and quoins at either end. Window openings at first and second floor have flat-arched heads and sills; two-over-two sashes to no.10, six-over-six to no.12 and one-over-one to no.14 – the variation across the group detracts from its character. The shopfront at no.10 is a good example with two-over-two sashes set between pilasters, appropriate signage including a projecting sign on a decorative iron bracket and awning with iron support brackets. Whilst the shopfront is appropriately detailed at no.12 the crass branding, fascia sign, modern awning and excessive signage – including a high level sign – all detract. The shopfront at no.14 was not inspected but the recess from the street, roller shutter and housing and modern box fascia all detract; the passageway to the rear has a modern door.

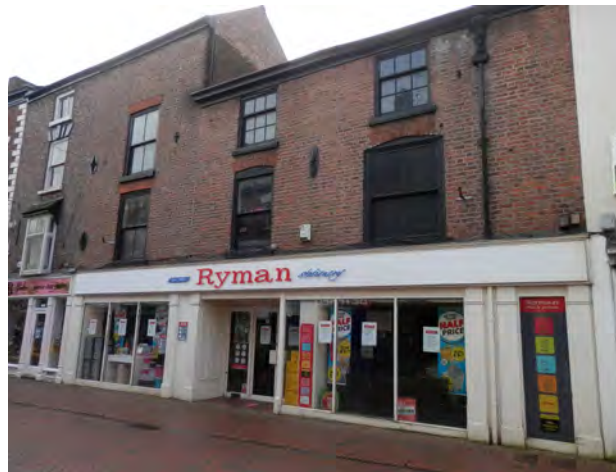
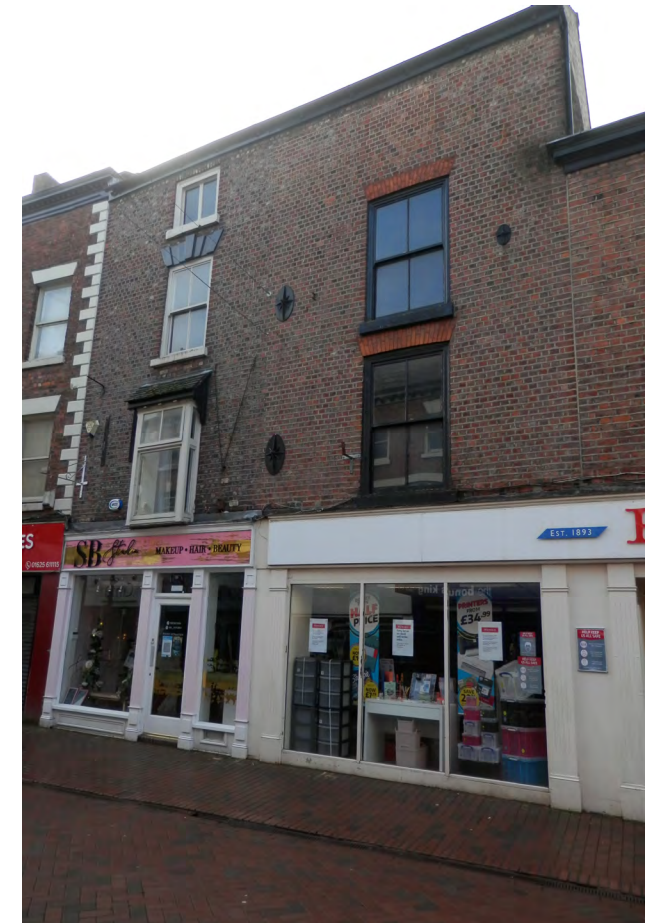
18-22 Chestergate

Notes: This group forms two separate buildings; no.16 - 18 constructed in browner brick and a storey taller. However as is fairly typical of the high street at ground floor level the shop units spans across the two, with a smaller single unit at no.16. The shopfront at no.16 is a traditional design with pilasters and a moulded stallriser and signage confined to the fascia level above. The passageway between nos.16 and 18 appears to have been consumed into the larger retail unit. The larger shopfront replicates some traditional elements including fluted pilasters and moulded panels to the recessed doorway, the low stallriser and modern mullions are again appropriate although overly simple and of no particular merit. Whilst a definition is maintained between the two buildings in the shopfront, the manner with which the modern box fascia sign spans across detracts. To the upper floors a bay window with pitched tile roof has been inserted at first floor to no.16 with a two-over-two timber sash window above and a small casement to

the attic storey which collectively give the façade a disjointed appearance. The upper façade at no.18 appears to have been altered with the two-over-two sash window at first and second doors uncomfortably close and what appear to be modern gauged brick heads. The roof is pitched with a gable end. At nos.20 - 22 the windows are set off centre, with two-over-two timber sashes at first floor under arched brick heads (large and black-painted at no.22 which detracts) and three-over-six at first floor – all with stone sills. Decorative wall ties have been inserted across both buildings whilst further modern fixtures and fittings on the façade detract.

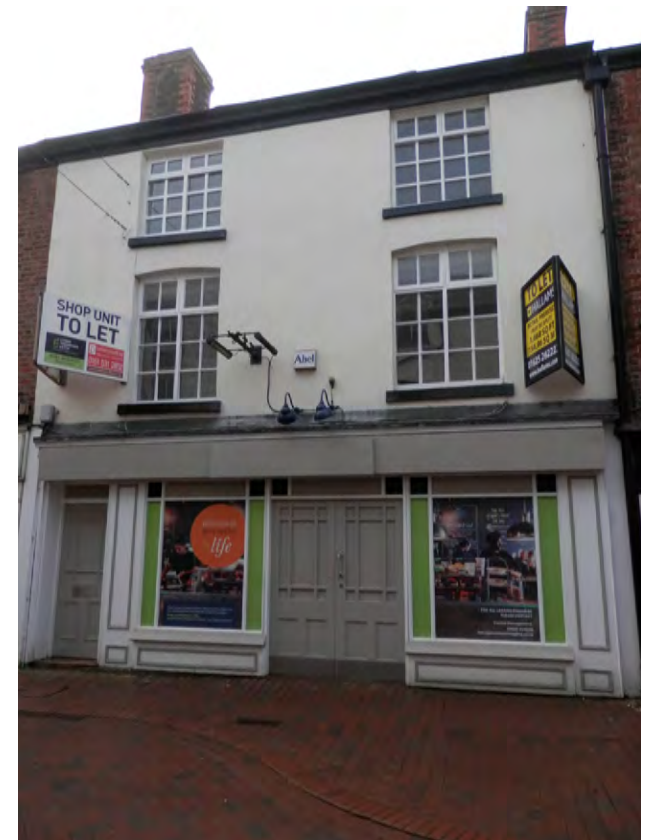
24-26 Chestergate

Notes: A three storey building comprising two bays with a rendered façade and moulded cornice to the eaves; pitched roof and visible chimney stacks. Owing to the rendered façade it is unclear if the window openings have been enlarged but they are larger than the prevailing character with modern multi-pane casements at both levels; arched head at first floor and all with stone sills. The ground floor shopfront is a good modern design which replicates traditional detailing including margin and transom lights and moulded stallrisers and pilasters. The temporary boarding to the fascia and advertising obscuring the shopfront glazing all detract. The cowl lights and wiring etc. and clutter detracts. The doorway to the passageway is a timber panelled door with fanlight.
