Donald Insall Associates
Chartered Architects and Historic Building Consultants

Macclesfield Conservation Area
Gazetteer

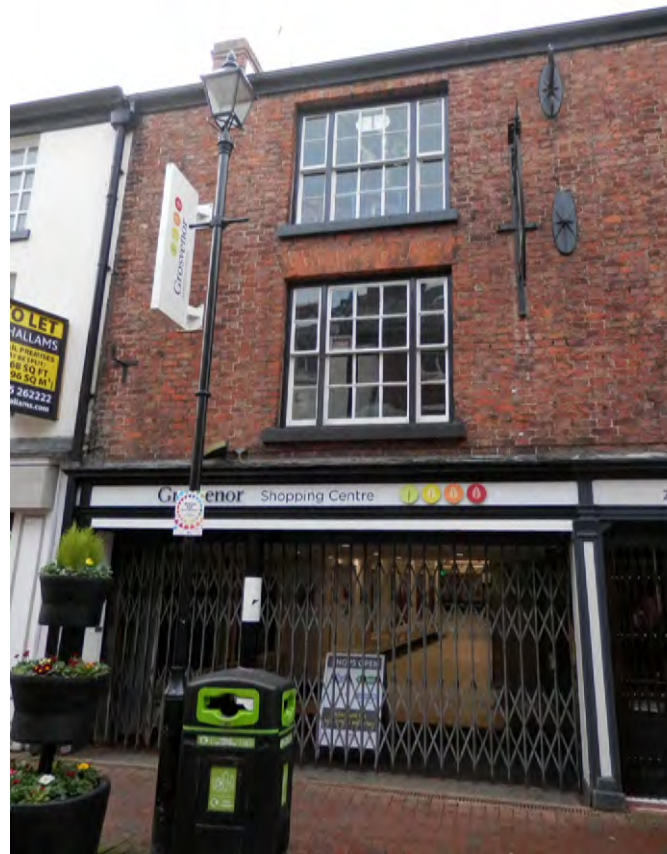
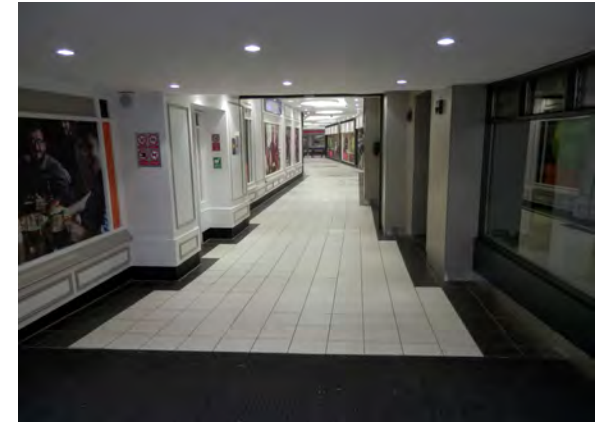
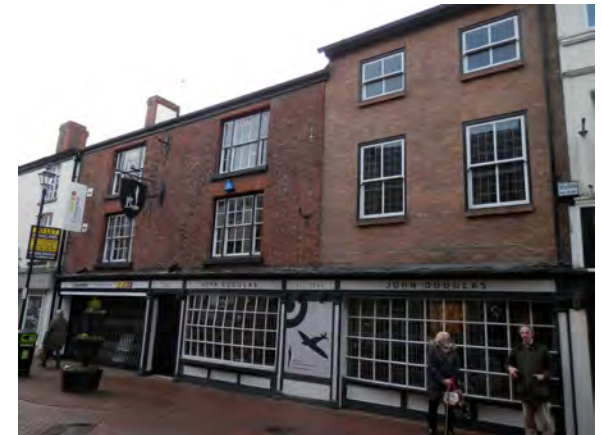
28 Chestergate, open passageway

Notes: Originally a house and now retail this is a three storey, timber-framed building, refronted in brick with a slate roof and moulded cornice. It comprises two wide bays with tripartite timber framed sash windows, six-over-six to the centre with two-over-two flanking, under flat-arched brick heads and stone sills. At ground floor the left-hand side of the building has been cut through to form a passage into the Grosvenor Shopping Centre behind whilst the retail unit to the right-hand side spans across into the adjacent unlisted building (formerly no.30). This building stands slightly taller and comprises two bays with two-over-two timber sashes and simple brick heads and stone sills. The manner with which the shopfront spans the two detracts from the definition of the original buildings however the shopfronts themselves are early 19th century with shallow bow windows with small panes and a moulded cornice. Signage is relatively restrained across the buildings and appropriately located at fascia level with a traditional hanging bracket at high level; the modern projecting box sign at no.28 however detracts. Whilst the open frontage

and modern column at no.28 also detract, the lattice grilles are an appropriate means of providing security to this open passageway. The poorly located security alarm at no.28 also detracts.

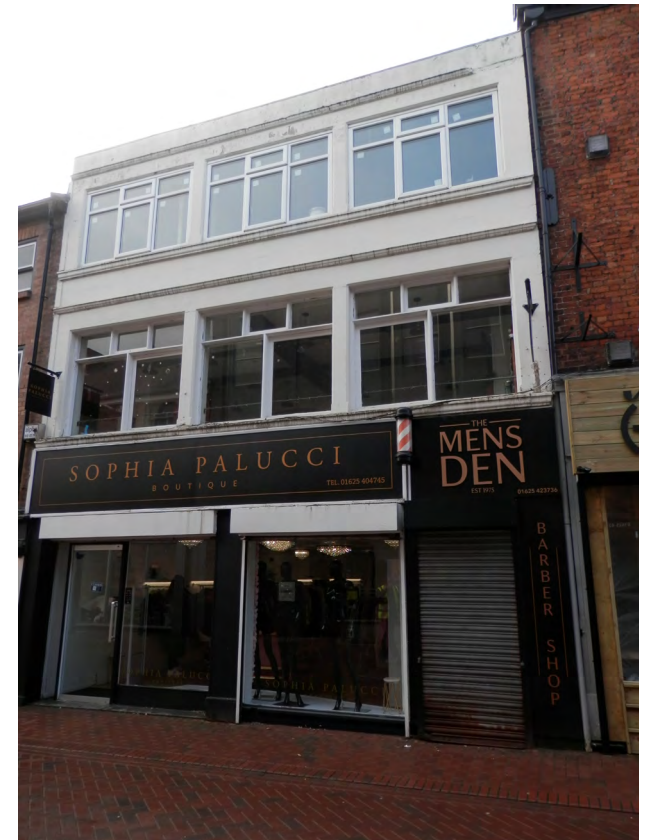
32 Chestergate

Notes: A three storey, rendered building which has an art-deco character which is of interest but is at odds with the general character along Chestergate. The arrangement of the three bays of first floor windows add to its art-deco character with three transom lights above and two lights below. The uPVC casements at second floor detract from this character. Moulded string courses run across the façade with a strong parapet at roofline. The contemporary shopfront at ground floor is suited to the character of the building however the fascia sign is oversized and the shutter boxes detract. The roller shutter, box housing and oversized fascia to the side access all detract however the barber's pole adds interest.

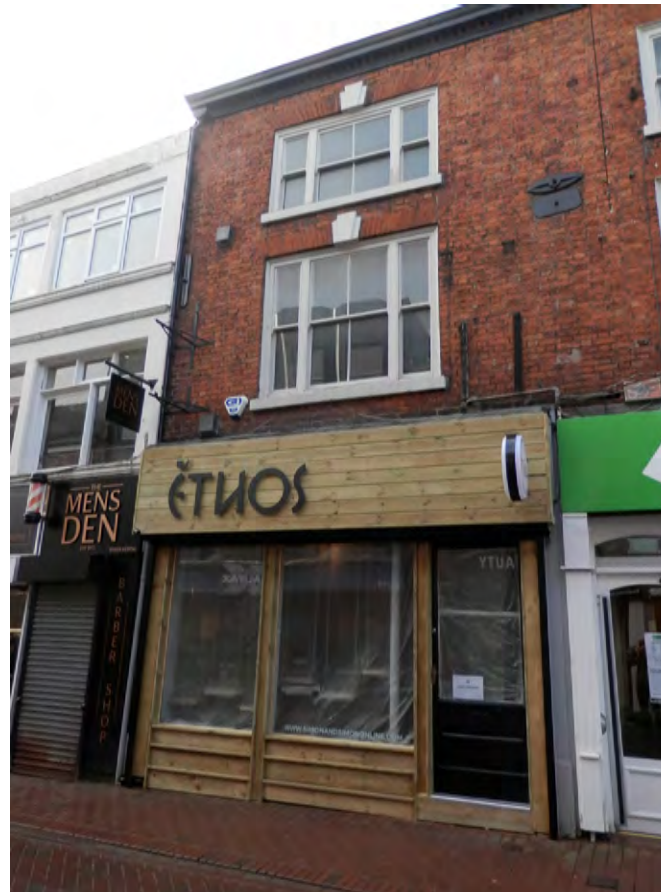
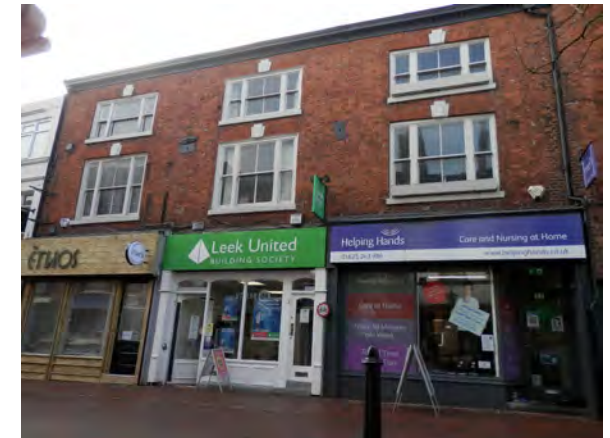
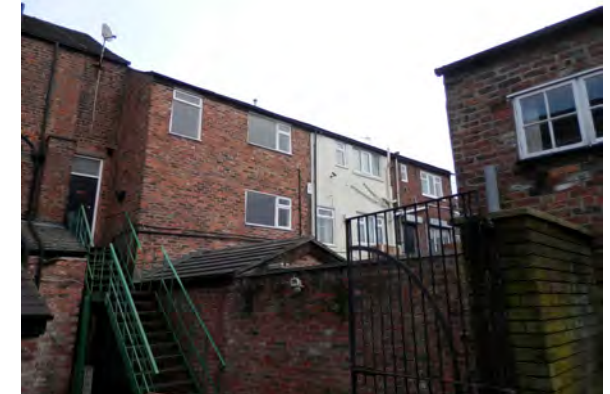
34-38 Chestergate

Notes: A three storey building constructed in red brick and arranged over three bays with modillion eaves cornice at eaves level. Windows are tripartite sashes; two-over-two to the centre with one-over-one flanking; flat arched heads and keystones and stone sills. An additional narrow blank bay over the passageway to the right-hand side with a simple door. Shopfronts are 20th century insertions to traditional designs with stallrisers, mullions and pilasters. The box fascia signs at no.s36 and 38 however detract alongside the advertising obscuring glazing to no.38. The modern shopfront at no.34 highlights how a contemporary aesthetic can still utilise traditional details – the manner with which the fascia projects from the façade however detracts. Wall ties have been inserted at upper levels whilst redundant fixtures and fittings add clutter and detract. To the rear no.36 has been rendered, with modern uPVC windows to all and roller shutters and box housing at no.34.

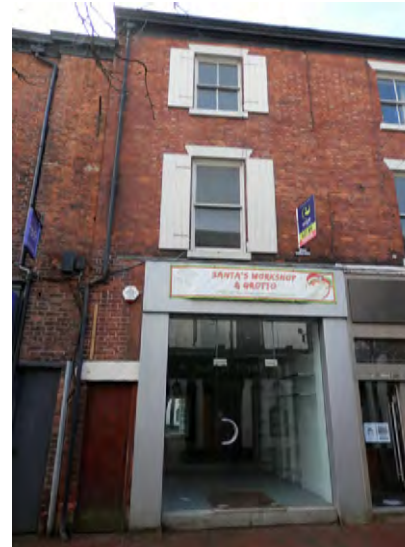
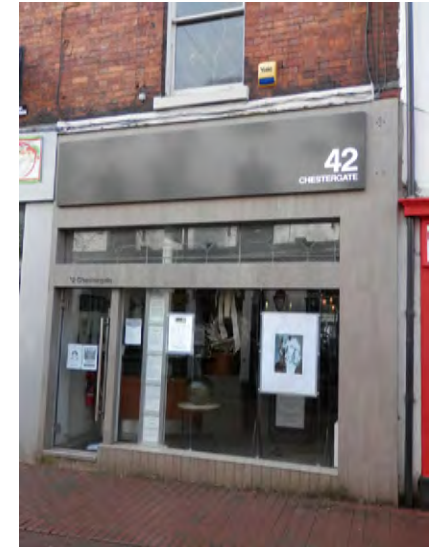
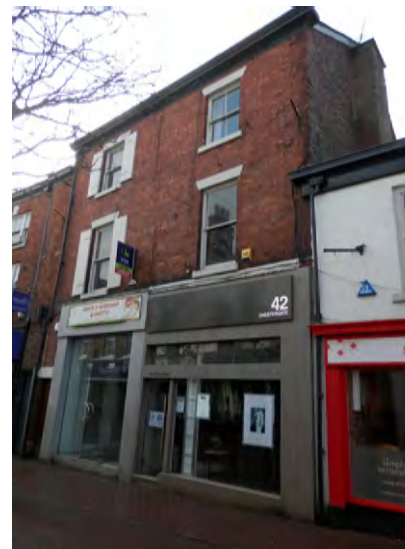
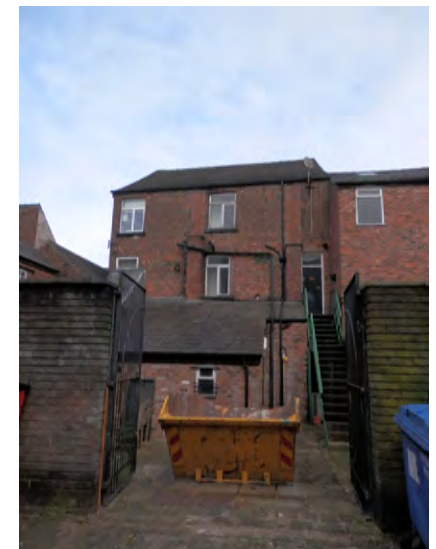
40-42 Chestergate

Notes: A three storey building constructed in red brick with a moulded wood eaves cornice, pitched roof and central chimney stack. It comprises two bays with one-over-one timber sashes at first floor and two-over-two sashes at second; all with flat-arched painted stone heads and sills. Windows at no.40 have shutters. The shopfronts are contemporary and detract; the tall, fully glazed opening at no.40 and plain surround are at odds with its historic character whilst at no.42 the overtly contemporary design and materials again fail to relate to the building above. A narrow passageway and simple door is located to the left-hand side. To the rear modern casements have been inserted with a projecting red brick extension at ground floor and external stairs to the upper floors.

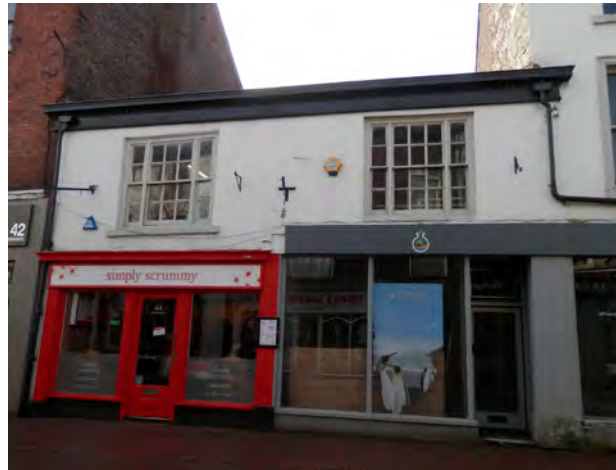
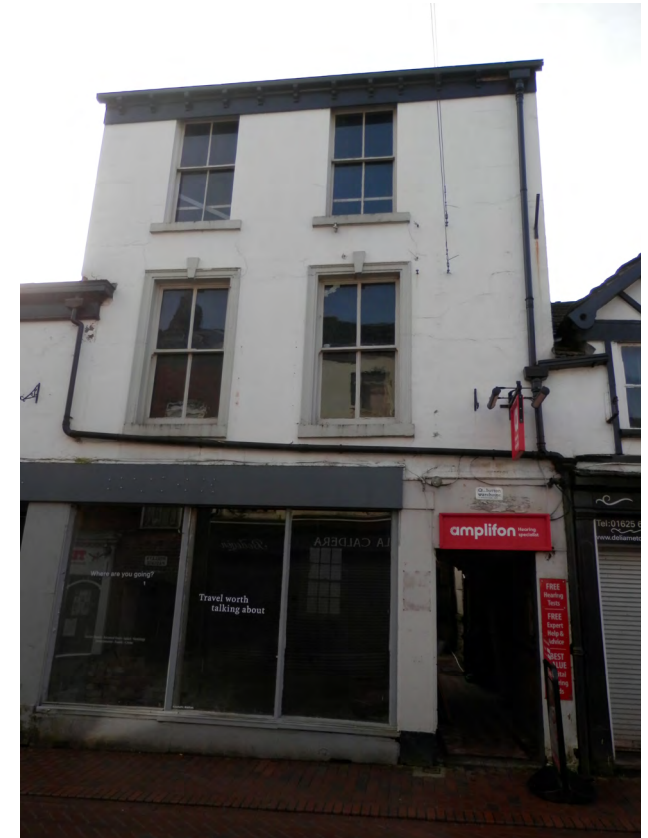
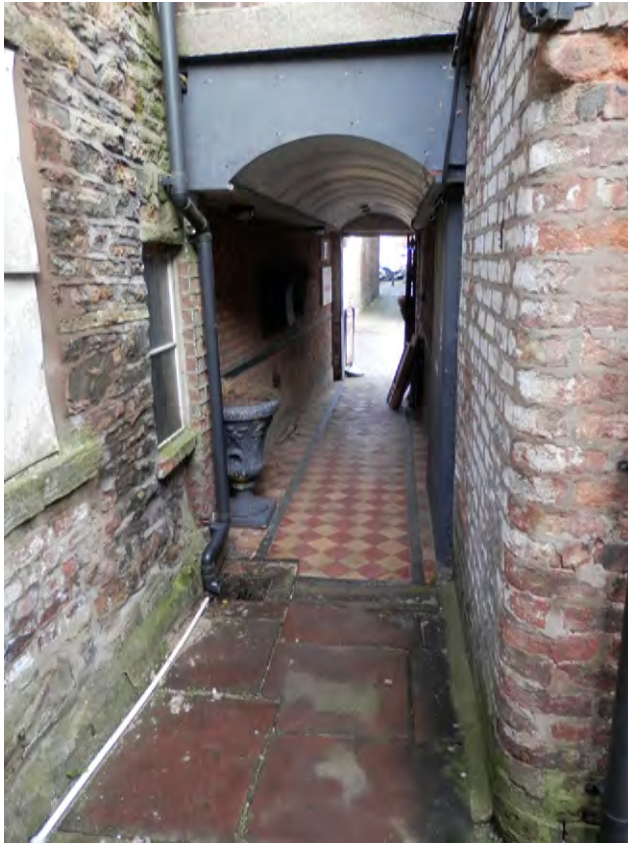
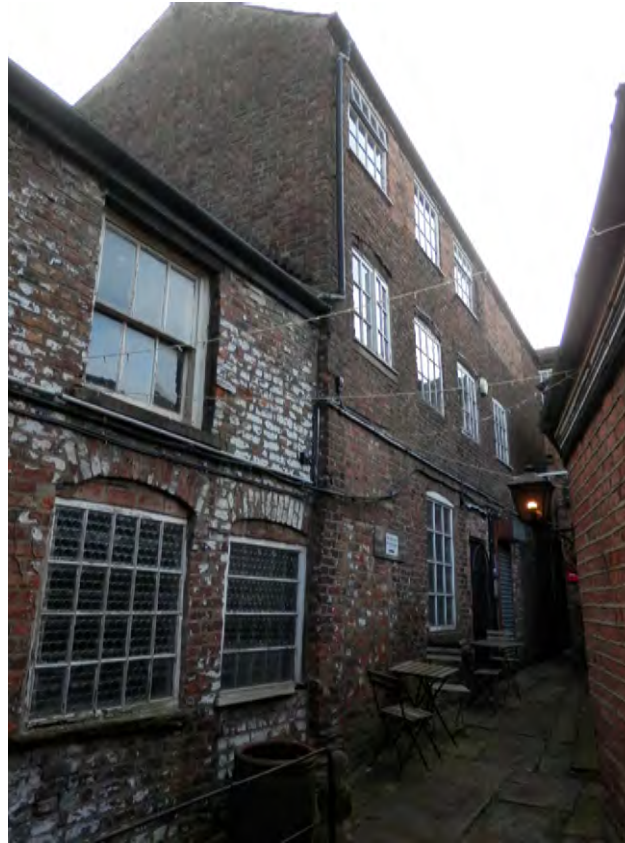
44-46 Chestergate

Notes: This group forms a pair of stucco fronted buildings; the right-hand side a storey taller than the left; both with a slate roof. As is characteristic of high street frontages the retail unit at ground floor spans across the two with a smaller single unit to the left-hand side. The larger shopfront is modern, whilst of no particular merit it follows the composition of a traditional design with stallriser, mullions and a recessed entrance. The distinction between the two buildings is expressed in the shopfront however the fascia sign spans across the two and detracts. The shopfront to the left is a traditional design with stallriser, glazed and panelled door, fascia board and cornice above. To the smaller element are two tripartite timber sash windows at first floor; six-over-six in the centre flanked by two-over-two; moulded

cornice to the eaves. To the taller element two-over-two timber sashes at both floor levels with moulded architraves at first floor. A tiled passageway provides access through to the rear, with a small courtyard bounded by the tall projecting wing of nos.46 and 48 and the tall buildings associated with the former works on Stanley Street to the south. The signage and box housing for the roller shutter detract.

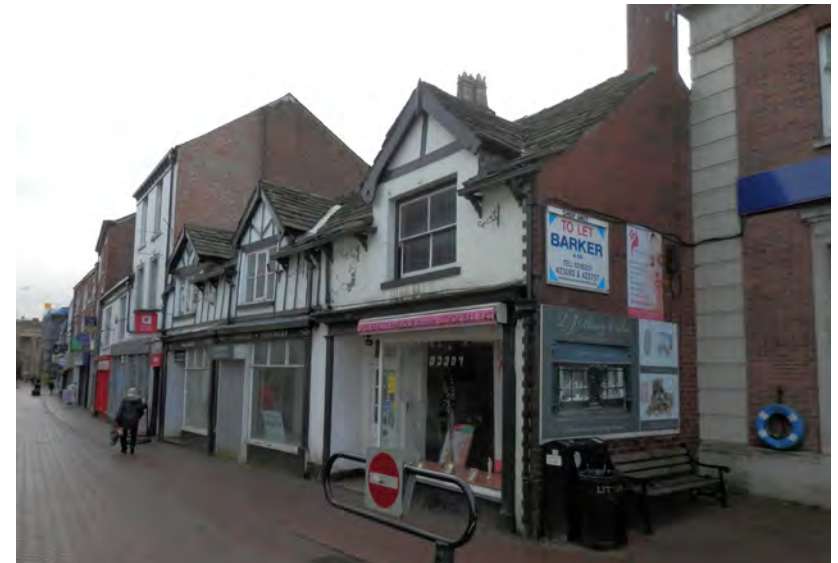
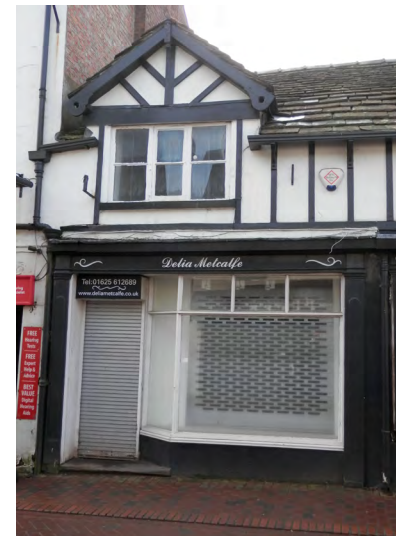
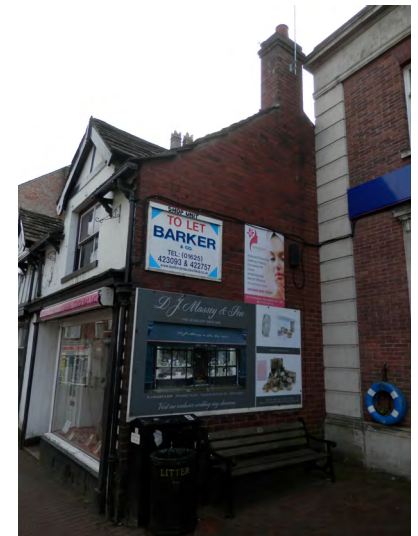
50-54 Chestergate

Notes: A group of three shops at ground floor with a timber framed interior, rendered façade over brick with mock timbering dating to c.1900. A small scale building comprising two storeys arranged over three bays with gabled dormers and finials to the bargeboards. The pitched, stone-flagged roof overhangs on brackets with tall chimney stacks. The return elevation is in brick with unsightly signage. Windows to nos.50 and 52 are three-light casements with a large two-over-two sash to no.54. Shopfronts are early 20th century insertions with stallrisers, multi-pane transom lights (to nos.50 and 52), slim fascias suited to the scale of the building and recessed doorways. Modern additions including roller shutters and box housing to nos.50 and 52 and modern canopy to no.54 all detract whilst redundant fixtures and fittings to the upper floor add clutter and detract – the internal shutter at no.50 is more appropriate.

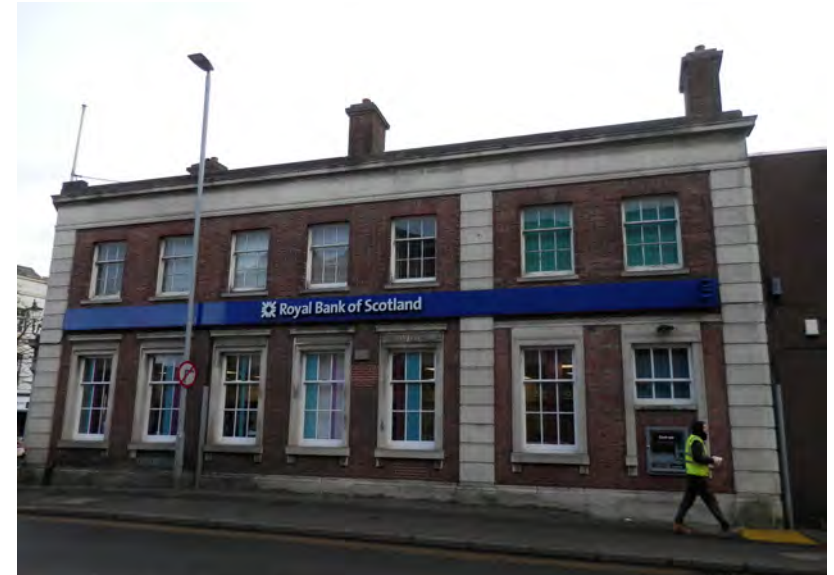
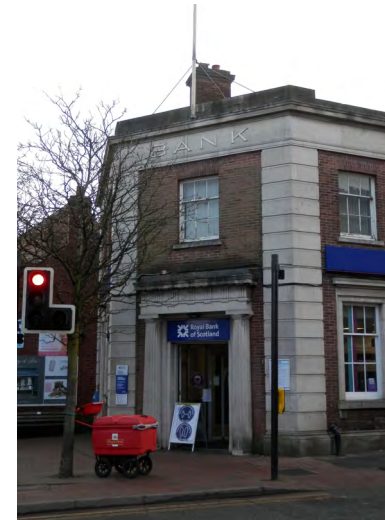
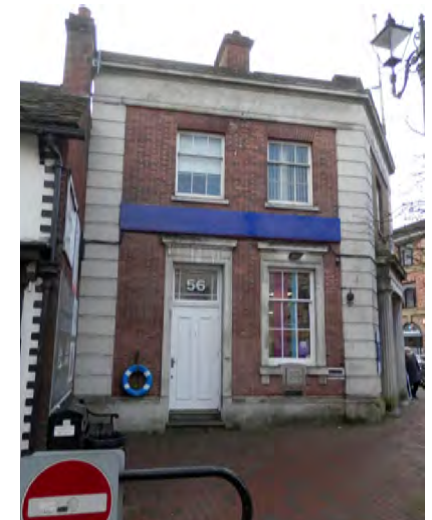
56 Chestergate

Notes: A grand neo-classical building set on a stone plinth which stands on the corner with Churchill Way. It comprises two storeys with rusticated pilasters and quoins, a stone plinth and deep cornice to the parapet. The principal frontage on Churchill Way comprises seven bays with three-over-six sash windows (foreshortened to the end bay to accommodate an ATM machine with stone architraves at ground floor and gauged brick heads at first floor. The canted corner return is a single bay with a classical doorcase including a pediment mounted on Doric columns. The bay to Chestergate is set back from the building line, it continues the composition of the elevation for two bays with a timber panelled entrance door in the end ground floor bay with fanlight and architrave. Tall chimney stacks at roof level are visible. Signage is poorly located and the main fascia cuts across the architectural detailing and detracts.

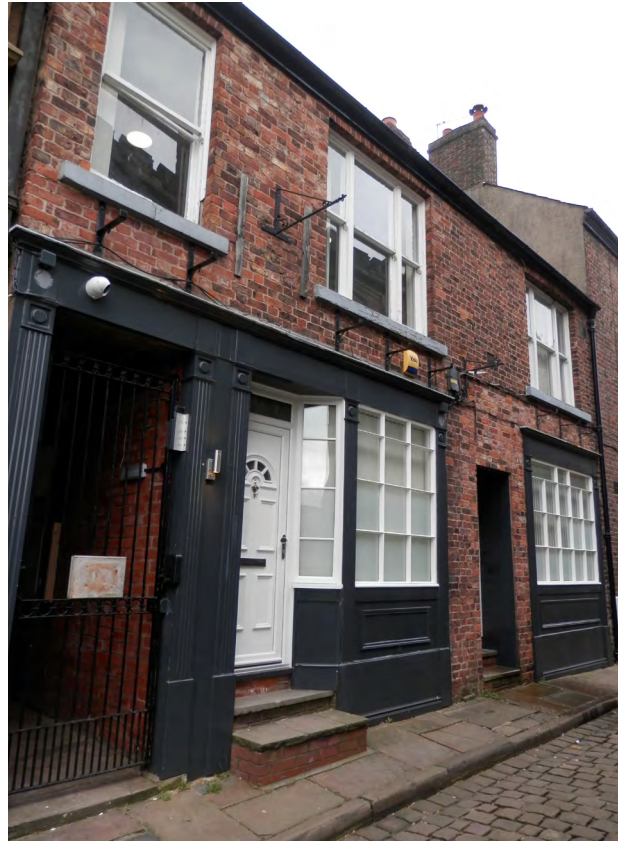
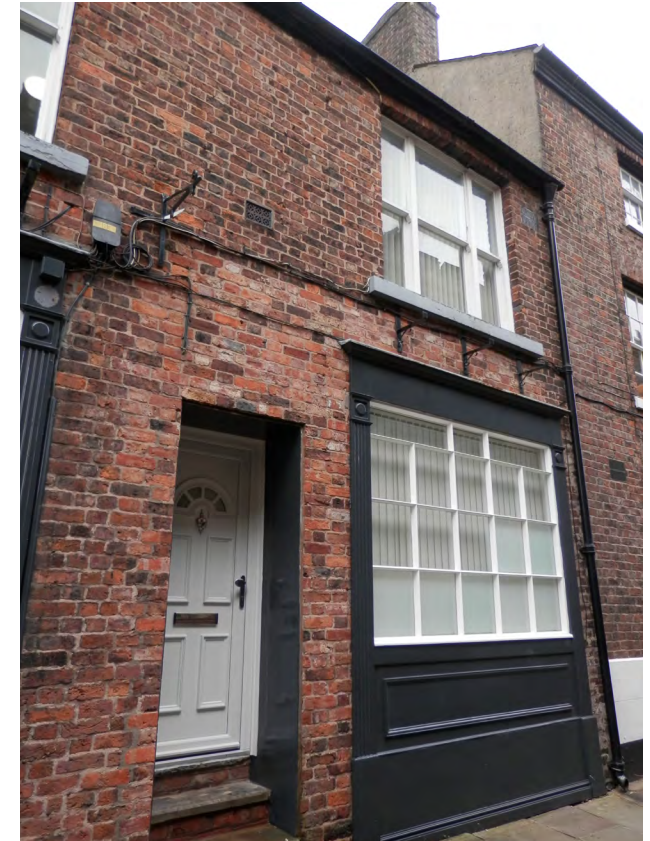
3 Churchside

Notes: A red brick building, comprising two floors and arranged over three bays, the left-hand bay narrower with a one-over-one sashes set over the passageway to the rear (with gate). The two further bays have tripartite sash windows at first floor with stone sills and one-over-one timber sashes. Inserted late 19th/early 20th century shopfronts with panelled stallrisers, fluted pilasters, multi-pane windows and raised entrances with stone steps – detailing repeats to the passageway architrave. Modern doors have been inserted associated with their residential use which detract. Redundant fixtures and fittings, wires etc. clutter the façade and detract.

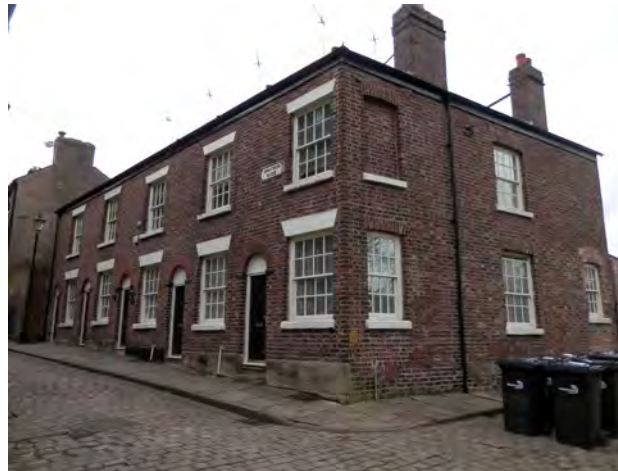
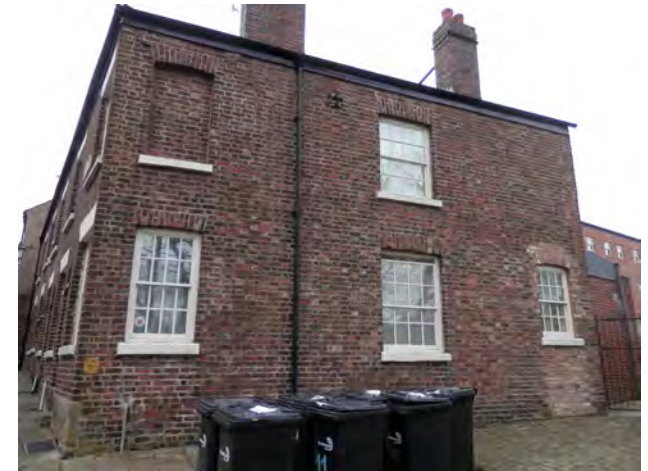
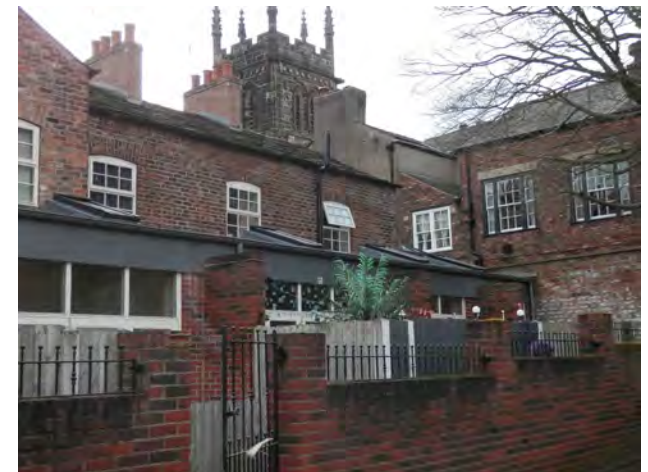
9-17 Churchside

Notes: A terrace group of late Georgian houses, constructed in brick with pitched slate roofs. Comprising two storeys, set on a stone plinth, each is a single bay wide with eight-over-eight timber sash windows with flat-arched painted stone heads and stone sills. Entrance doors are set to the left with four-panelled timber doors and blind painted fanlights in round-arched stone architraves. The uniformity which is retained across the group is of particular merit. Window bays repeat for two bays to the return elevation; first bay first floor window infilled with brick and a new window inserted in place of a door to the rear. To the rear a gable end to the left-hand side with central arched opening now infilled; otherwise a uniform modern extension across the group at ground floor with pronounced rooflights. Modern casements at first floor under arched brick heads, whilst designed to replicate multi-pane sash these detract.

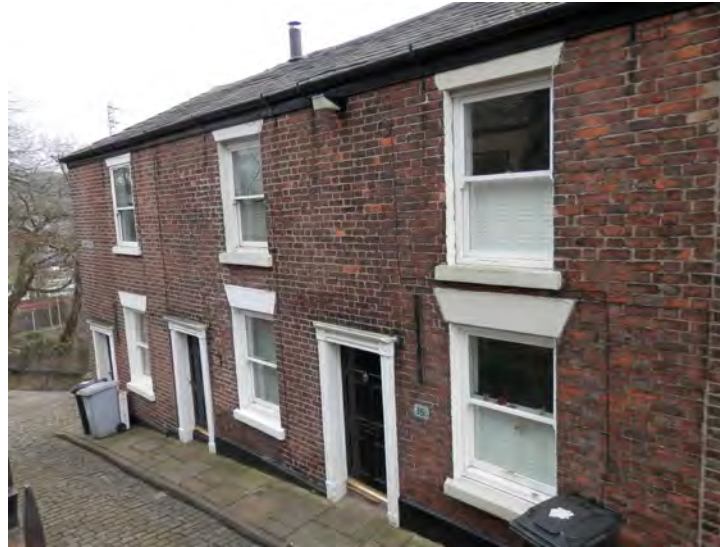
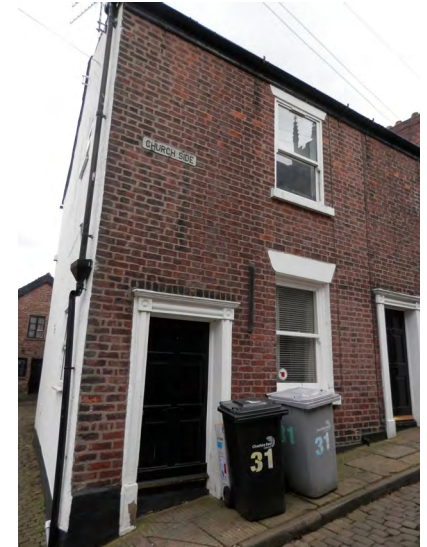
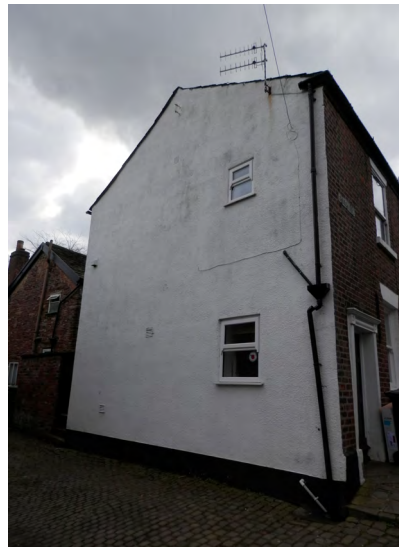
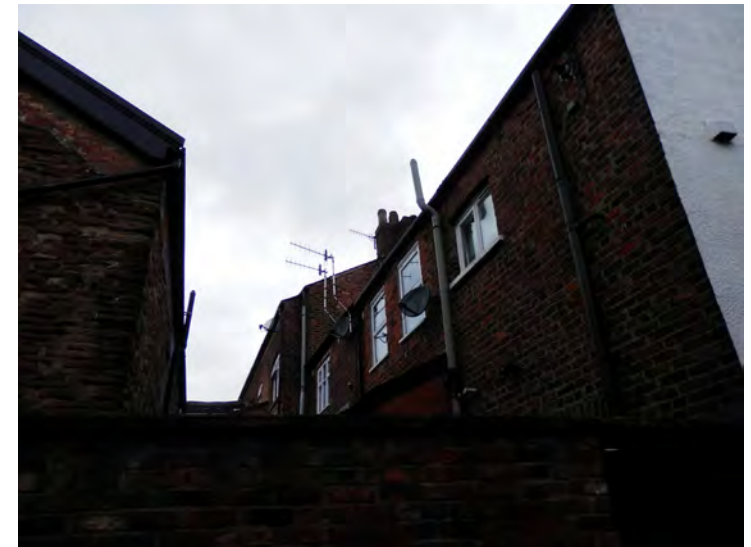
31-35 Churchside

Notes: A row of three houses at the east end of the terrace, built hard up against the pavement edge. Constructed in red brick and comprising two storeys with pitched slate roof and set on a plinth which mediates the sloping street. Each a single bay with modern one-over timber sash windows with flat-arched painted stone heads and stone sills. Decorative architraves to the six-panel door entrances. The retained uniformity of the group is of particular merit although modern house numbers detract. The east elevation is rendered with small modern uPVC casement at both floors which detract; modern windows also to the rear elevation which similarly detract.

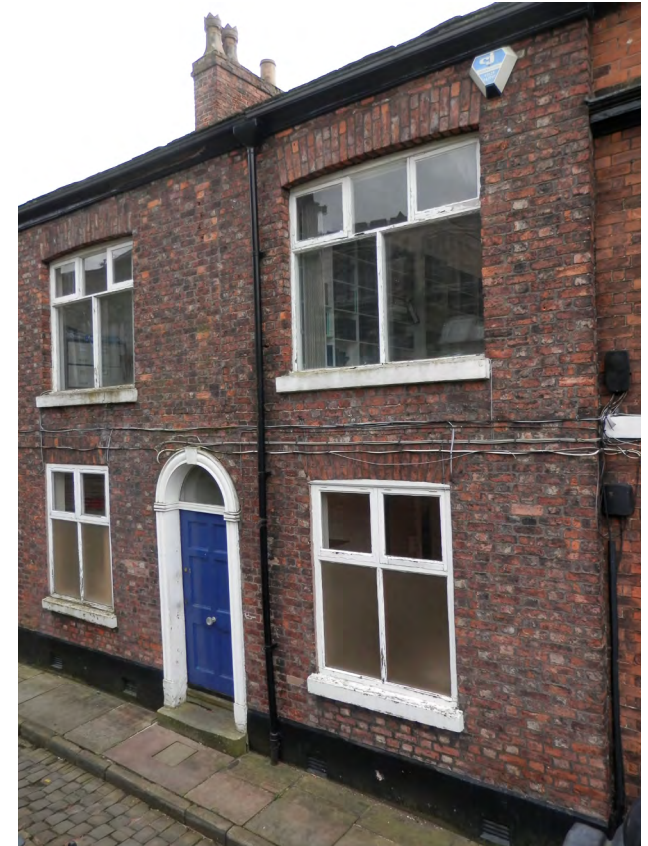
41 Churchside

Notes: A former house within the terrace built hard up against the pavement edge, set on a painted plinth with stone step to entrance. Constructed in red brick and comprising two storeys with a pitched slate roof. Two bays flanked the central entrance with round-arched reeded architrave with plain fanlight and six-panelled door. Windows are large modern casements within original openings with cambered brick heads which detract. Wires across the façade detract.

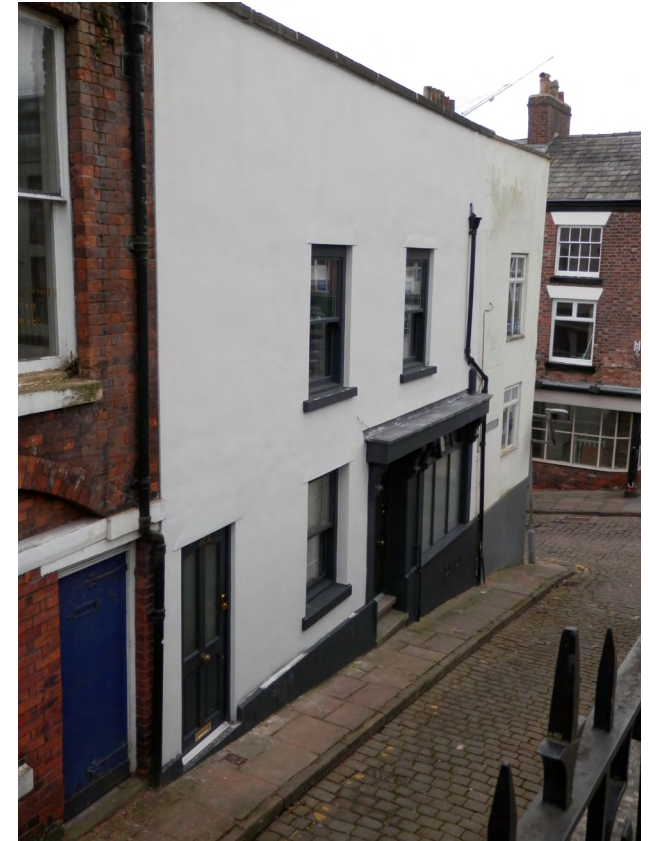
47 Churchside

Notes: Heavily altered from its original form with roughcast render over brick or timber framing and a strong parapet line. Comprises two storeys set on a plinth which mediates the change in street level. Two one-over-one sash windows at first floor, entrance door to the left, one-over-one sash and inserted traditional shopfront at ground floor. The shopfront jars with the otherwise overtly modern character of the building which belies its history.

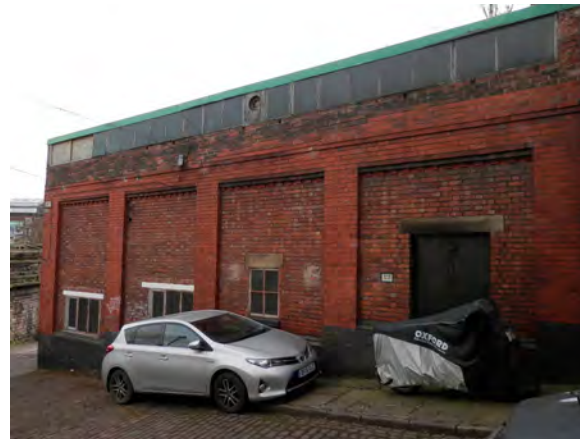
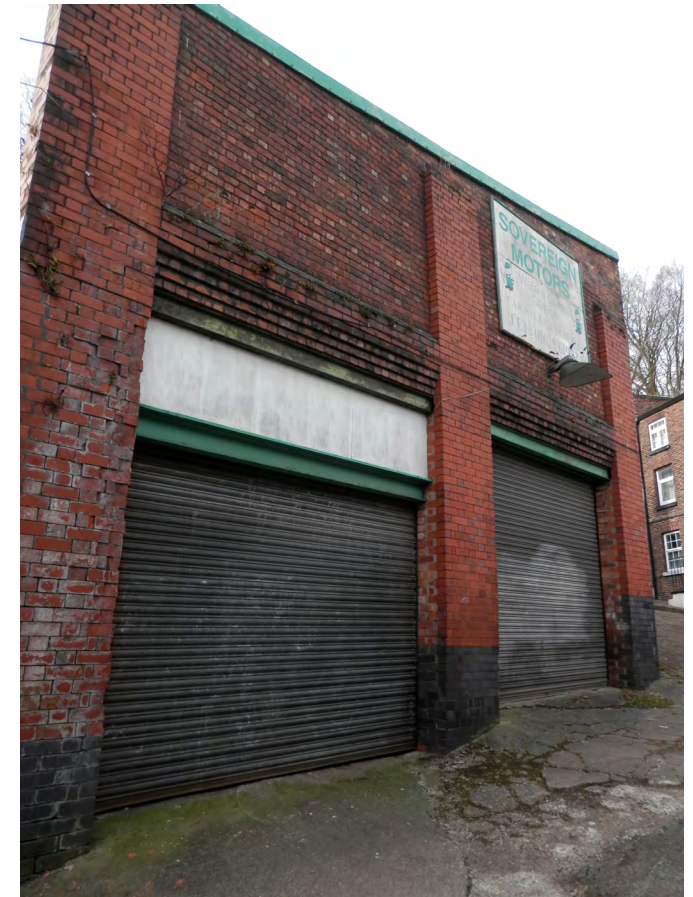
Waters Green Garage

Overall condition: Fair

Notes: A simple red brick building comprising two recessed bays framed by blank flat pilasters and set on a black brick plinth. Return to Brunswick Hill comprises four bays with window openings at ground floor (three light to first two bays and square four light window to third) entrance door to rear. Glazed clearstory at roof level, some panes now boarded. Whilst the red brick detailing is of some interest the general condition, roller shutters and high level signage all detract. A modern range is set back from Gas Road, in red brick with large simple windows openings and a corrugate metal roof – the general condition and roller shutter again detract.

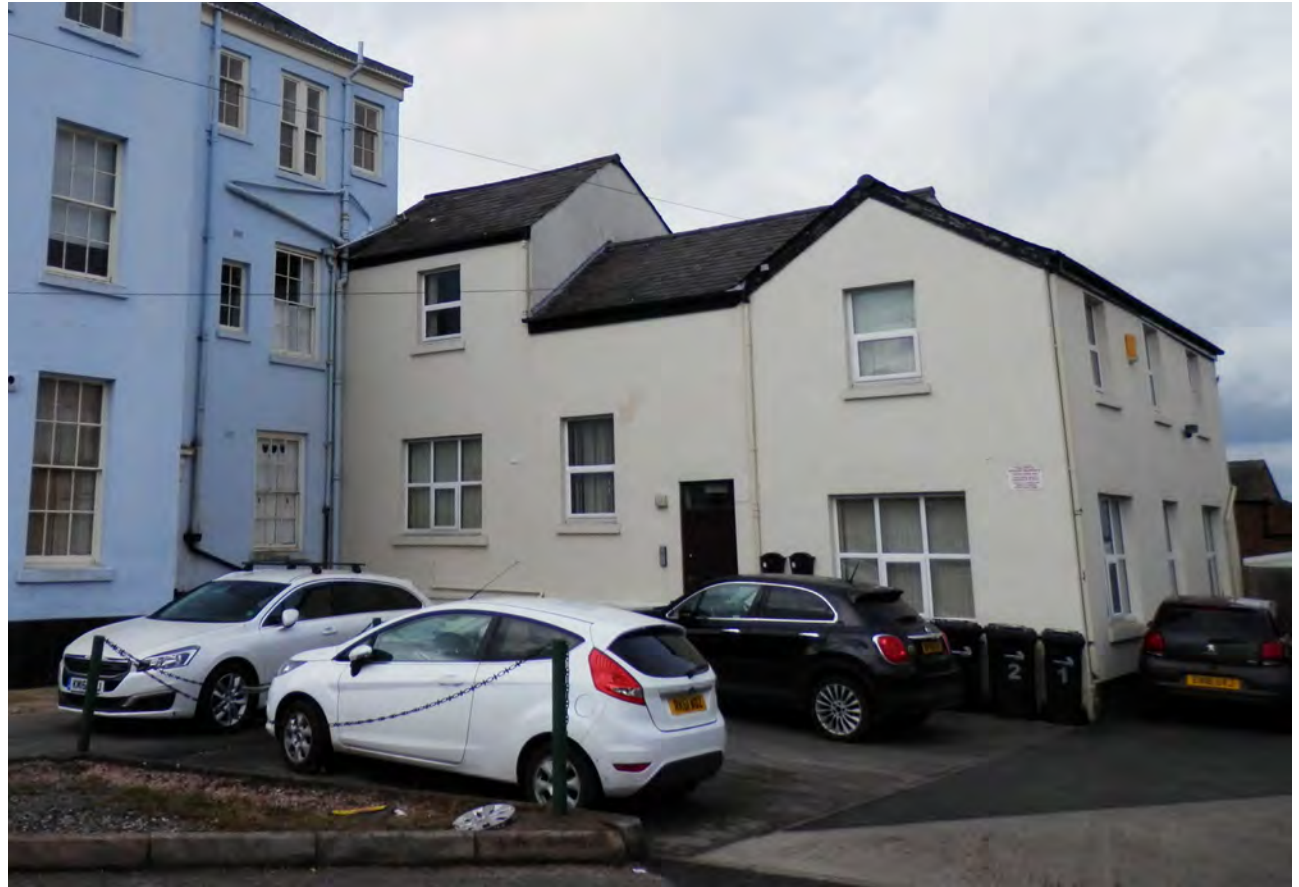
Peartree House. Jordangate

Notes: A two storey building comprising three elements; two wings with pitched roofs that step down in height before a three bay wing with pitched roof set perpendicular. Walls are rendered and roofs clad in slate; windows are modern casements and detract.

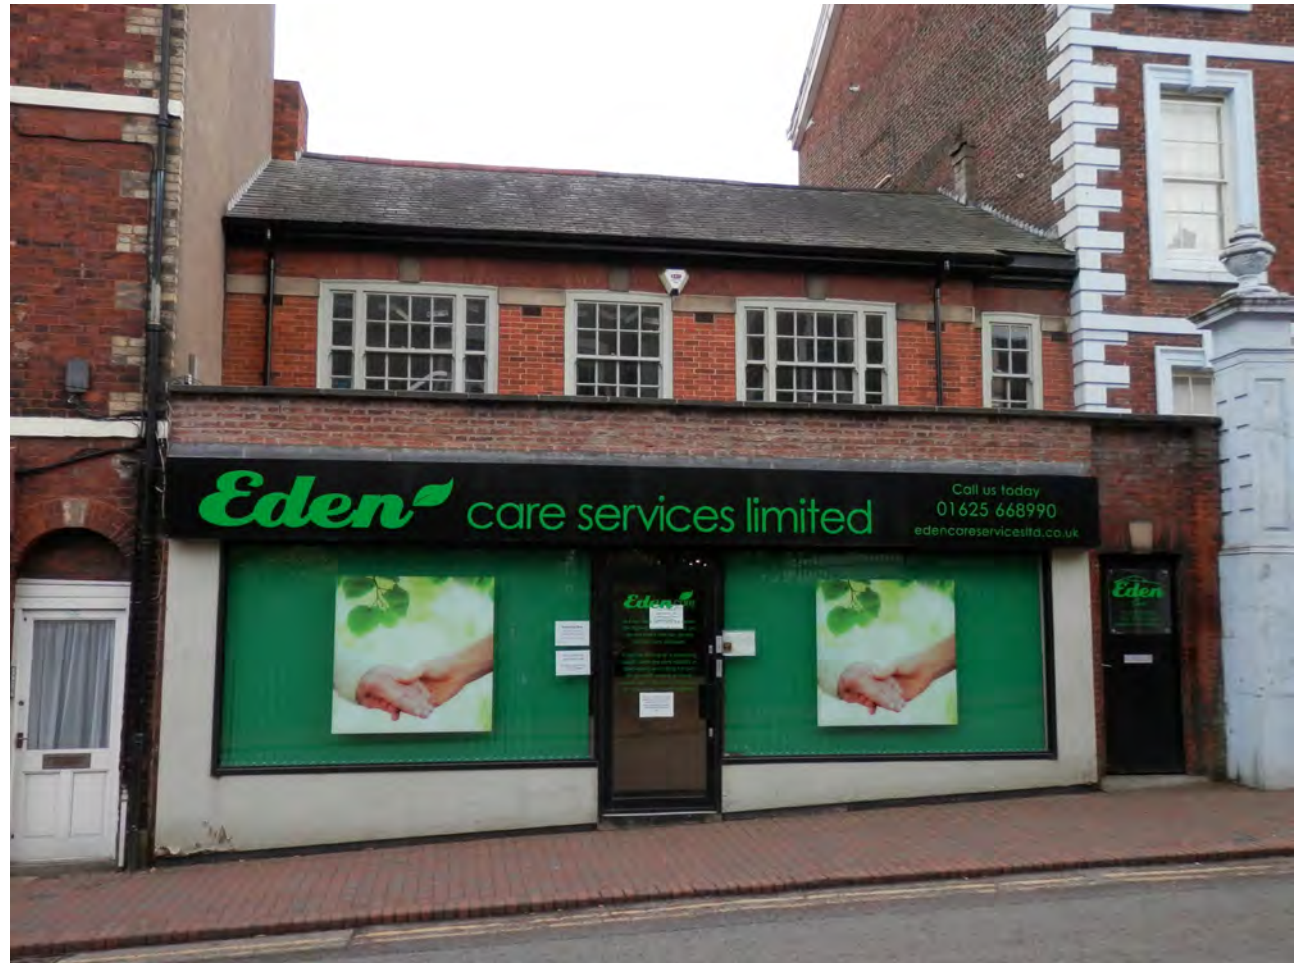
10-12 Jordangate

Notes: The original building aligns with Jordangate House with the first floor exposed above the later ground floor addition which steps forward to align with the remaining terrace along Jordangate. The roof is pitched and clad in slate whilst the first floor is red brick with stone string course; windows are arranged over three bays with a further bay to the left-hand side with a smaller four-over-four timber sashes. The central window is an eight-over-eight timber sash whilst the two flanking bays have tripartite sashes, eight-over-eight to the centre with two-over-two flanking. Painted stone architraves and cambered brick heads with stone keystone. The later ground extension obscures the original façade; the red brick parapet and left-hand side bay with entrance door set under brick head with keystone retain a sense of its historic character, the contemporary shopfront and box fascia sign however detract. Security alarm at first floor is poorly located.

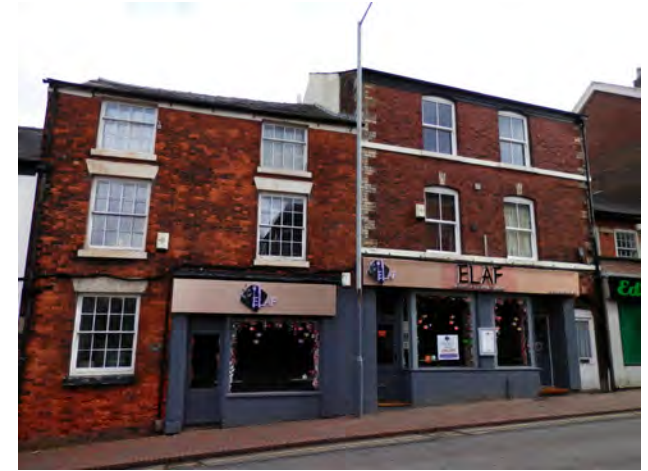
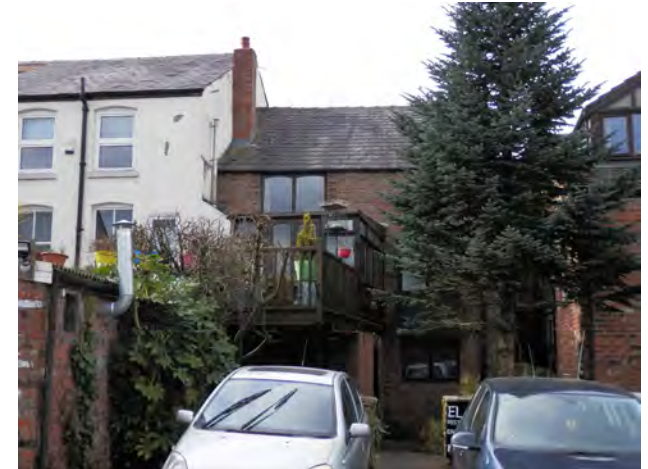
14-18 Jordangate

Notes: Two distinct three storey, red brick buildings, the pitched roofline stepping down between as the road slopes away. The ground floor commercial use spans both properties however a distinction is retained between the two in the shopfront and fascia. The first building comprises two bays with two-over-two timber sash windows set under arched brick heads at first floor, at second floor the arches puncture the moulded cornice. String courses at sill level run across the façade. The passageway entrance to the right-hand side again has an arched brick head with modern panelled door. Painted brick quoins frame the building. The second building again comprises two bays with eight-over-eight sashes windows with painted stone heads and sills; string course to eaves; the left-hand bay repeats the window detailing at ground floor. The 20th century shopfronts could better relate to the architectural character of the building above but are reasonable (the left-hand element is a better example); the modern box fascia signs however detract as well as wiring and security alarms etc. on the façade.

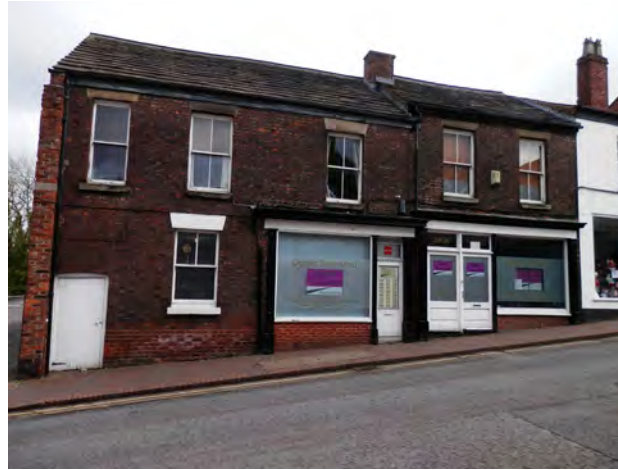
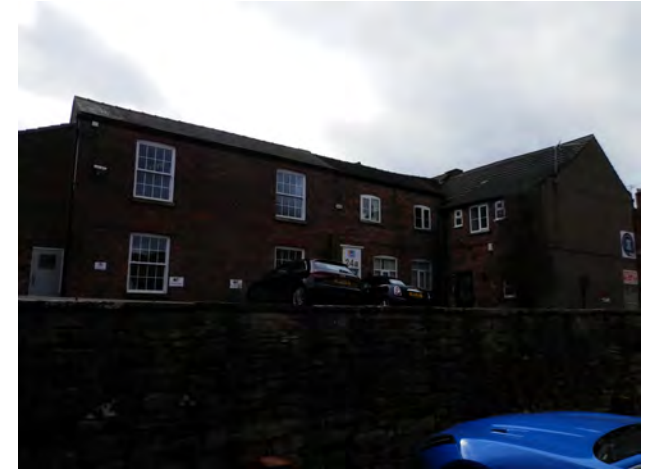
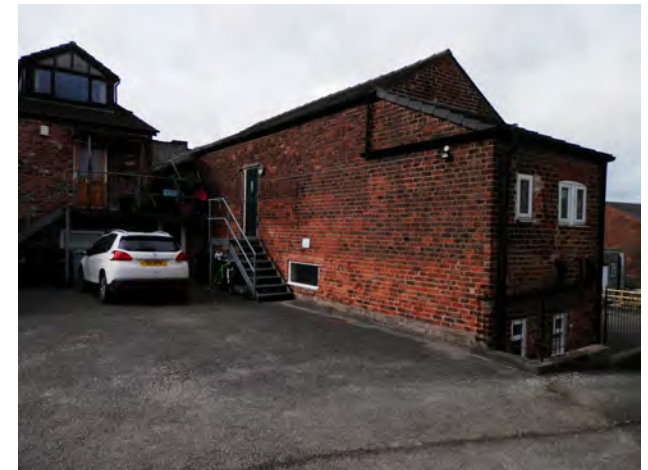
24-26 Jordangate

Notes: A pair of two storey buildings; no.24 narrower and comprising two bays whilst no.26 arranged over three unequal bays. Constructed in brown-red brick with a small step down in the pitched roof with small brick chimney stack. Windows are two-over-two timber sash with stone heads and sills, one-over-one sash to the left-hand side with a two-over-one sash at ground floor and timber boarded door to passageway under arched brick head adjacent. The shopfronts are a traditional design with pilasters, narrow fascia and cornice. The modern red brick stallriser to no.26 detracts whilst the additional entrance door at no.24 gives a slightly odd composition. To the rear a deep projecting two storey wing; eight-over-eight sashes to the two end bays. The remaining modern casements and modern signage over the entrance door all of which detract.

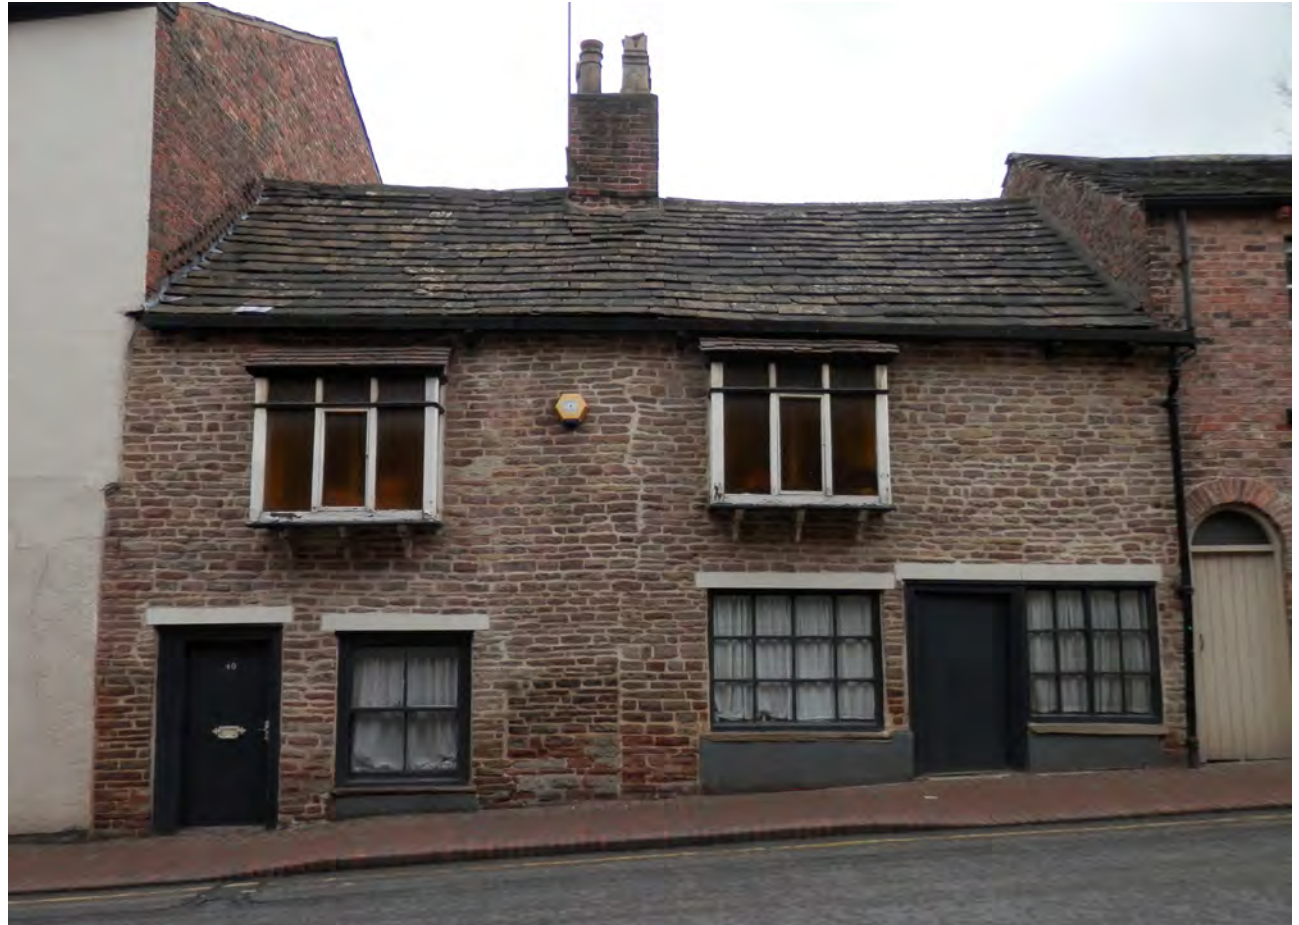
38-40 Jordangate

Notes: A pair of small-scale two storey houses, likely to have an earlier core – constructed in coursed rubble stone with stone-flagged roof and axial brick chimney stack. At first floor are late-19th century rectangular oriel windows with three-light timber casements and tiled roofs. At no.38 a central entrance with timber boarded door flanked by simple multi-pane 19th century shop windows all set under lintels. To no.40 a wide tow-over-two timber sash set low in the façade. Security alarm is at odds with the historic character.

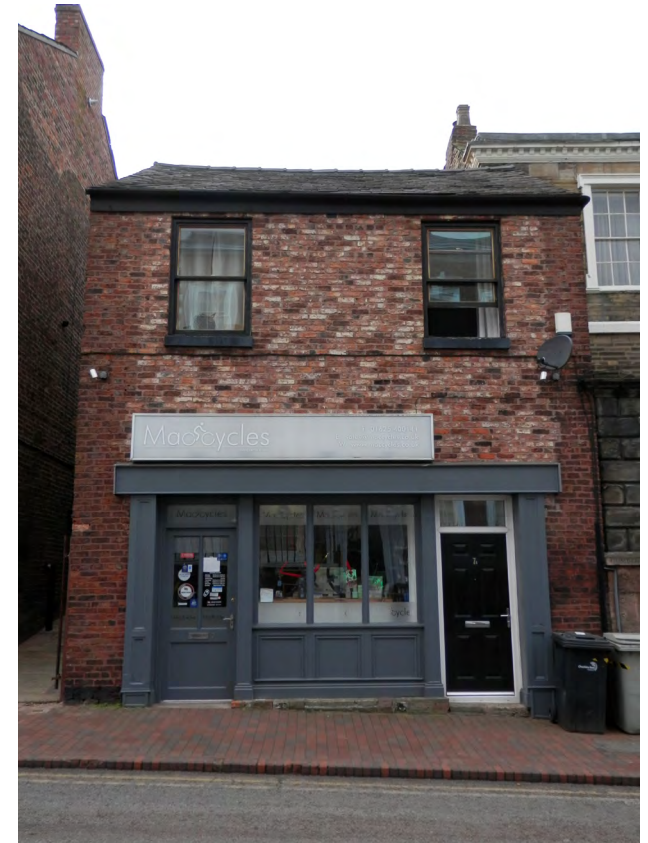
7 Jordangate

Notes: A two storey red brick building with pitched slate roof. The façade has been remodelled with replacement brickwork and an inserted shopfront which is a sympathetic traditional design with pilasters, moulded stallriser and three-light shopfront. Whilst the fascia board is appropriately sized, signage is located above and detracts. Two one-over-one sash windows at first floor; satellite dish and modern fixtures/wiring to façade detract.
