Donald Insall Associates
Chartered Architects and Historic Building Consultants

Macclesfield Conservation Area
Gazetteer

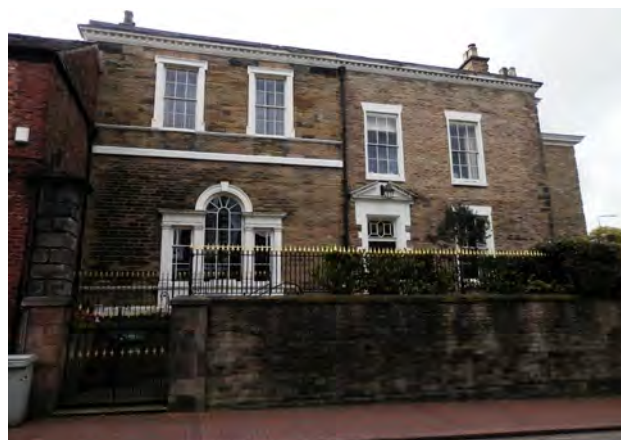
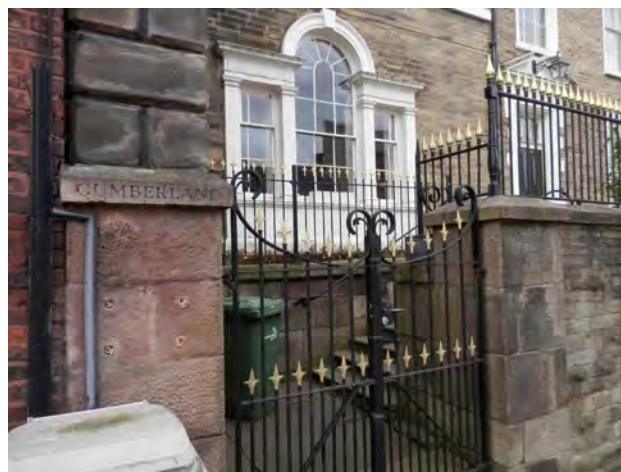
Notes: A two storey building set back from the street with raised ground floor; tall early-19th century boundary wall with railings. The original Georgian house is set to the left-hand side, successively extended and converted into two houses it has a rather disjointed composition. Constructed in courses square rubble with ashlar dressings and a pitched stone flagged roof. To the left-hand side a two window range with six-over-six timber sashes with architraves at first floor, painted sill band and Palladian window at ground floor. The main entrance is now located in the later right-hand range with a pedimented doorcase, arranged over two bays with six-over-six sashes with simpler architraves. A moulded modillion eaves cornice spans across the two phases. To Cumberland Street the third phase of the building (Stafford House), arranged over three bays with a central round-arched entrance with Tuscan architrave and radical fanlight. Windows are six-over-six timber sashes with flat-arched heads. A modern structure in the front garden obscures

part of the façade; to the west façade a ground floor extension with pitched slate-clad roof and two window bays at first floor to the rear.

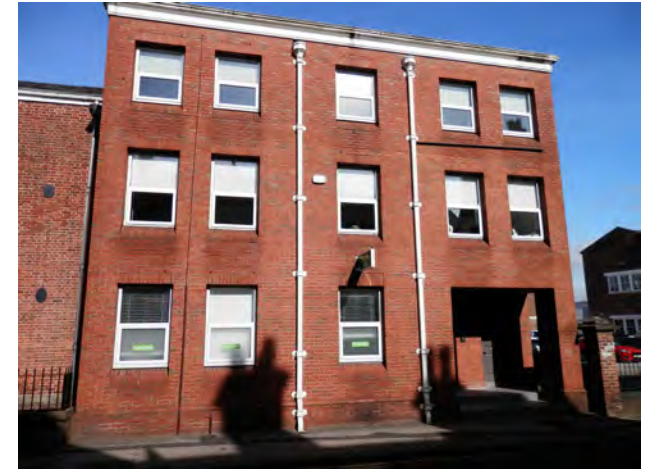
9 King Edward Street

Notes: A three storey, red brick building arranged over five bays – paired to the outer two bays. Splayed brick sills and simple heads which contrast with the traditional downpipes and prominent cornice to the parapet. Projecting sign is awkwardly located and detracts. Recessed entrance to the corner bay; open to the front and side elevations, with two entrance doors and tiled steps; signage appropriately fixed to the inside face. Gable end to the east façade with two central bays which repeat the detailing with an entrance door set to the left-hand side.

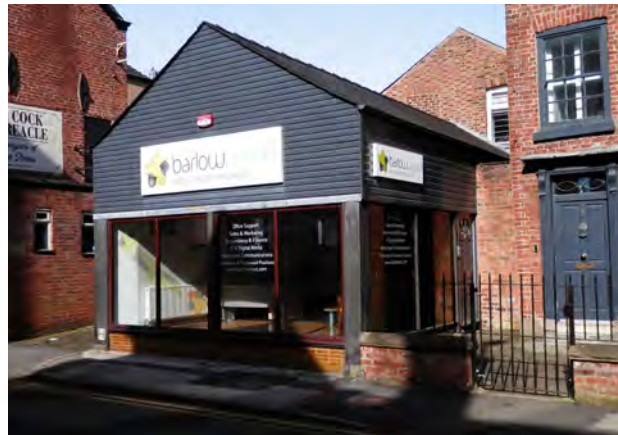
11a King Edward Street

Notes: To King Edward Street a remodelled contemporary frontage with pitched roof and gable end. Large full width glazed shopfront with tiled stallriser and panelled above with extends to the east elevation with a modern entrance door to the rear. Fascia sign is oversized. The single storey west elevation retains the historic red brick with three bays of simple casements with a plain door and door to the rear. A two storey range to the rear with two bays; one square window and one segmental. Pitched roof and gable end with one window blocked and one with casement under brick heads at upper level.

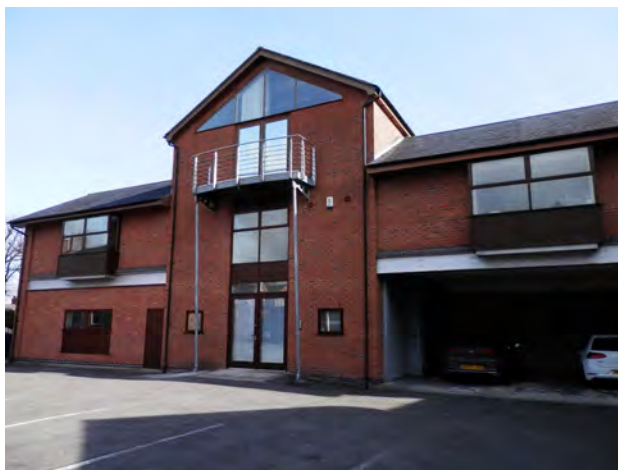
The Stables, King Edward Street, east

Notes: A collection of buildings set to the rear of 11a King Street. To the east a building consented at the end of the 20th century constructed in red brick with a central three storey gabled bay and two flanking two storey ranges with pitched roof. To the central bay a glazed middle section, projecting balcony at second floor and large glazed openings above; projecting rectangle bays to the wings and open car parking at ground floor to the right-hand bay. To the west a single storey red-brick range, with pitched slate roof and inserted dormer windows with modern three-light casements. Facade is six bays; two with simple boarded entrance doors set under fanlights the others with two-light casements with fanlights above; all set under cambered brick heads. To the left-hand side a two storey gabled

wing; remodelled with a large glazed opening at first floor and mock timber above with glazed timber doors and fanlights at ground floor. The reuse of the former stables adds to the historic character however the attempt at contextual design to the modern building is fairly unsuccessful.

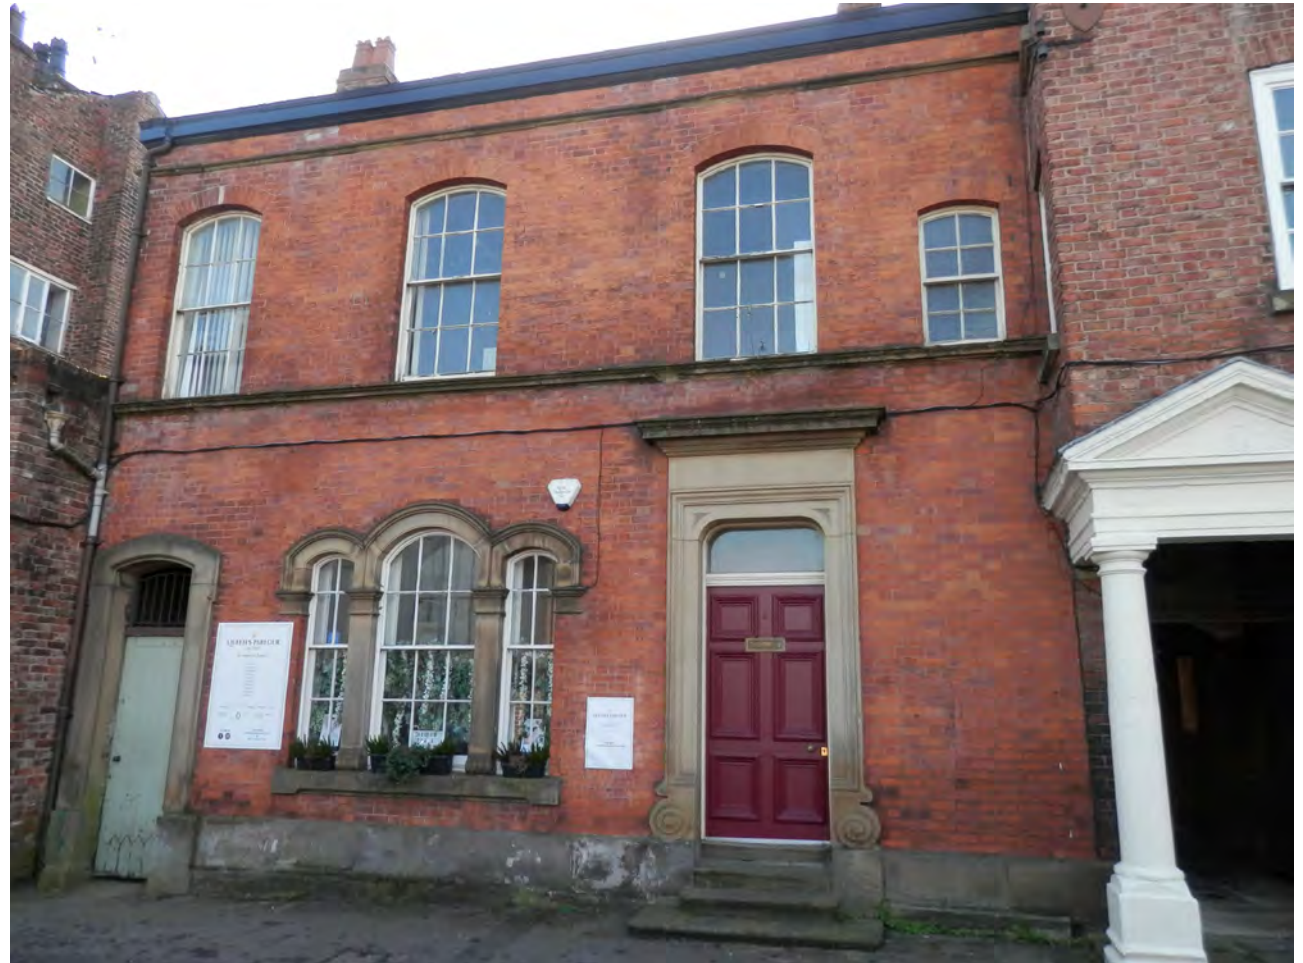
2 King Edward Street

Notes: A two storey red brick building arranged over three bays; and set on a stone plinth with pitched roof and brick chimney stacks. Arched six-over-six timber sashes at first floor with brick arched heads and a stone sill band – additional two-over-two sash to the right-hand bay. At ground floor stone doorcase with pediment, six-panelled door and stone steps; simpler stone architrave to passageway opening to the left-hand side with boarded door and metal grille above. Tripartite window at ground floor with arched stone heads; six-over-six to the centre and two-over-two flanking. Large sign to left-hand side is poorly located in relation to the window.

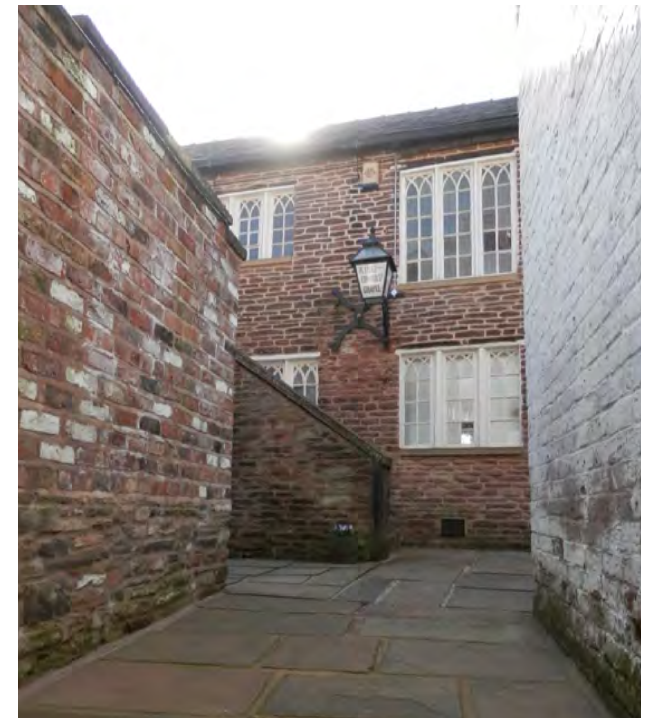
Unitarian Chapel, King Edward Street

Notes: Located to the rear of the buildings fronting King Edward Street and accessed via the passageway under no.6. It is constructed in coursed and squared rubble with a stone-flagged roof. It comprises two storeys arranged over six bays with external staircases giving access to the galleries at each side with lower doorways beneath. Upper doorway has an ogee arch. Windows are two and three lights with mullions and traceried glazing aside from the central windows at each floor, blocked on the inside in 1929 when the other windows were renewed and retaining their 19th century glazing with interlaced tracery and coloured margin lights. Building not fully inspected owing to location. To the rear three-light windows at first floor repeat the detailing, paired over four bays with buttresses between. Tall vent at roof level detracts.

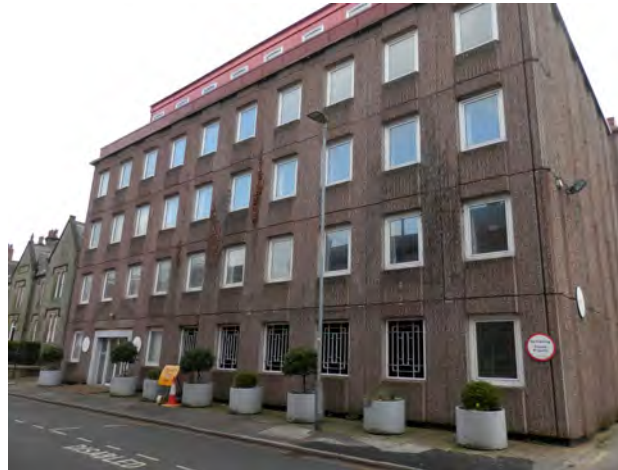
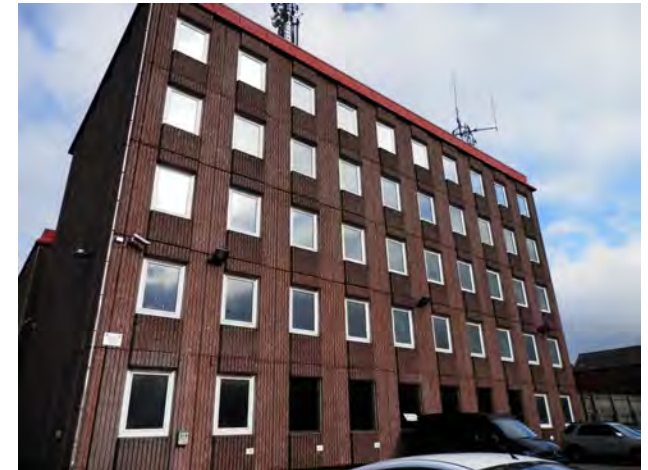
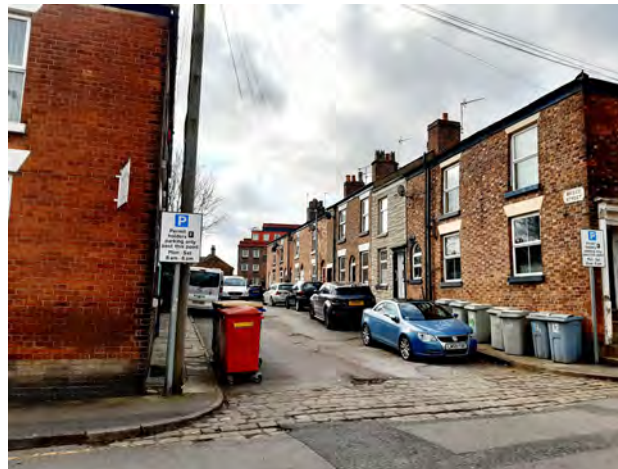
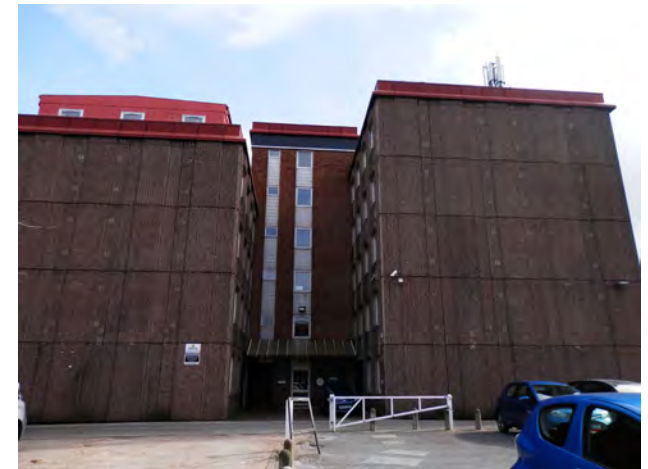
Notes: A channelled concrete building comprising four principal floors and arranged over ten bays with single light square casement windows and advanced panels between. At ground floor the entrance spans two bays, set from the left-hand side whilst five further bays have openings with grilles, windows otherwise follow the upper floors. To the rear is a further block, connected by a recessed brick range – both a storey taller – with a canopy at ground floor and windows which repeat the design from the front overlooking the open courtyard. The west facing faces are blank. The rear elevation of the rear block repeats the detailing from the King Street façade. At roof level is a parapet clad in red facing material and a red roof storey over the northern block. With telecoms masts to the rear. Sovereign Court is one of the few detracting buildings in the conservation area which has a wider impact on the conservation area – principally owing to the red roof storey and the prominence of the building generally owing to the surrounding open hard landscaping.

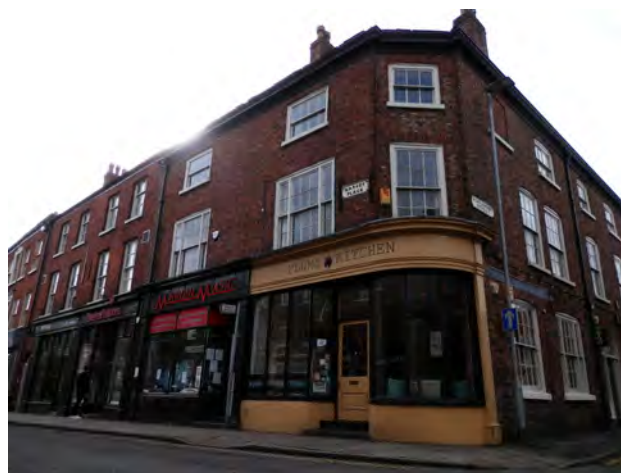
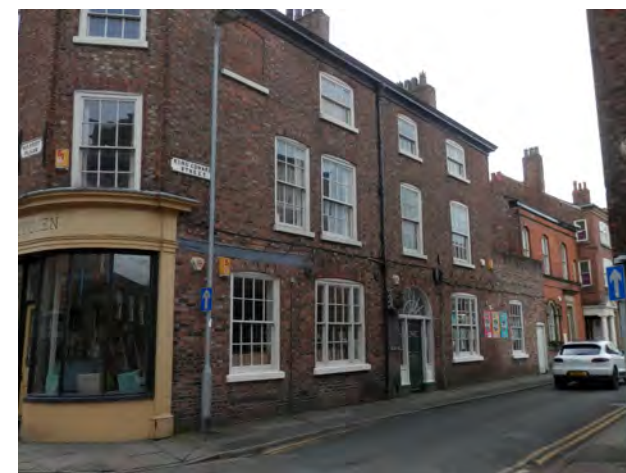
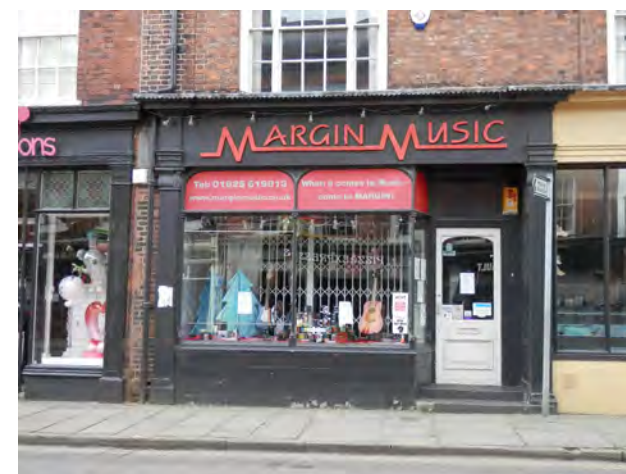
1-3 Market Place & 2a King Edward Street

panelled door and side lights with attractive traceried fanlight above. Windows at ground repeat the tripartite design from the Market Place façade whilst at upper floors are multi-pane timber sashes suited to their scale; window at second floor to front is infilled. Pitched roof with tall brick stacks. Wiring and modern fixtures and fittings detract as well as signage to the rear of the King Edward Street elevation.

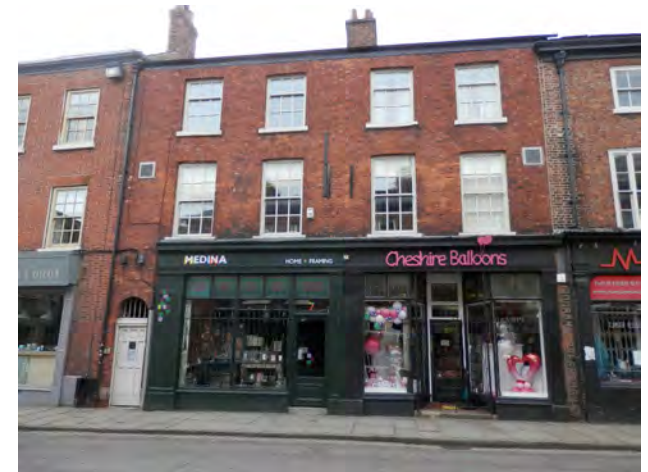
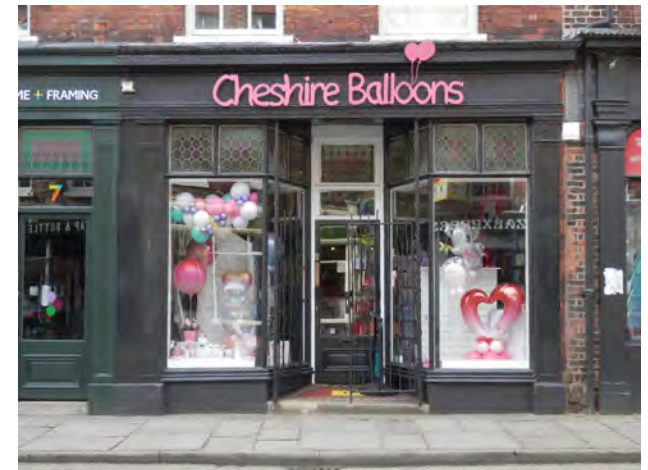
5-7 Market Place

Notes: A three storey, red brick building arranged over four bays with six-over-six timber sash windows at first floor and three-over-six to the floor above – all with flat-arched gauged brick heads and stone sills. A plain cornice to the eaves and central chimney stack. A late-19th century shopfront to no.5 a recessed tiled entrance, mullions, stallriser and handsome leaded transom lights. Framed by pilasters with fascia and cornice. Detailing is repeated at no.7 which is another good example, with flush entrance and arched entrance to passageway with panelled door to the left. Redundant fixtures and fittings, wiring and vents at upper floor level all detract.

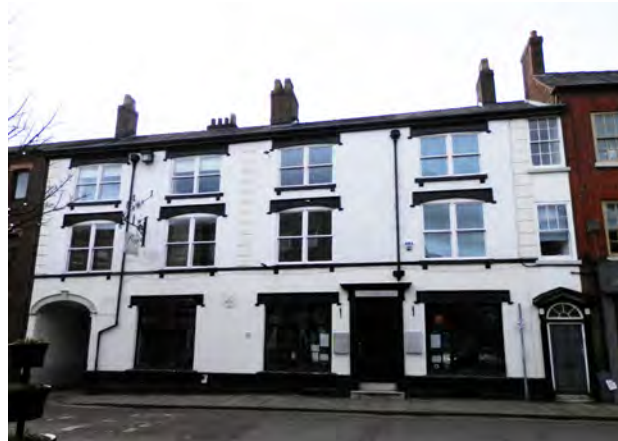
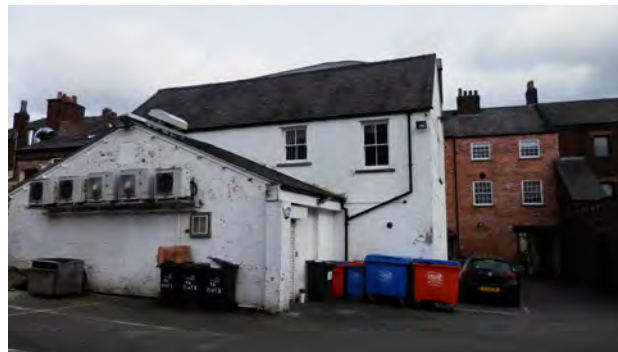
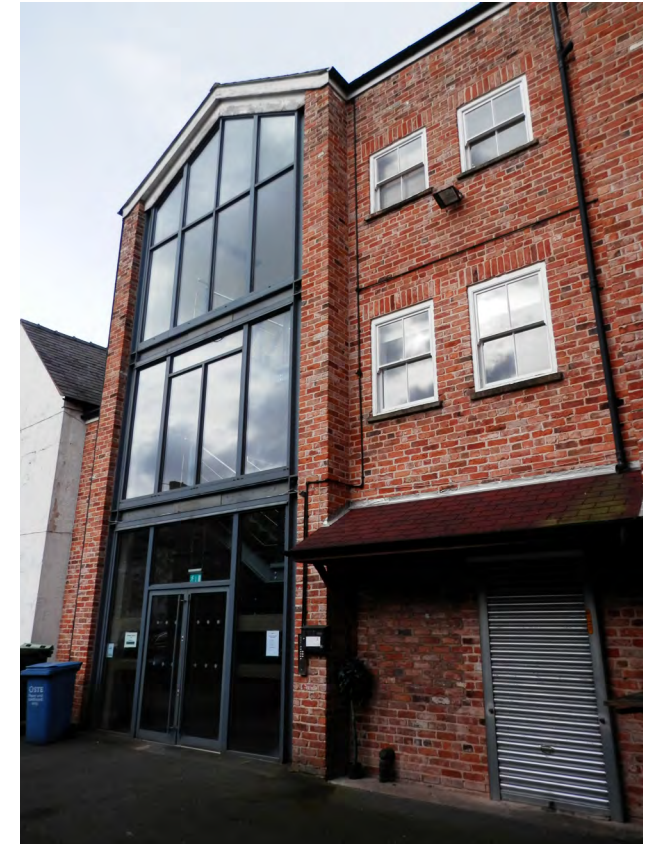
11 Market Place

Notes: Formerly a public house, comprising three storeys set on a plinth and arranged over four bays with stucco quoins framing either end and in the centre. Windows to the upper floors are paired one-over-one sashes with thin hood moulds. To ground floor the doorway is set right of centre with an architrave, flanking openings are three-light windows with mullions and transoms. To the left-hand side a segmentally arched passageway with keystone archway; to the rear two bays of eight-over-eight windows with simple brick heads above. Pitched roof with prominent chimney stacks. To the rear a modern three storey wing consented in 2006, in red brick with largely glazed gabled bay which steps forward – windows otherwise with simple brick heads and two-over-two sash window, canopy and roller shutter at ground floor. Two further ranges to the rear; the first two storey with a pitched roof and two-over-two sash windows; the second a single storey perpendicular building with pitched roof, roller shutter and boxing and wall-mounted a/c units all detract.

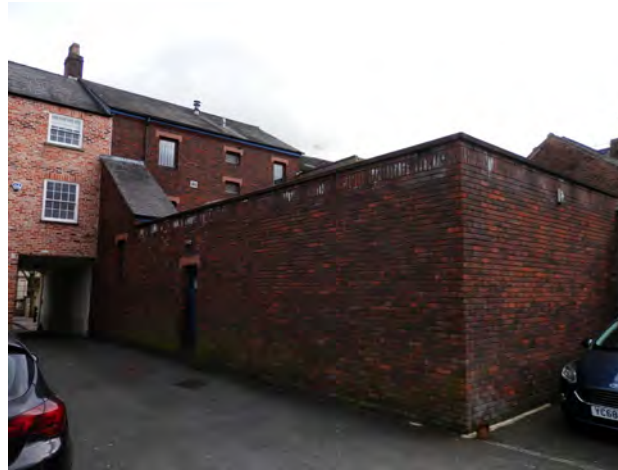
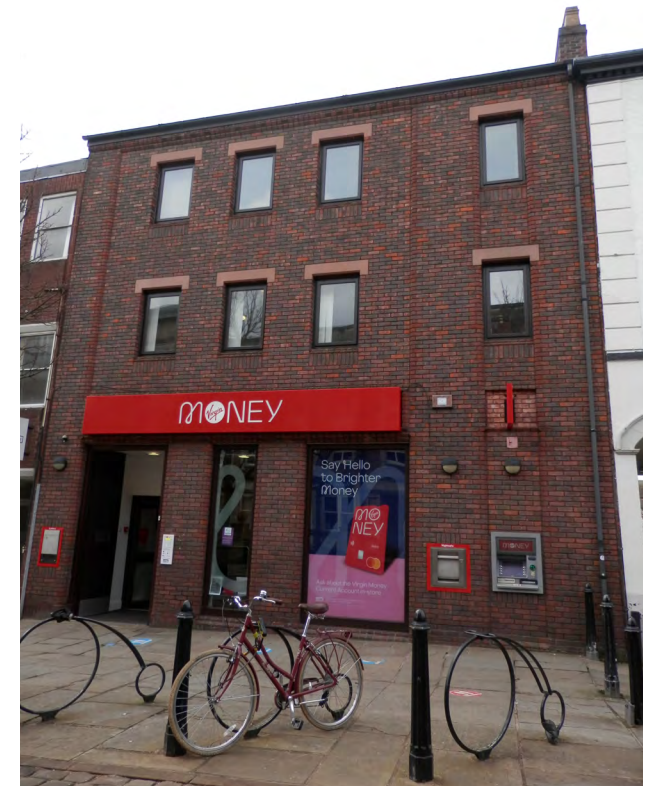
15 Market Place

Notes: As a modern development the building sits comfortably in the townscape in terms of its scale, however owing to its prominent location on Market Place it detracts from the historic character of the conservation area. It comprises three floors, constructed in red/brown brick with recessed sections arranged over four bays of single light window openings at upper floors with simple lintels. To the ground floor a simple contemporary shopfront suited to the character of the building, the box fascia sign and internal signage obscuring the window detract. Safe and ATM machine to the right-hand side. Detailing repeats to the rear, roof is pitched.

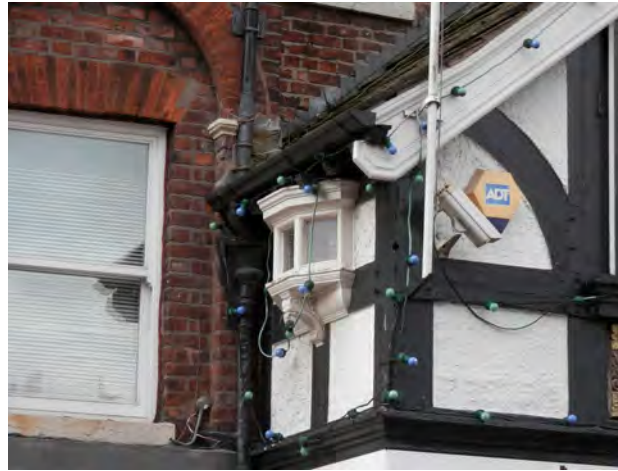
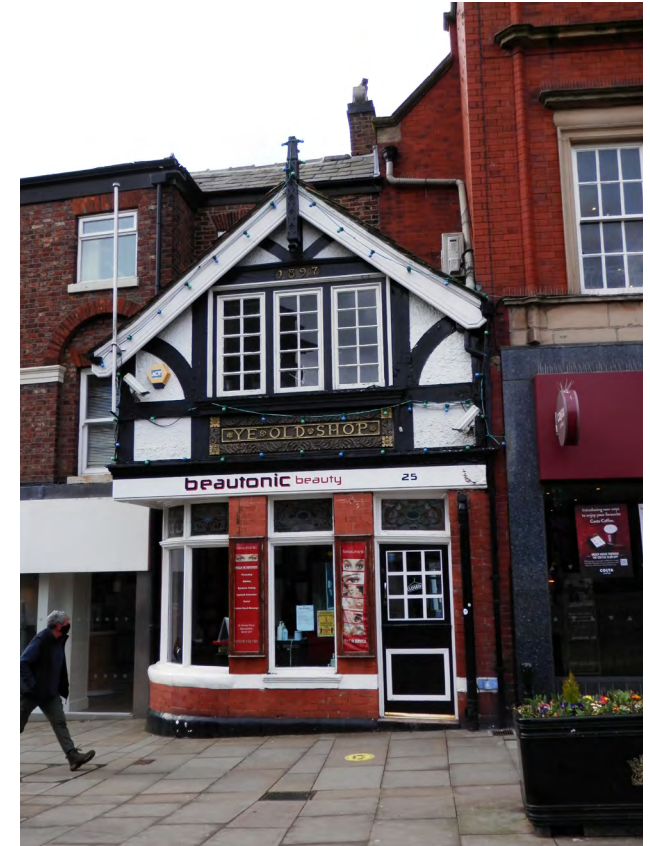
25 Market Place

Notes: A curious small-scale two storey building with small footprint. To first floor a gable end with barge board, timber boarding and rendered façade. A three-light windows with multi-pane light; above '1897' and below 'Ye Old Shop'. At ground floor the shopfront curves and the first floor oversails to the corner, red brick stallriser on plinth and flat red brick pilasters – decorative stained glass to transom lights and a panelled door with glazed top. Fascia sign is appropriately located although overtly contemporary; signage boards on the façade detract. To the south return a small bay window at high level on bracket. Modern security cameras and fittings/wiring detract.

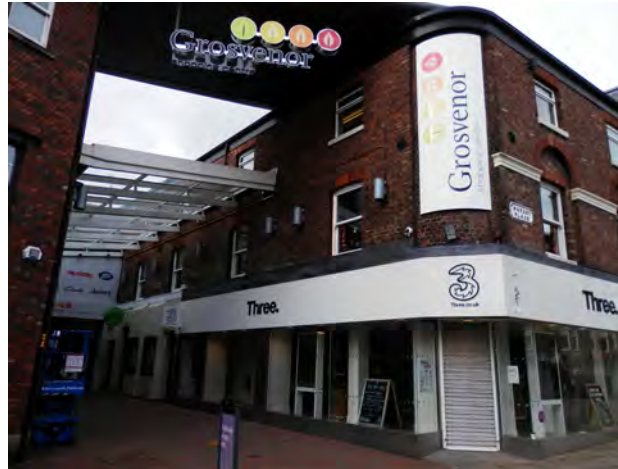
27-29 Market Place, side elevation

Notes: A three storey building constructed in red brick; two bays to Market Place which extends four deep bays to the rear with modern canopy for the Grosvenor Shopping Centre at roof level with hanging signage and between first and second floors behind – both of which detract. Windows at first floor are one-over-one timber sashes in brick arched recess with simple brick heads with moulded string course. To the second floor modern casements and a moulded cornice at roof level. To the shopping centre façade window details repeat at both floor levels. To the ground floor the modern shopfront, box fascia sign and roller shutter detract. Shopfront extends to the return elevation with the rear two bays now faced in tiles with display cases and utilitarian doors – all of which detract. Modern fixtures and fittings including lighting clutter the façade and detract.

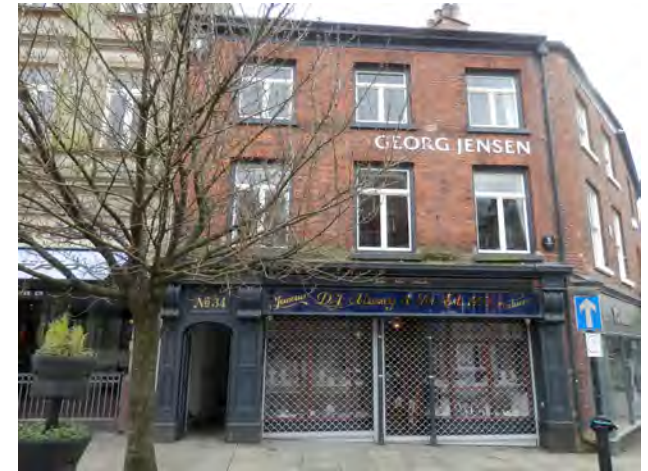
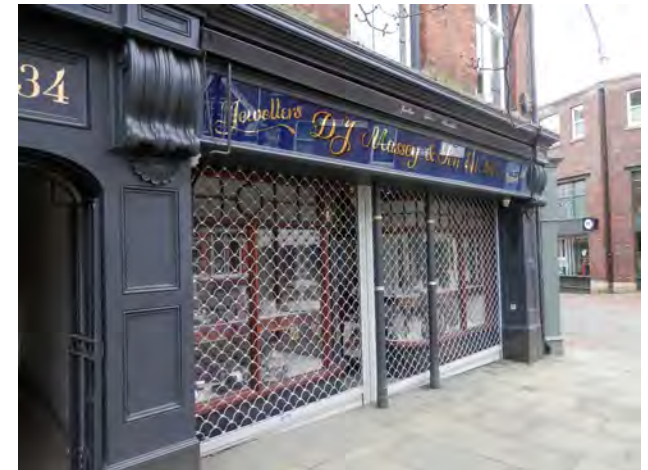
34 Market Place

Notes: A three storey red brick building comprising three floors arranged over three bays with two light casement windows with transom lights to the upper floors under flat-arched brick heads with stone sills. To the eaves a moulded cornice. The shopfront is a traditional design with curved recessed central entrance and framed by decorative pilasters. Mullions to the windows, decorative transom lights and stallriser. Two narrow columns support the fascia above with traditional signage and awning. Shutter is open lattice which allows views through to the shopfront although would be better located internally. Arched passageway to the left-hand side with metal decorative gate.

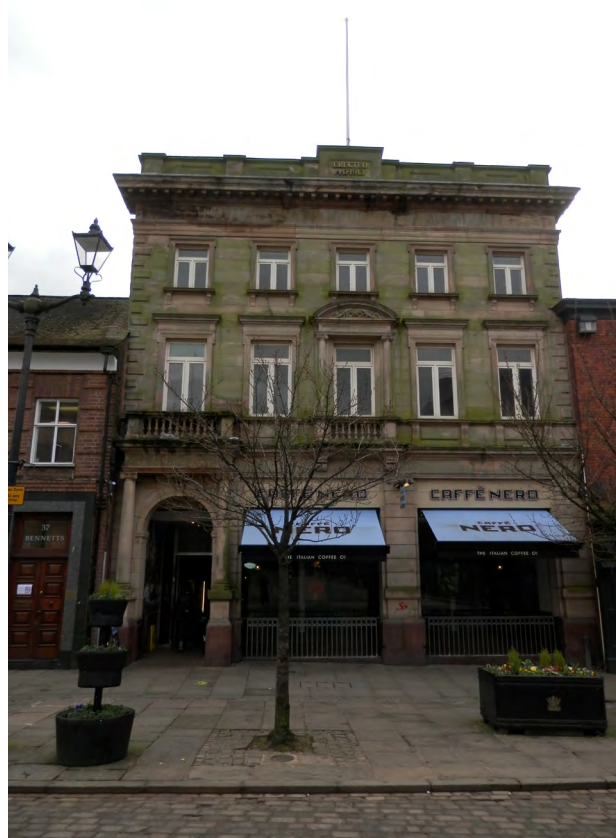
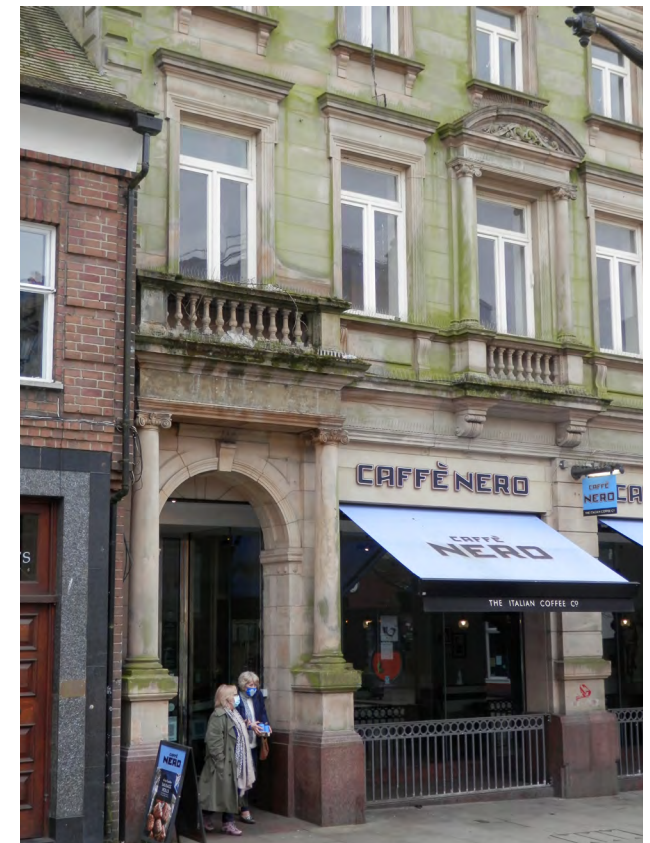
35-35b Market Place

Notes: A prominent building on the south side of Market Place which references the Greek Revival style of the Town Hall arranged over five bays. Constructed in ashlar with the entrance framed by a pediment with Ionic columns in front of an arched opening with recessed modern entrance. Bottle balustrade above – repeated to the centre of the first this time on brackets. Central window at first floor has a segmental arched pediment, again on Ionic columns. Windows otherwise have moulded architraves, simpler to the second floor with bracketed sills. Windows are two light casements with transom light above. To the roof level a prominent dentil cornice with panelled parapet above. To the ground floor two contemporary recessed shopfronts and railings flush with the building line; awning housing accommodated within the recess. Signage above is letters only, restrained and appropriate.

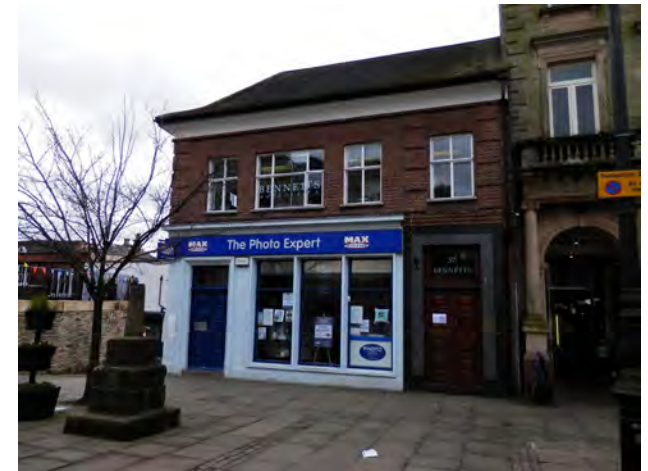
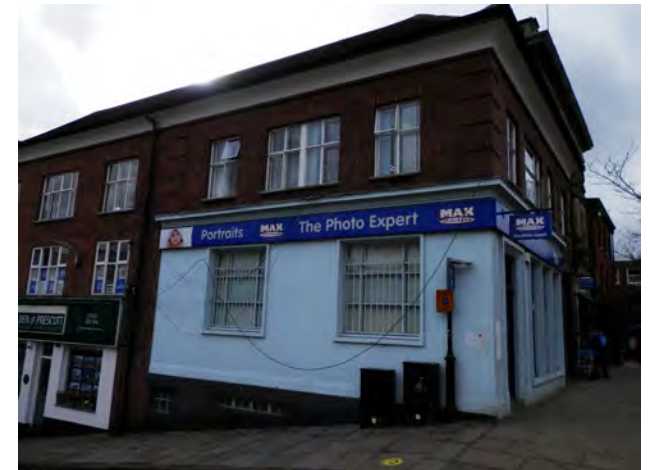
37-39 Market Place

Notes: A two storey brick building that continues round in to Church Street and follows the proportions of the wider streetscape. Constructed in red brick with brick quoins to the corners and framing the right-hand bay. Four window bays; four light timber casements to all but the larger six-light openings with simple brick heads and stone sills. Pitched roof with curved cornice to eaves. The entrance to the right-hand side has a granite architrave, panelled door and fanlight above. Shopfront follows a traditional composition with mullions, fascia and cornice however the colour and modern box fascia sign are unduly prominent and detract. Panelled entrance door repeats to the shopfront. Windows to the return elevation follow the design of the principal façade; central window paired with mullion. The ground floor is rendered and painted white, alongside the fascia which continues to this elevation this detracts. Two large multi-pane windows at ground floor which appear to be blocked internally which again detracts.

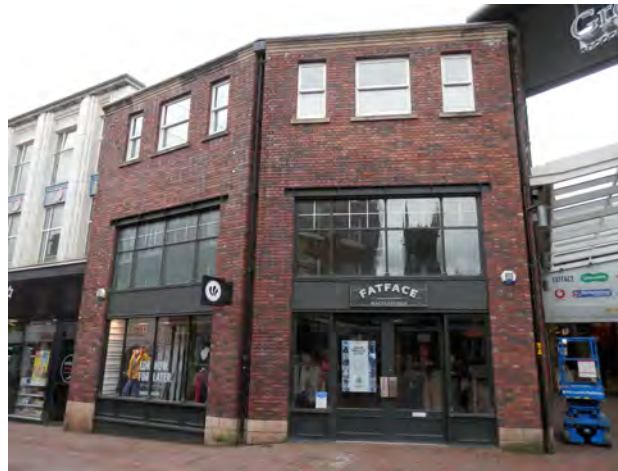
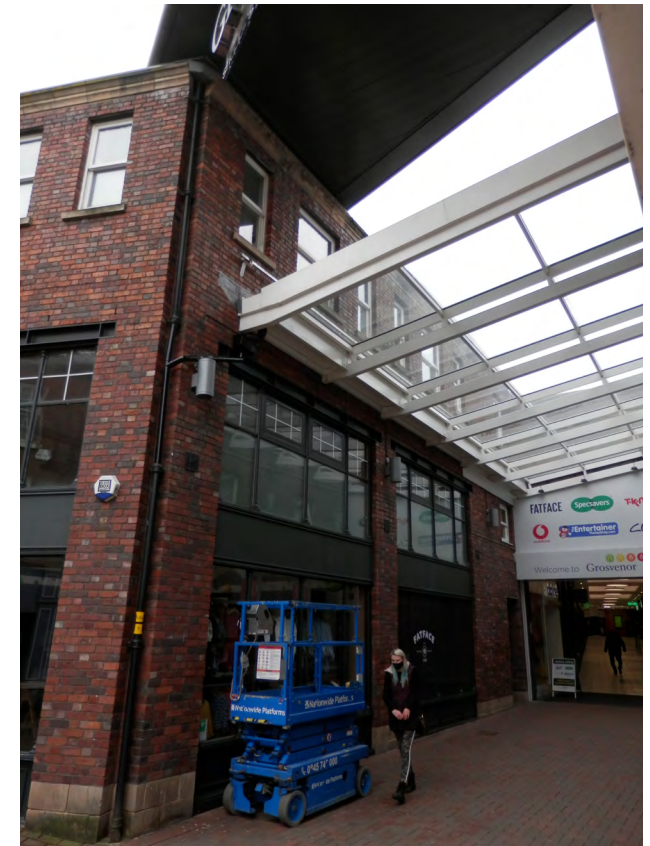
1-3 Mill Street

Notes: A three storey building, two bays to Mill Street set at an angle. Constructed in red brick with stone plinth and cornice; three windows at second floor all with one-over-one sash windows with stone sills. The double height shopfronts set under metal bressumer beam are at odds with the character of the historic shop frontage, they are otherwise well detailed with decorative mullions and panelled stallrisers and would otherwise form a good example. The detailing repeats to the side elevation with extends into the Grosvenor Shopping Centre with canopy at roof level with hanging signage and set above the double height shopfronts.

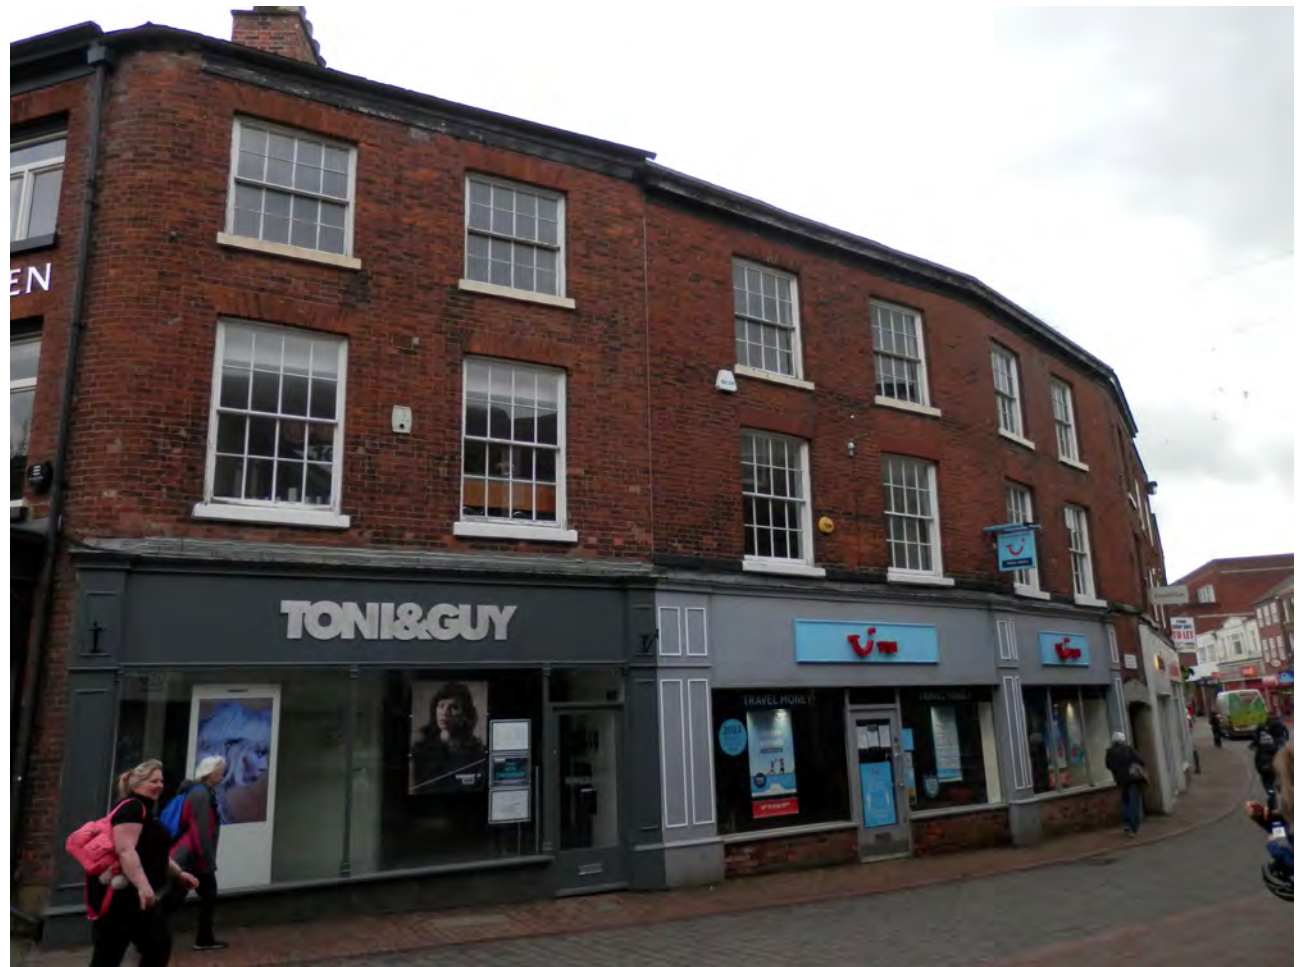
2-6 Mill Street

Notes: A group of three red brick buildings set at an angle and comprising three floors; each with two bays at upper floors. Windows are eight-over-eight timber sash windows with brick heads and painted stone sills – a moulded cornice at eaves level. Shopfront to no.2 is a good example with stallriser, decorative mullions and framed panelled pilasters. Fascia signage is appropriate. To nos.4 and 6 the deep fascia board gives the shopfronts a stunted appearance which detracts despite the otherwise incorporating traditional detailing.

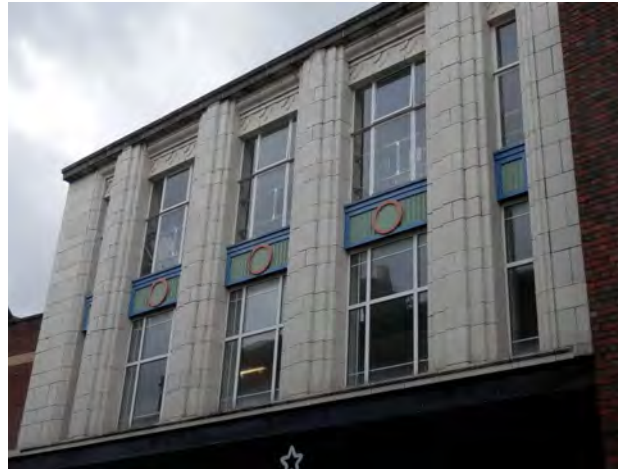
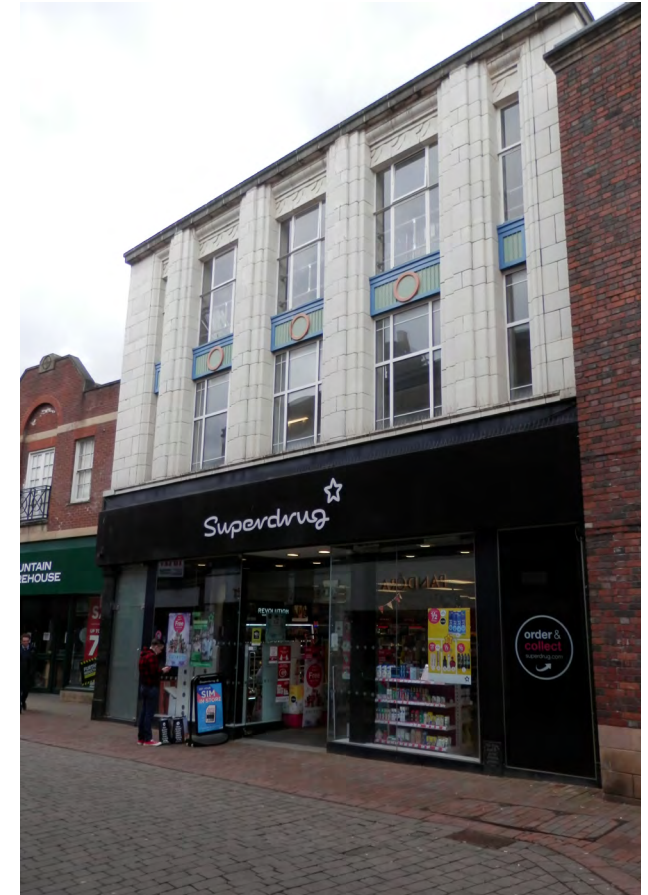
5-7 Mill Street

Notes: A distinctive art deco building which is at odds with the prevailing character but adds interest to the townscape. Comprises three floors arranged over five windows bays framed by column tiled columns. Windows are casements with side-lights and transom lights – modern replacements at first floor – narrow to the two outer bays. Decorative panels between the floors which add interest. The modern shopfront does not relate to the architectural character of the building whilst the box fascia sign is oversized and detracts.

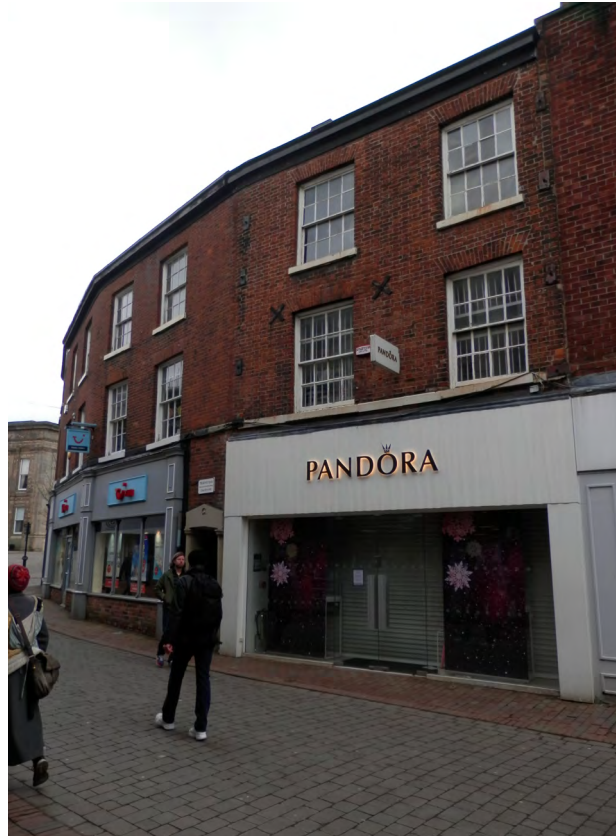
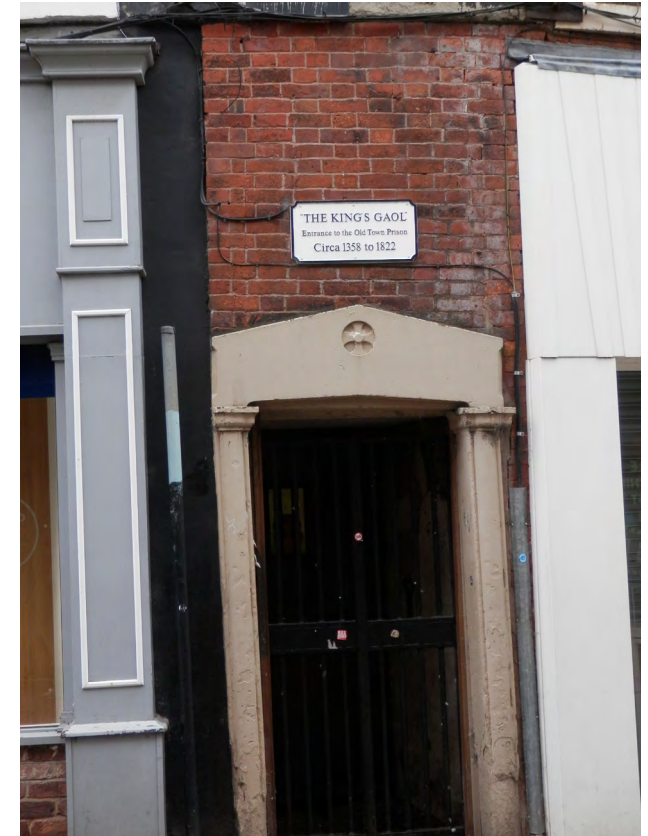
8 Mill Street

Notes: A red brick building comprising three floors; arranged over two bays at upper floors. Windows are eight-over-eight timber sash windows with brick heads and painted stone sills – a moulded cornice at eaves level. The fully glazed contemporary shopfront, oversized fascia and projecting sign are poorly suited to the architectural character of the building and detract. Passageway to the right with pedimented doorcase set on columns and metal gate – above a sign which states 'The Kings Goal – Entrance to the Old Town Prison – Circa 1358 to 1822.

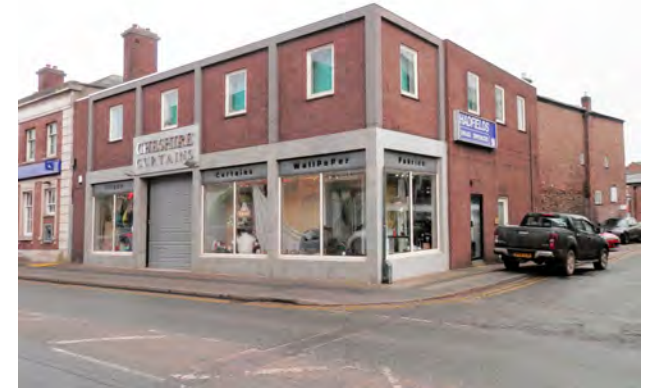
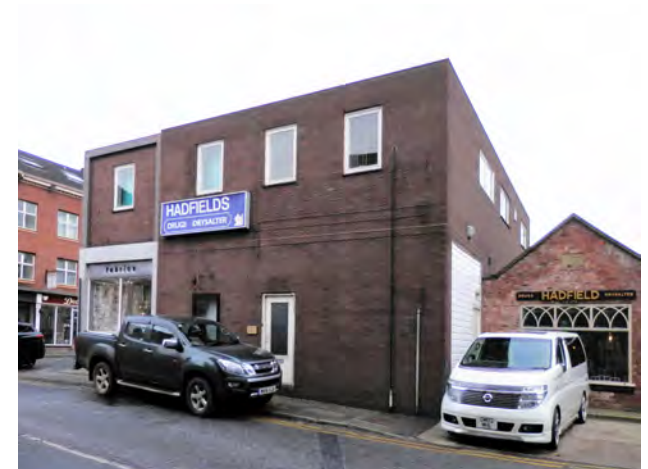
89 Stanley Street

Notes: A red brick building facing Churchill Way and comprising two storeys. Four bays to Churchill Way, set within a rendered frame with single fixed light windows at first floor and contemporary shopfront below. The roller shutter to the entrance bay and oversized signage above detracts. Detailing continues for one bay to return elevation before a simpler three bays with no framing – again to the rear. Oversized signage detracts and infilled opening to rear does not follow the character of the building. Comfortably accommodated in streetscape owing to its scale but otherwise fails to relate to its historic context.

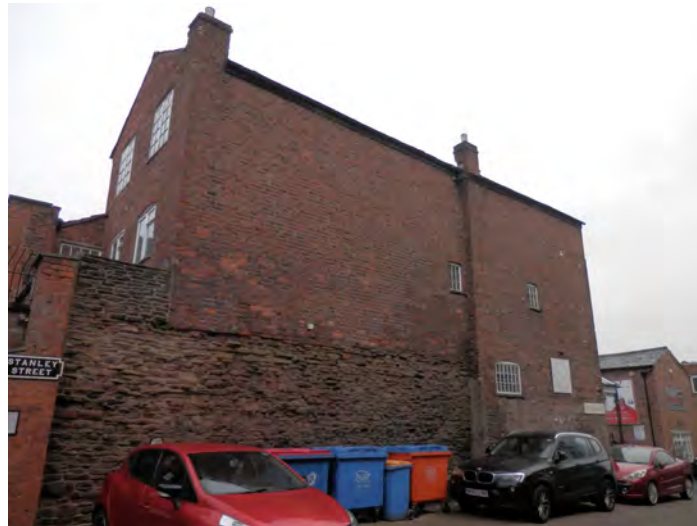
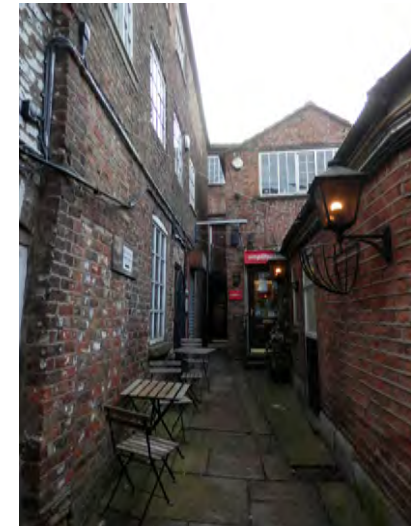
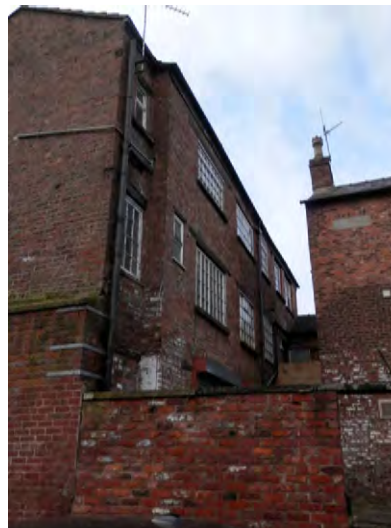
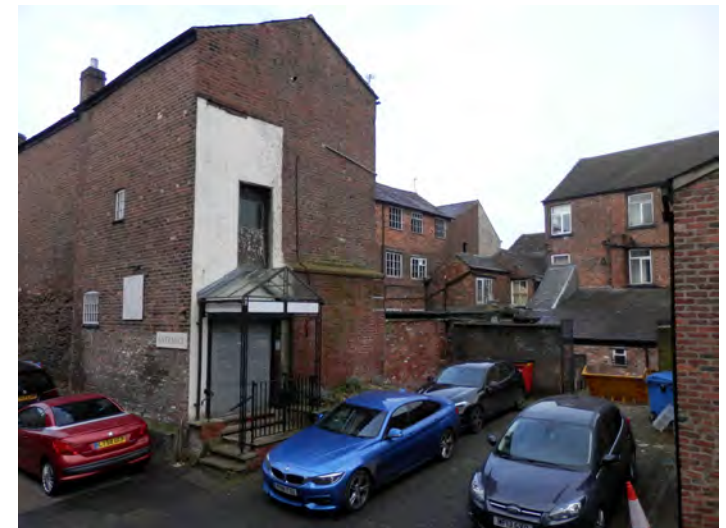
Stanley Works, Stanley Street

Notes: To Stanley Street a tall brick range with coursed rubble to the lower part of the façade and three multi-pane fixed light windows with arched brick heads and a protruding chimney stack. Pitched roof with a gable end and modern windows under brick arched headers to west façade. To the east façade a rendered and painted section with modern glazed canopy and roller shutter – all at odds with the character of the building. To the rear large windows openings with multi-pane windows with simple lintels and sills – detracting roller shutter and housing at ground floor. A rear range, stands perpendicular – connected by a shallow brick bay – which extends into the courtyard accessed from Chestergate. Three storeys, the second a later extension, with pitched roof, windows again are largely multi-pane casements – with a number of detracting insertions.

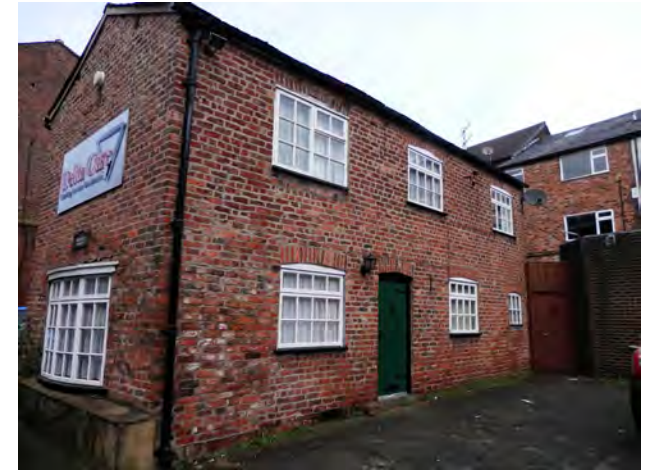
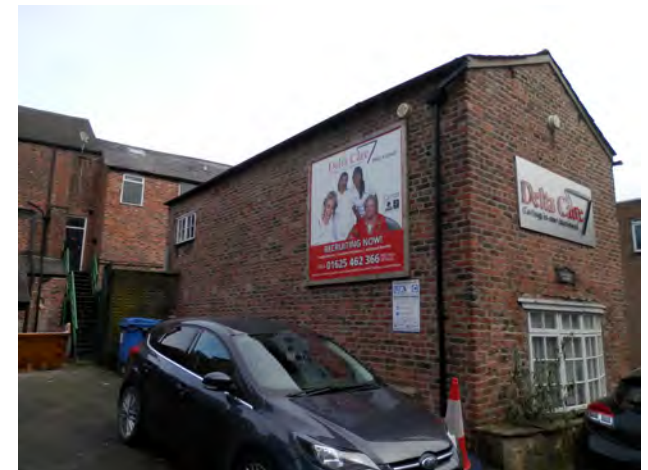
Stanley Mews, Stanley Street

Notes: A simple two storey block with pitched roof and gable end. The front elevation comprises three bays at first floor with a multi-pane casements under cambered brick heads; repeated at ground floor with the timber boarded entrance door centrally located. Constructed in red brick with a cambered multi-pane bay windows at ground floor in the gable end. To the rear elevation a high level paired window with four-lights to the left-hand side. High level and oversized signage detracts as well as other modern fixtures and fittings to the façade.
