Donald Insall Associates
Chartered Architects and Historic Building Consultants

Macclesfield Conservation Area
Gazetteer

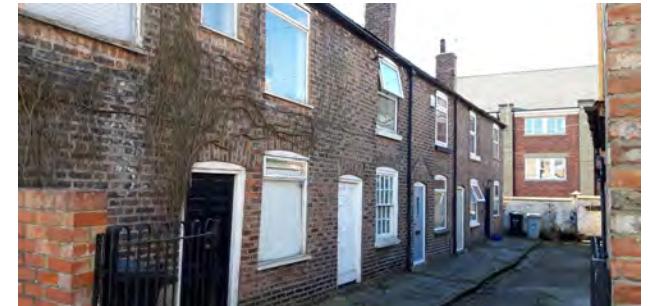
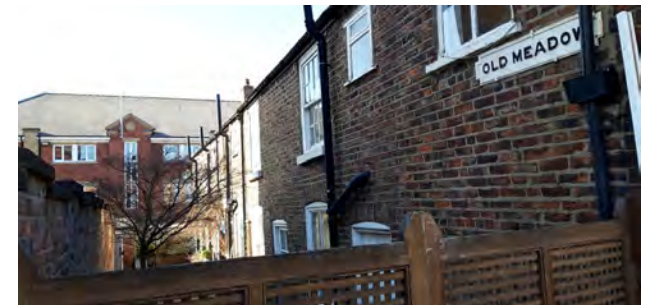
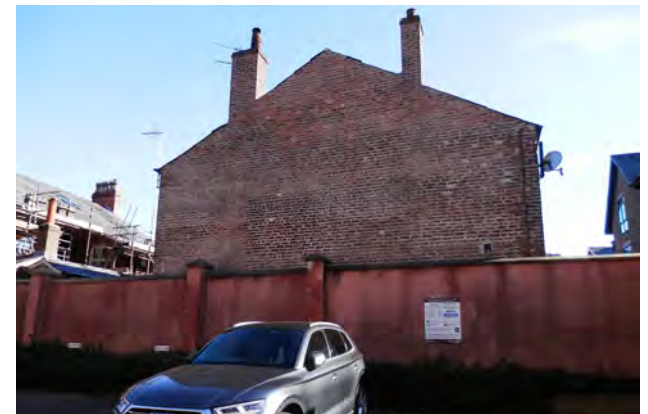
3-6 Old Meadow, Bridge Street

Notes: A small mews set perpendicular to Bridge Street behind a red brick wall with modern gate. Two storeys in brown brick comprises single window bays with doors offset, all under cambered brick arches. Pitched roofs with tall chimney stacks. Eight-over-eight sashes at ground floor to no.4 otherwise windows are uPVC casements which detract. Doors are all modern replacements. Gable end visible to west; rear elevation visible in oblique views.

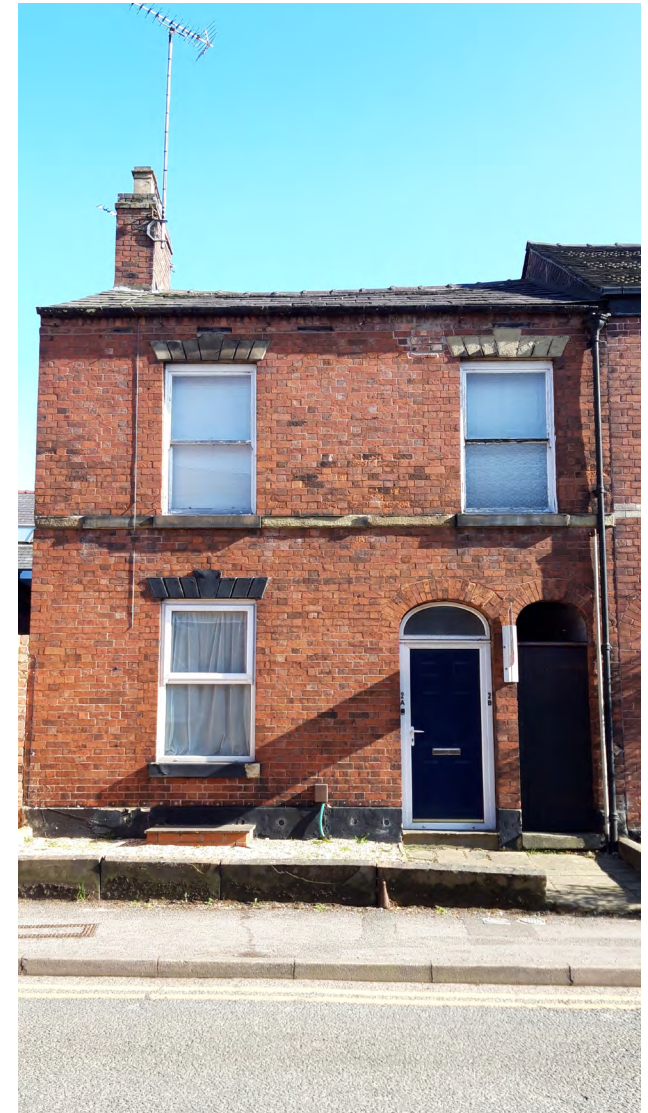
2 Catherine Street

Overall condition: Fair

Notes: No.2 stands at the end of a uniform group with a differing character, emphasised by the step down in the roofline. Roof is pitched, slate clad with a chimney stack to gable end. It comprises two storeys and is constructed in red brick with stone banding aligning with the stone sills, keystone lintels and brick dog tooth detailing to the eaves. Windows at first floor are one-over-one timber sashes whilst at ground floor are uPVC. The entrance door and passageway are set under brick arches with fanlights; passageway has a door.

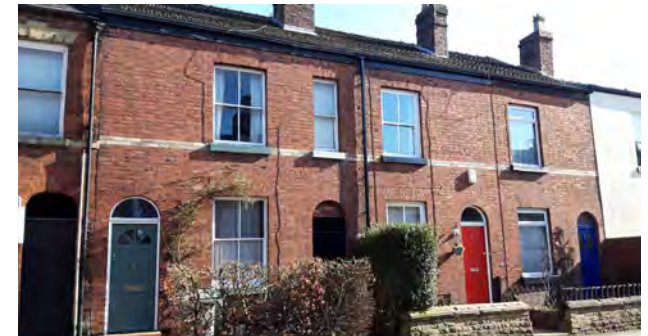
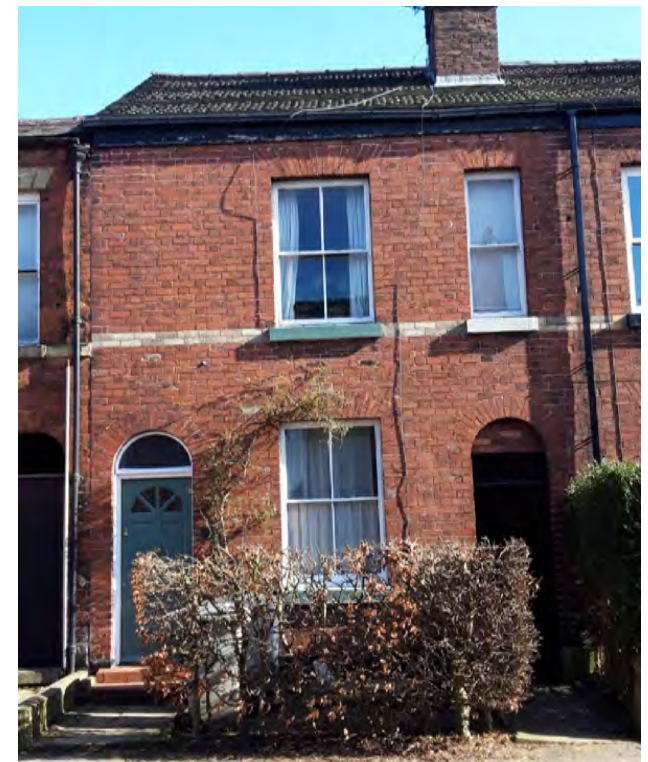
4-8 Catherine Street

Notes: A handsome group of two storey residential properties, constructed in red brick with white brick banding at first floor sill level, flat gauge brick lintels and stone sills. Roof is pitched and punctured by chimneys. Doors are a variety of timber panelled doors with plain fanlights above set in brick arches. Front yards are bound by dwarf stone walls to nos.6 and 8 with hedging to no.4. The passageway through to the rear at no.4 has a door with a narrow one-over-one sash above. Otherwise windows to no.4 are original two-over-two sashes; to no.6 are replacement two-over-two sashes and at no.8 are modern casements – the sequence of these windows demonstrates the impact that poorly designed replacement windows can have.

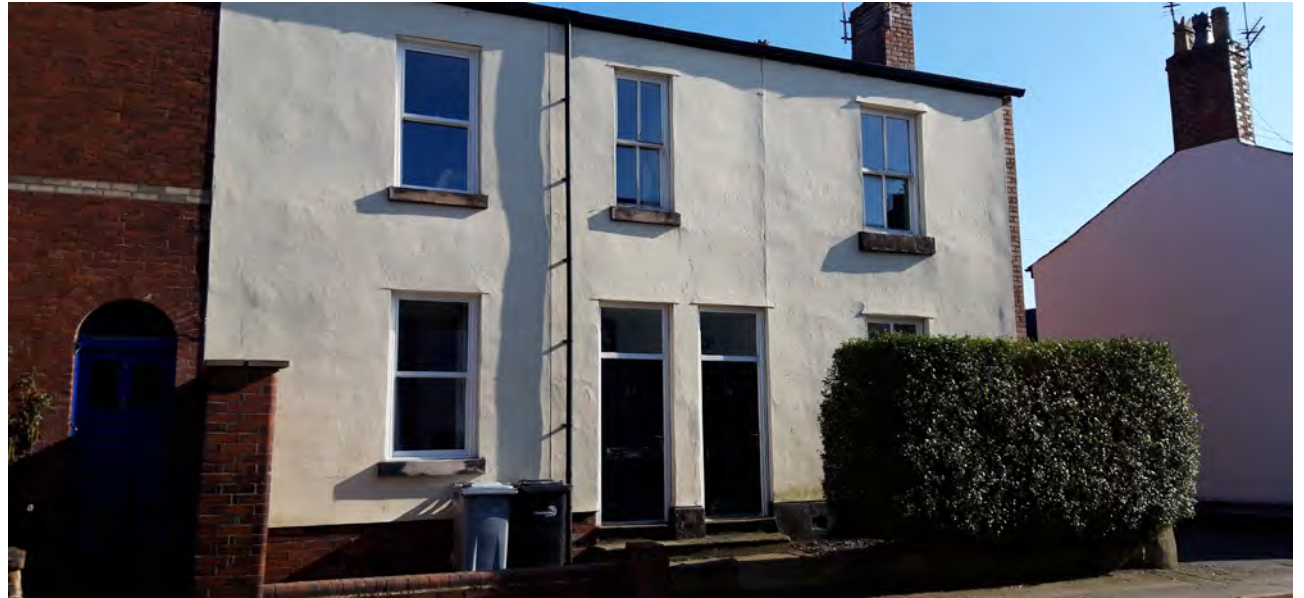
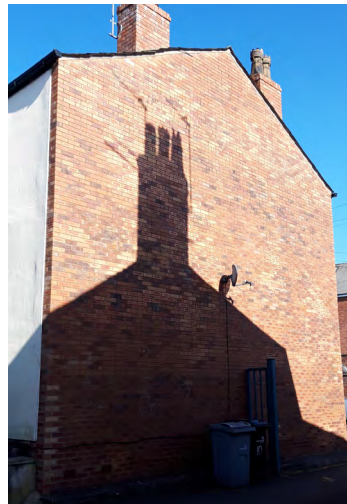
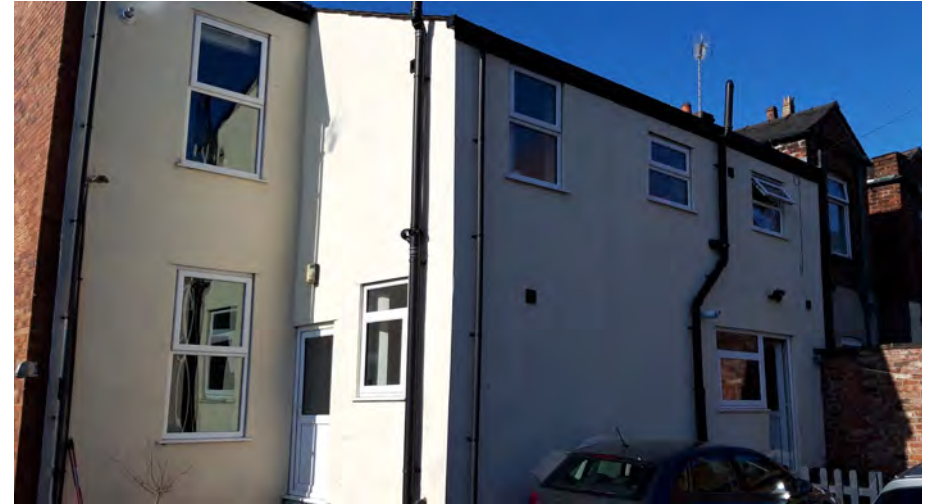
8a-10 Catherine Street

Notes: Earlier pair than adjoining terrace to the north; two storeys set behind small front yards with a rendered and painted façade. Windows to no.10 and the central bay above passageway (now infilled) are two-over-two timber sashes; to no.8 are uPVC sashes – all with stone sills. Doors are six-panelled with overlights. South facing return is red brick with a gable end, roof is pitched – punctured by chimney stacks. Parking to rear; rear elevation is again rendered with uPVC casements across both buildings.

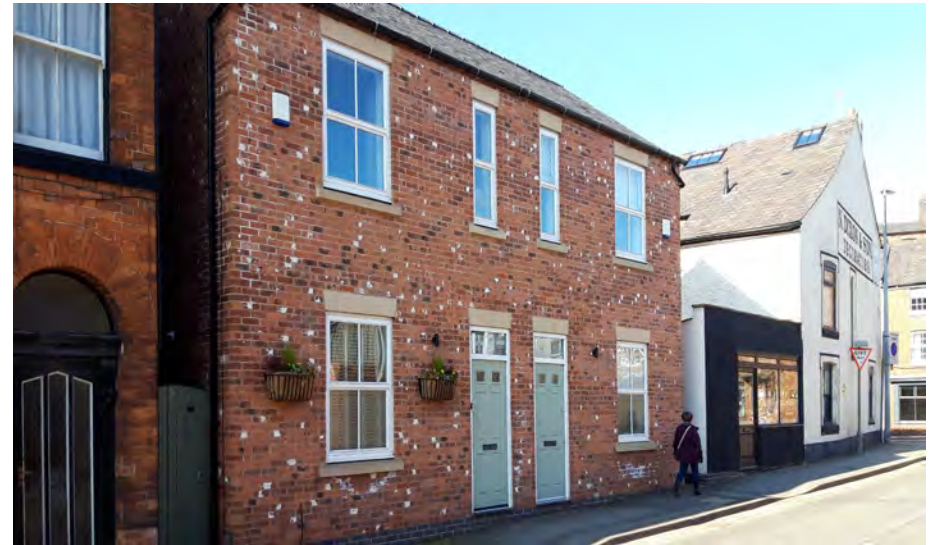
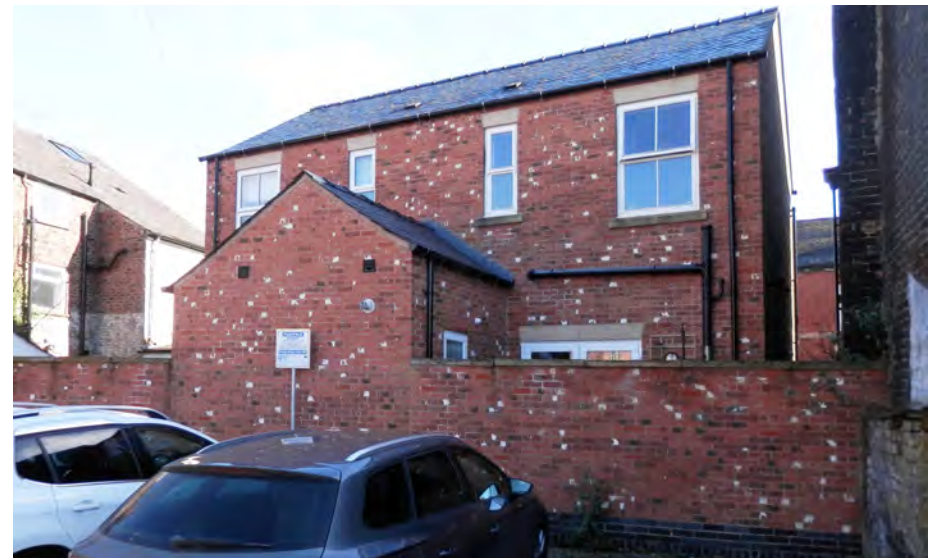
1a-1b Catherine Street

Notes: Residential scheme replacing former warehouses, contextual design and scale with pitched roofs although the detailing including uPVC casement sashes and flat façade and absence of chimneys creates an inauthentic relationship with the rest of the street.

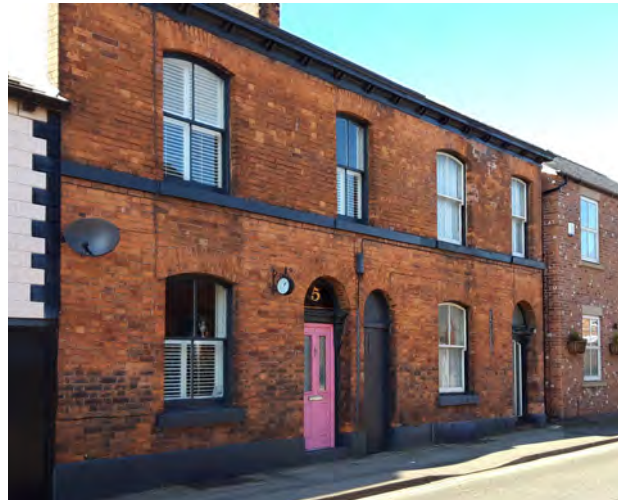
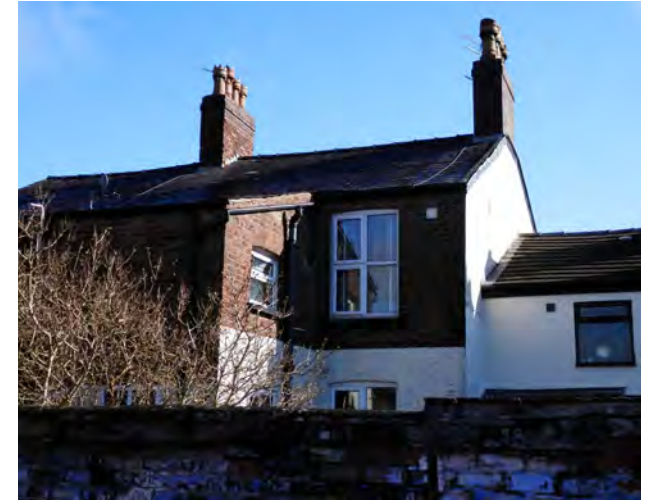
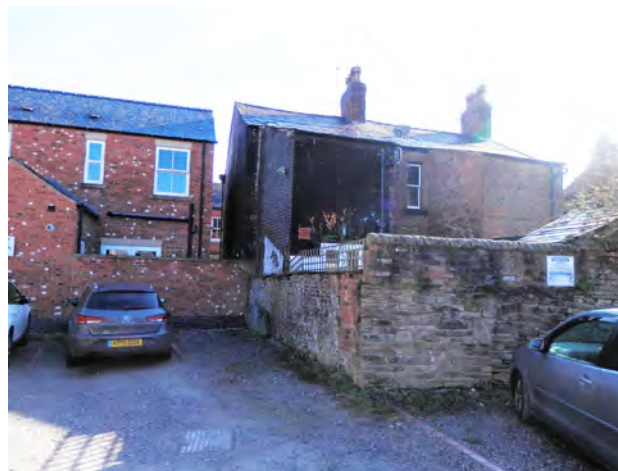
3-5 Catherine Street

Notes: A handsome pair of two storey residential properties built hard up against the pavement edge. Pitched roofs with chimneys and exposed gable ends. Constructed in red brick with painted banding at first floor sill level and plinth, arched brick lintels and stone sills and bracketed eaves. Door to no.5 is a four-panelled door with glazing to upper panels; to no.5 has full height glazed panels; both with bracketed doorcase and fanlight set under brick arch. Windows are two-over-two timber sashes. The passageway has a timber boarded door and to the fanlight. To the rear two storey wings continue from the roof pitch, plain brick and partially painted; uPVC casements to rear of no.5.

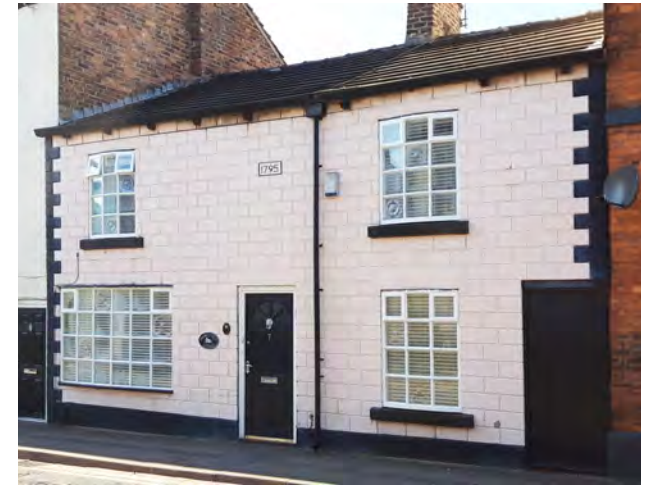
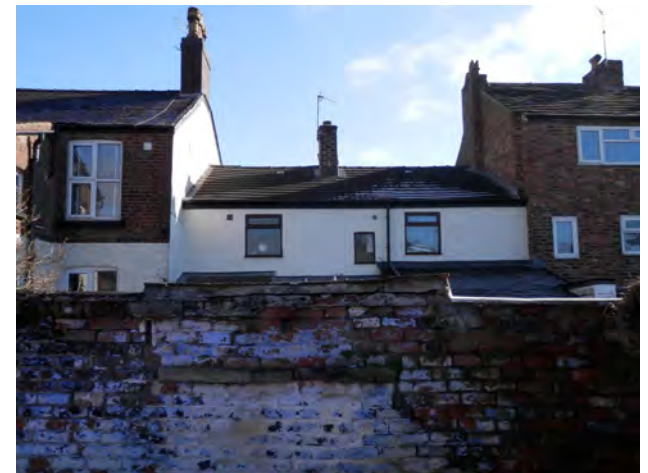
7 Catherine Street

Notes: A small scale, two storey building with a wide frontage. Date on façade states 1795 however it has clearly been refronted with rusticated render; painted quoins and bracketed eaves. Curved windows at first floor and a wide curved windows to the left-hand side at ground floor; flat to right-hand side. Windows are multi-pane timber casements. Rear is rendered and painted with casement windows and projecting single storey wings.

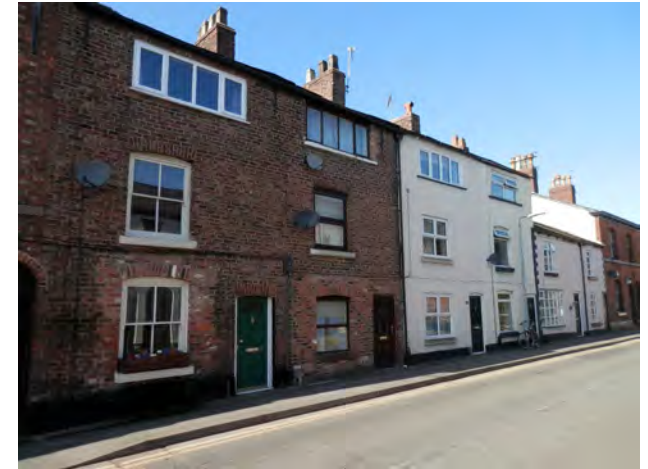
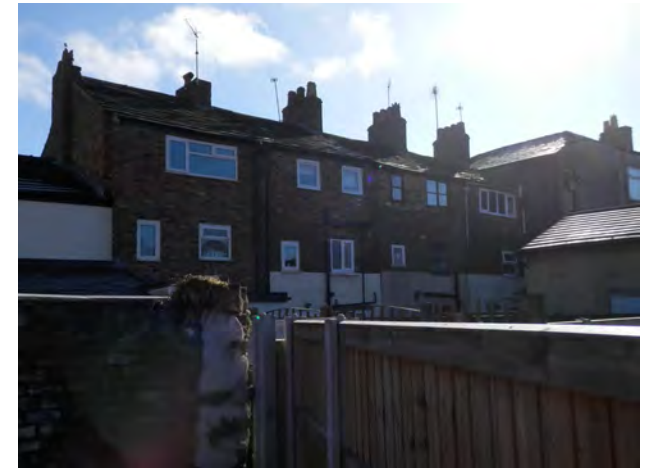
11-17 Catherine Street

Notes: A three storey group of four buildings; constructed in red brick with pitched roofs and chimneys. Wide window openings at second floor suggest a link to the silk industry. A number of alterations have been undertaken to the façades which have eroded their character to a degree, of greatest impact is the rendering and painting of nos.11 and 13; patched brickwork at nos.15 and 17 suggest shopfronts have been removed and infilled. Windows are uPVC casements; other than two-over-two sash windows at no.17. Doors are a variety of modern panelled; arched brick lintels to doors and windows at ground and first to nos.15 and 17. uPVC windows to rears and ground floors painted (visible extension to no.11).

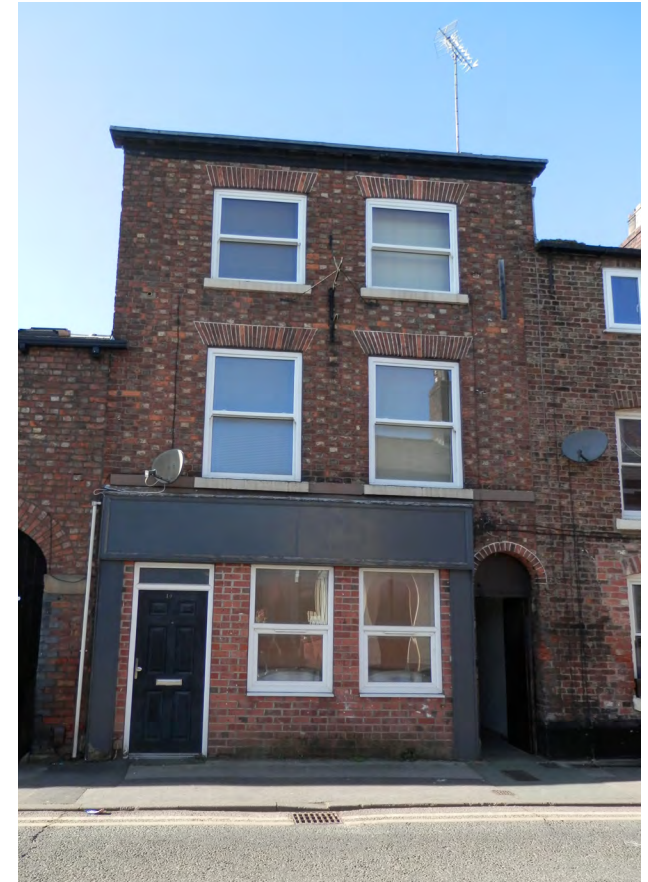
19 Catherine Street

Notes: A taller three storey, red brick building than the adjoining group to the north. Windows are modern uPVC, sills have appear replaced and lintels repointed. Banding aligns with first floor sills. The arched passageway opening remains at ground floor, with a door inserted. A previous shopfront has been removed and infilled with the fascia and plain pilaster retained which have compromised the proportions, and poorly detailed brickwork and windows which detract.

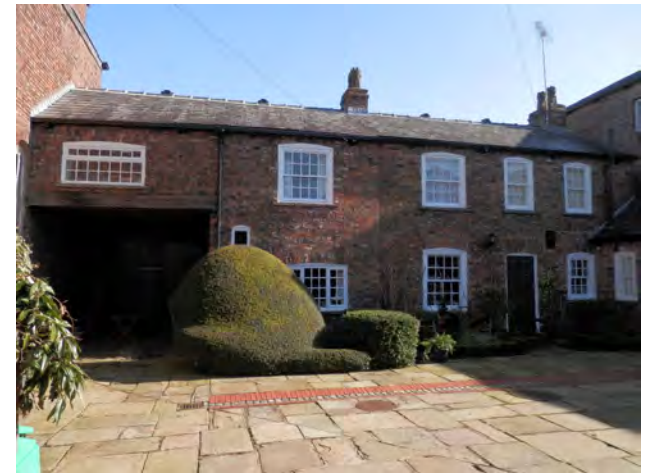
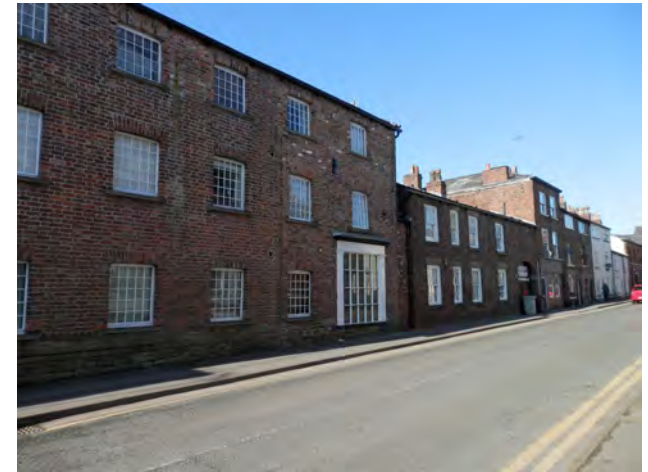
Notes: A former foundry, this presents a successful conversion of a former industrial complex into a large development of flats, consented in 1987. The border of the conservation area lines along three frontages with cobbled streets in front of the ranges to Pinfold Street and Pierce Street. L-plan range enclosing a courtyard with traditional paving adjacent to the building; each part of the complex style retaining its distinctive scale, character roof form and detailing. To Catherine Street a shopfront remains in the right-hand bay of the three storey block whilst signage and what appears to be access for bins infills the former arched entrance to the north. The car parking to the north is of no particular merit with modern setts but otherwise the development has stood the passage of time well.

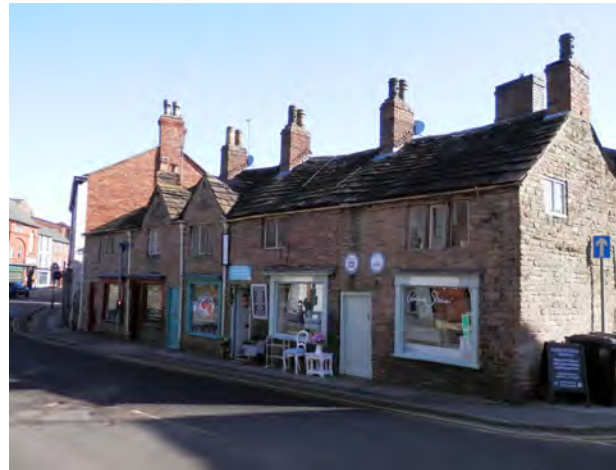
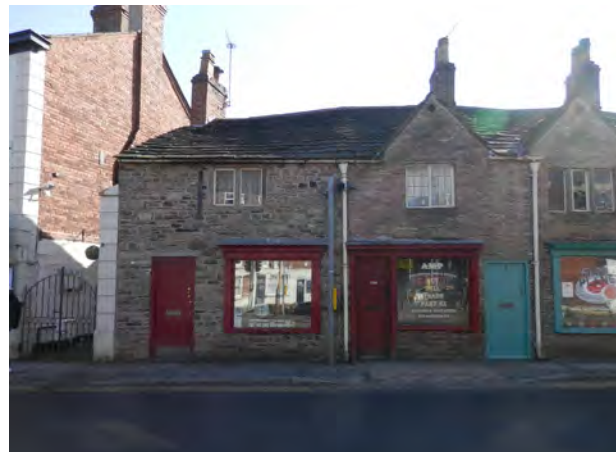
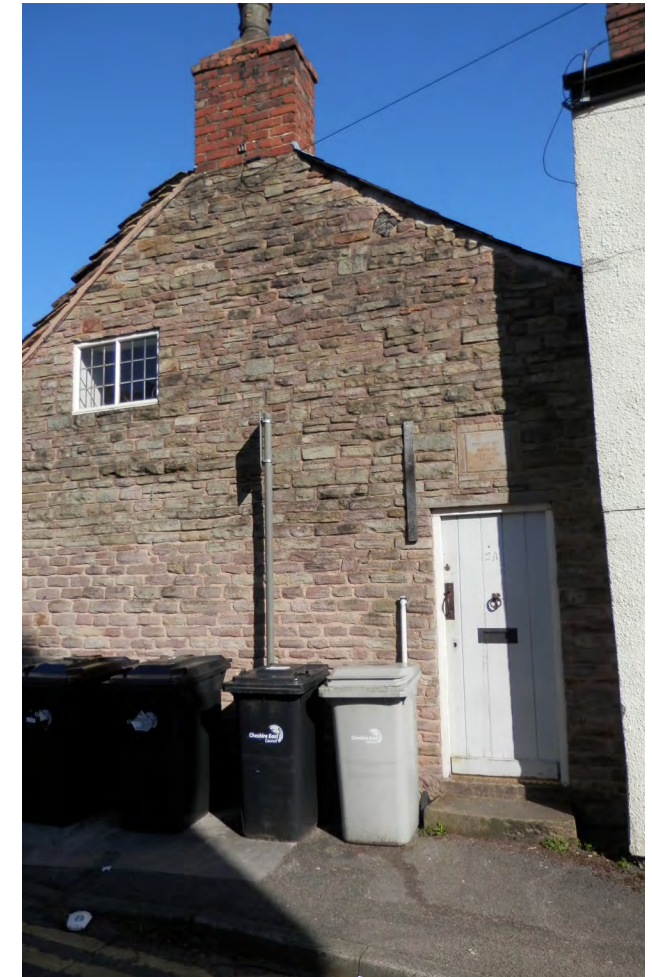
1-7 Chester Road

Notes: Handsome and best example of early-17th century cottages, small scale terrace of three in local sandstone with Kerridge stone-flagged pitched roof, brick chimney stacks and original stone mullion windows at first floor. Irregular composition with gables to nos.1 and 3 and no.1 double width. Ground floor 19th century shopfronts add charm although signage at nos.5 and 7 demonstrate the challenge of retail uses in small-scale buildings of this nature. Further access from alley to rear on Pinfold Street with exposed gable end and side door to no.7. Important in the understanding of the historic development of the conservation area.

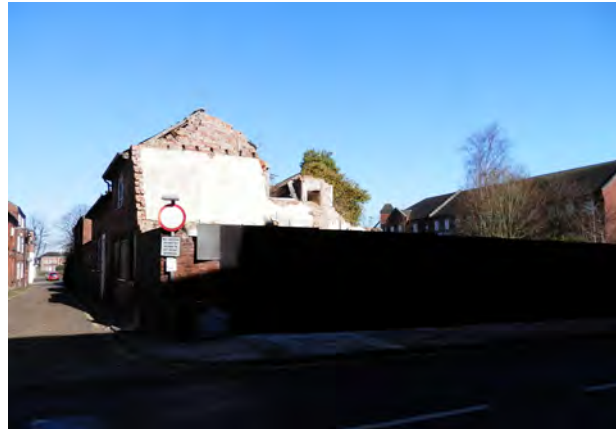
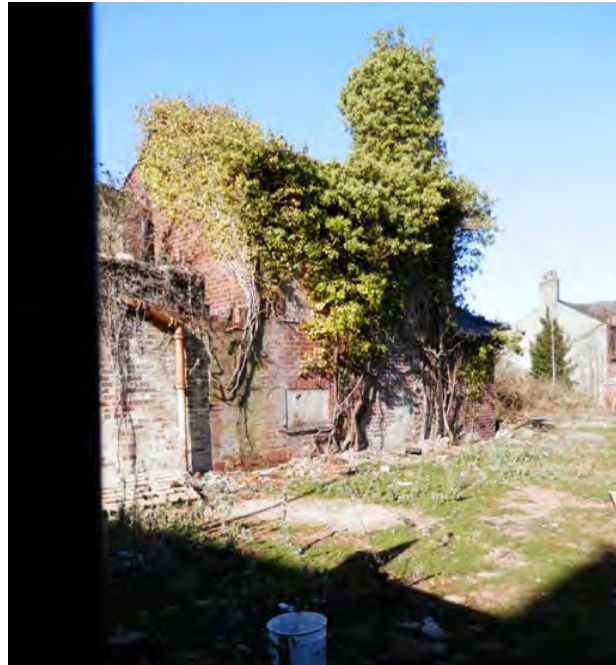
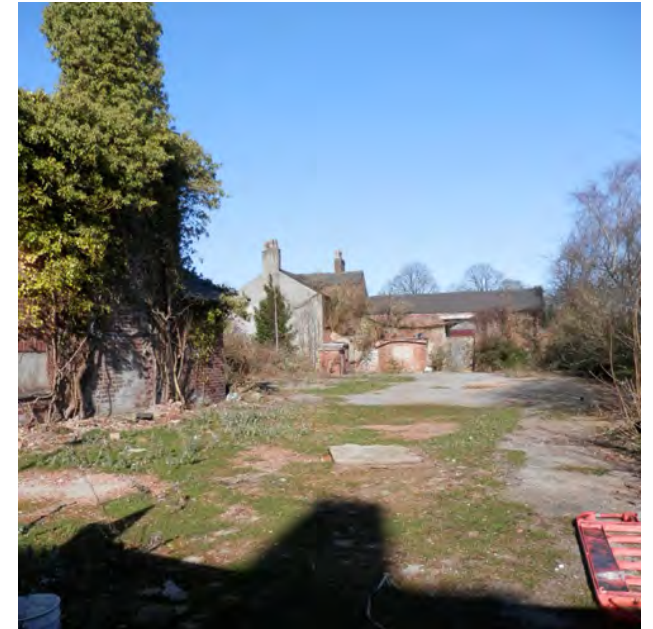
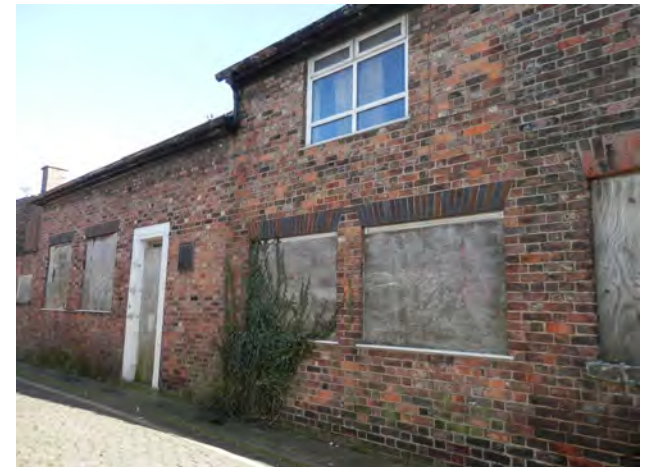
61-63 Chestergate, Former Kings Head Public House

Overall condition: Demolished

Notes: Following the demolition of the King's Head Public House only fragments of the historic building remains fronting Little Street. The Little Street frontage steps down along the street and is characteristic of a secondary façade; red brick with red brick lintels this remaining section contributes to the historic character of Little Street. However windows are largely boarded with a uPVC casement at first floor. Otherwise the site is vacant behind boarding and in need of redevelopment.

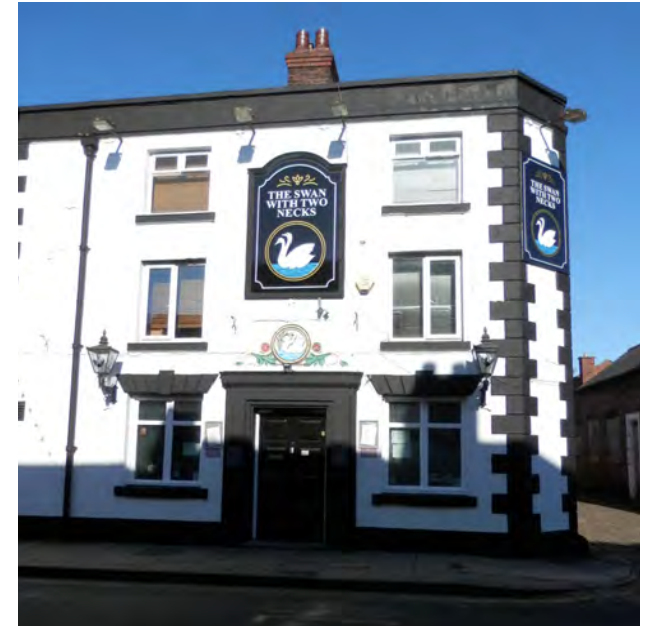
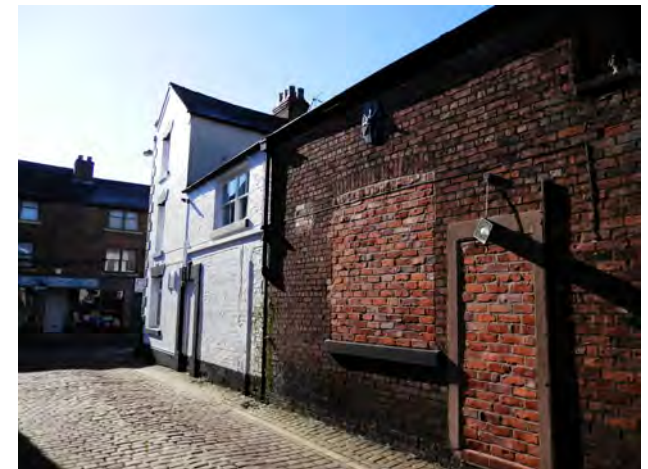
65 Chestergate

Notes: The Swan with Two Necks stands on the corner with Little Street and is set over three storeys; roof is pitched with a chimney stack. It is rendered and painted with quoins to the canted corner and lintels with keystone to the ground floor windows and windows in the side return which continues the detailing of the main façade for a single bay. The high level signage and lantern lights is characteristic of the use, the high level lights are more utilitarian and modern casements detract. Brick outbuildings step down and project to the rear with the first section painted; openings are largely infilled with a single window opening at first floor with a pair of modern sashes.

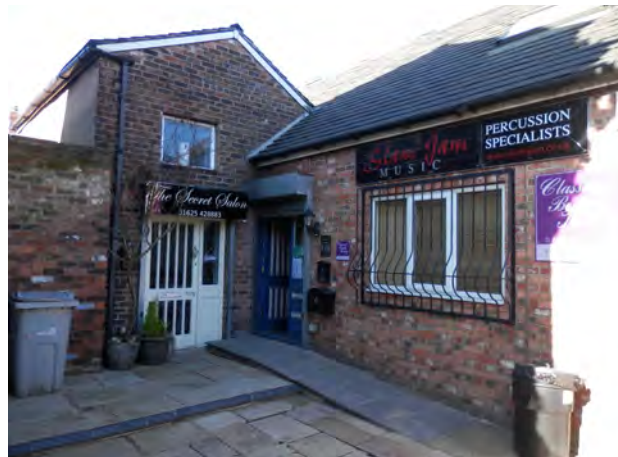
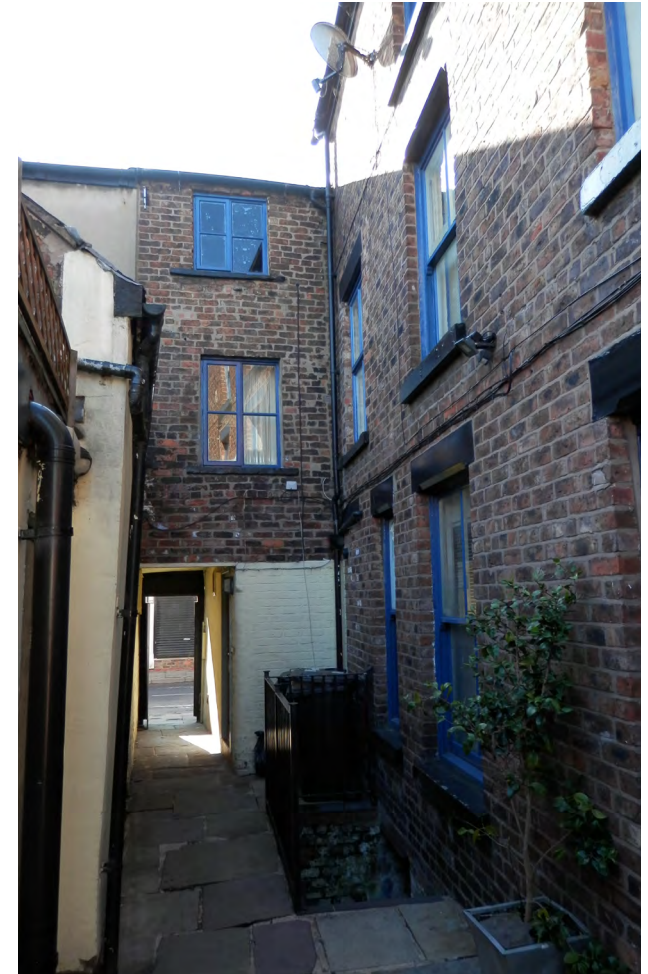
Notes: Simple red brick, three storey building with brick lintels to first floor and two-over-two timber casements. The shopfront at no.67 is a good example, fascia in poor condition; shopfront and shutter housing at no.69 detract. Timber fixings on the façade and flue all add clutter and detract. Passageway to the right-hand side provides access through to the rear when a large three storey wing projects with timber sashes and further small scale modern outbuildings. Chimney stacks to the gable ends of the pitched roofs.

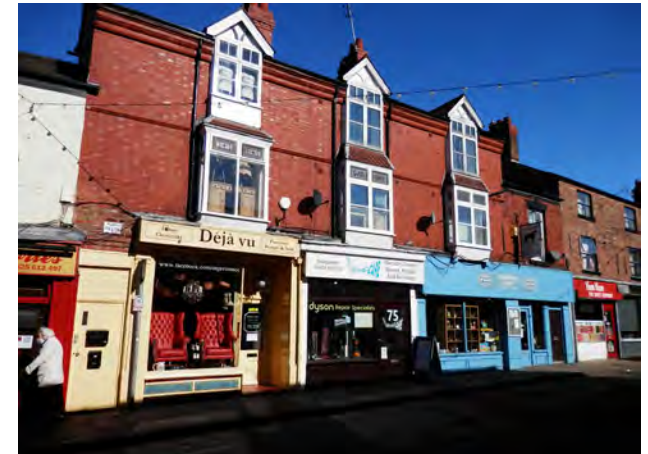
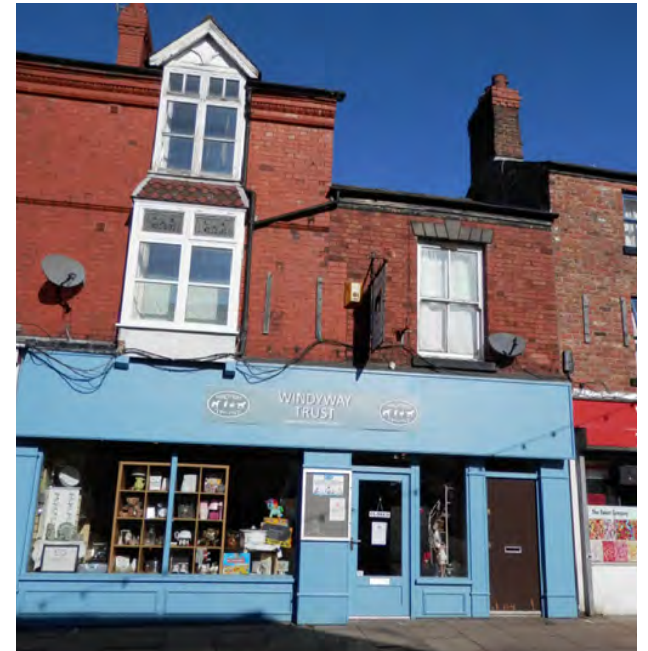
71-77 Chestergate

Notes: Nos.73 - 77 are stylistically different from the prevailing character with Edwardian detailing including projecting central bays at first and second floors with gables puncturing the roofline, with cornice, tiles to the bays at first floor and stained glass to toplights. Otherwise arranged over three storeys, with pitched roof and chimney stacks set perpendicular to one another. No.71 is a smaller scale earlier building with a sash window at first floor with keystone lintel. Shopfronts are all good examples, however the shopfront spanning across nos.71 and 73 blurs the definition of the original building and the fascia is oversized. The first floor projecting sign at no.71 and wires/clutter across the façades detract. The passageway to the side of no.77 is blocked with a door.

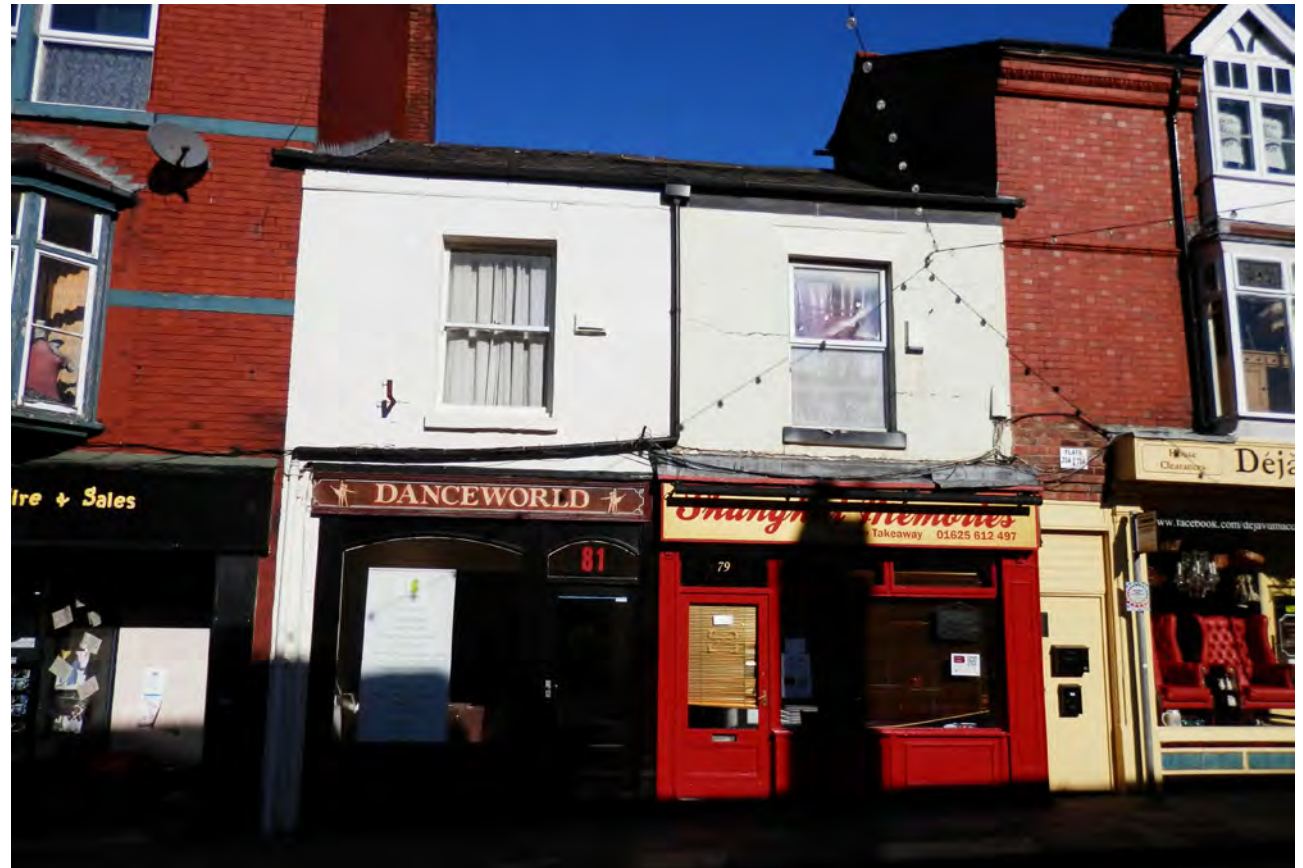
79-81 Chestergate

Notes: A pair of two storey buildings in the largely three-storey streetscape with pitched roofs; rendered and painted with good examples of shopfronts at ground floor. Wires to no.79 and some fixings add clutter.

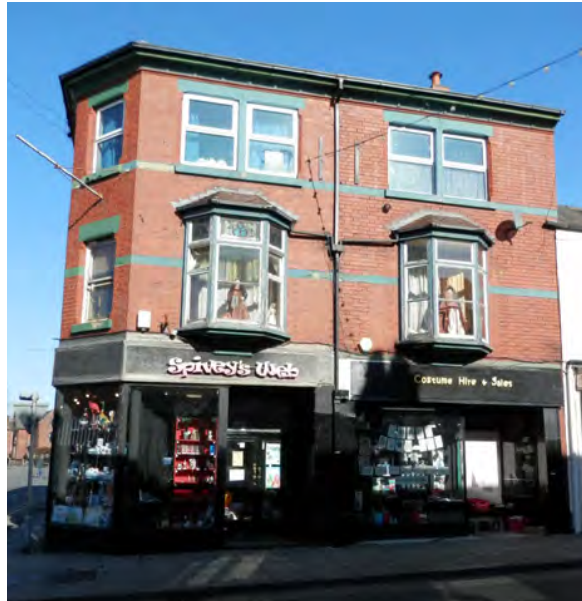
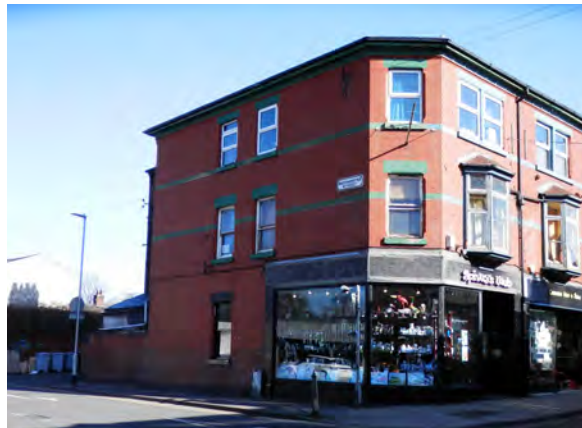
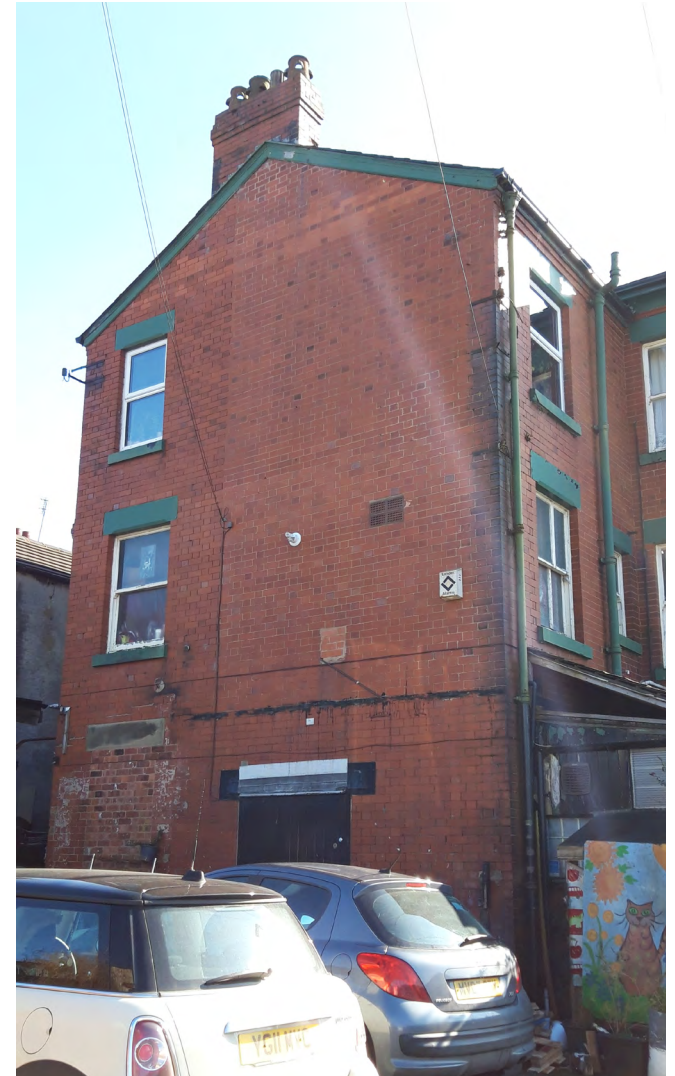
83-85 Chestergate

Notes: Nos.83 - 85 are stylistically different from the prevailing character with late Victorian detailing including projecting canted bays at first floor with tiled roofs and stained glass toplights, painted banding, lintels/mullions to the paired windows at second floor and cornice to the eaves. Arranged over three storeys with a canted return to Westminster Street with a single bay of windows. Fascia to no.83 is oversized and fixings at upper floors add clutter. The shopfront and upper floor detailing at no.85 returns to Westminster Street with car parking to the rear with truncated boundary wall. Tall wing projects to rear which is visible from Westminster Street with a detracting ground floor infill extension. Windows at first floor are original timber sashes and uPVC casements at second floor.

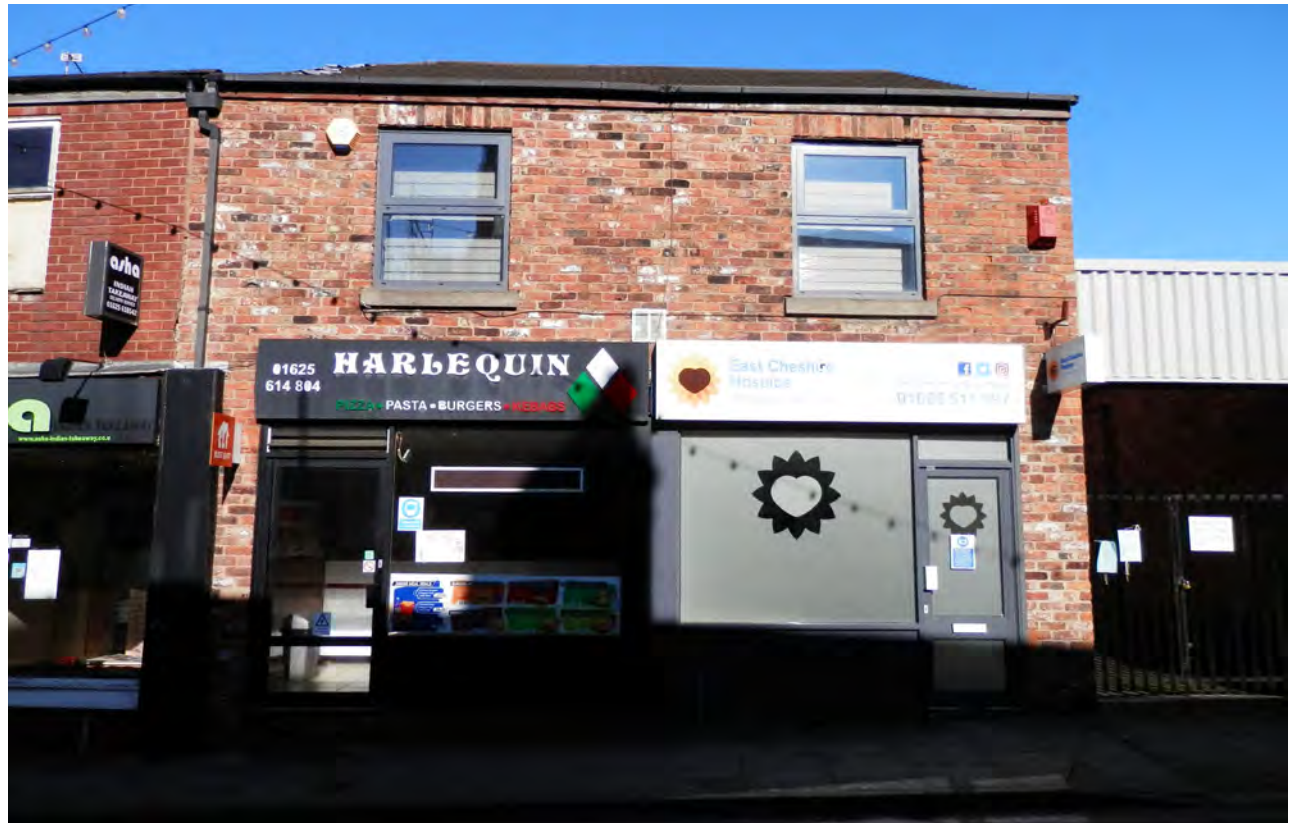
95-97 Chestergate

Notes: Simple, two-storey red brick buildings with brick lintels at first floor and good examples of shopfronts at ground floor; pitched roofs with no chimneys. Windows at first floor are modern casements; projecting sign at no.97 should be raised to align with the fascia.

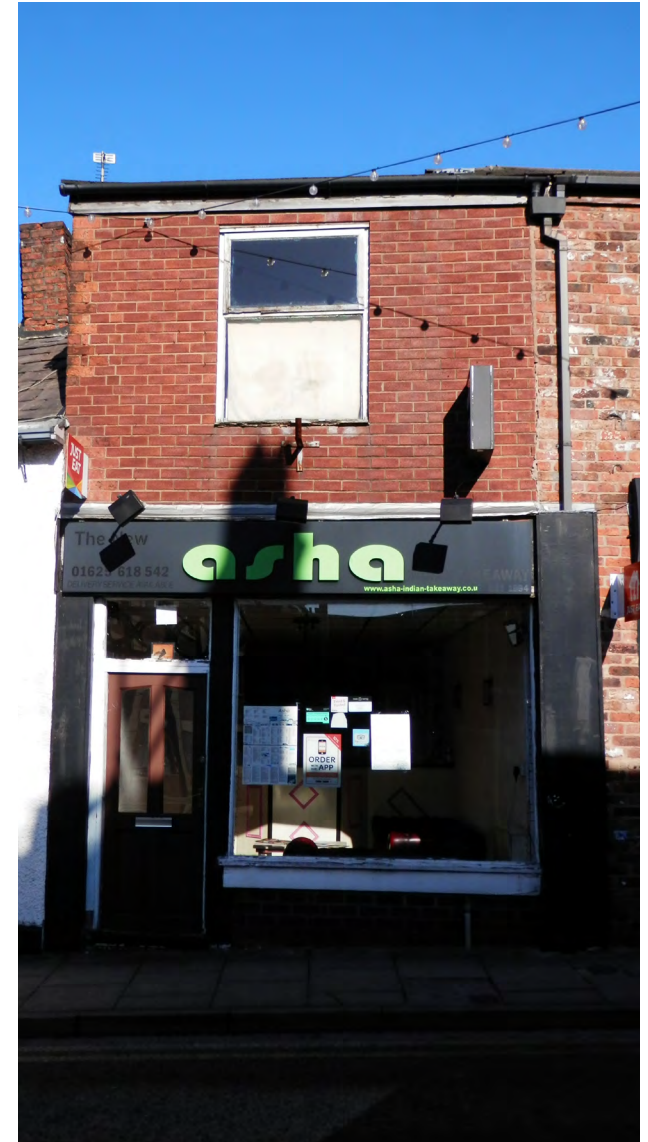
99 Chestergate

Notes: Simple, two-storey red brick building which forms a group with nos.95 - 97 but contrasting brickwork and absence of a lintel and chimney suggests a remodelling. First floor window is a modern casement; projecting signs at first floor and fascia spotlights add clutter and detract.

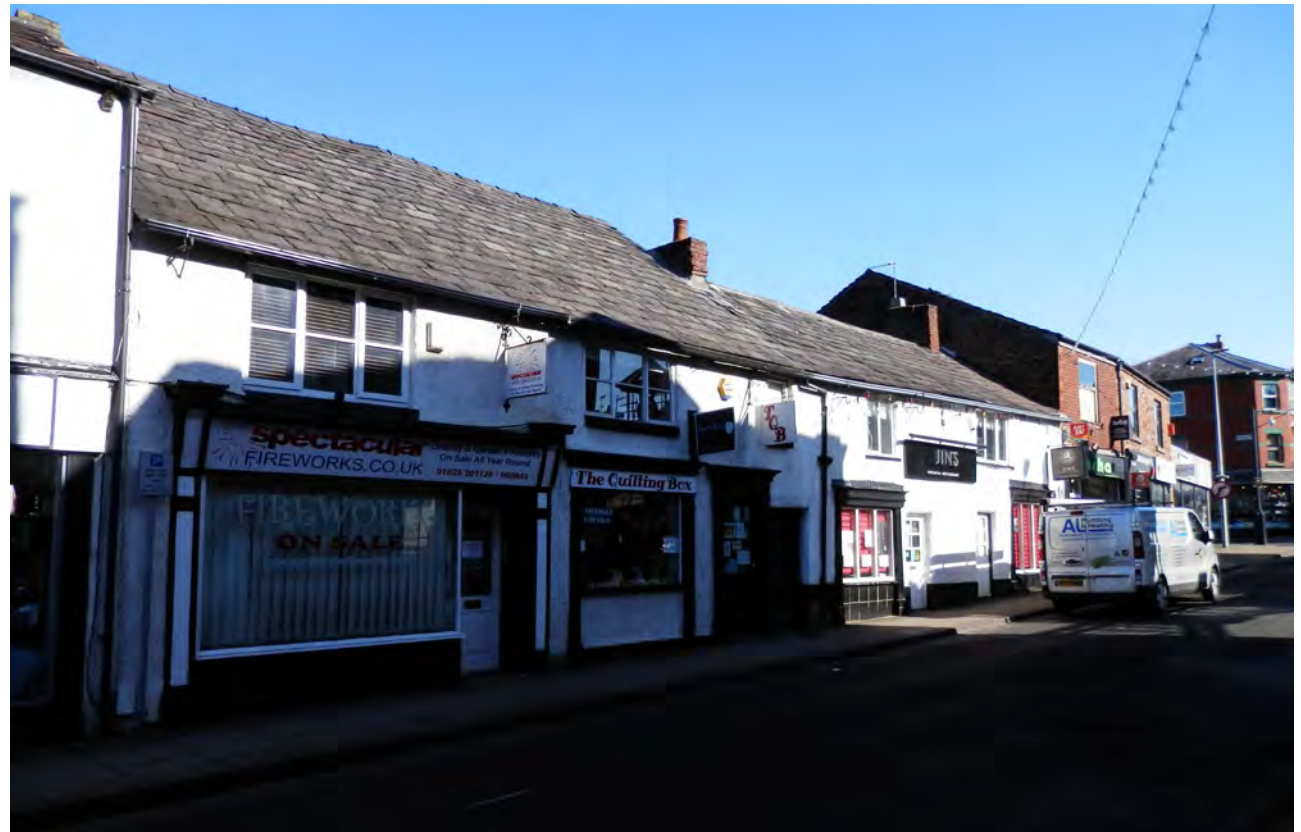
101-107 Chestergate

Notes: Small scale, two storey group with an irregular composition; the deep stepped stone-flagged pitched roofline, low chimney stacks and central passageway form two pairs (nos.101 – 103 now a single unit at ground floor) of different phases. Shopfronts at nos.101 – 103 are late-19th century or early-20th century with plain architraves suited to the understated character of the building, set each side of two doorways. Large, high level sign and projecting sign detracts. The shopfront to no.105 follows the same character whereas no.107 has grander projecting pilasters with the door incorporated into the shopfront; high level projecting signs again detract. Windows at first floor are timber casements.

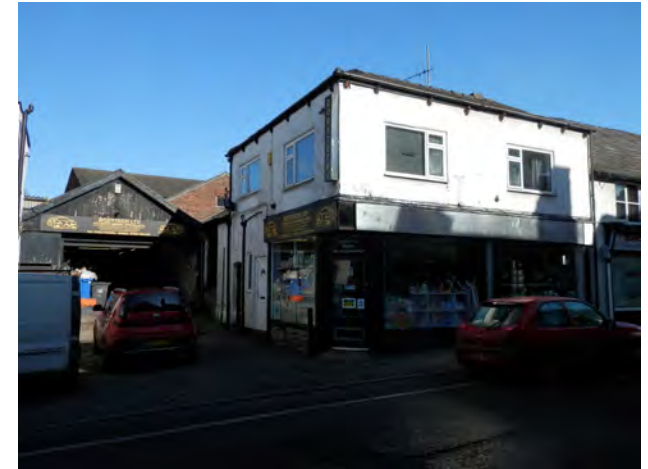
109 Chestergate

Overall condition: Fair

Notes: The slate clad roof, eaves brackets and full width single storey projection to the rear give evidence of its historic character of this two storey building, this has however been eroded through the rendered façade, uPVC side door and casement windows and high level signage to the side elevation. The shopfront spans the entire width and returns to the side elevation, cutting away the corner of the building which creates a sense that the upper floor is floating. Set back from the street and infilling part of the historic yard area is a single storey garage, timber clad with a gable end and forecourt in front.

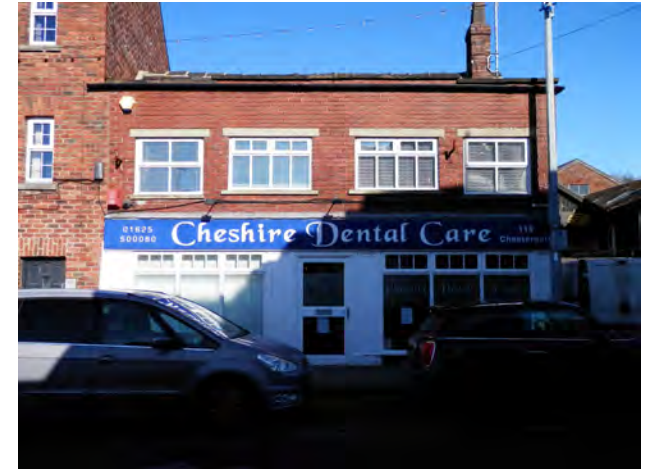
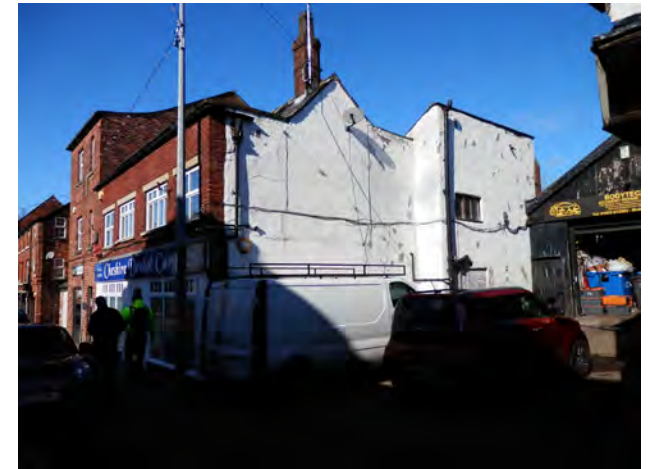
115-115a Chestergate

Overall condition: Good

Notes: Likely to have original been a dwelling; a pair of shops at the time of listing and now a single medical use at ground floor which has removed any sense of an original two-unit plan. Built over two storeys on an internal timber-frame, the roughly coursed rubble has now been refronted in brick to early-20th century designs. uPVC windows at first floor and to the ground floor shopfront detract. The side elevation reveals more of the building's historic character with a truncated gabled wing, chimney stack and further 19th century addition to the rear – all painted. Wires running across the side façade detract.
