Donald Insall Associates
Chartered Architects and Historic Building Consultants

Macclesfield Conservation Area
Gazetteer

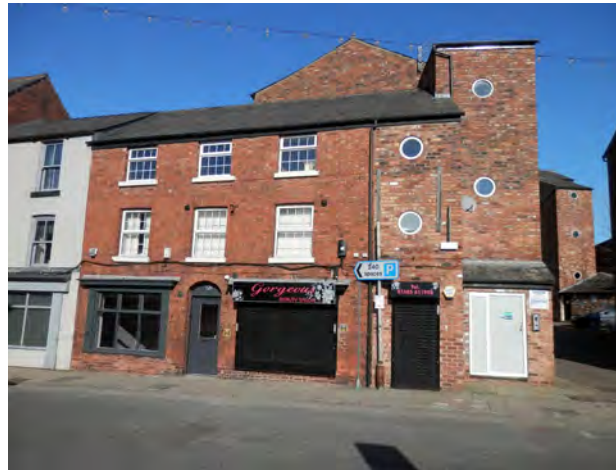
121 Chestergate, George's Court

Overall condition: Good

Notes: St George's Court is a redevelopment set back from Chestergate of the former Royal George Mill which also fronts onto King Edward Street with a pedestrian access through. It stands as a good example of the adaptive reuse of a historic building and some elements of the design are commendable including the retention of a substantial element of the original building, use of traditional paving to the parking area and timber external walkways. The use of uPVC for windows and doors however detract and the pedestrian access particularly is uninviting. The use of red brick for the elements fronting Chestergate sit well in the townscape; no.117 is three storeys with red brick lintels, the shopfront is simple and appropriate however the signage and uPVC windows detract. Flanking either side of the entrance are two staircores, recessed from the street which again utilised red brick to harmonise with porthole windows which are at odds with the local context, but repeated on the staircore visible within the

site, subtly unify development – the ground floor door to the left-hand staircore detracts. No.121 steps down from the recessed staircore but remains three storeys and has been extended by one bay, repeating the same design – the use of porthole windows here slightly less successful where it is an extension of the adjoining historic facade. The remainder of no.121 retains its historic character with red brick lintels to windows at upper floors and an arched central doorway flanked by shopfronts. To the left-hand side is a good example with architraves; the shopfront to the right-hand side was not surveyed however the roller shutters and signage detract. uPVC windows at upper floors detract. Fixings and wires across both nos.117 and 121 add clutter and detract.

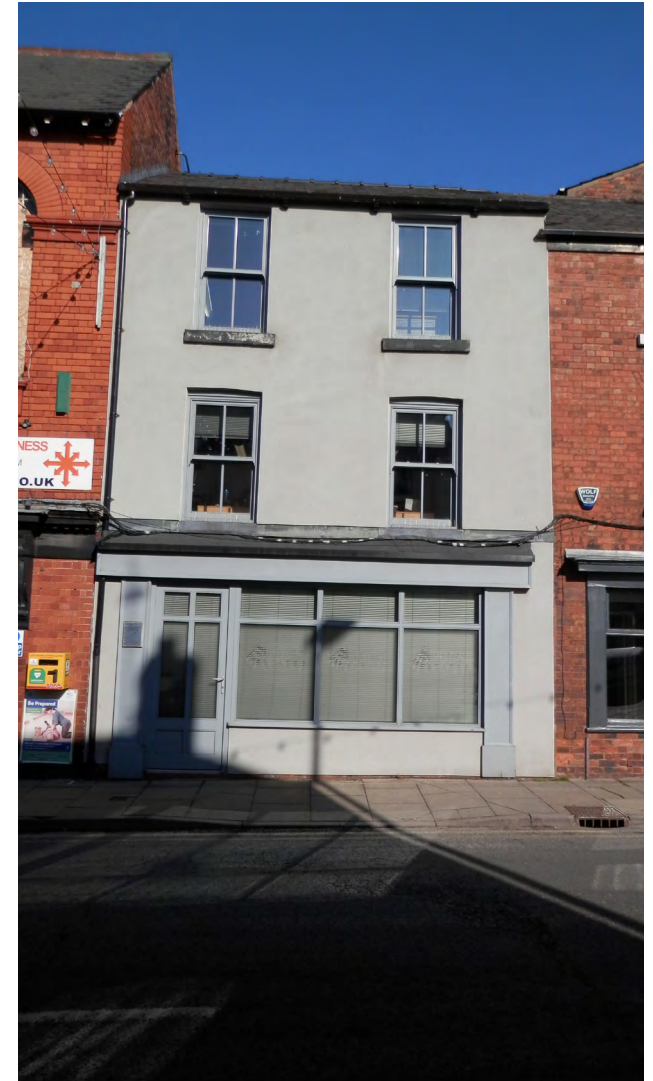
123 Chestergate

Overall condition: Good

Notes: A three storey building which has been rendered, concealing its historic character however bracketed eaves remain and whilst the sash windows at first and second floors are modern replacements they are a good example of replacement windows. Similarly the shopfront and fascia board is a good example.

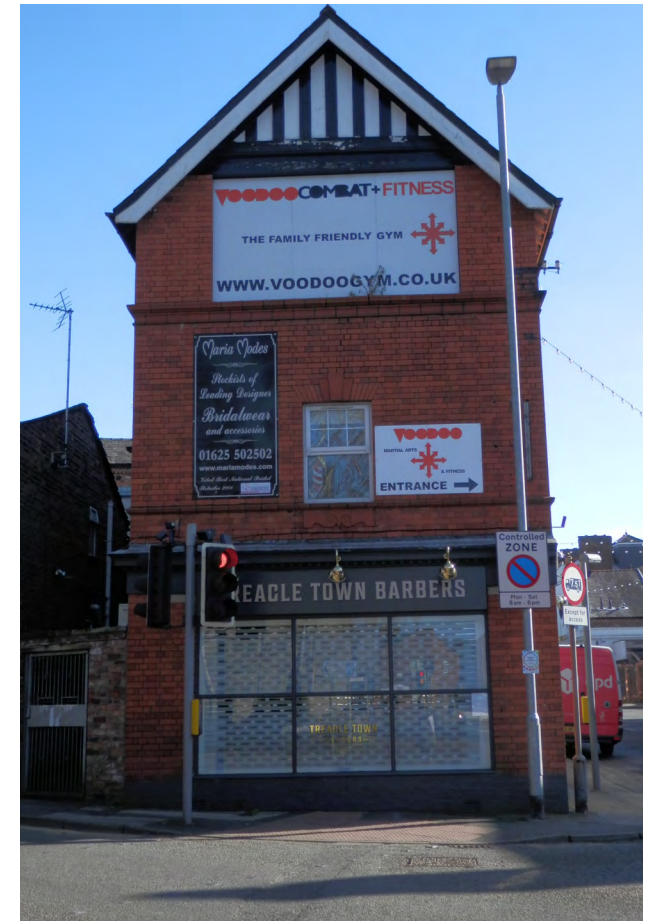
125-131 Chestergate, return elevation to King Edward Street

Overall condition: Good

entrance bay has a large arched opening with keystone (now infilled) which spans both floors and breaks the cornice; the doorway has a bracketed doorcase with a dentil cornice. High level signage and other clutter here detracts. The shopfront to no.131 returns to King Edward Street where the gable end and timber panelling at high level is exposed; high signage beneath detracts.

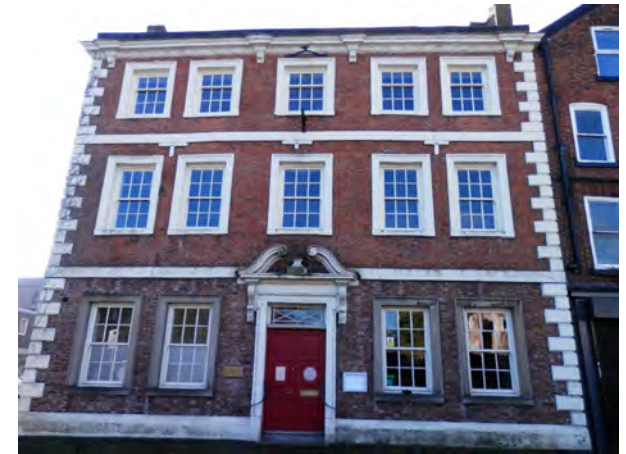
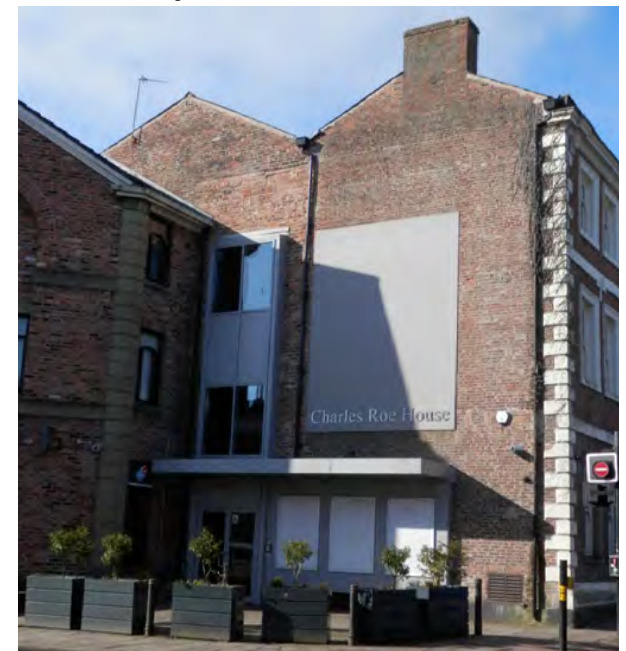
60b – 62a Chestergate

Overall condition: Good

Notes: A good example of a Georgian house, arranged over three storeys in red brick with painted stone decorations, gable end to M-pitched roof exposed to Churchill Way – chimney stack to front pitch. Altered in the 19th century and restored in the 20th century – sash windows at ground floor have been reinstated to replace a previously inserted shopfront. Most recently a contemporary entrance and signage was installed in the gable end (consented 2016, exposed by demolitions to allow for Churchill Way widening) which jars with its historic character and the building was connected internally to the 1980s Charles Roe Chambers on Churchill Way.

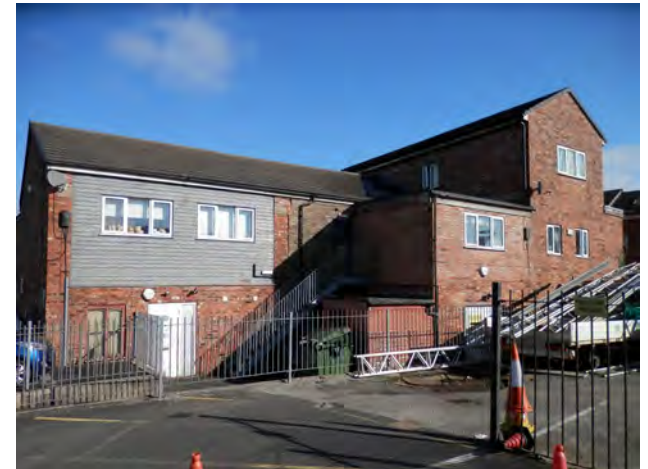
66-68 Chestergate, rear

Overall condition: Good

Notes: A handsome domestic scaled, three storey pair, later alterations including replacement windows, shopfront and signage at no.68 and poor brickwork repair and first floor lintel at no.68 detract. Roof is pitched with chimney stack. Rear has an entirely modern character with no sense of original plots or rear gardens.

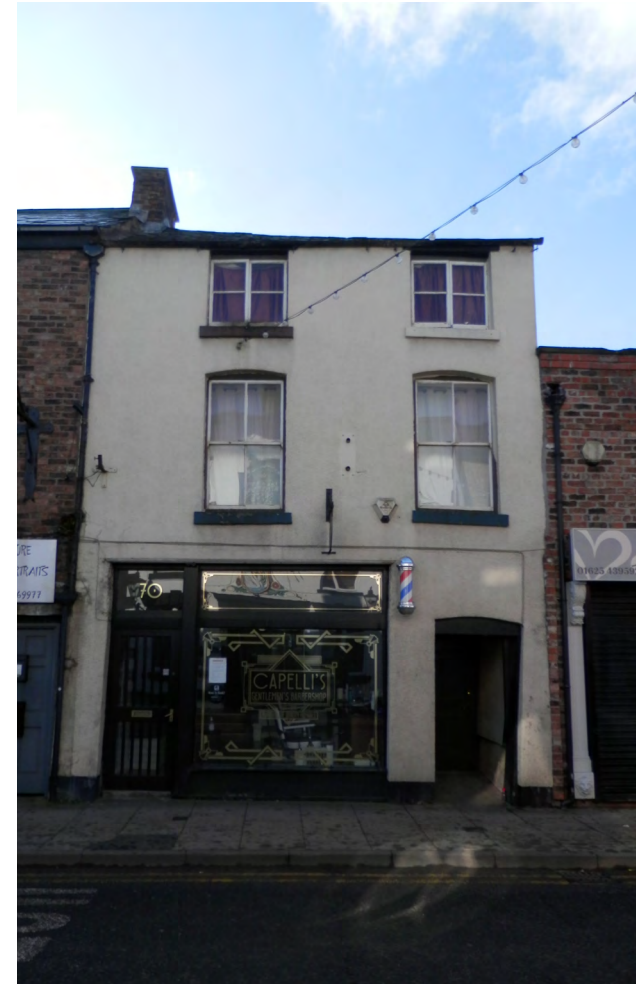
70 Chestergate

Overall condition: Fair

Notes: Three storey building with rendered/painted façade which highlights redundant fixings/clutter on façade, pitched roof; windows appear original. Shopfront and signage are a good example of an appropriately detailed replacement.

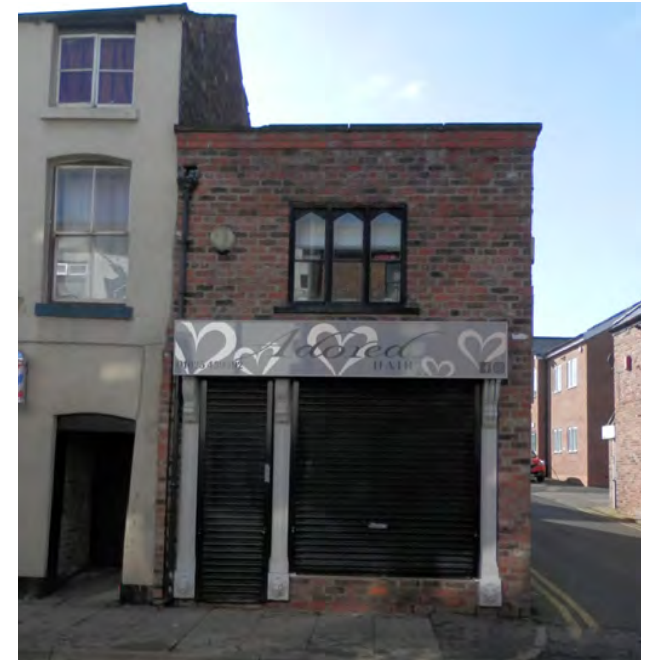
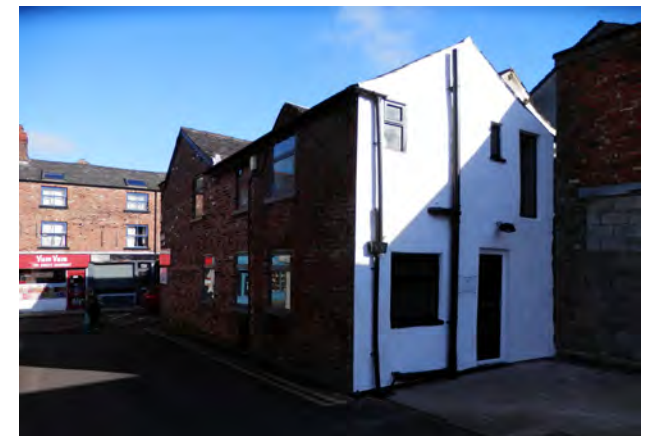
72 Chestergate

Overall condition: Good

Notes: A two storey building, the front and side walls (fronting access to rear parking) reconstructed in early-21st century, windows are all modern. Roller shutter and oversized signage detract (shopfront not viewed). Pitched roof to main frontage and two storey wing with gable ends.

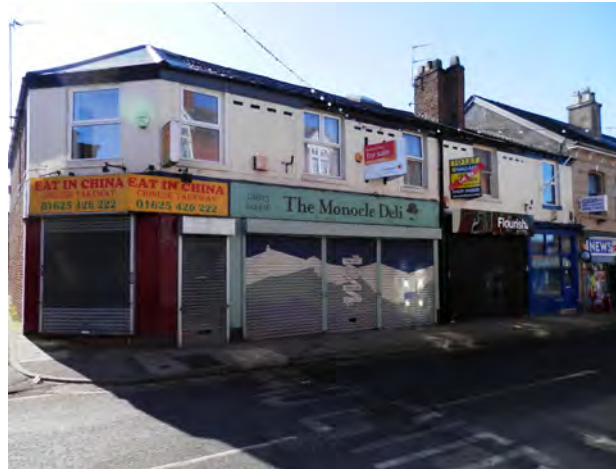
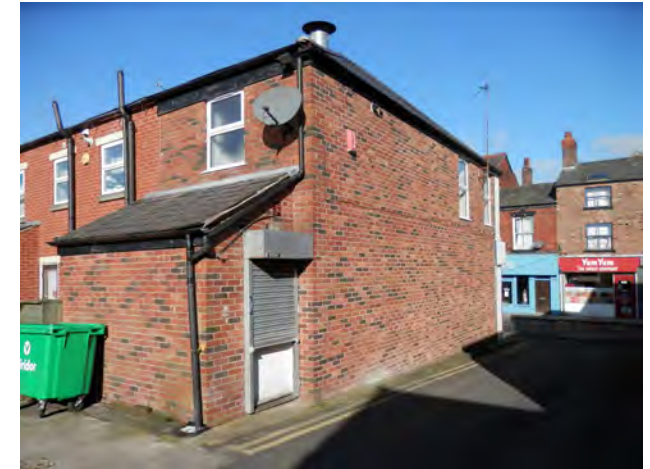
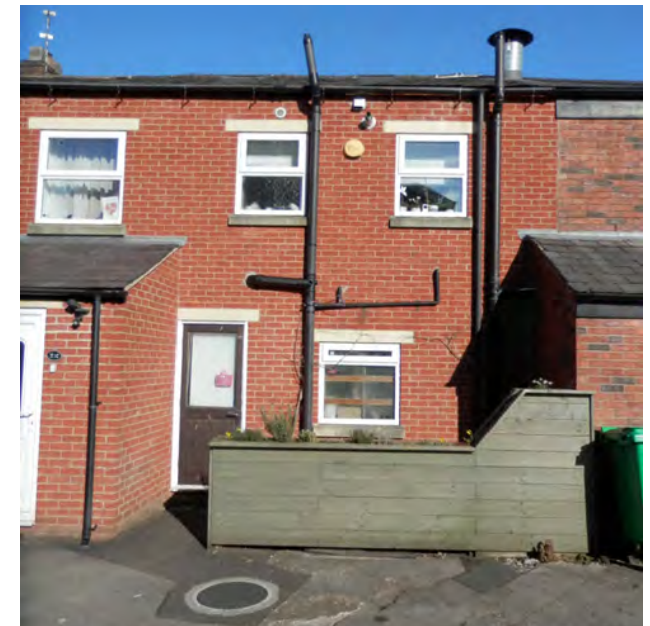
72a-76 Chestergate

Overall condition: Good

Notes: A small scale, two storey terrace group with pitched roofs and chimney to no.76; rendered/painted first floor; brick to return elevation fronting access to rear parking. First floor windows are modern uPVC casements to all but no.74 and detract; signage and roller shutters at ground floor detract (shopfronts at nos.72a – 74 not viewed). uPVC casements, doors (with roller shutter to 72a), modern brickwork and porches to rear all detract from historic character.

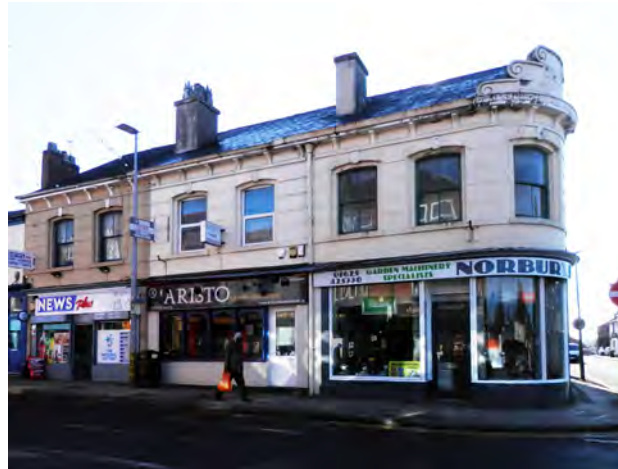
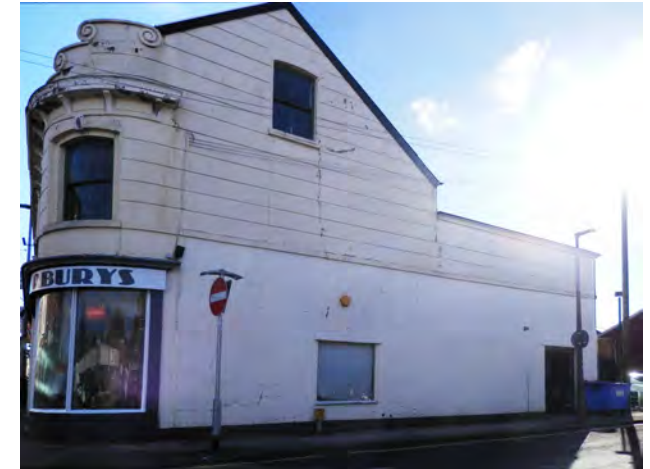
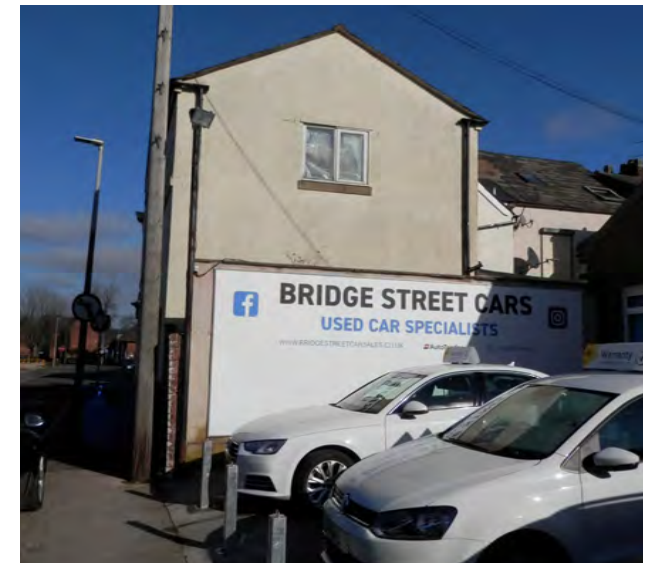
78-82 Chestergate

Overall condition: Fair / needs repainting

Notes: A handsome, two storey group with rusticated painted render at first floor, bracketed cornice and scrolled pediment where no.82 façade curves into Bridge Street. Roof is pitched with render chimney stacks and gable end to Bridge Street. Original sash windows remain at first floor to nos.78 and 82; detracting uPVC casements to no.80. High level projecting signs detract; stallrisers and signage to nos.78 and 80 are oversized and the projecting roller shutter box at no.78 detracts; large glass shopfront to no.82 is overly contemporary. Ground floor return elevation is plain with a modern window opening at ground floor; modern render and casements to rear – No.82 extended late 20th century.

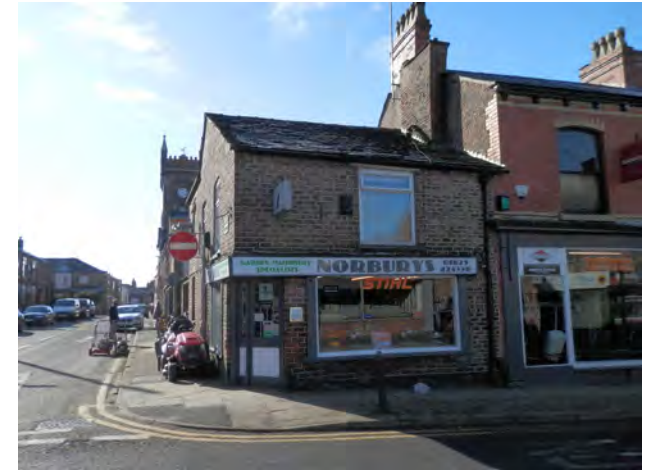
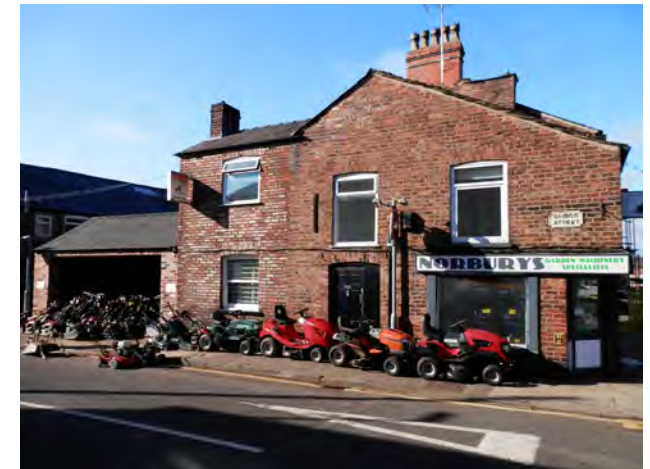
84 Chestergate

Overall condition: Good

Notes: A small scale, two storey building sat on the corner with Bridge Street with an exposed skewed gable end and tall chimney stack adjoining no.86, later two-storey rear wing along Bridge Street and a late-20th century single storey double garage to rear. All but rear ground floor window are uPVC casements which detract, alongside high level projecting sign.

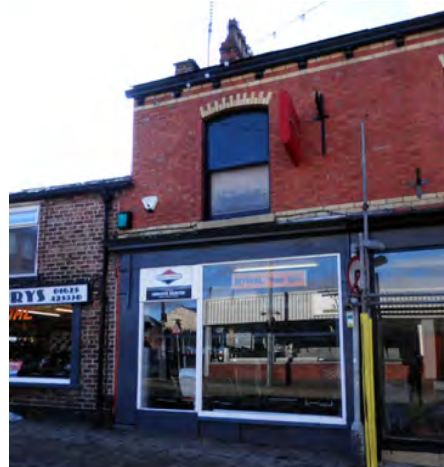
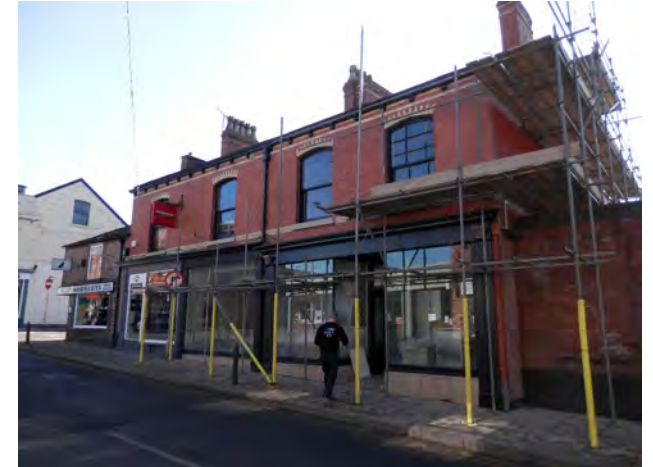
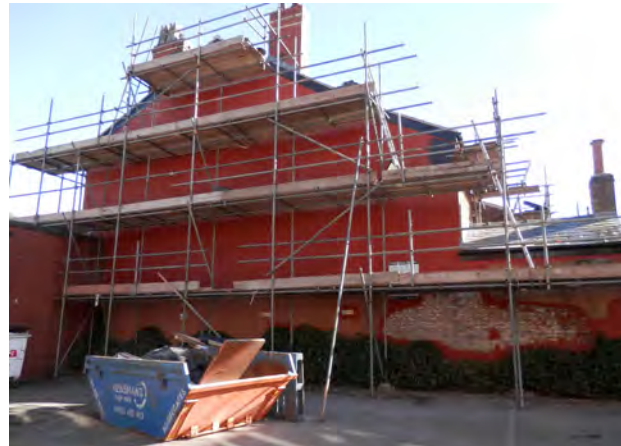
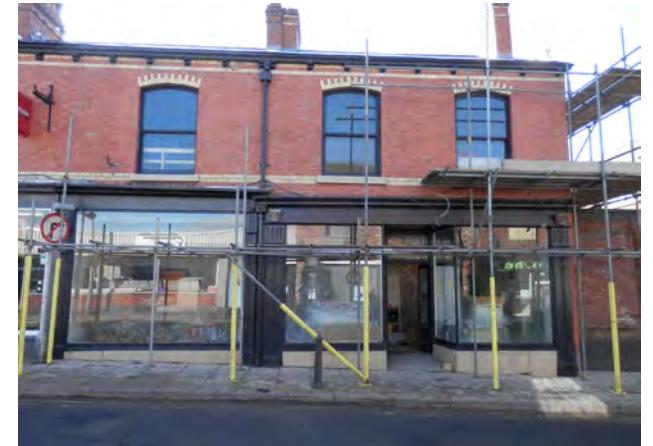
86-90 Chestergate

Overall condition: Under refurbishment

Notes: Handsome two storey group exhibiting late-Victorian features with white brick detailing, modillions to the eaves, one-over-one sash windows and a good quality shopfronts with pilasters to nos.88 and 90. Pitched roof and prominent chimney stacks with brick detailing. No.86 is connected internally with the commercial use at no.84; the loss of the doorway to the street and projecting high level signage detract. The return elevation to the adjacent car parking is plain brick with a gable end and projecting single storey wing, and red brick chimney stacks with white brick banding visible.

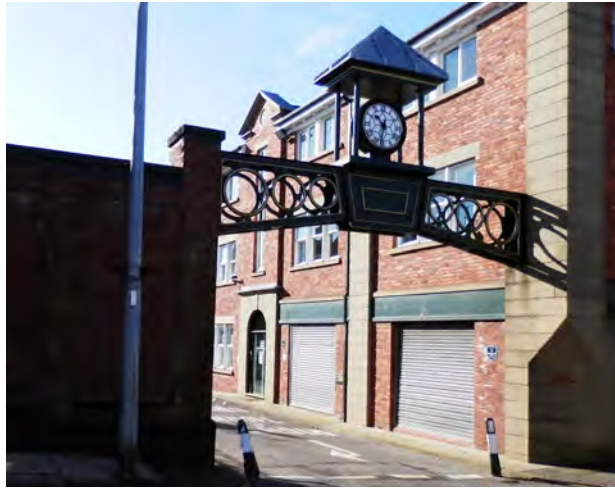
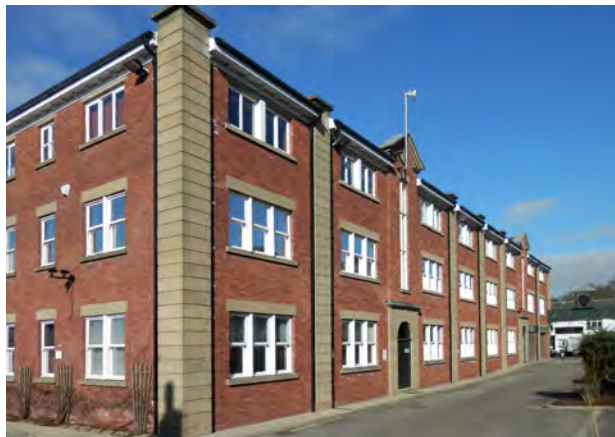
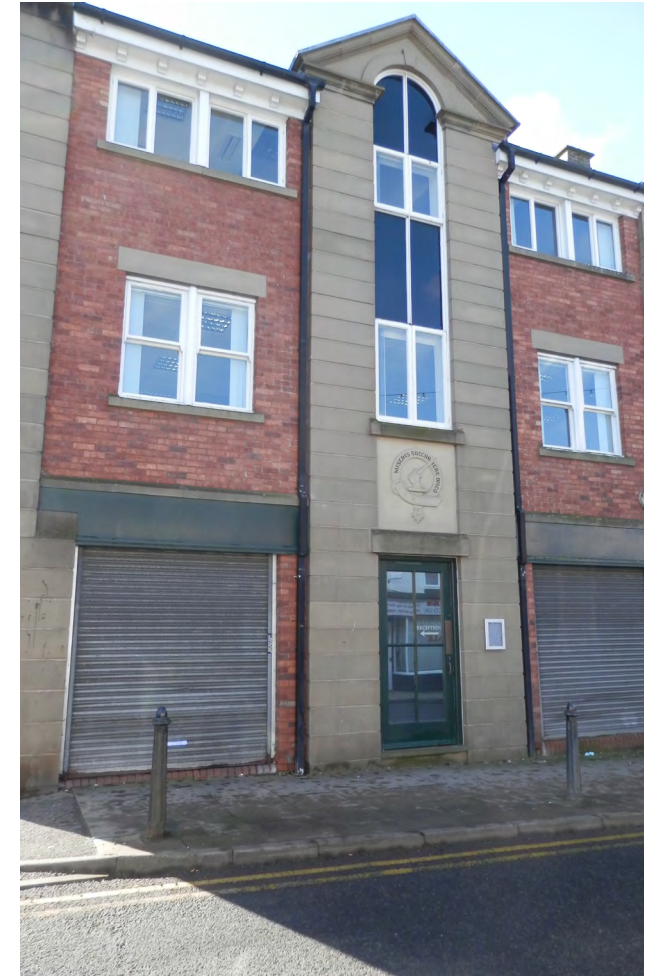
100 Chestergate

Overall condition: Good

Notes: A three storey development in red brick with attempts at replicating historic detailing with a central gabled bay, modillions to the eaves and 'quoins' and lintels to a limited degree of success. The depth of the building is at odds with the prevailing rear building line which, alongside the car park to the side (along line of historic access to rear of site) and rear, bears no relationship to the historic plots; a number of a/c units are fixed to the west facade. Roller shutters to the shopfronts detract; the arched opening with clock to rear of site has some charm.

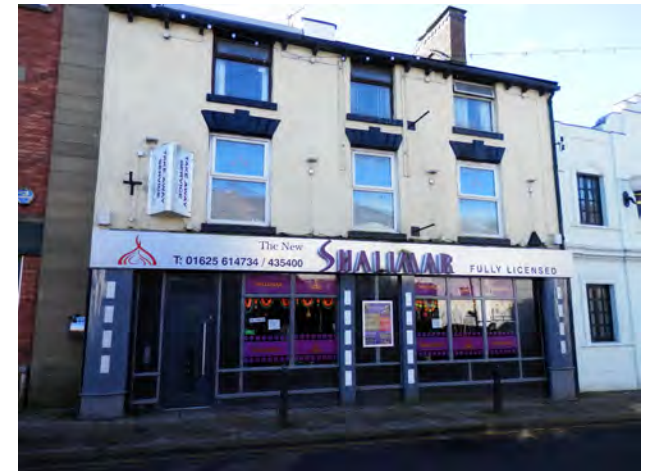
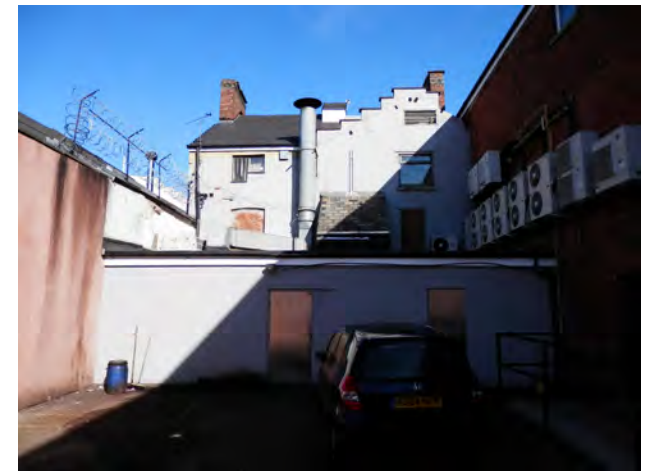
102 Chestergate

Overall condition: Good

Notes: Three storey, three bay building with rendered façade at upper floors, bracketed eaves and painted lintels with keystone at first floor. Pitched roof and tall chimney stacks. Windows are modern casements which detract, shopfront, signage clutter and high level sign all detract. Full width rear extension, extract vent, rendered façade and modern windows.

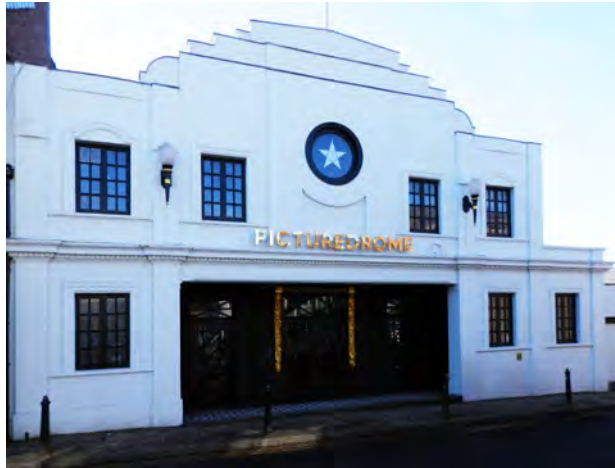
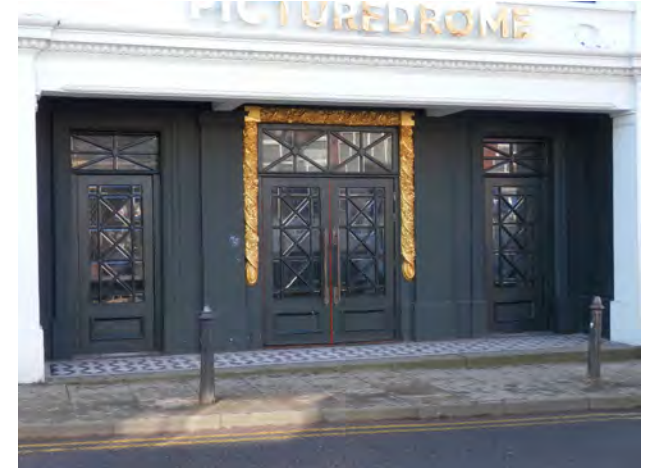
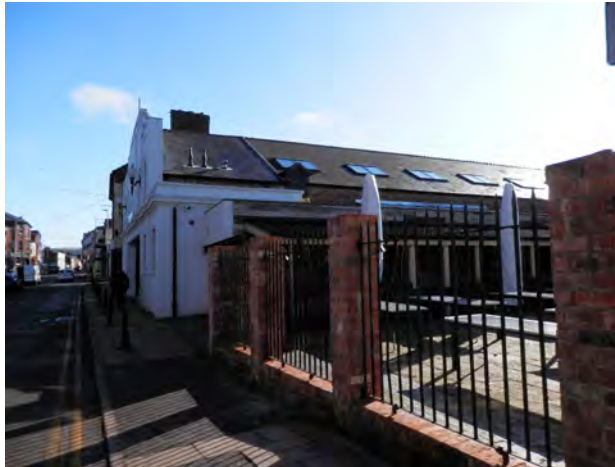
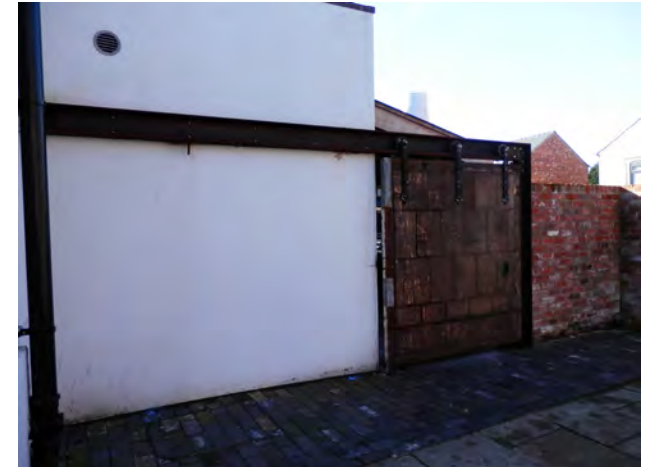
104 Chestergate, The Picturedrome

Overall condition: Good

Notes: The first purpose built cinema in Macclesfield, converted to use as a bingo hall in the 1970s and then offices 2003 with a mezzanine inserted (now removed). Recently converted into a market style restaurant with the side extension enlarged and adjacent car park on corner with Catherine Street) now providing outdoor seating (consented 2018). The art deco detailing of the façade provides an interesting example of its type and signifies its original use within the streetscene.

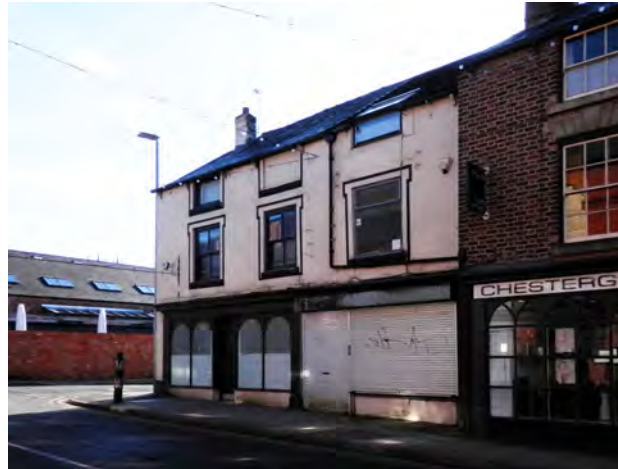
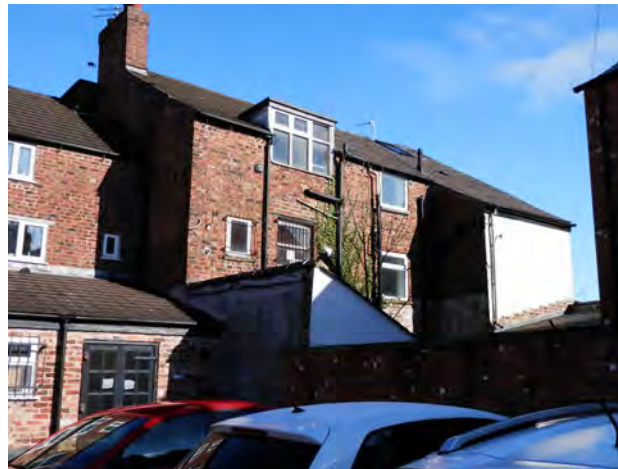
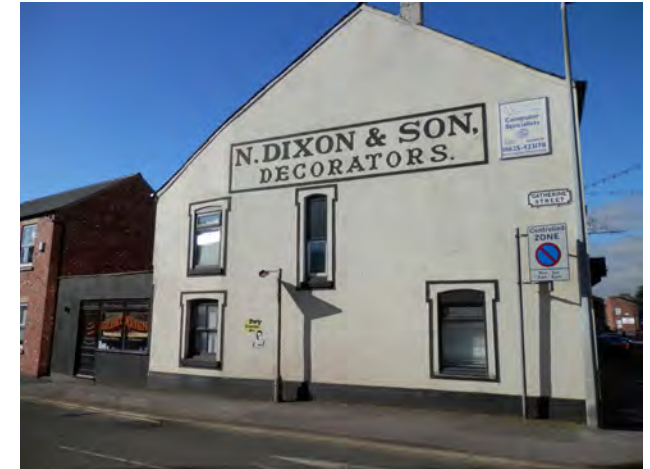
106-108 Chestergate

Overall condition: Fair

Notes: A pair of buildings which retain some Victorian detailing including bracketed eaves and what appear to be replacement two-over-two sash windows at first floor at no.106 and within one opening on the side return to Catherine Street; windows are otherwise modern casements with a second floor window blocked at no.106. The façade is rendered and painted, with windows architraves painted on. Arranged over three storeys, the second floor has squashed proportions with a window projecting into the roof and a rear dormer at no.106. Roof is pitched with a skewed gable end to Catherine Street where it extends a further half storey over projecting wing. The shopfront at no.106 is a good example although the stallriser would benefit from being painted. The solid roller shutters at no.108 detracts (shopfront not viewed); painted signage on side return adds interest although the signage board adjacent detracts.

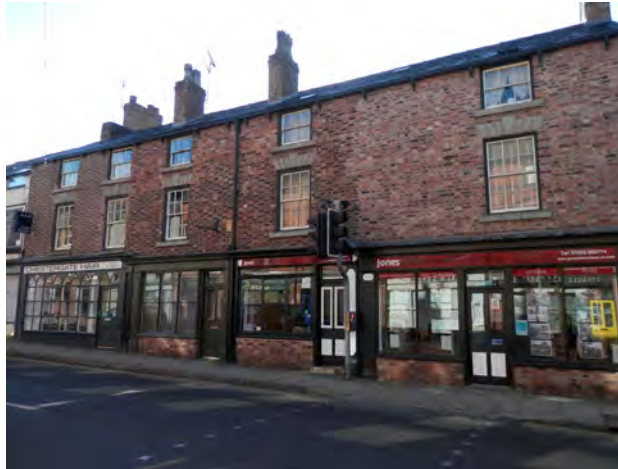
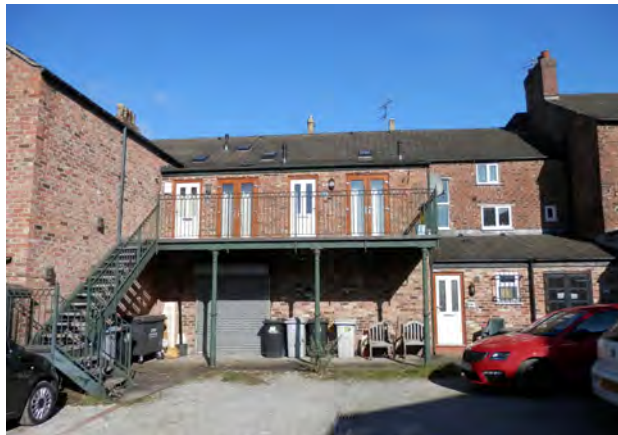
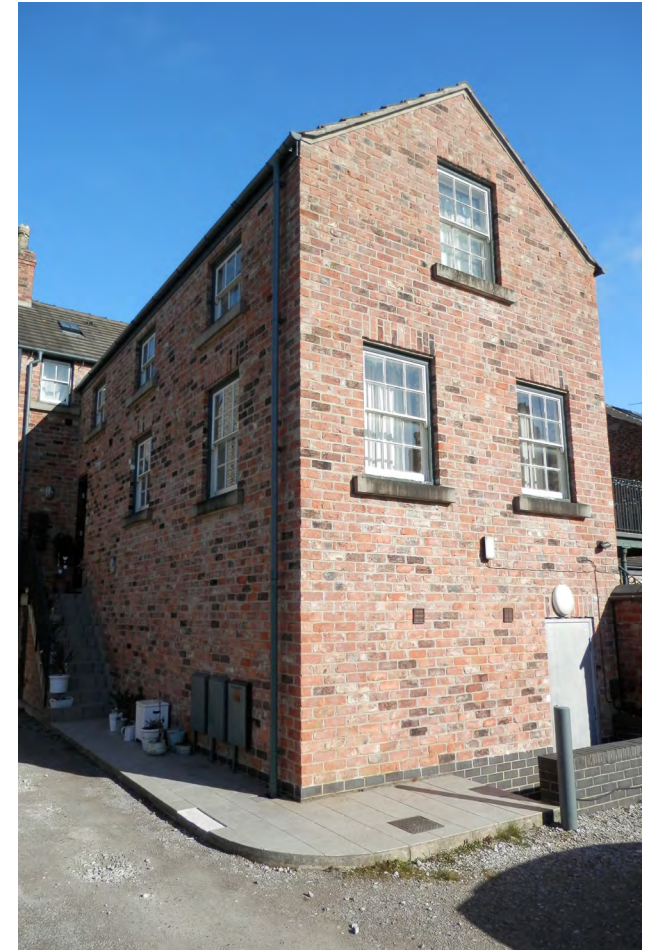
110-116 Chestergate

Overall condition: Good

Notes: A terrace of four shops with accommodation above. Constructed in red brick over three floors with channelled painted stone heads and painted stone sills to the windows; the two outer properties wider than the two in the centre. Roof is pitched with prominent brick chimney stacks. The façade at no.116 has been reconstructed with a clear joint in the façade. The shopfronts have been renewed and are all good examples with discreet signage other than the high level projecting sign at no.110 which detracts. Windows are six-over-six sash at first floor and three-over-three to the second floor. Side return to rear parking is rendered and painted whilst a three storey wing projects to the rear (consented 2007) and is a good example of a modern extension with multi-pane sash windows. The rear of the remainder of the terrace has been subject to alteration with modern extensions, detracting casement windows, balcony and stair providing access to the upper floors (nos.112 and 114) and a roller shutter at no.114.

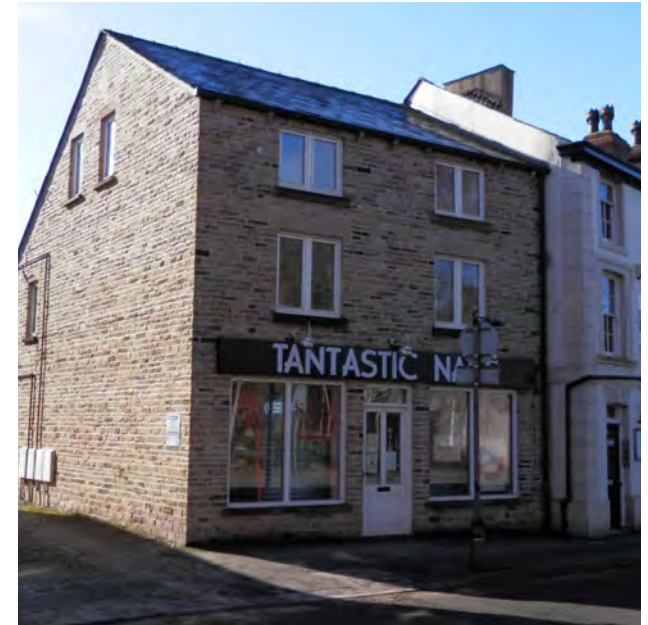
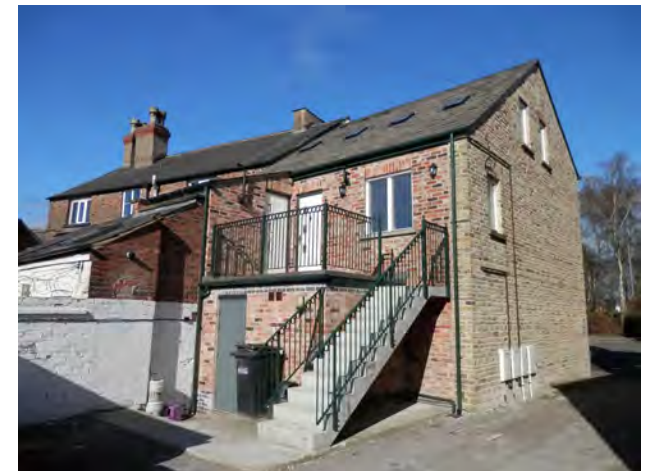
120 Chestergate

Notes: The yellow brickwork and detailing suggest a 20th century remodelling or reconstruction, regardless it is a good example with bracket eaves, lintels and sills. Comprising three storeys, windows are timber casements and the shopfront appropriately proportionate, the fascia would benefit from being smaller and the external lights adds clutter. The roof extends a further half storey to the rear with a series of further extensions in red brick and concrete stair providing access to the first floor.

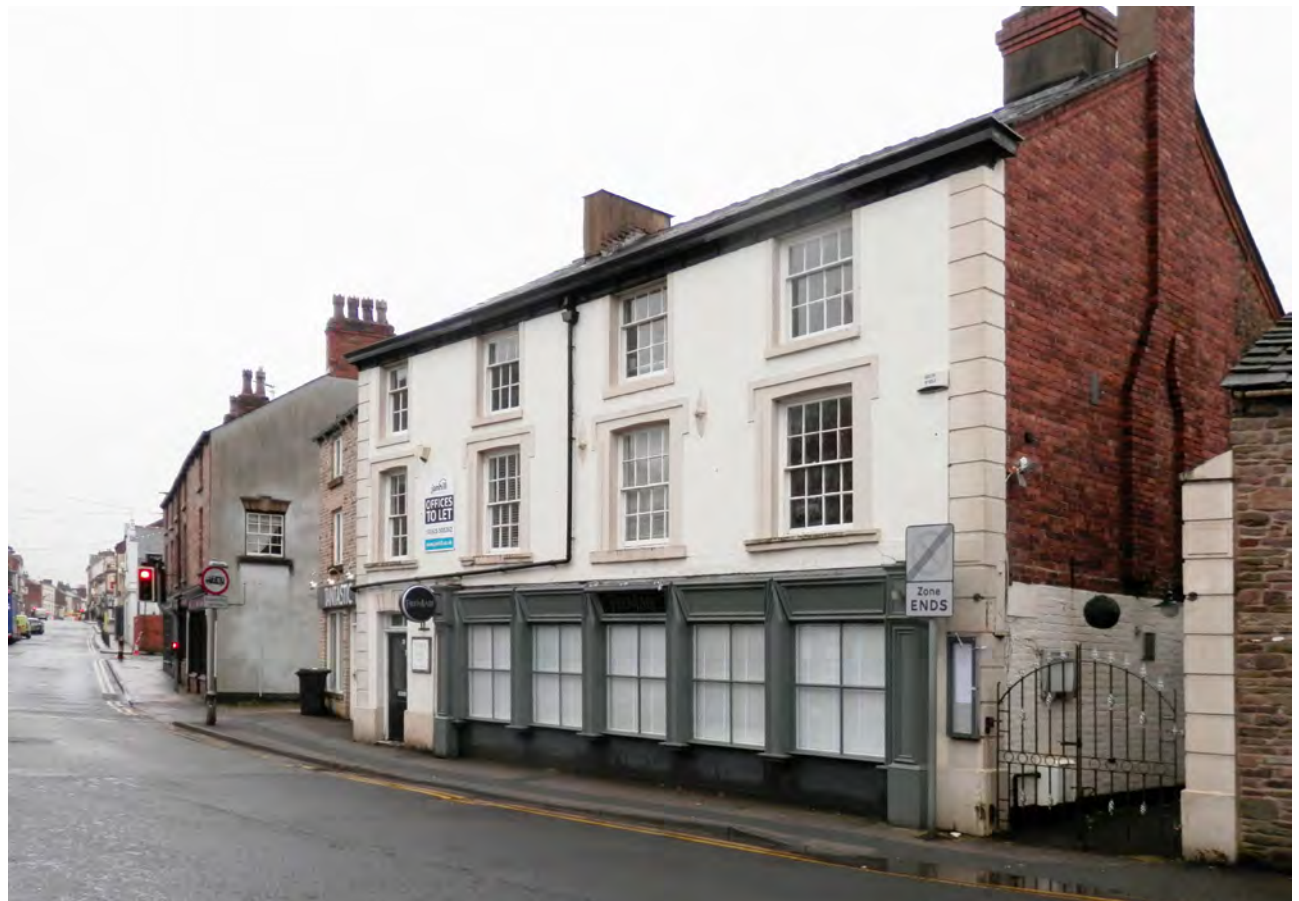
122 Chestergate

Notes: Rendered façade over brick with stressed angle quoins, lugged architraves to the first floor and plain architraves to the second. Set over three floors - windows are eight-over-eight sashes to the first floor and four-over-eight to the second floor. The offset shopfronts were likely inserted in the 19th century and are a good example; the doorway set to the left of the façade is possibly original with a shallow arched channelled head. Temporary to let signage detracts. The east elevation is rendered where exposed whilst the west is exposed red brick, painted at ground floor with a gable end to the pitched roof and chimney flues expressed in the façade with stacks above.

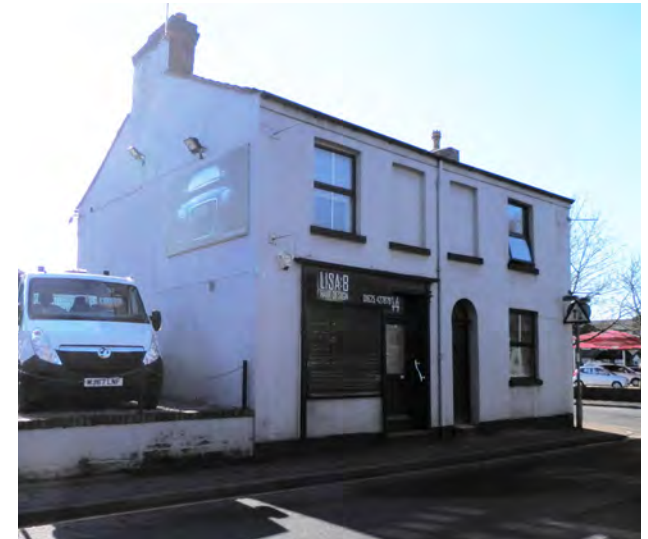
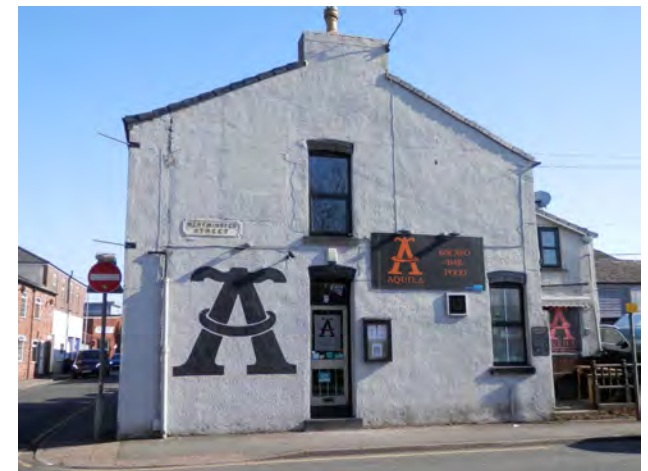
44-46 King Edward Street

Notes: A pair of two storey buildings rather isolated in the townscape, surrounded by car parking for the garage forecourt to the south on Westminster Street and for the car wash on the facing corner of Westminster Street. They are however a remaining fragment of the historic townscape prior to the formation of Westminster Street at the end of the 19th century. Now rendered with central windows at first floor blocked; stone lintels and arched opening at ground floor to no.46 – additional entrance in the side elevation. Roofs are pitched with exposed gable ends and chimney stacks. Windows are modern casements; sympathetic shopfront inserted at no.44 – roller shutter detracts. To return and rear elevation painted signage adds visual interest; further signage and projecting awning and housing clutters.

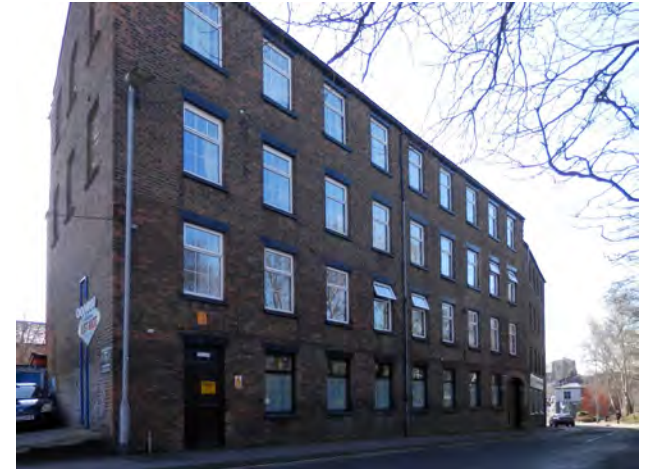
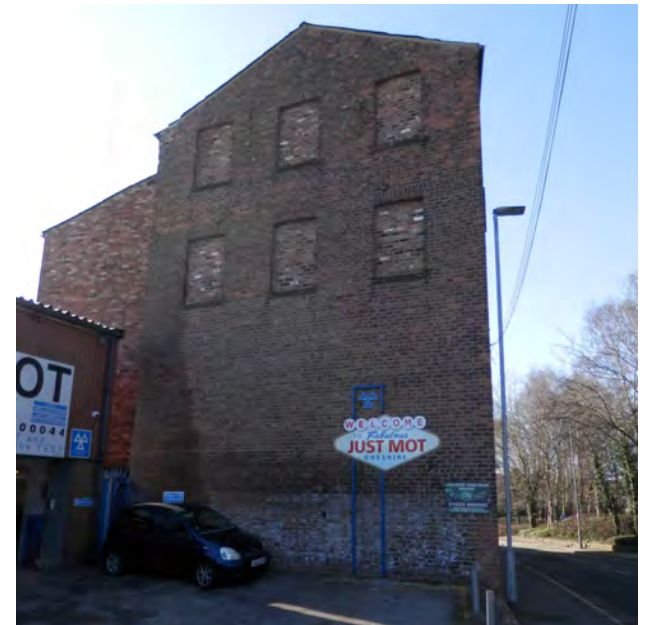
Former Works

Notes: The former works now forms part of the St George's Court development which fronts onto Chestergate with a pedestrian access through. It stands as a good example of the adaptive reuse of a historic building and some elements of the design are commendable including the retention of this substantial element of the original building on King Edward Street. Brown brick with a pitched slate roof it spans nine bays and comprises four storeys. Lintels and sills are painted and windows are detracting uPVC casements. Arched opening to west side has a timber panel door whilst a single pedestrian door to the opposing side of the facade. Large sections of brick appear rebuilt. Windows to the east face are bricked in with brick lintels; modern brick staircore to the rear is visible.

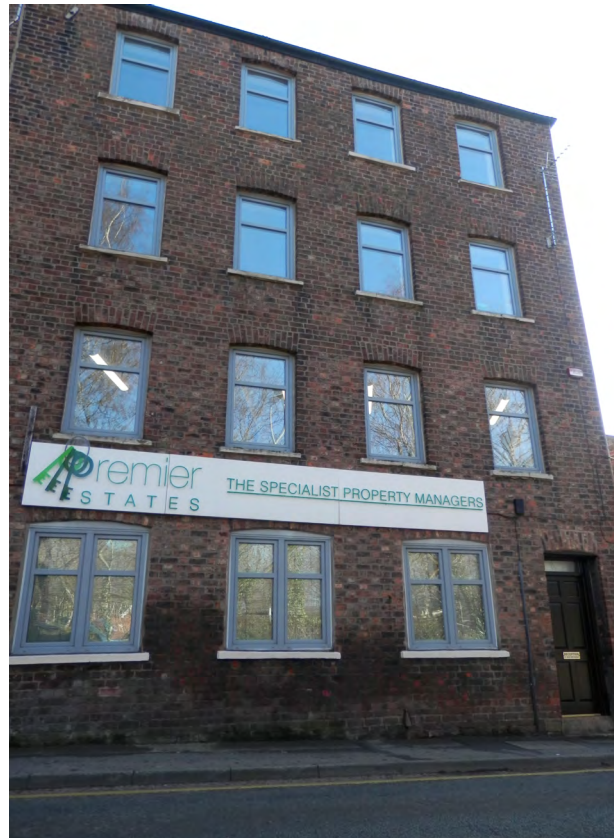
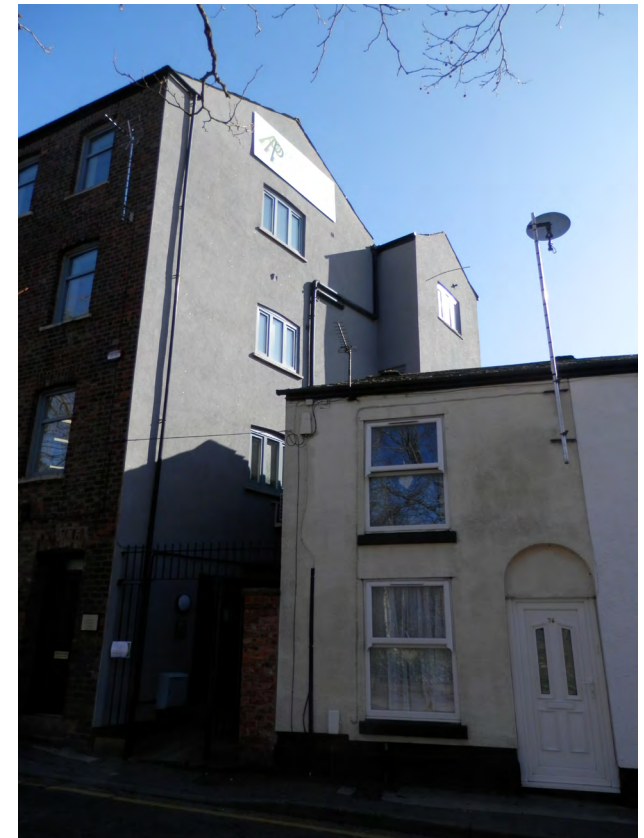
72-74 King Edward Street

Notes: A former industrial building which is a good example of a scheme of adaptive reuse. Brown brick with a pitched slate roof it spans four bays and comprises four storeys. Windows have brick lintels and stone sills; entrance door in right-hand bay is panelled and set under an arched opening. Whilst windows are modern replacements they are formed in timber and are sympathetic. The side elevation the pitched roof profile and is rendered and painted. Signage to the front elevation and at high level on the side detracts.

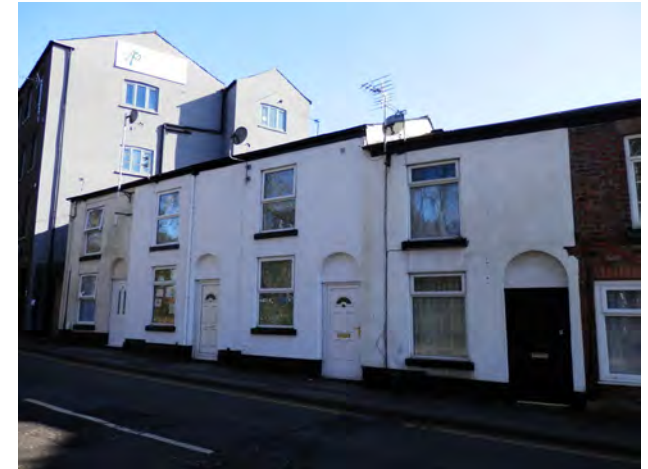
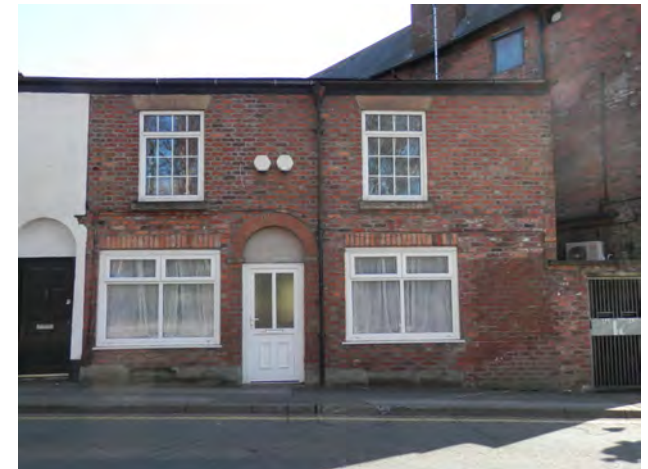
Notes: A small scale terrace group of cottages build hard up against the pavement on a plinth. The historic character has been lost to a degree owing to alterations undertaken to the facades. A step in the pitched roofline groups them into two sets of single bay two storey buildings. No.84 is double fronted and remains expose red brick; window uPVC casements have however been inserted at ground floor with replacement brick lintels and patched brickwork; casements at first floor are also uPVC with stone lintels and sills. The entrance door is uPVC but retains its arched opening – fanlight now blocked. A modern gate inserted in the brick wall to the west provides access to the rear. Nos.76 – 82 now have a rendered and painted façade with uPVC casements and doors which detract; the arched opening to the doorways remain but fanlights are infilled.
