Donald Insall Associates
Chartered Architects and Historic Building Consultants

Macclesfield Conservation Area
Gazetteer

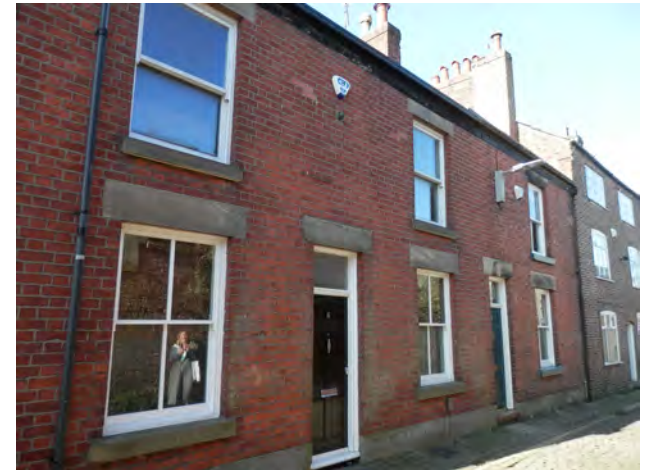
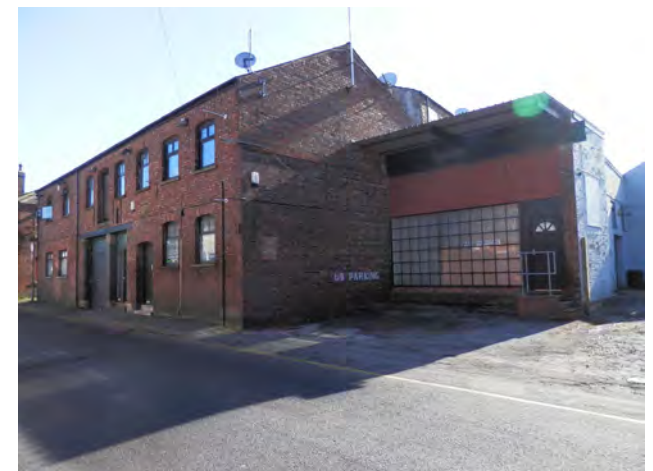
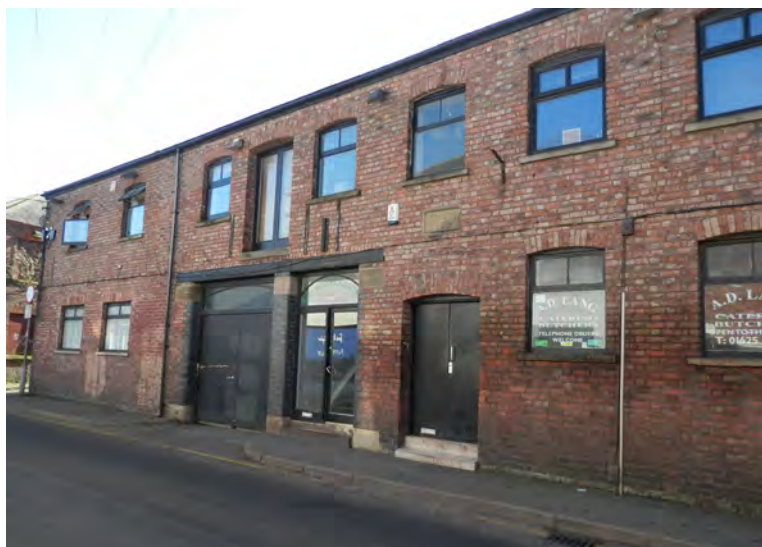
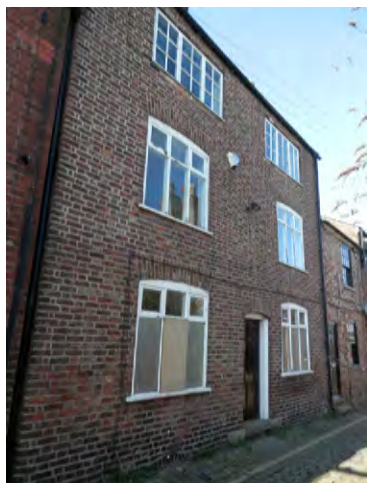
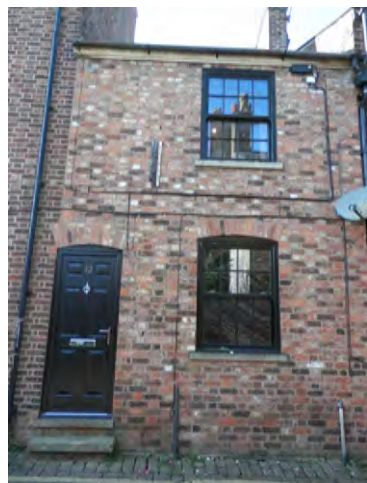
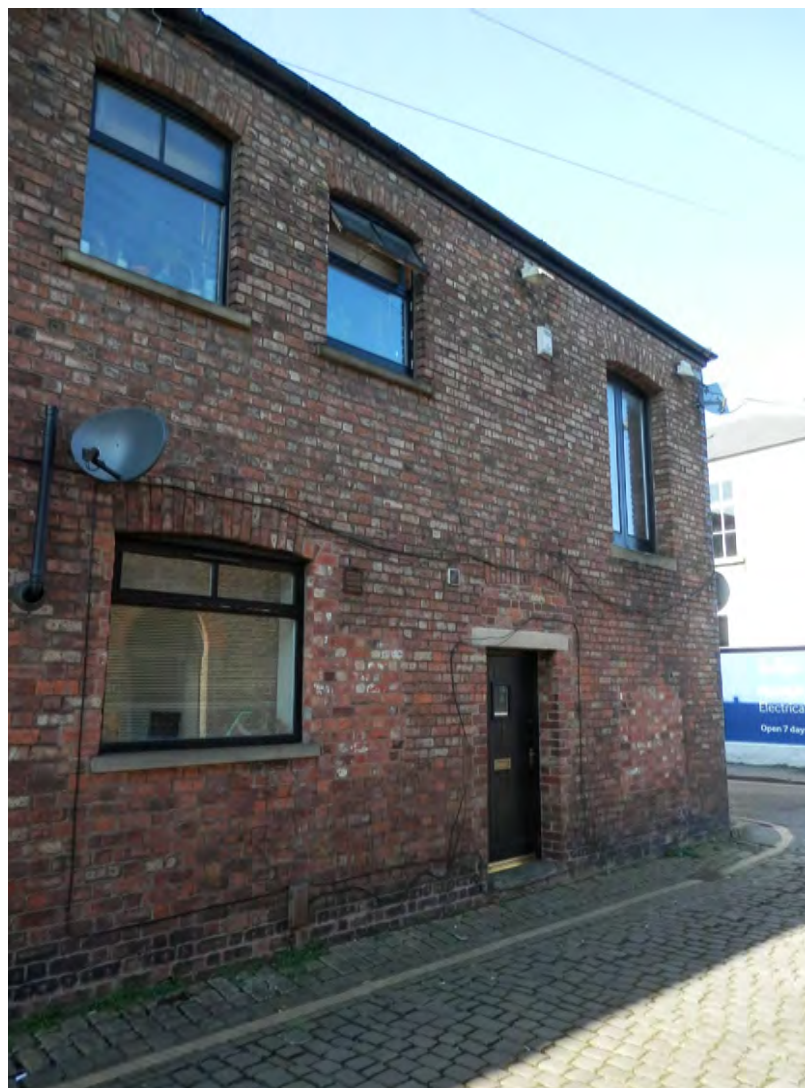
The block facing King Edward Street is the 1909 stable/warehouse/entrance range for Wood and Son which connects the mill to the rear to the associated domestic buildings along Little Street (these two elements forming the two long sides of the mill yard). It is two storeys with a seven windows range; brick cambered window arches and opening for loading door at first floor – all windows at first floor are modern replacements. At ground floor the two window openings to the left-hand side are later insertions with surrounding patched brickwork. Central vehicular access with wooden doors and main entrance (modern door) remain with stone and engineering brick jambs;

bressumer beam above and secondary entrance to the right with solid door. Return to Little Street, engineering brick to curved corner, cambered window arches and loading bay opening repeat – all with modern windows. Ground floor opening has been altered with concrete lintel – brick arch still evident. Lights, wires and other fixings to the façade detract. West elevation is brick with gable end to pitched roof; the modern front to the recessed bay to the west and hardstanding in front detracts.

To Little Street a domestic range; no.12 adjoining the 1909 range comprises two storeys with cambered brick arches at ground floor; eight-over-eight timber sash windows at both floors. The manager's house at no.10 stands a storey taller with workshop accommodation at second floor evident in the larger window openings with 20th century casements under flat arches. Cambered arched openings at ground and first floors with 20th century three-light casements, timber sills. Nos.6 and 8 form a pair, red brick with stone lintels and sills modern timber sashes, mix of one-over-one and two-over-two; panelled doors. High level street light detracts. Rendered and painted blank south façade with gable end to pitch roof and chimney stack.

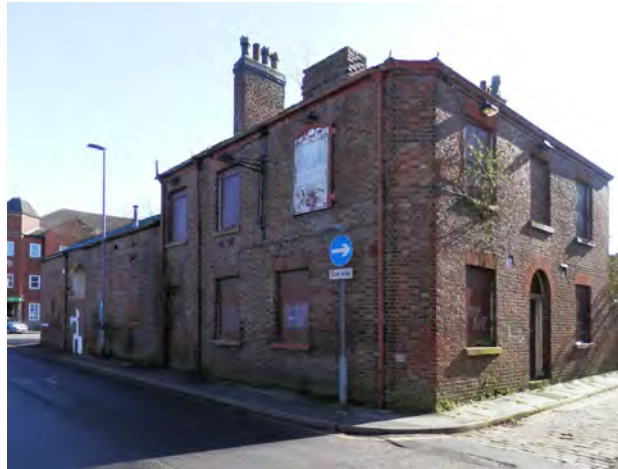
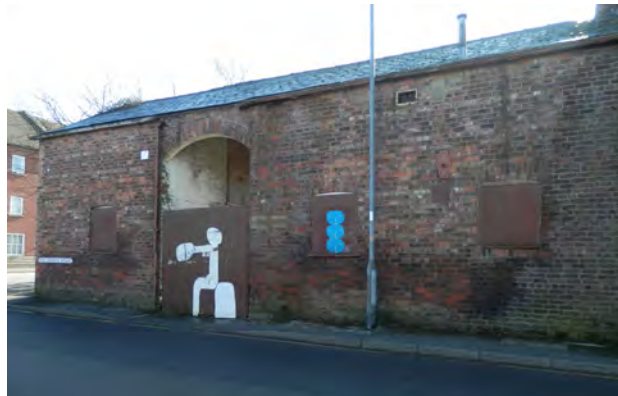
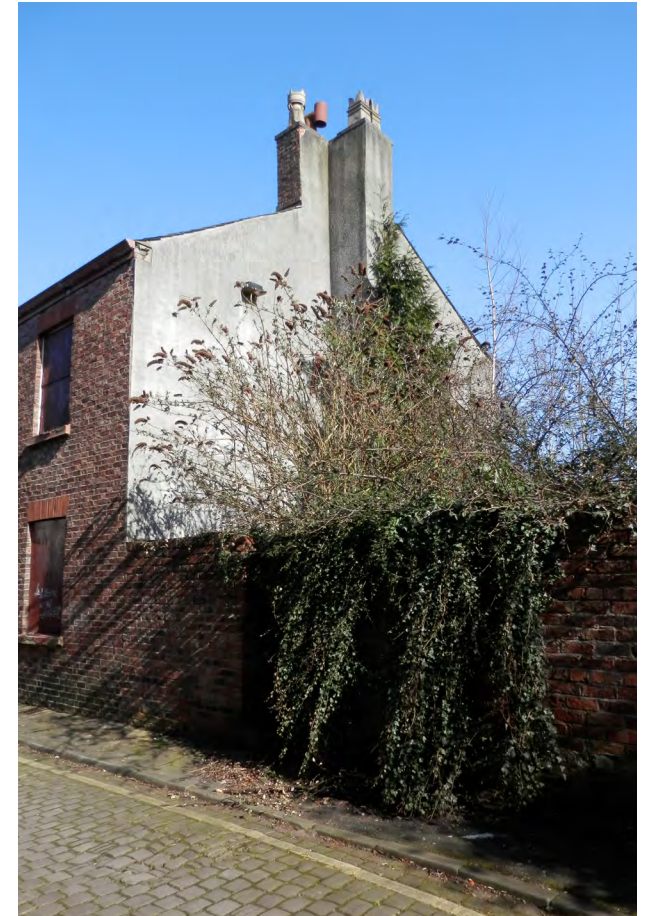
15 Little Street, Former Three Pigeons Public House

Overall condition: Derelict and poor

Notes: A two storey former public house (The Three Pigeons) on the corner with King Edward Street in red/brown brick. Little Street façade comprises three bays with a tall brick boundary wall extending south. Cornice to eaves, stone sills and brick lintels, arched to the central doorway – window above bricked in, windows otherwise boarded. Return to Little Street is three bays which repeats windows details, all board. Public House signage to first bay at first floor; arched doorway to the rear at ground floor. Hanging sign bracket remains. To the east on King Edward Street the roof level steps down half a storey, roof is pitched. Tall arched opening through to rear with small arched window openings at ground floor, brick sills – all blocked. Elevation to south on Little Street is rendered and painted with gable end and chimney stacks. The buildings are vacant and in a poor condition however they still contribute to the historic character of this part of the conservation area. They form part of the wider development site with Nos.61 and 63 Chestergate, now largely demolished.

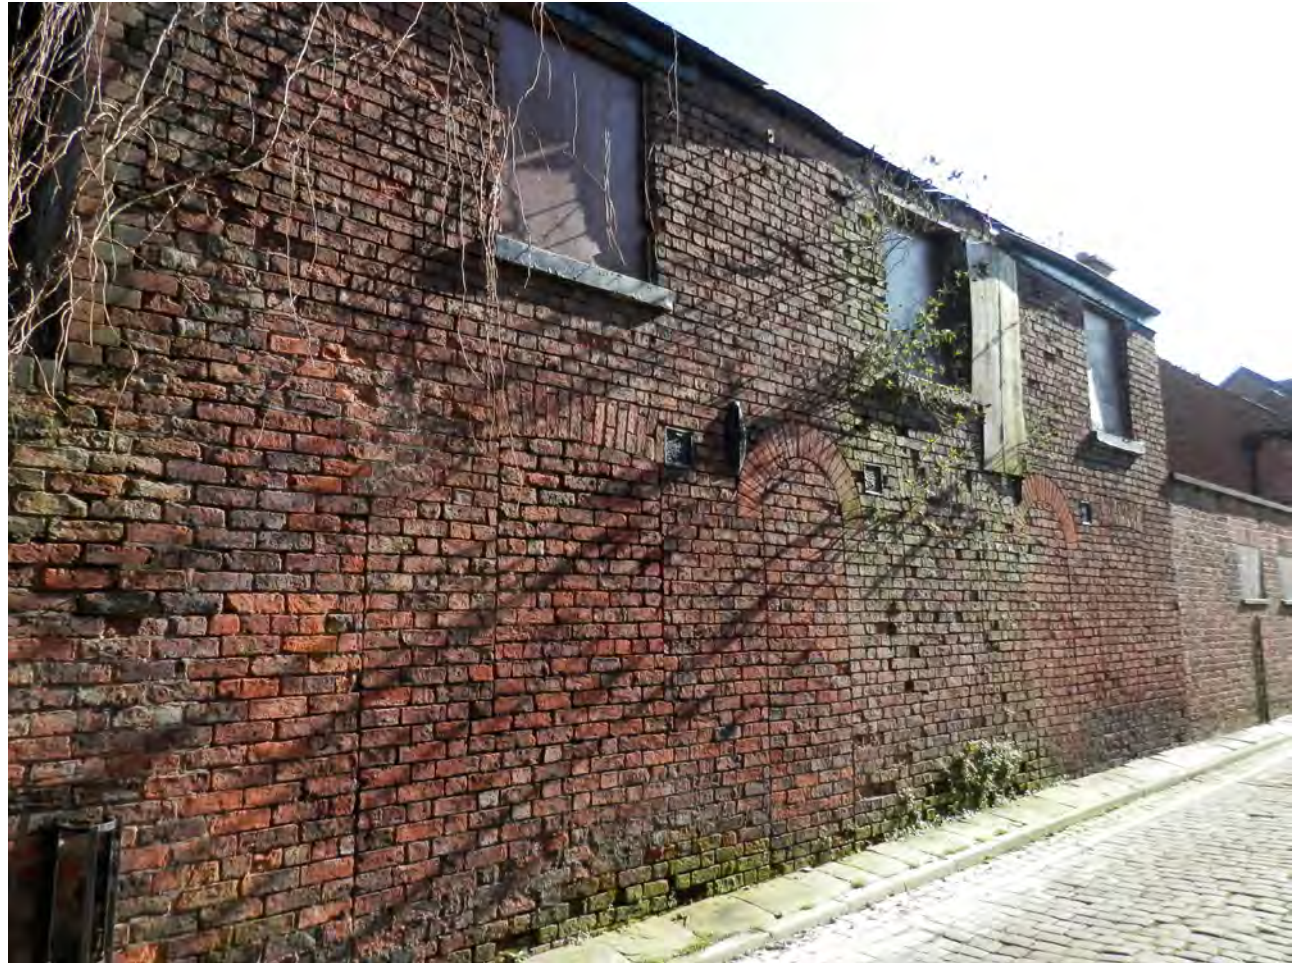
Unnumbered, Little Street east

Overall condition: Derelict and poor

Notes: A two storey range on the east side of Little Street which is vacant and derelict; ground floor openings are all infilled with brick, arched door openings and cambered brick arches to windows still evident in brickwork. Stone sills at first floor but windows blocked.

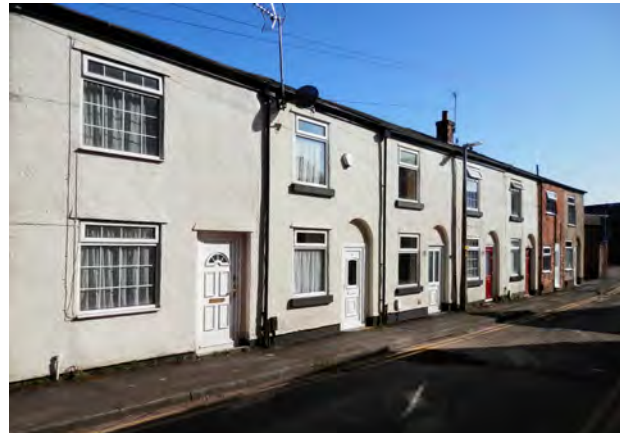
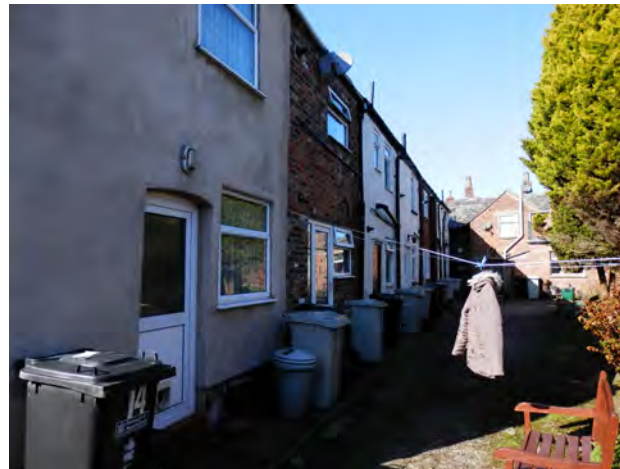
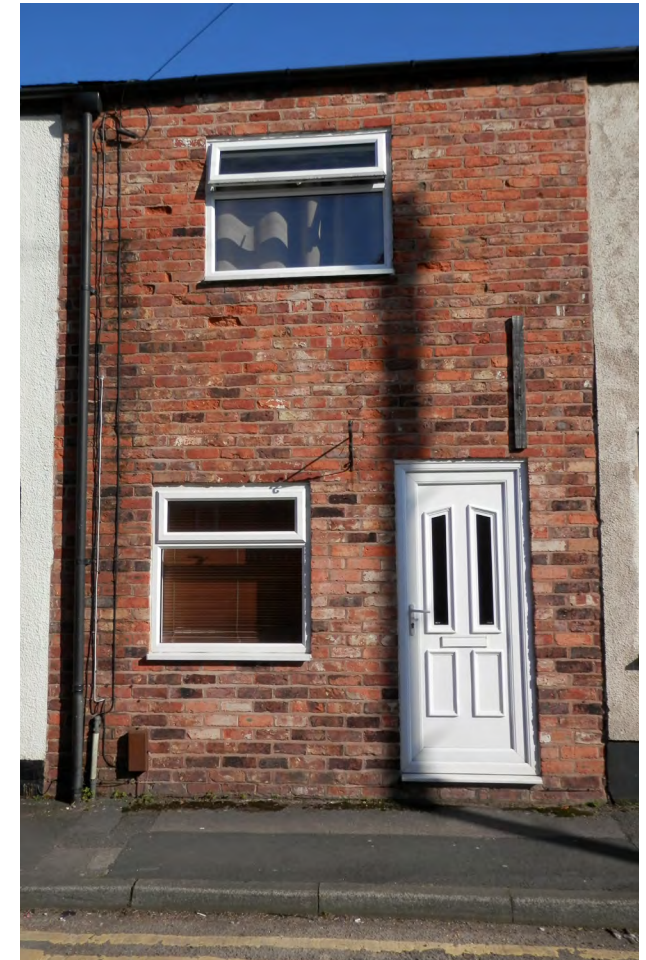
2-14 Pinfold Street

Notes: A small scale terrace group of cottages built hard up against the pavement on a plinth. The historic character has been lost to a degree owing to alterations undertaken to the facades. Aside from no.12 facades are rendered and painted façade with uPVC casements and doors which detract; the arched opening to the doorways remain (at nos. 4, 6, 8, 10 and 14) but fanlights are infilled. Stone painted sills remain at nos.4 – 10. No.12, whilst, brick appears to have been refronted or rebuilt with no detailing to the window or door openings; no.2 similarly has lost its arched doorway and sills. Roofs are pitched with gable end exposed at no.14. Chimney remains at no.2 and between nos.8 and 10. Alleyway runs along the rear.

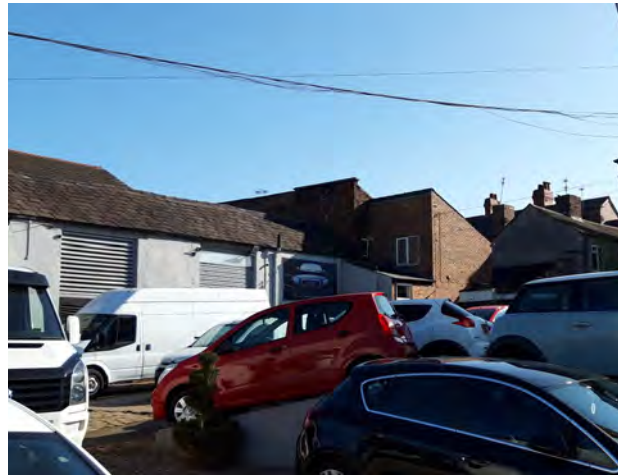
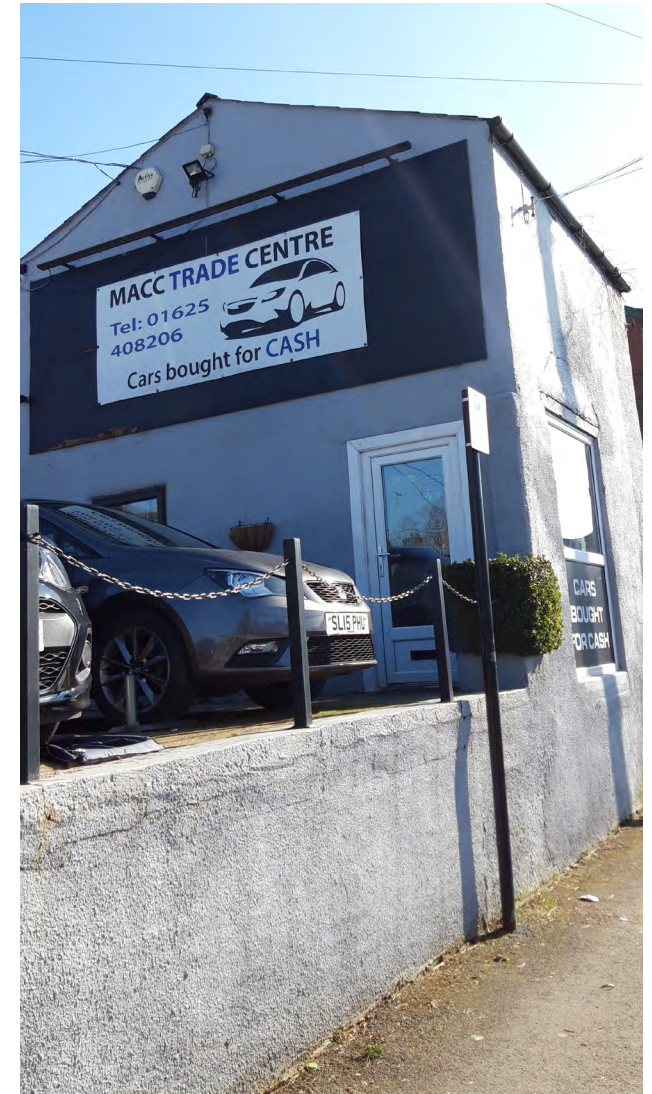
3 Westminster Street

Notes: A simple two storey building set hard up against the pavement edge, pitched roof with gable ends. Rendered and painted façade and lack of window openings other than a single opening to street and side elevations with modern units. High level sign and further clutter attached to façade detract. Forecourt is set at a raised level with traditional paving; a range runs along the rear of the forecourt with large openings and visible pitched roofs, roller shutters detract and cars dominate.

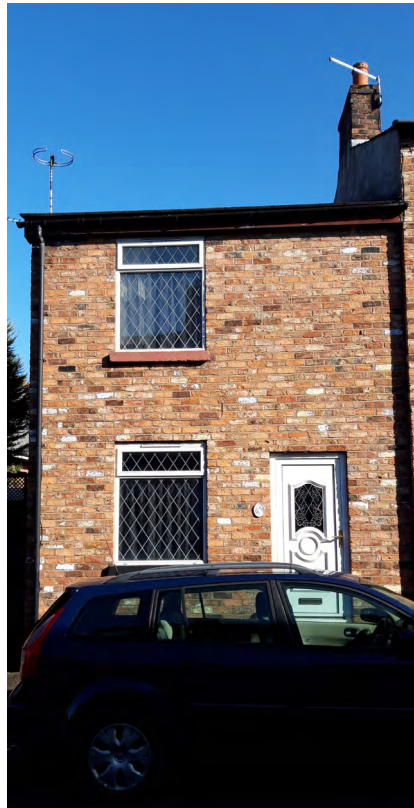
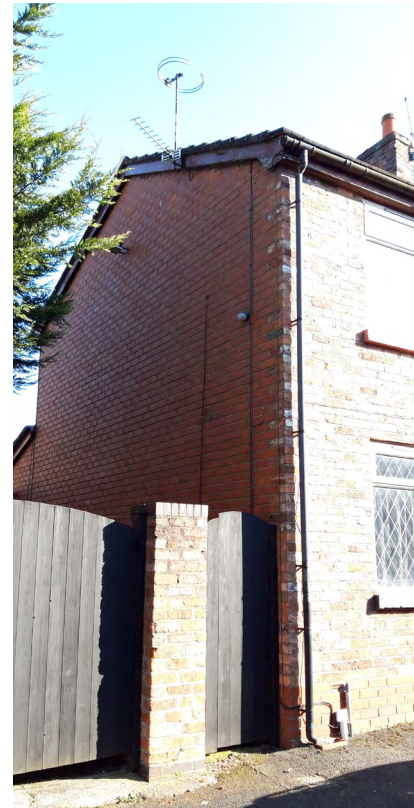
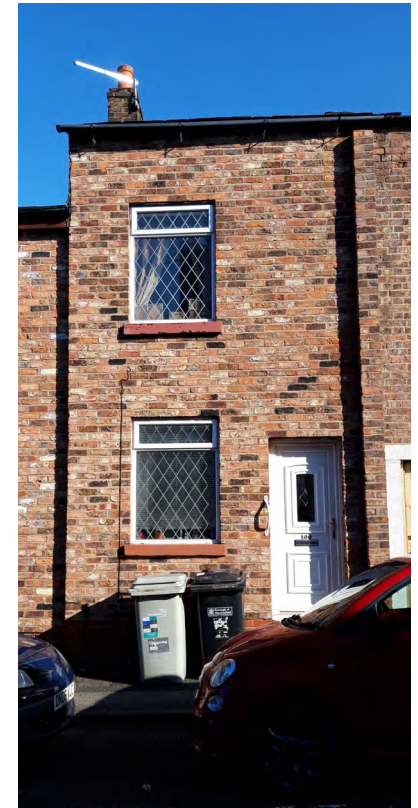
Notes: The pair of buildings are rather curious in the narrow frontage, one window bay wide with entrance door, and their absence of detailing to the windows and door surrounds suggests the facades are either later insertions or they have been remodelled. Notwithstanding no.100 continues the pitched roofline of no.21 Cumberland Street with gable end and chimney stack before it steps down to no.98. Windows and doors are uPVC with stone sills, a tall brick boundary wall with timber panelled gates extends to the north. The gable end wall is in contrasting red brick and a projecting single storey rear extension is visible.

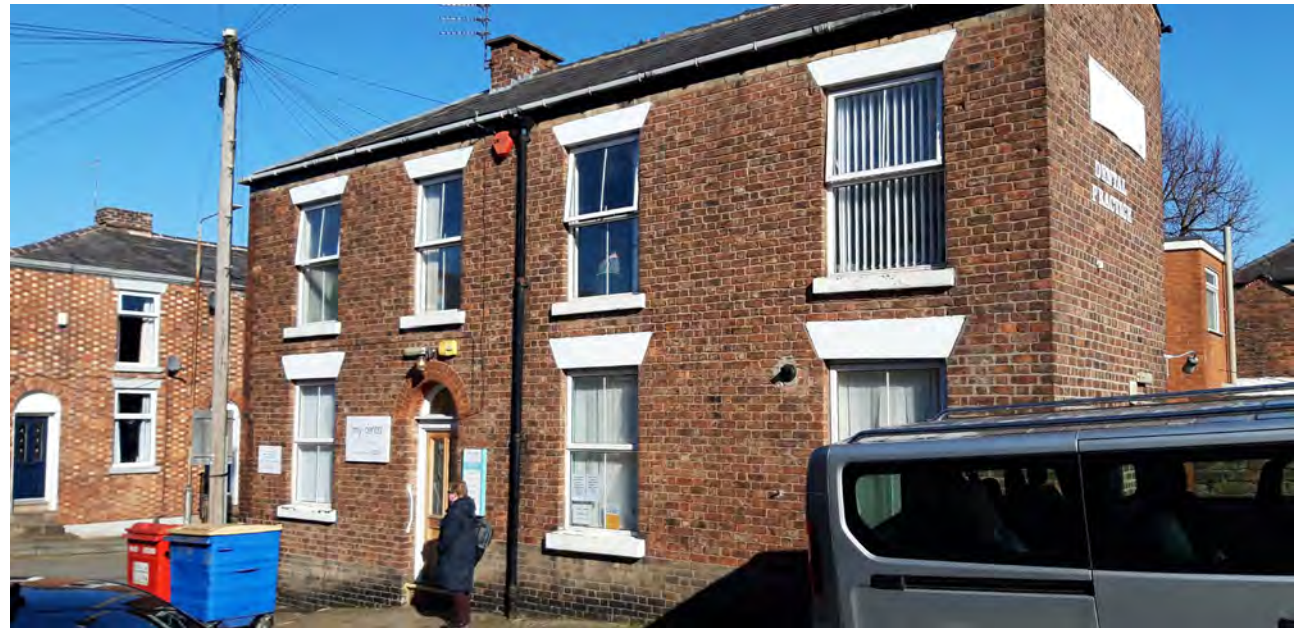
102 Brock Street

Notes: A four bay frontage to Brock Street with a single bay return to Cumberland Street. Comprising two storeys and constructed in red brick on a contrasting brick plinth with painted lintels and sills. Windows are uPVC casements which have sought to replicate the two-over-two sash design. Roof is pitched with chimney. Entrance door is off centre with brick arched opening, flue to front elevation and proliferation of signage detracts.

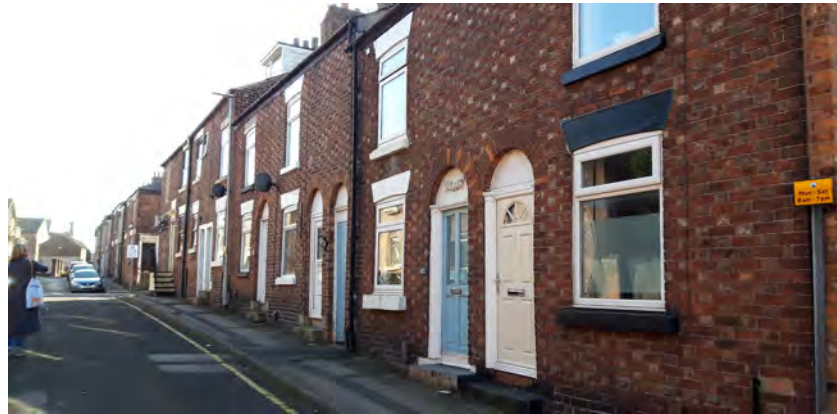
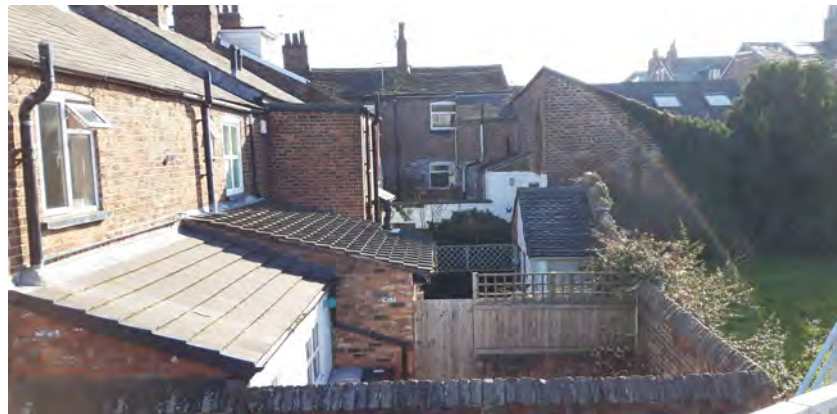
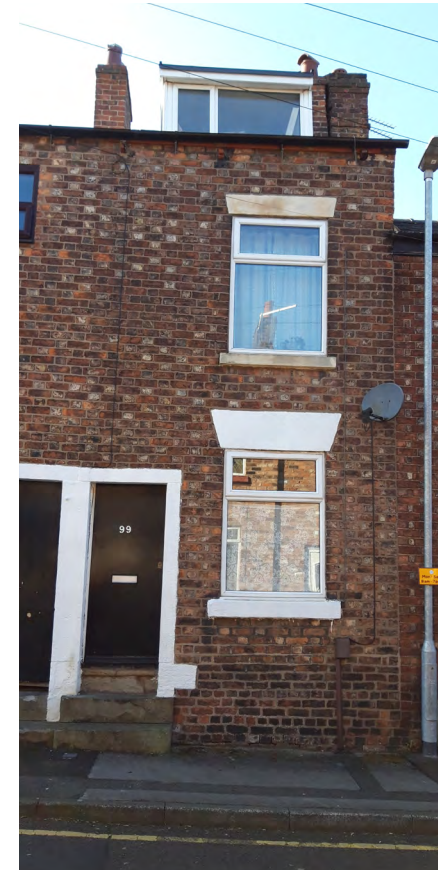
91-99 Brock Street

Notes: Two storey terrace group with a pitched roof which steps down at two intervals along the street with exposed gable ends and chimneys. Red brick with a chequerboard effect. Single bay arrangement with doors set to the side. Repeated detailing including painted lintels and sills, brick arch openings to the doors with blocked fanlights. Windows are modern uPVC windows which detract, doors are principally uPVC and inappropriate – stone steps provide access from the street, the timber and glass panelled door to no.93 is sympathetic. Satellite dishes add clutter and detract. Passageway to side at no.95 with timber boarded door. No.99 steps up to align with the side return of no.23 Cumberland Street; doorway is a simple square painted architrave paired with a passageway with door. A front dormer extension detracts.

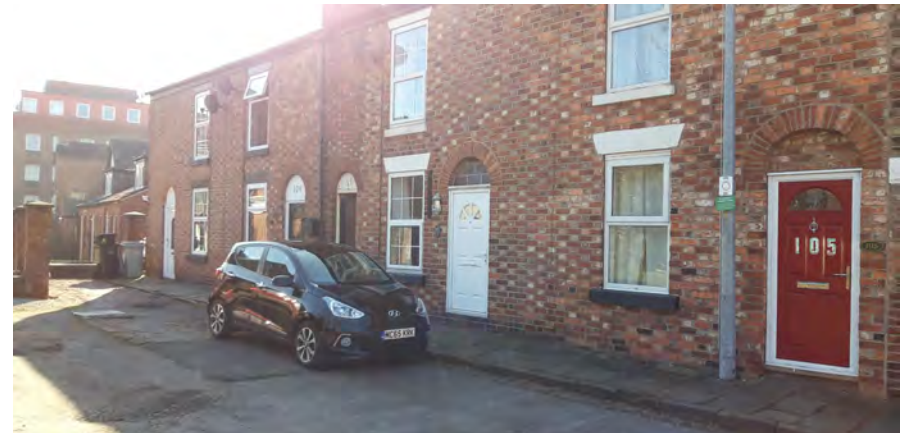
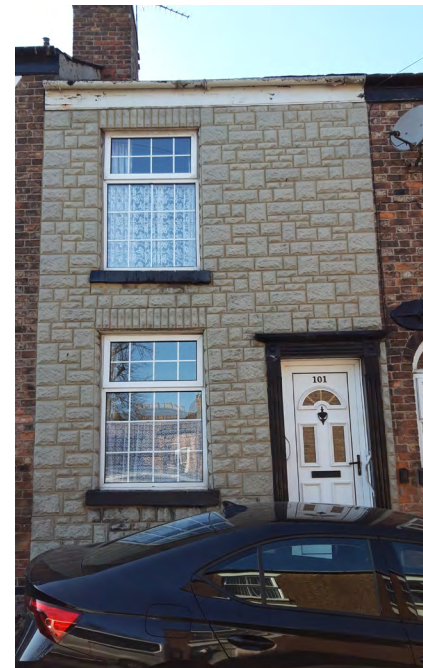
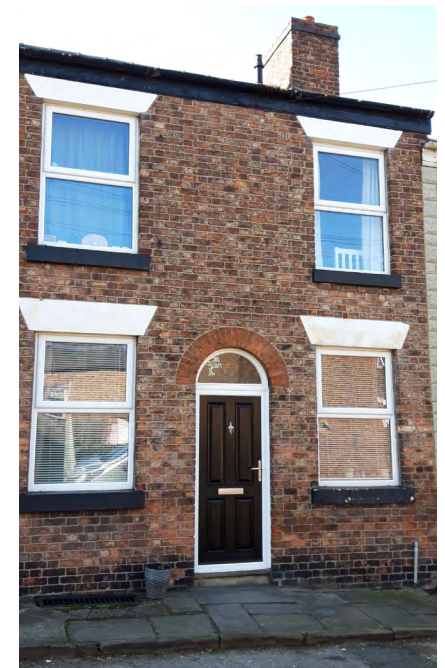
Notes: A two storey terrace group with a pitched roof and chimneys. Nos.105 - 111 have a shared character, single bay arrangement with doors set to the side in red brick with a chequerboard effect. Repeated detailing including painted lintels and sills, brick arch openings to the doors with blocked fanlights, detracting blockwork to no.107. Windows are modern uPVC windows which detract, doors are principally uPVC and inappropriate – stone step at no.105 and brick to no.107. Satellite dishes add clutter and detract. Passageway to side between nos.107 and 109 with timber boarded door and brick arch. No.103 is double fronted with a panelled door but otherwise follows the detailing of nos.105 - 111. No.101 has been refronted with an additional doorcase, uPVC windows and doors and detracts from the uniform character.

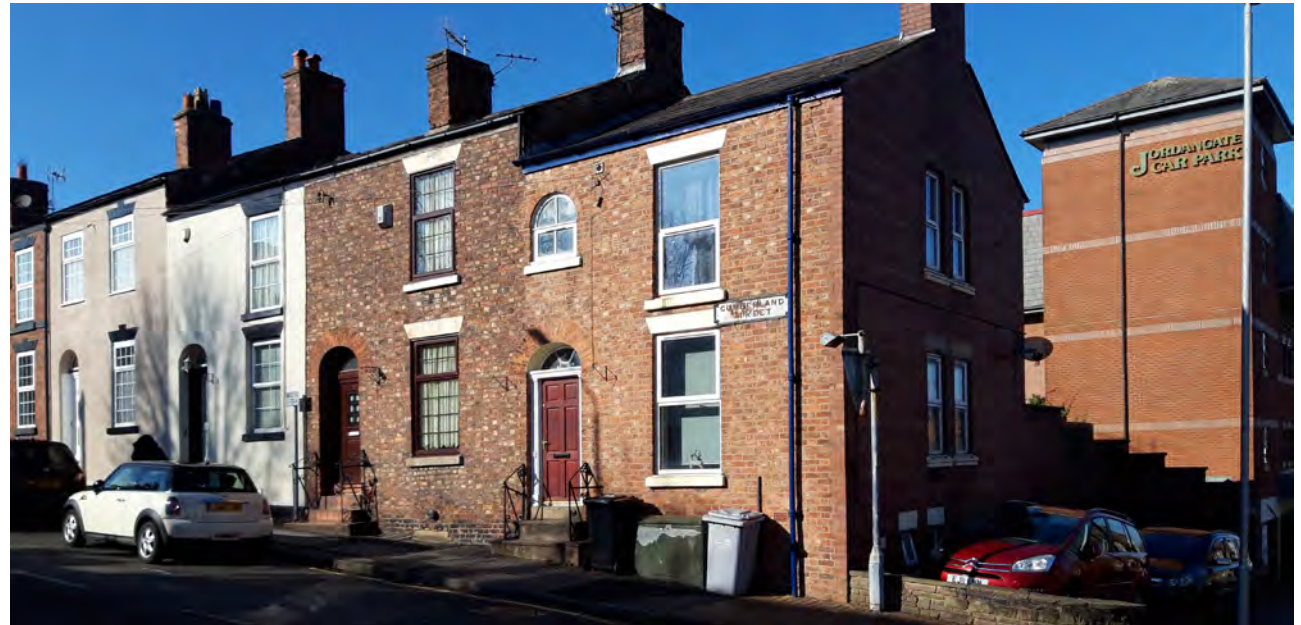
3-9 Cumberland Street

Notes: A two storey terrace group with an interesting pitched roofline which steps to mediate the change in levels with chimneys on the gable ends. One window bay with door set to the side – additional window with arched opening at first floor to no.1. Painted lintels and stone sills; brick arches to doors with fanlights and stone entrance steps with railings. The uniform character has been eroded through the insertion of contrasting uPVC windows and a variety of door designs which detract. Constructed in red brick; nos. 7 and 9 are now rendered which also detracts. Paired windows at ground and first floors in side elevation to no.3 facing Jordangate.

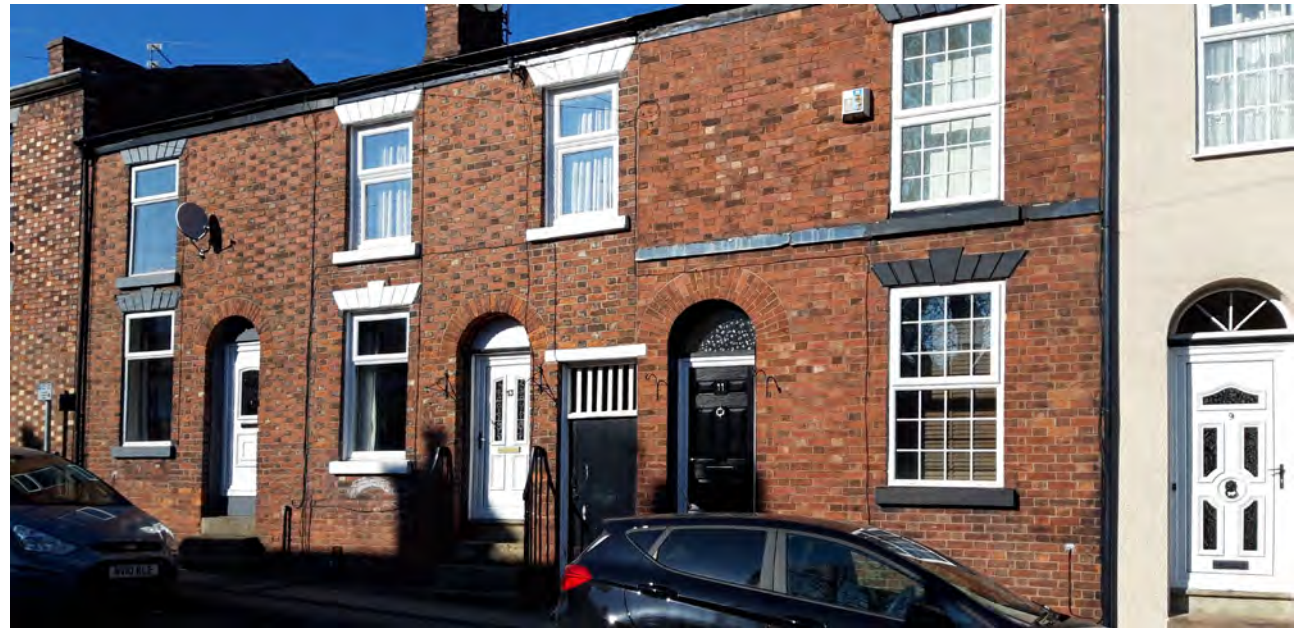
11-15 Cumberland Street

Overall condition: Good

Notes: A two storey group within the terrace which continues the aesthetic, constructed in red brick with subtle chequerboard effect, brick arched openings and stone entrance steps. Pitched roofs with chimney stacks. Doors are again later insertions and varied; uPVC casements detract. Passageway to side of no.11 with flat stone lintel. Painted sills and lintels with keystones.

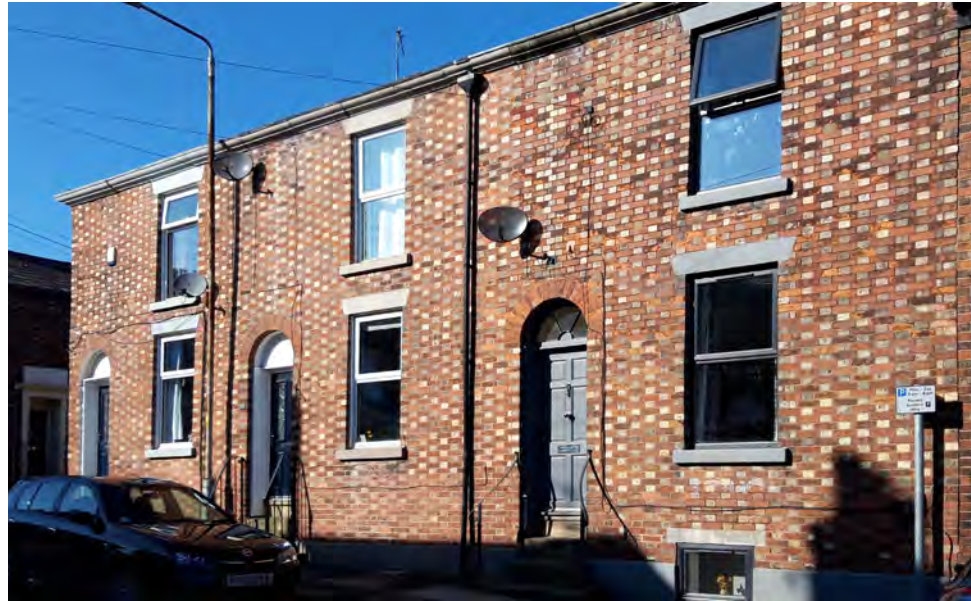
17-21 Cumberland Street

Overall condition: Good

Notes: Group of three at the end of the two-storey terrace with pitched roof on the corner with Brock Street. Red brick with chequerboard effect, brick arched openings and stone entrance steps. Doors are all timber panelled and sympathetic with fanlights above – blocked at nos.19 and 21. Painted lintels and sills - uPVC casements detract. Set on a plinth with a basement level window at no.17. Satellite dishes add clutter and detract. Return elevation to Brock Street is plain with infilled windows (lintels remaining) and patched brickwork.

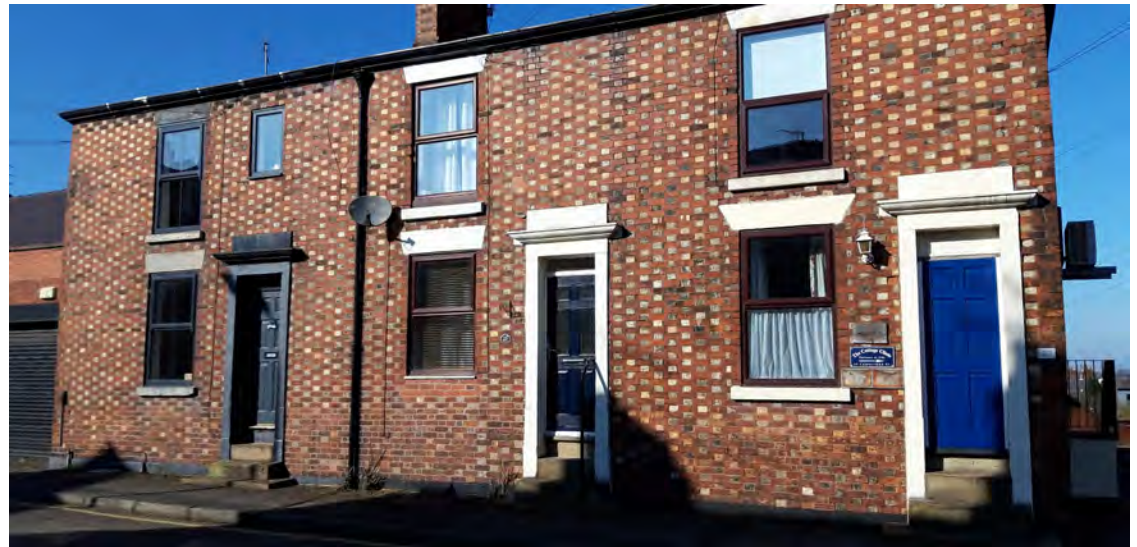
23-27 Cumberland Street

Overall condition: Good

Notes: Group of three two-storey terrace on the corner with Brock Street. Red brick with chequerboard effect with pronounced doorcases with cornice and plain square pediment; stone entrance steps. Doors are all timber panelled and sympathetic. Painted lintels and sills - uPVC casements detract; additional window inserted at first floor to no.27. Pitched roofs and chimney stacks with contrasting brick corners. Return elevation to Brock Street has a raised entrance and two window bays which repeat the detailing from the main façade; a/c unit at ground floor level detracts.

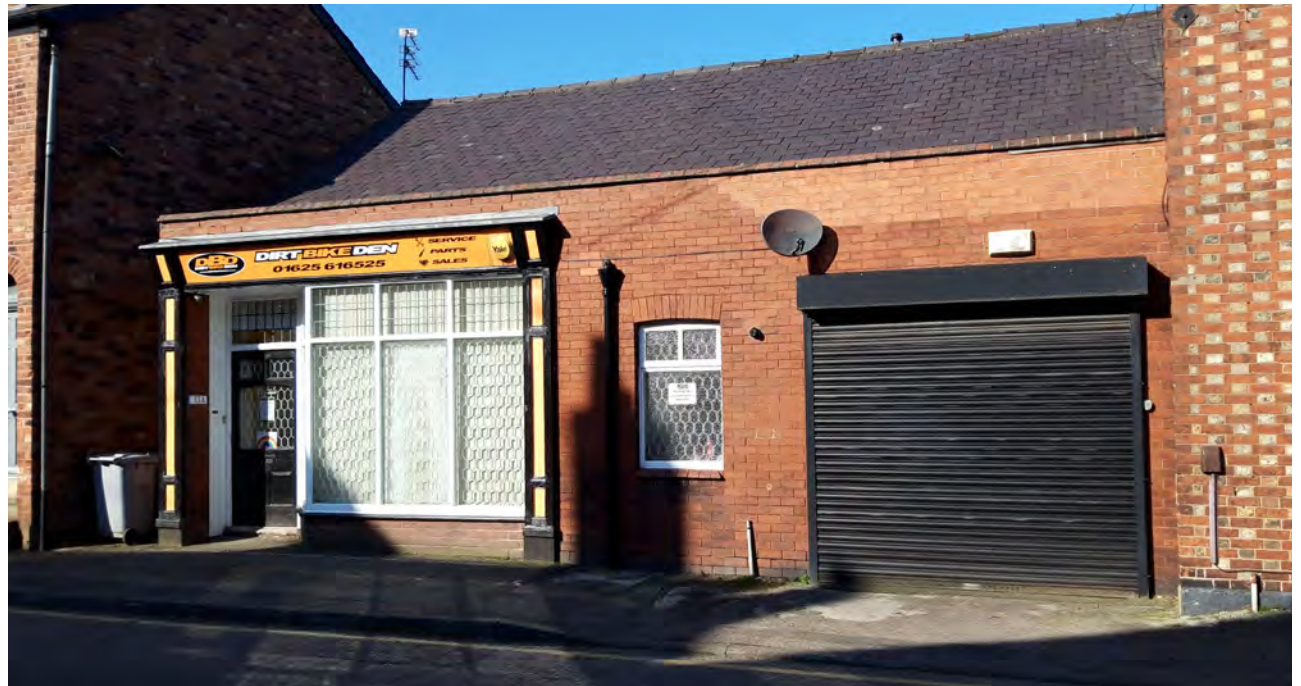
33a Cumberland Street

Overall condition: Good

Notes: Remodelled redundant storage building; single storey red brick set back from the building line. Visible, slate-clad pitched roof. Inserted traditional shopfront with pilasters, central window under brick arch and double width opening with detracting roller shutter and box.

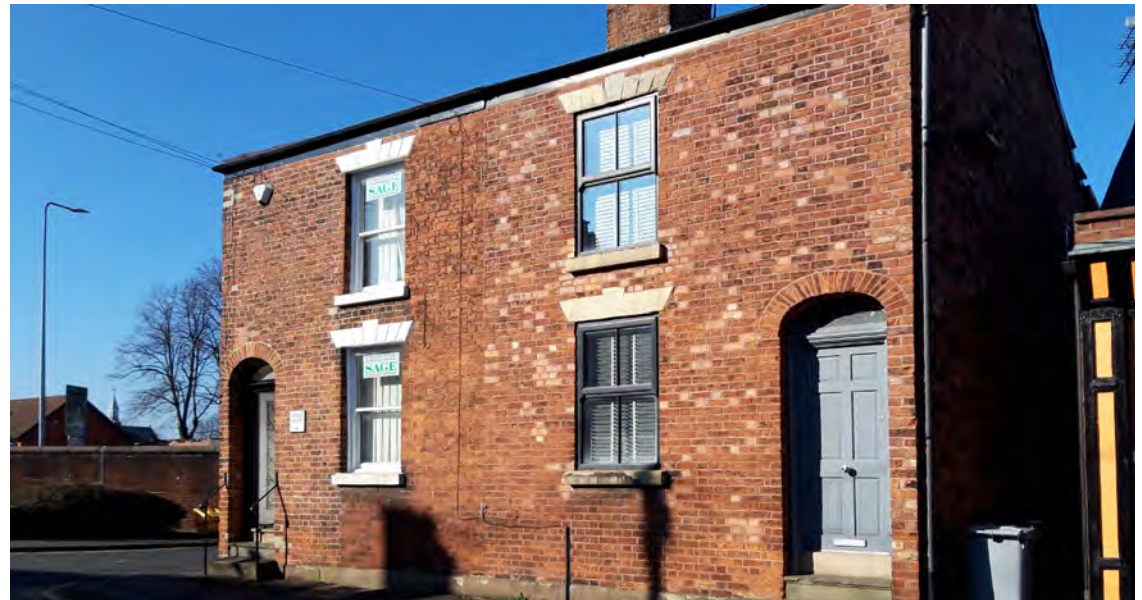
33-35 Cumberland Street

Overall condition: Good

Notes: Pair at western end of the street where it was truncated to allow for the new road system. Two storeys in red brick with brick arched openings and stone steps; pitched roof with chimney stack. Sashes remain at no.35, uPVC casements intended to replicate the sash design at no.33. Painted lintels with keystones and sills; panelled door and fanlight at no.33 is sympathetic. Arched window in side return to no.35; high level signage to side and rear elevations detracts. Parking at rear. Range of outbuildings set around car park to rear; two storey section with pitched roof and simple window openings with casements; wall mounted a/c unit and access stair detract. Single storey range has a corrugated metal roof and timber boarded doors with strap hinges set under concrete bressumer beams.

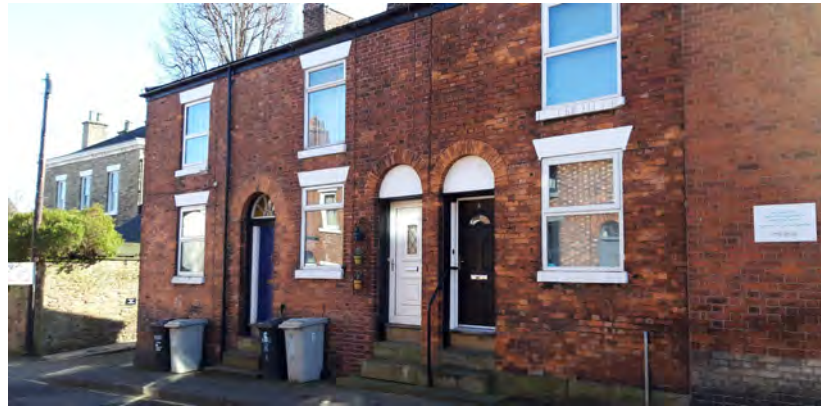
4-8 Cumberland Street

Overall condition: Good

Notes: Terrace group of three, comprising two storeys in red brick with brick arched openings and stone entrance steps. Pitched roof and chimney stacks. At nos.6 and 8 fanlights are blocked and modern doors; timber panelled door and fanlight at no.4 is sympathetic. Painted lintels and sills, windows are uPVC casements and detract. Return elevation to no.4 has a single window bay to rear repeating detailing from front facade and two storey projecting wing with perpendicular pitched front, uPVC casement to side. Rear two storey wings to nos.6 and 8 are modern, contrasting brick to no.6 detracts in views from Brock Street.

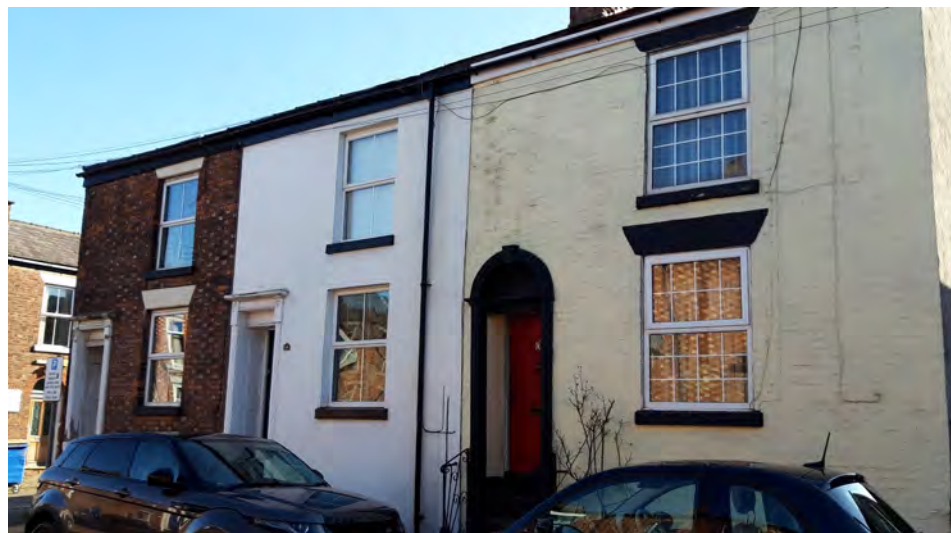
12-16 Cumberland Street

Overall condition: Good

Notes: Terrace group of three, comprising two storeys with pitched roof and chimney stack to nos.14/16. Exposed red brick to no.12, rendered to no.14 and painted brick to no.16 has eroded the uniformity which detracts; Regency doorcases at nos.12 and 14, arched with keystone to no.16 – all with recessed doors. Painted sills and lintels, uPVC casements detract. Return to Brock Street has two window bays which repeat the detailing to no.12 façade.

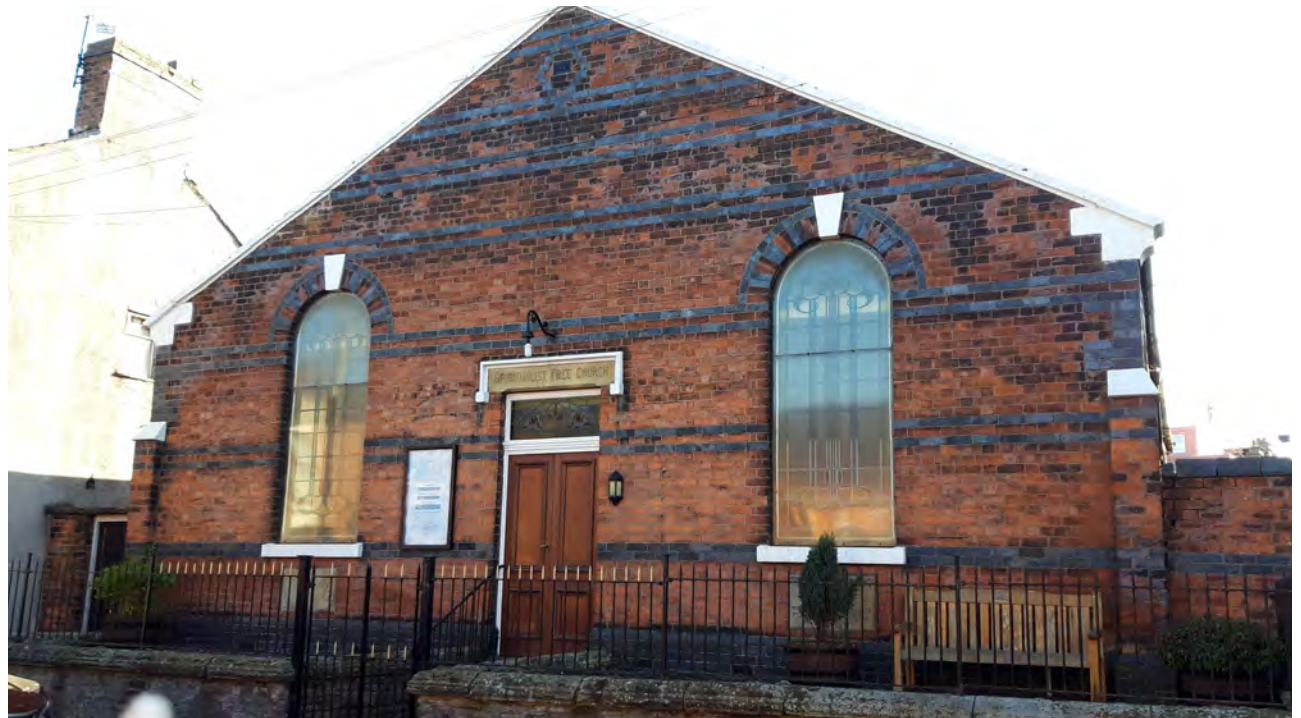
18 Cumberland Street, Macclesfield Spiritualist Church

Overall condition: Good

Notes: A tall single storey building with pitched roof and gable end to Cumberland Street. Red brick with dark brick detailing to brick arched windows, with keystones, and banding. Square doorcase with wooden panel doors and stained glass overhead; stained glass to two tall flanking arched windows – Perspex or similar added externally for protection. Setback from street with stone wall and metal railings. Brick walls flanking either side.

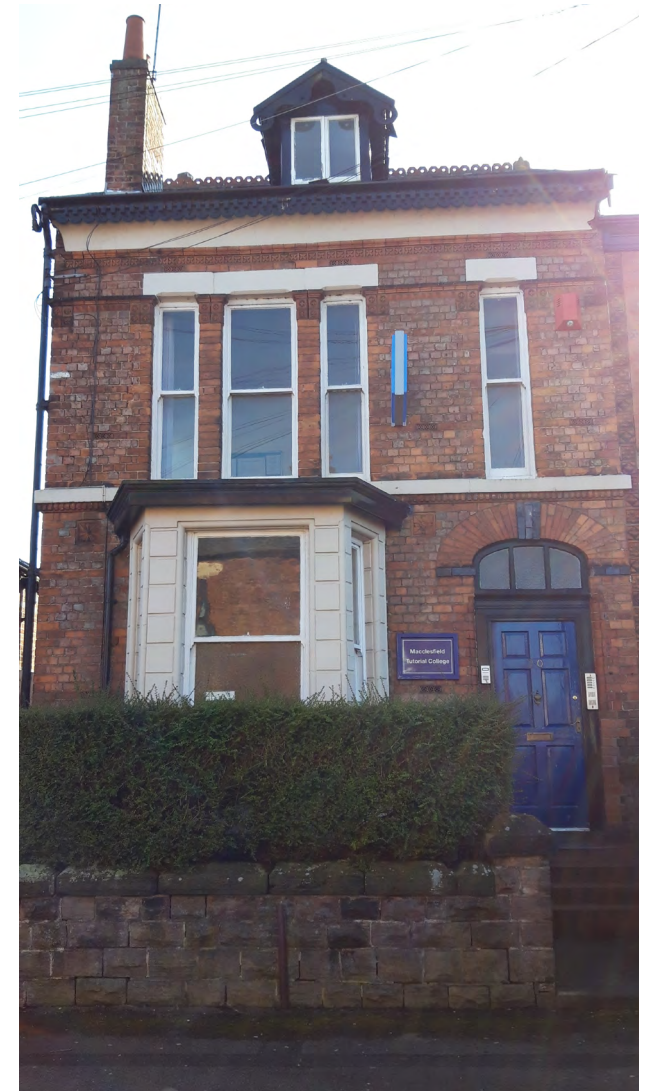
20 Cumberland Street

Overall condition: Good

Notes: A grander terrace building at the western end of Cumberland Street, set behind a small front garden with stone wall and hedge. Part of a terrace group of contrasting buildings with varied roofline. Comprising two storeys with raised ground floor and detailing including projecting rusticated canted bay window at raised ground floor, arched doorcase with dark brick detailing and panelled door, stone banding and plain cornice, tripartite window under stone lintel at first floor and narrow window adjacent. Windows all one-over-one timber sash. Narrow gabled dormer with modelled barge board and tall chimney stack to pitched roof. High level projecting sign detracts.

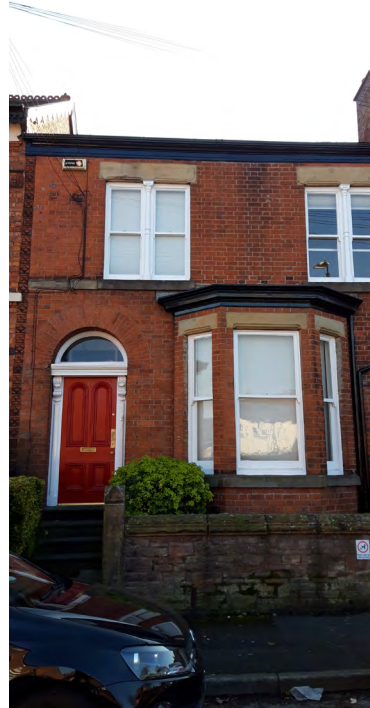
22 Cumberland Street

Overall condition: Good

Notes: Two storey red brick building with raised ground floor, pitched roof and chimney set behind a small front garden with stone wall. Part of a terrace group of contrasting buildings with varied roofline. Detailing including projecting canted bay window at ground floor with cornice, brick arched doorcase with pilasters, stone banding and lintels, paired windows at first floor with modelled mullion and cornice to eaves. Windows all one-over-one timber sash. Passageway to right-hand side with timber boarded door. Projecting two storey wing to rear with sash windows.

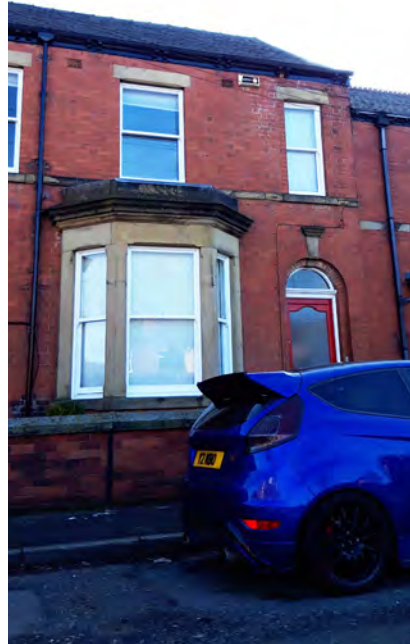
24 Cumberland Street

Overall condition: Good

Notes: Two storey red brick building with pitched roof and chimney set behind a small front garden with red brick wall and stone coping. Part of a terrace group of contrasting buildings with varied roofline. Detailing including projecting canted stone bay window at ground floor with cornice, brick arched doorcase with stone keystone, stone banding and lintels and three windows at first floor. Windows all one-over-one timber sash. Passageway to left-hand side with timber boarded door. Projecting two storey wing to rear with sash windows.
