Donald Insall Associates
Chartered Architects and Historic Building Consultants

Macclesfield Conservation Area
Gazetteer

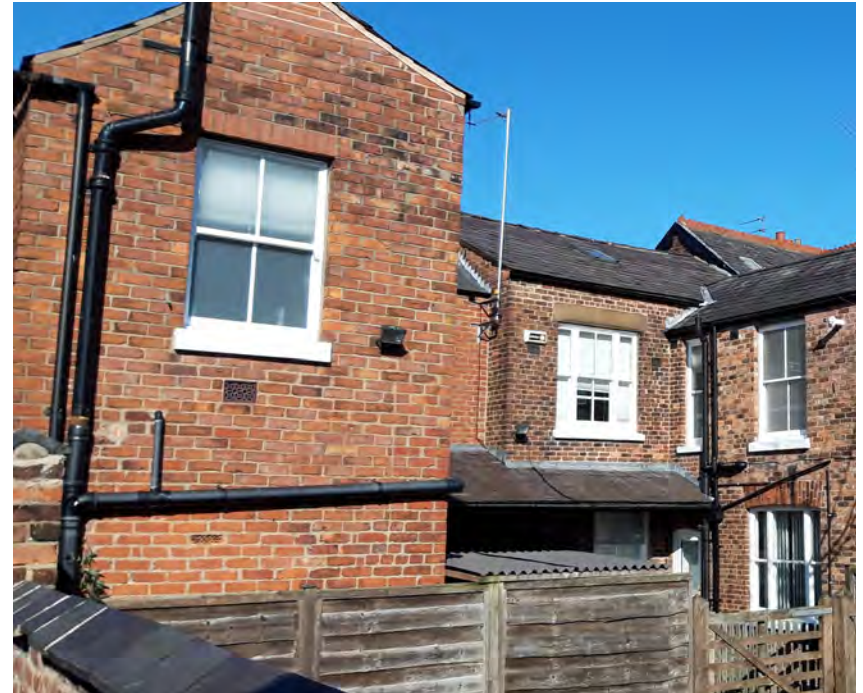
24 Cumberland Street, rear

Notes: Two storey red brick building with pitched roof and chimney set behind a small front garden with red brick wall and stone coping. Part of a terrace group of contrasting buildings with varied roofline. Detailing including projecting canted stone bay window at ground floor with cornice, brick arched doorcase with stone keystone, stone banding and lintels and three windows at first floor. Windows all one-over-one timber sash. Passageway to left-hand side with timber boarded door. Projecting two storey wing to rear with sash windows.

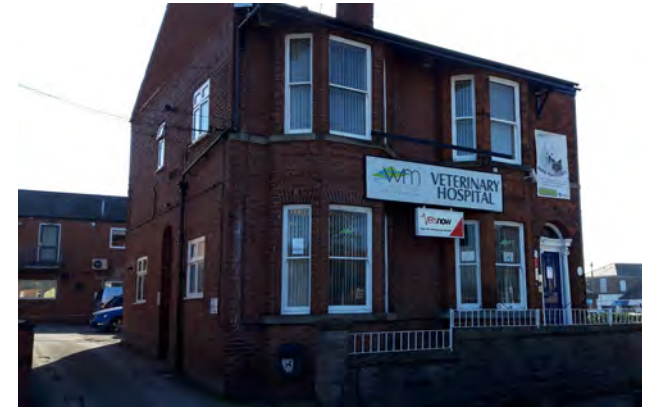
38 Cumberland Street

Overall condition: Good

Notes: Two storey building with pitched roof and chimney stack set back from the street behind a stone wall with gate pier and modern low railings on top. It is located on the edge of the inner ring road and has a rendered side elevation with exposed gable end and tall projecting wing. The front elevation has two bays of projecting canted bays with brick lintels and stone sills and roof eaves projecting over. The doorway has a brick arched opening with fanlight, panelled door and doorcase with pilasters and cornice. Windows are one-over-one timber sash. Proliferation of signage and at high level detracts. Recessed entrance to east elevation with brick arch; windows are uPVC casements and to the rear a mix of uPVC casements and timber sash. Projecting rear wing appears to have been extended by a storey, small ground floor extension with pitched roof.
