## Appendix 1 – Network Management and Enforcement

## Appendix 1 – Examples of improvement projects delivered

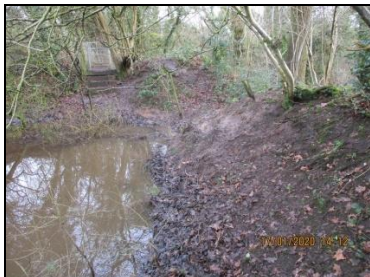
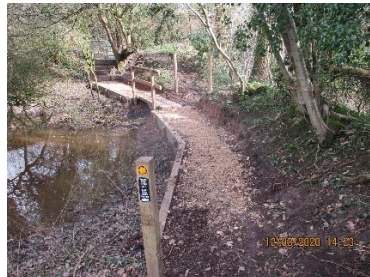
**Rainow Footpath No. 23:**

With a financial contribution from the Peak and Northern Footpath Society, the 6 metre bridge was replaced, with additional features to extend its lifespan, including damp proof course, eco-grid and water-proof paint.

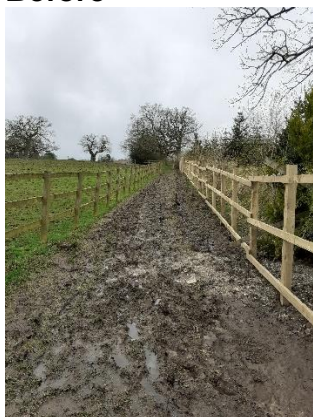
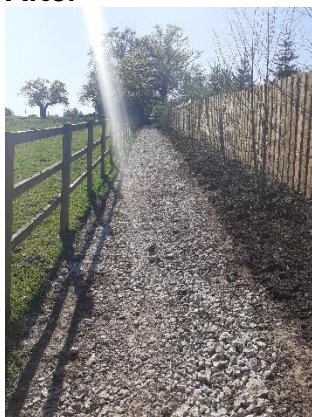
**Congleton Footpath No. 70:**

20m revetment, surfacing and associated drainage works to improve a very muddy path near the urban fringe area, forming, with the canal towpath, a circular walk for local residents.

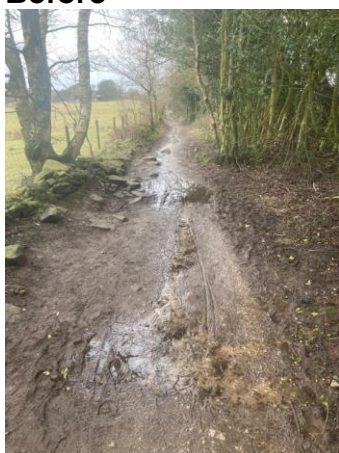
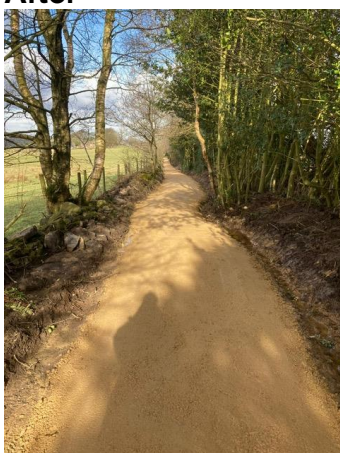
**Mottram St Andrew Footpath No. 3:**

With a small financial contribution from the Council, the owners of this path have resurfaced a 100m section that was a very muddy. The owners removed over 80 tonnes of mud, installed land drains, laid weed suppressing membrane on which they put 40 tonnes of MOT hardcore. Alongside the path, they also planted 15 acer trees.

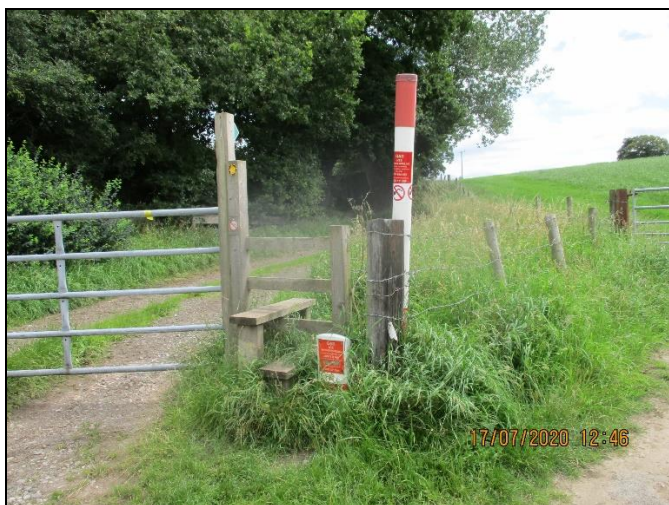
**Disley Footpath No. 28:**

150m of this very popular path, which also forms part of the Gritstone Trail promoted route, has been resurfaced and a trench dug alongside to aid drainage.

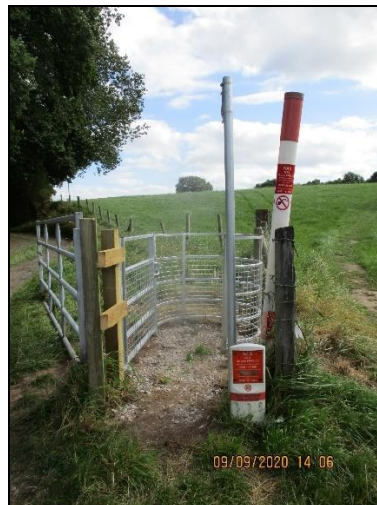
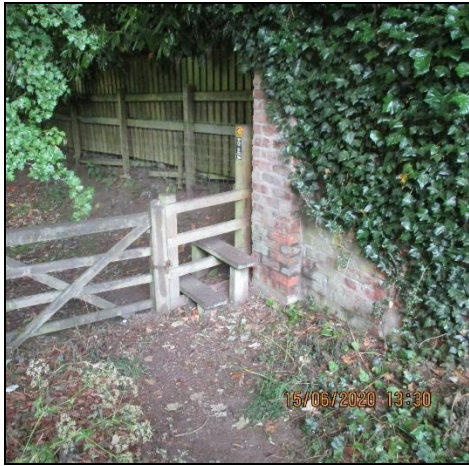
**Betchton Footpath No. 19 Before**

**Accessibility improvements:** investment in durable metal path furniture, such as the following examples of a gate replacements of stiles on a Public Footpaths, results in reduced maintenance, reduced liabilities and more accessible routes:
